TIER 3

ENVIRONMENTAL RISK ASSESSMENT

FORMER MUNICIPAL LANDFILL

WHITEGATE

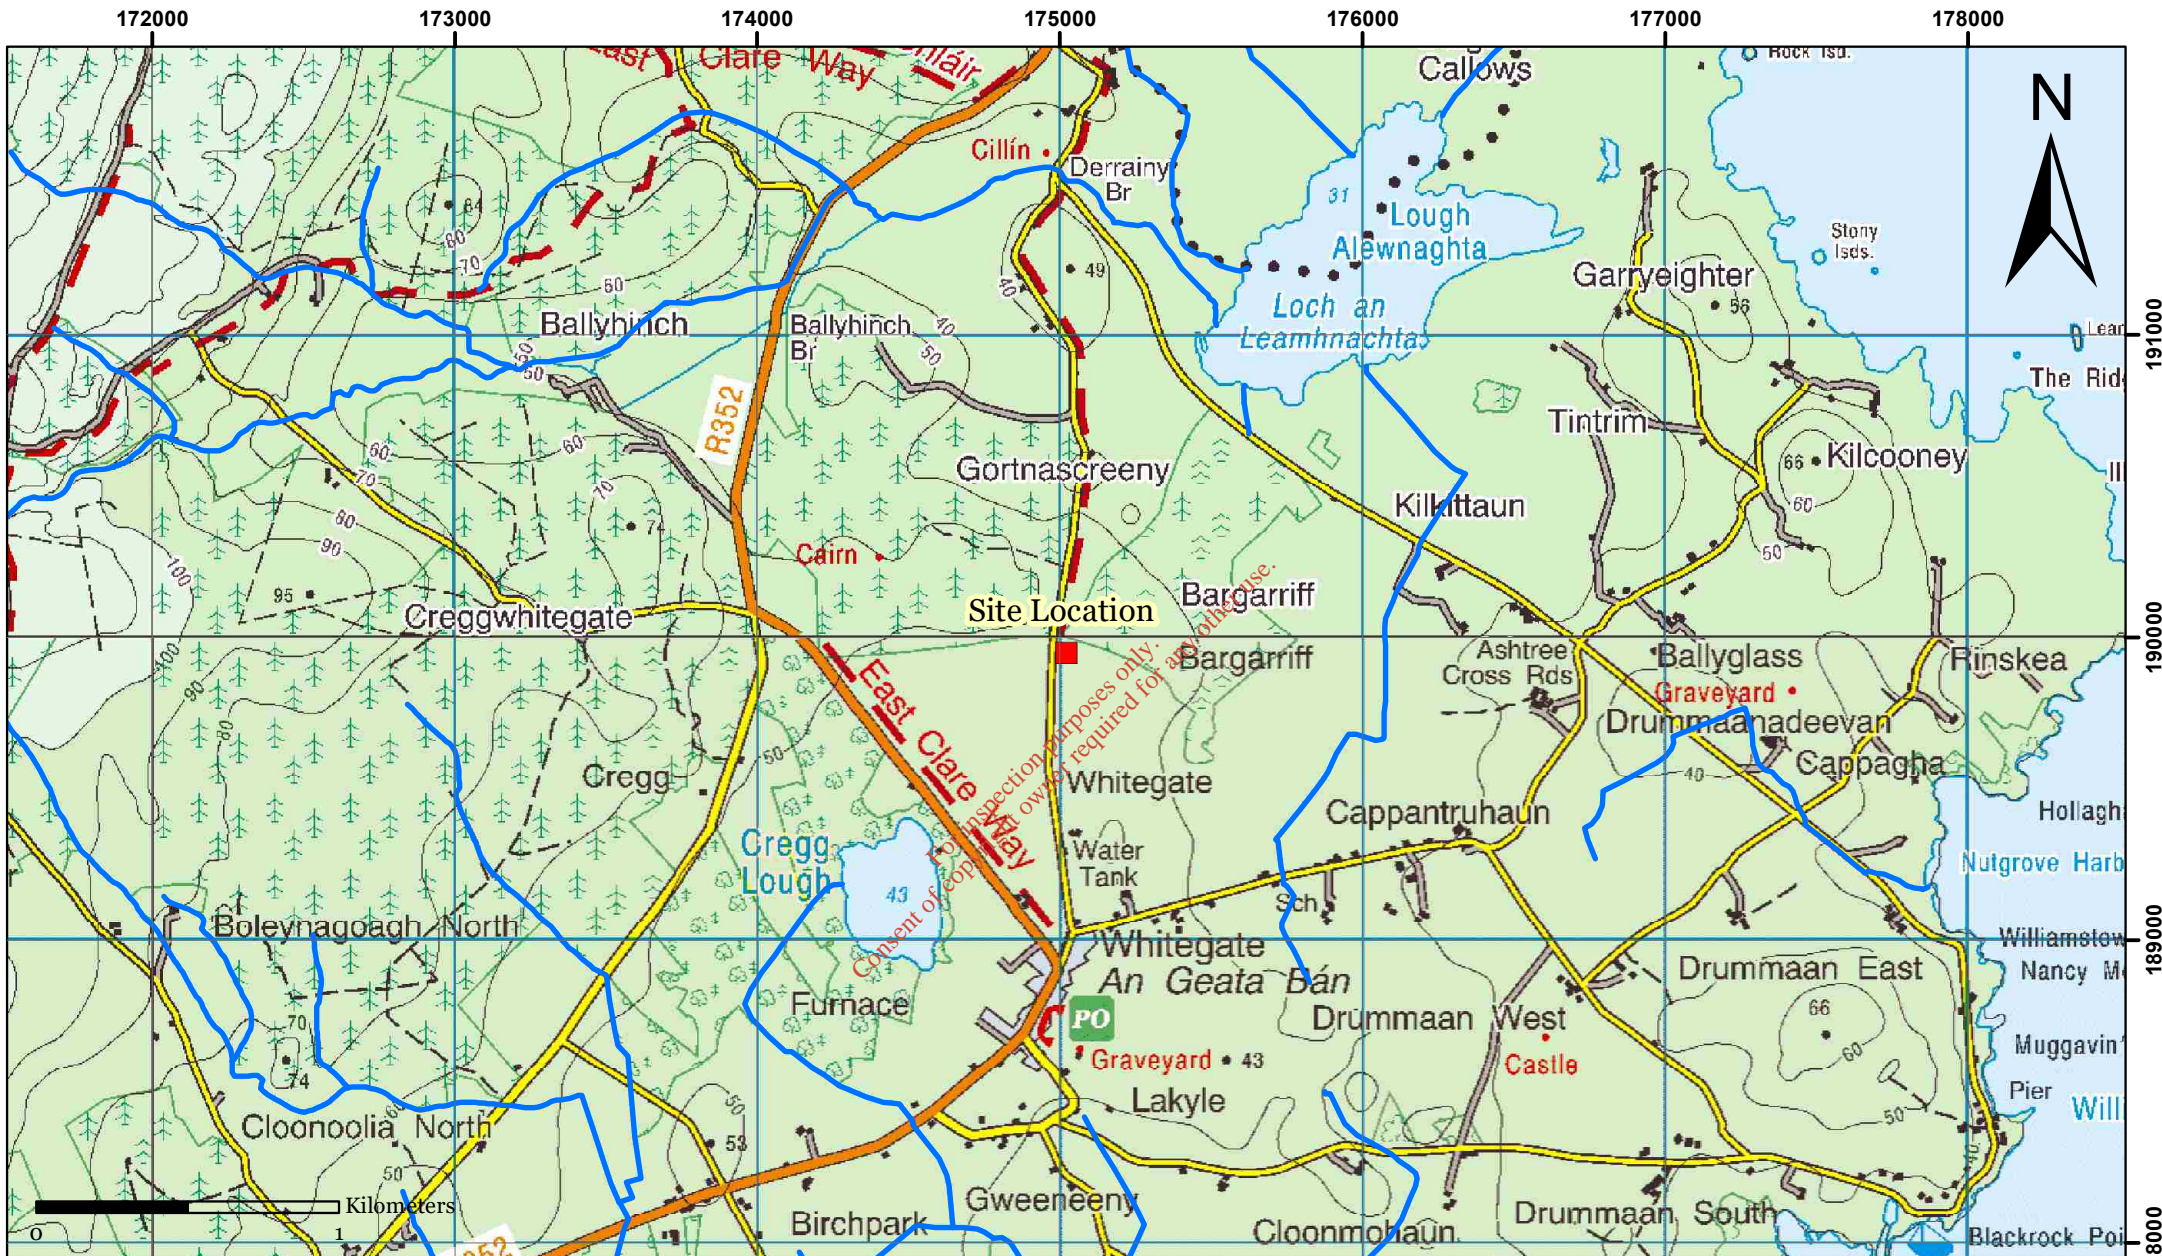
Figure 2.4

The site is located in the catchment of Lough Allewnaghta. There is a land drain running west to east along the northern site boundary western boundary. This drain discharges to the Derrainy River to the northeast of the site which eventually discharges to Lough Allewnaghta c 1km northeast of the site. Cregg Lough is located c1.15km to the southwest of the site but there is no drains connecting to this Lough from the site and drainage out of Cregg Lough is to the southwest away from the site into Lough Derg (Figure 2.4).

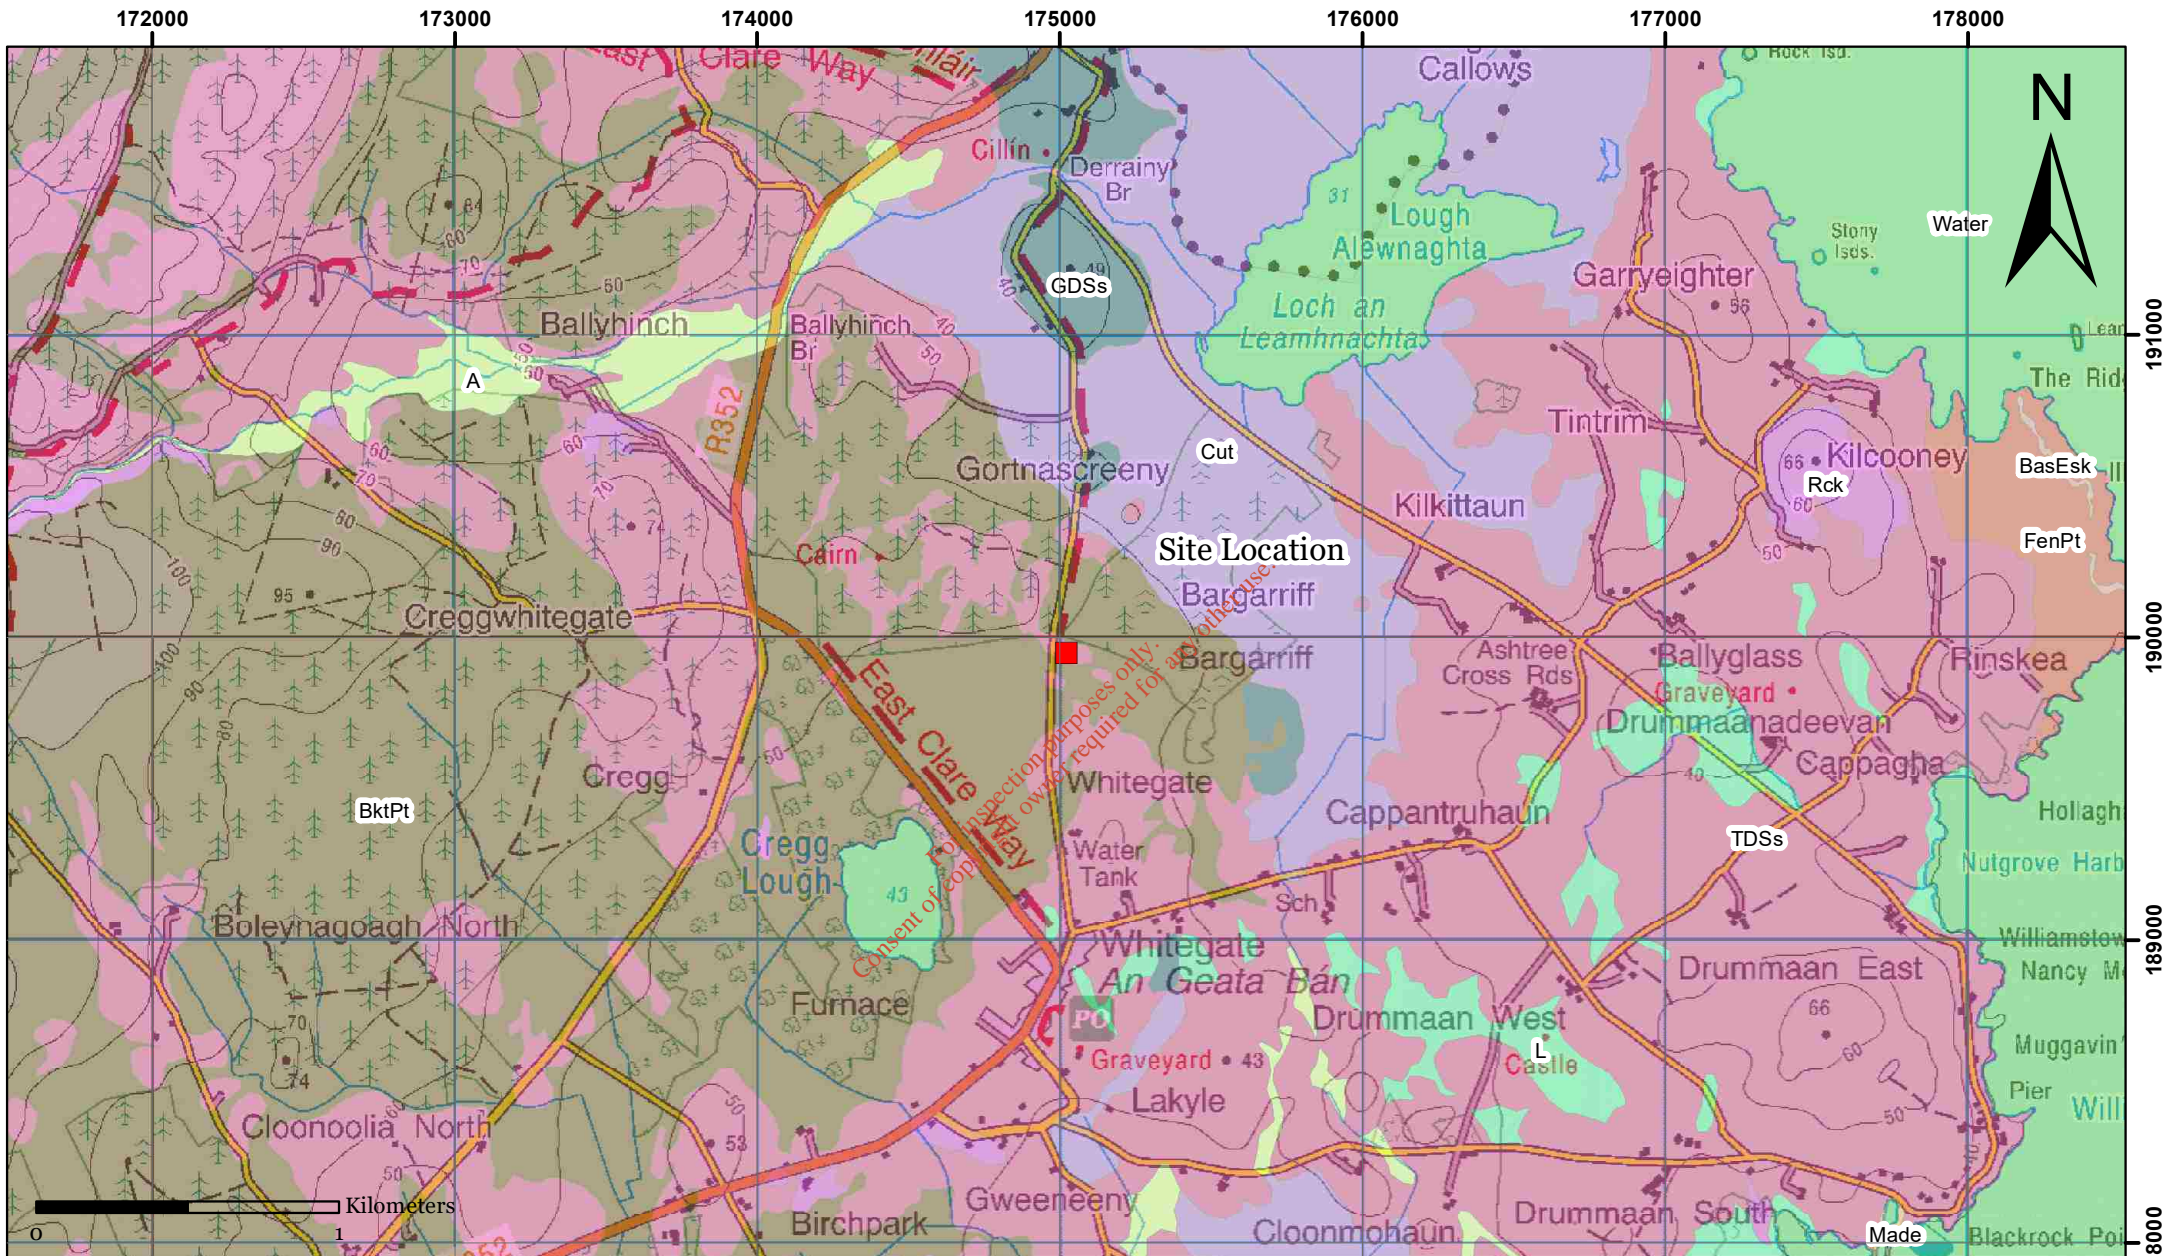
Figure 2.5

Figure 2.5, which is derived from the Teagasc Maps, shows the subsoils beneath the site and in the surrounding area comprise cut over peat.

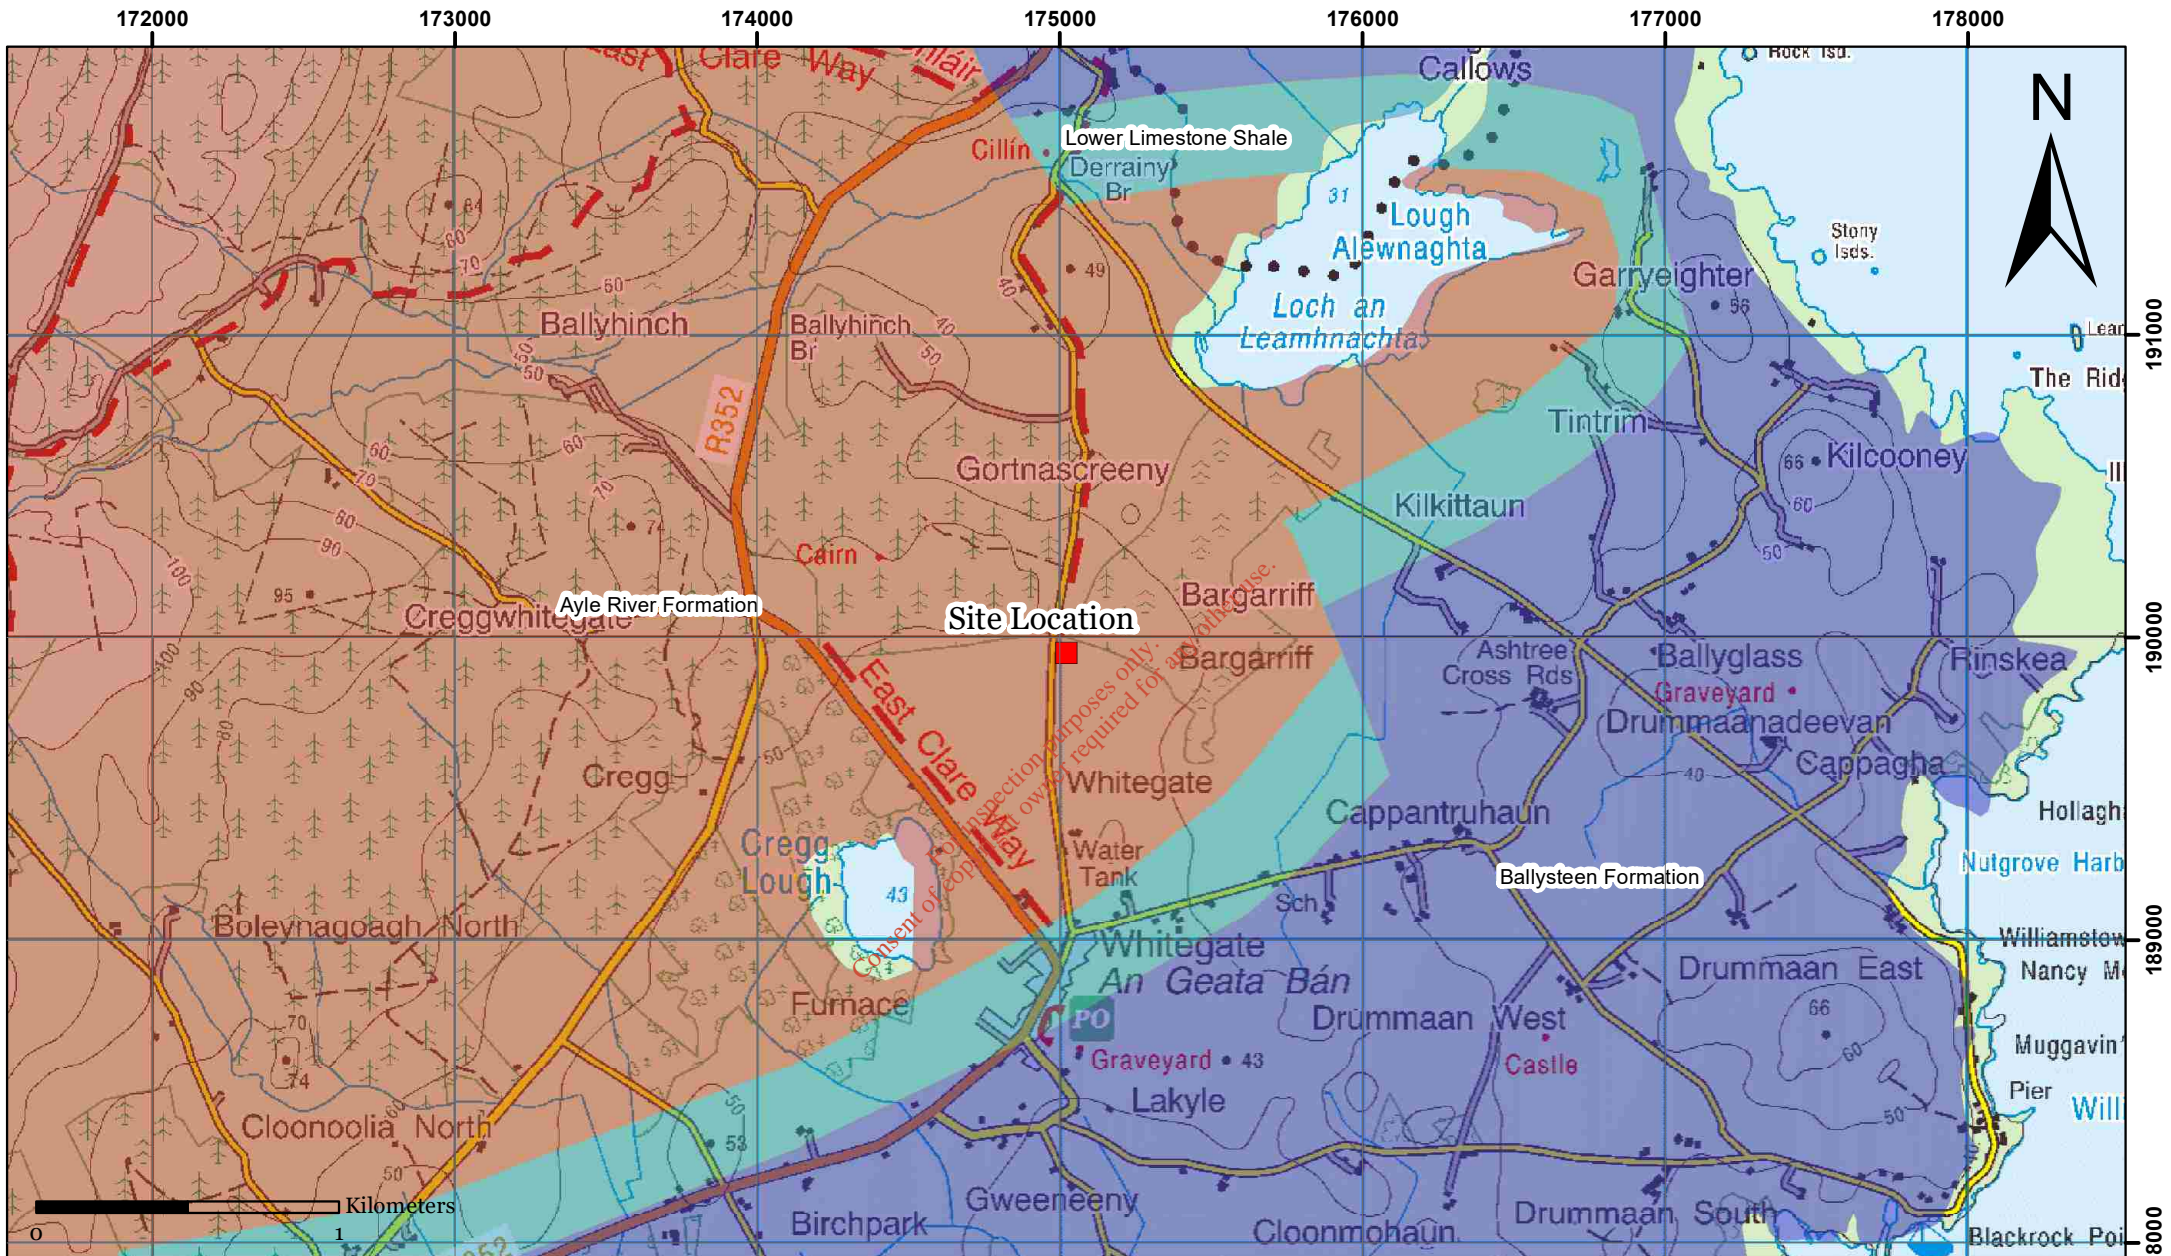
CLIENT	Clare County Council
TITLE	Bedrock Geology

The site is underlain entirely by a mudstone and siltstone conglomerate from the Ayle Rier Formation. (Figure 2.6).

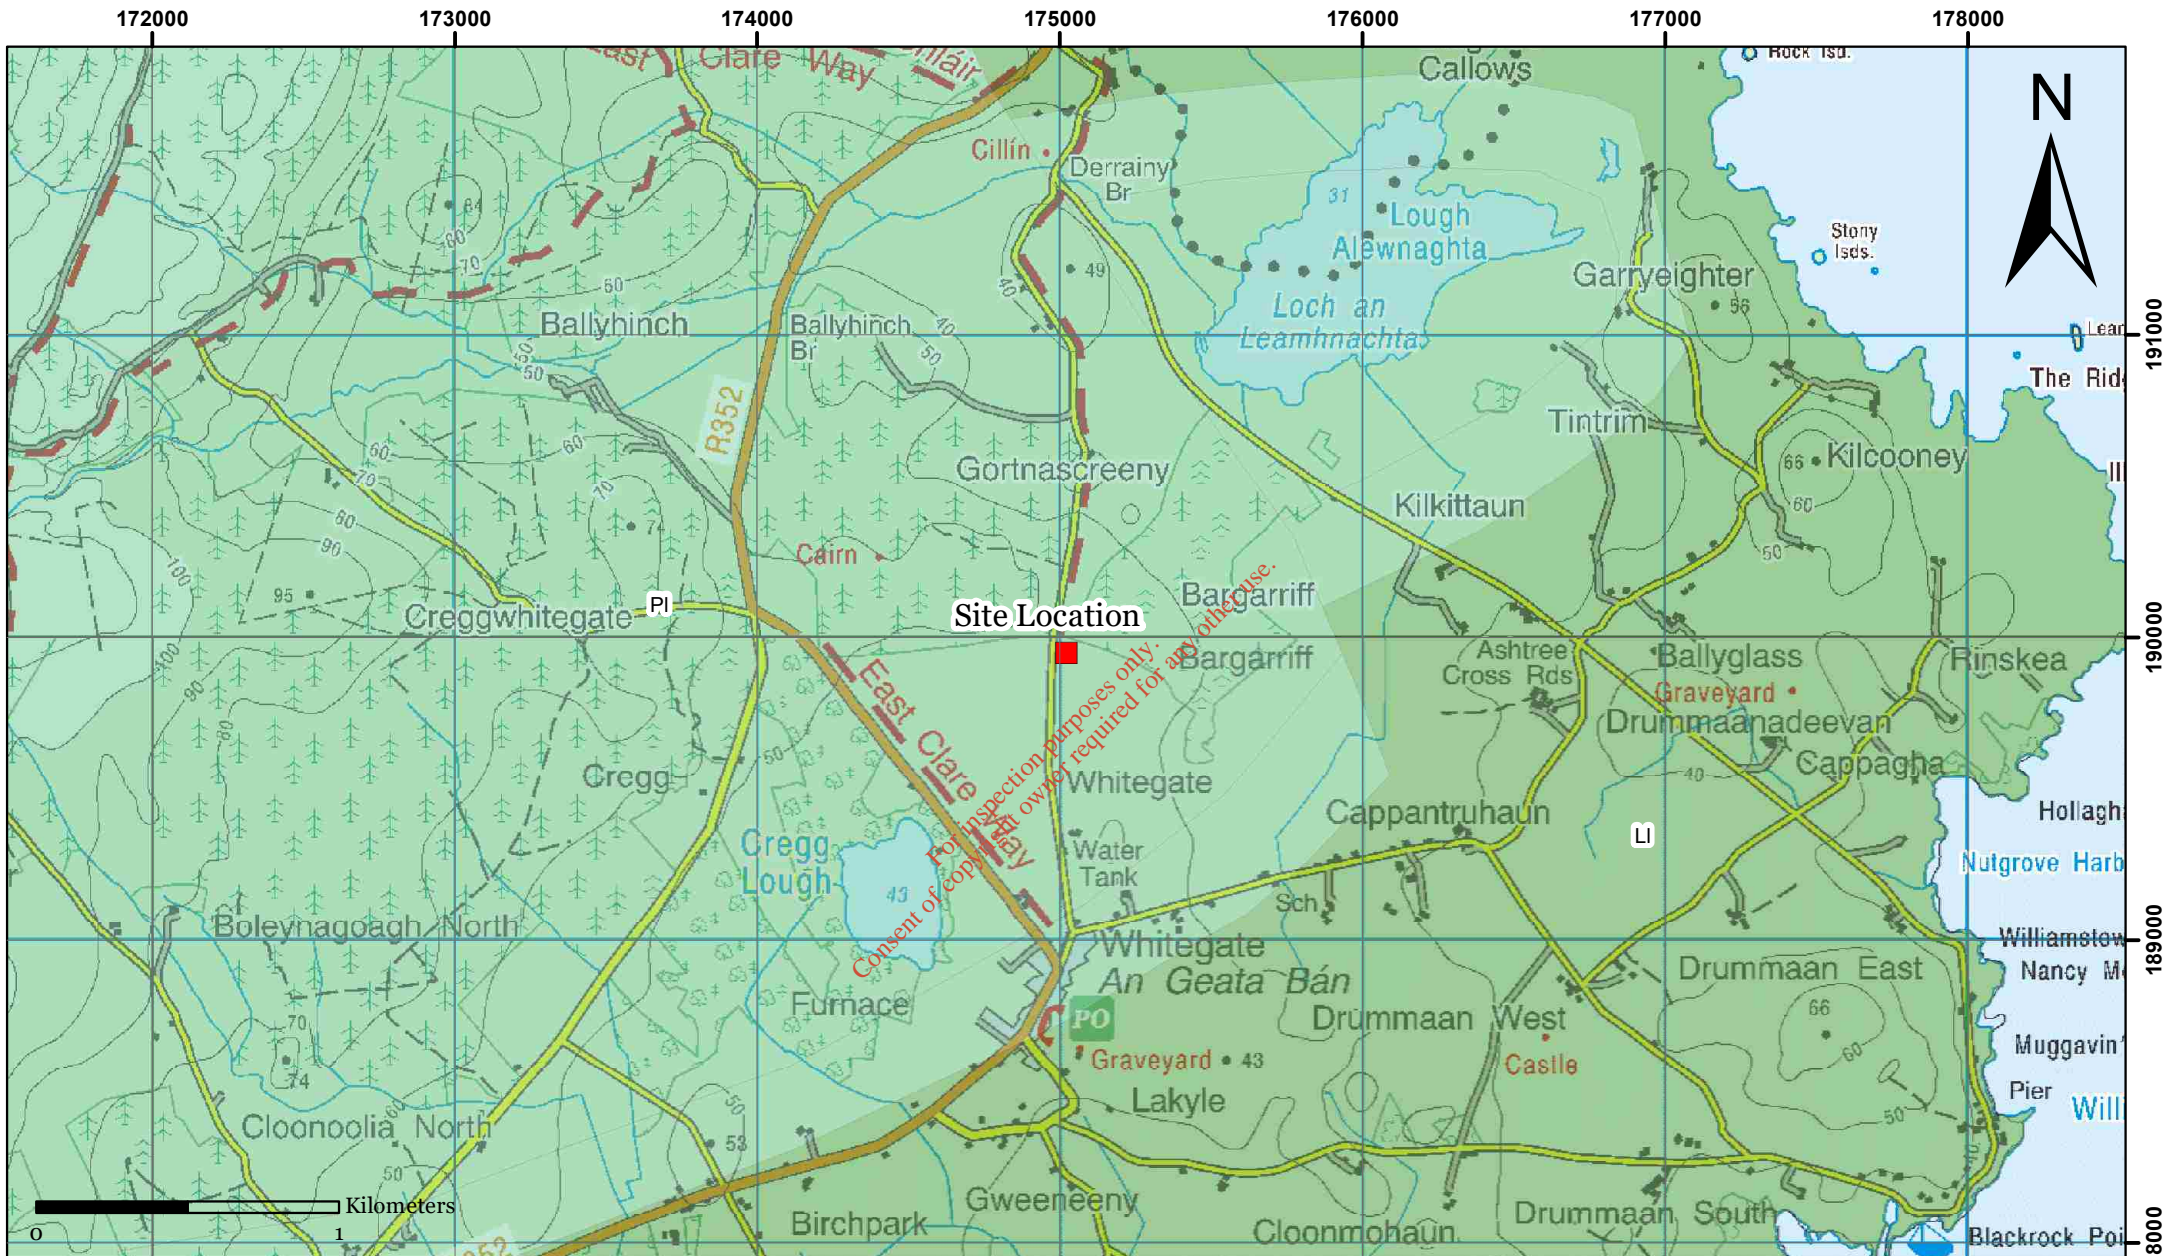
Figure 2.8

The vulnerability rating for the bedrock aquifer underlying the peat in the area is classified as Moderate indicating the presence of up to 5m of subsoils above the bedrock (Figure 2.8) however the harvesting of peat has reduced the vulnerability rating and the trial pit excavations indicates that the vulnerability in T-6 and T-8 is Extreme. .

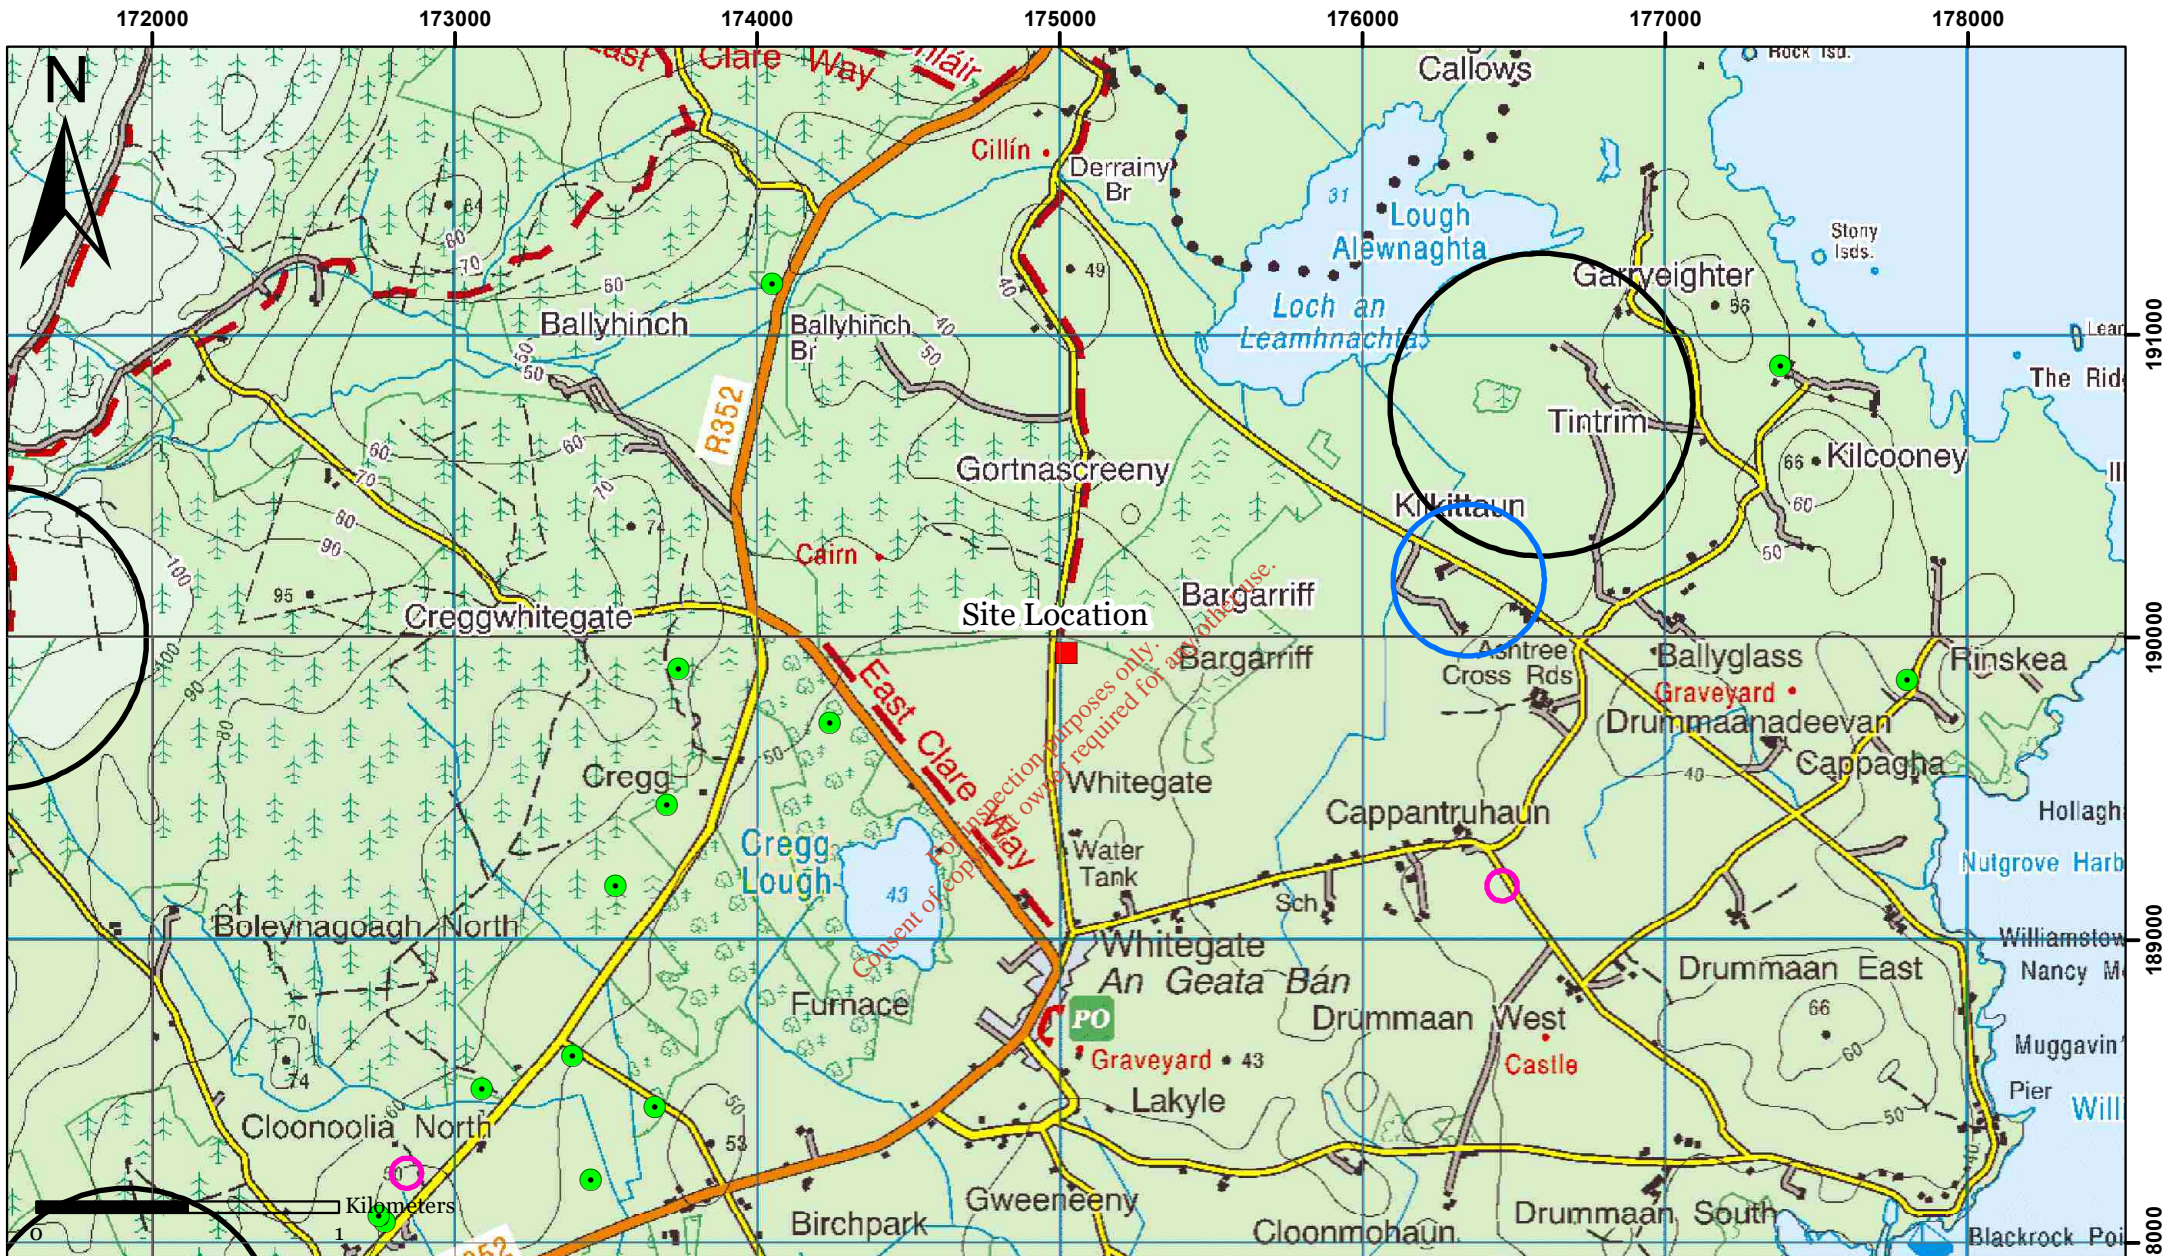
Figure 2.9

OCM conducted a review of the GSI database to identify the location of any nearby wells or springs. The Whitegate public water supply well is located c3km to the southwest of the site in a separate hydrologic catchment. The closest down hydraulic gradient well identified by GSI is c1.5km to the east of the site in Killkittuan townland and is an agricultural and domestic well installed in 2002 with an abstraction rate of 32 m³/day. (Figure 2.9). This is also the closest well to the site identified by the Council during the Tier 2 investigations.

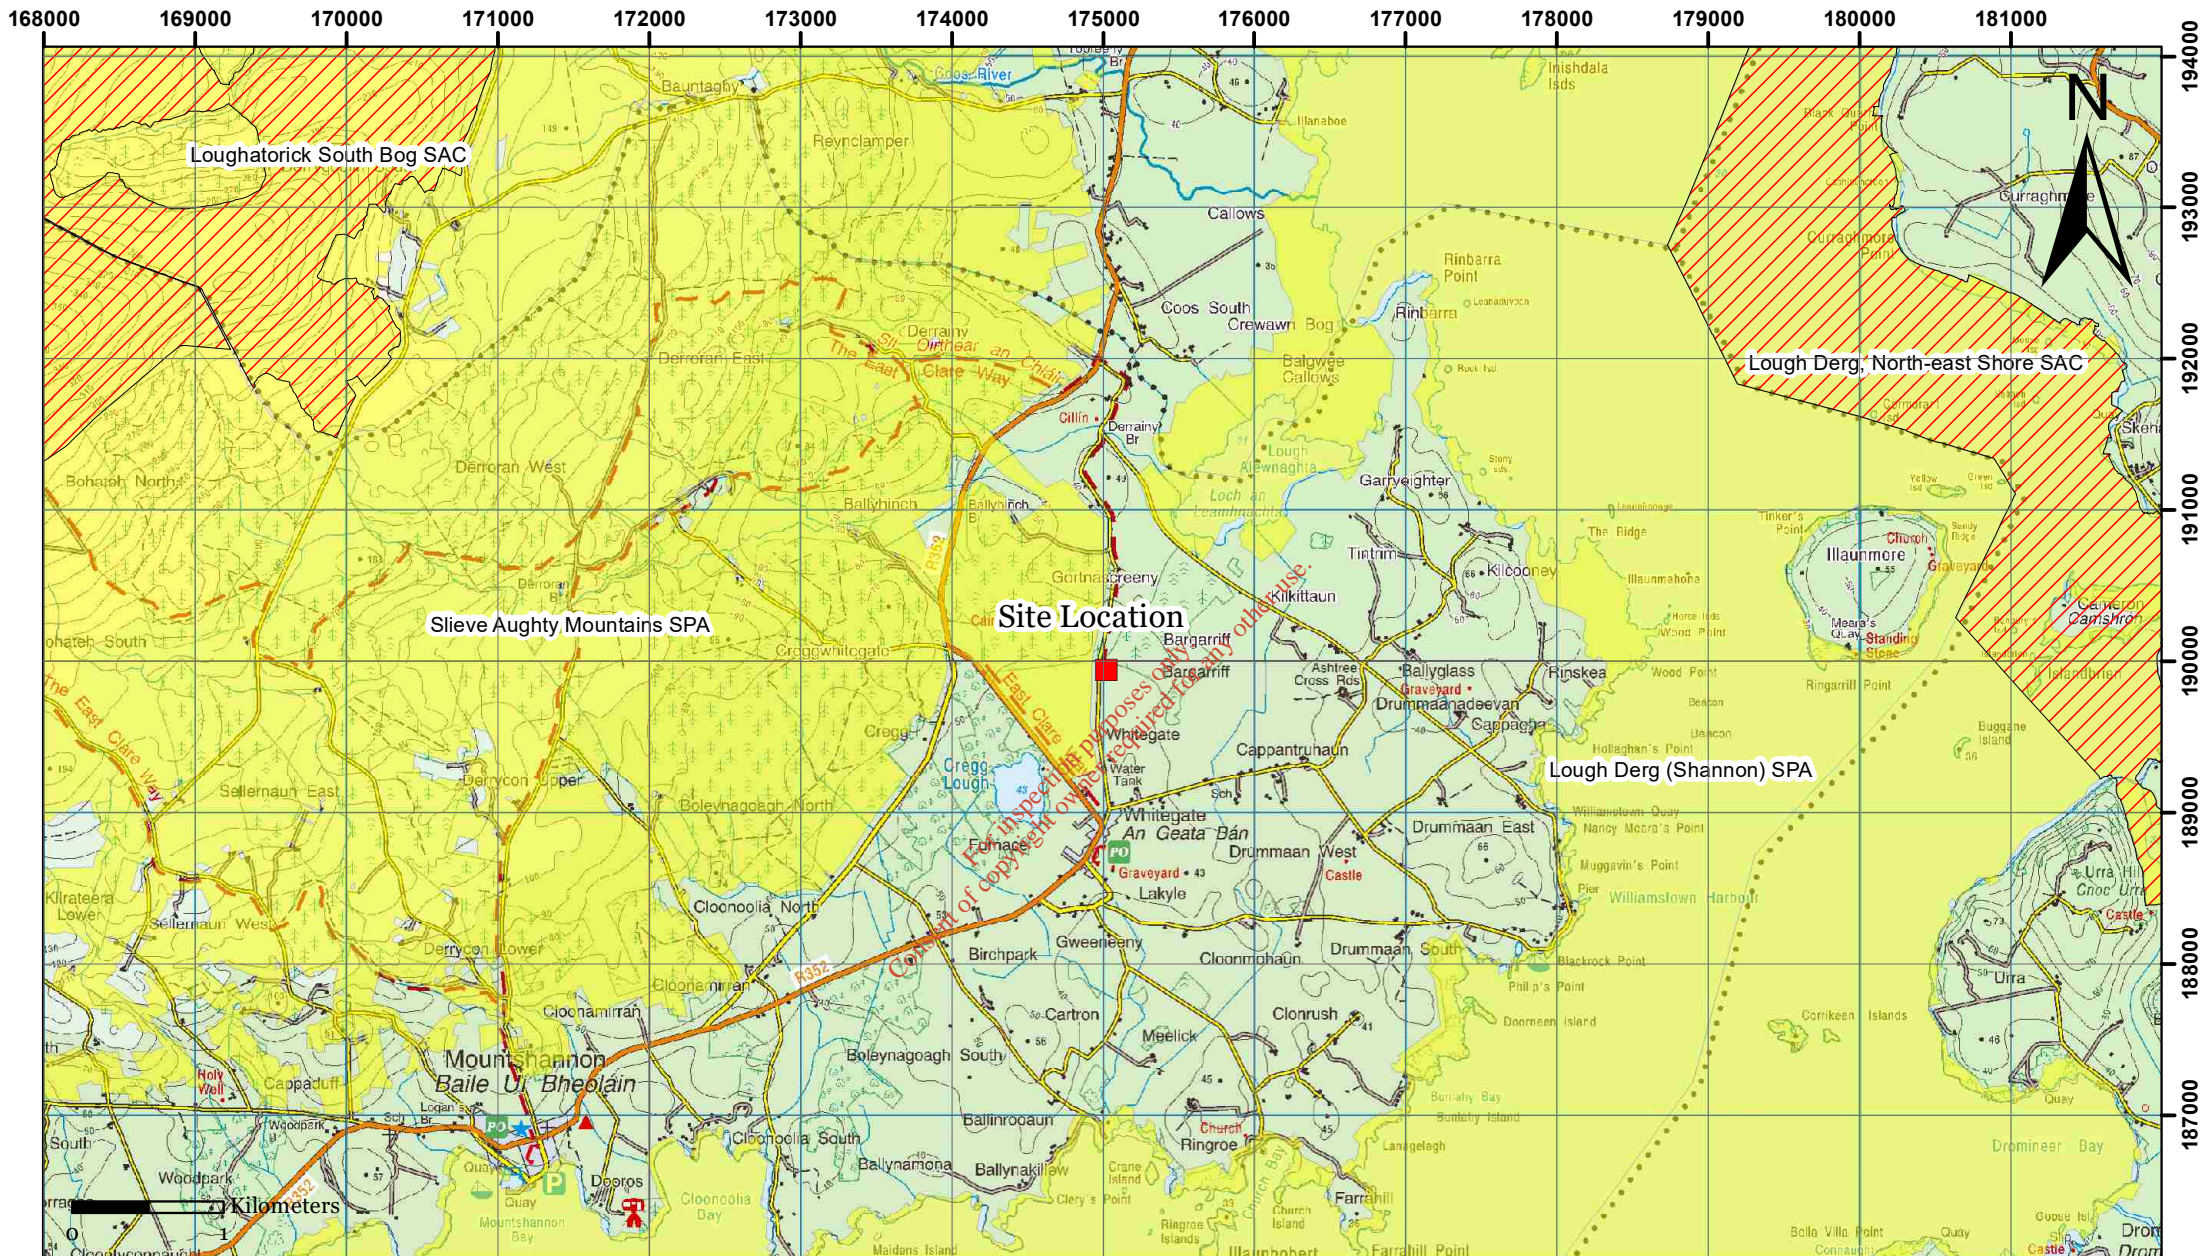
Figure 2.10

The site is not located in a Natura 2000 site. The Slieve Aughty Special Protection Area (SPA) is located on the western side of the public road to the site (Figure 2.10). It is up hydraulic gradient and upstream of the site. A Conservation Plan for the Slieve Aughty Mountains SPA has not yet been prepared by the Department of the Environment, Heritage & Local Government. However, it is understood that the principal nature conservation objectives for the site are to maintain the population of the species (hen harrier & merlin) for which the site is selected, and to maintain and, where possible, enhance, the habitats on which the harriers are dependant.

The desk study assessment by CSEE which is included in Appendix 2 concluded that based on a detailed consideration of the feeding habits of Merlins and Hen Harriers the proportion of the diet of these birds derived from aquatic/riparian food chains is insignificant, thereby ruling out any significant likelihood of a food chain impact on these species (or indeed any other element of the Slieve Aughty Mountains SPA biota) from the landfill.

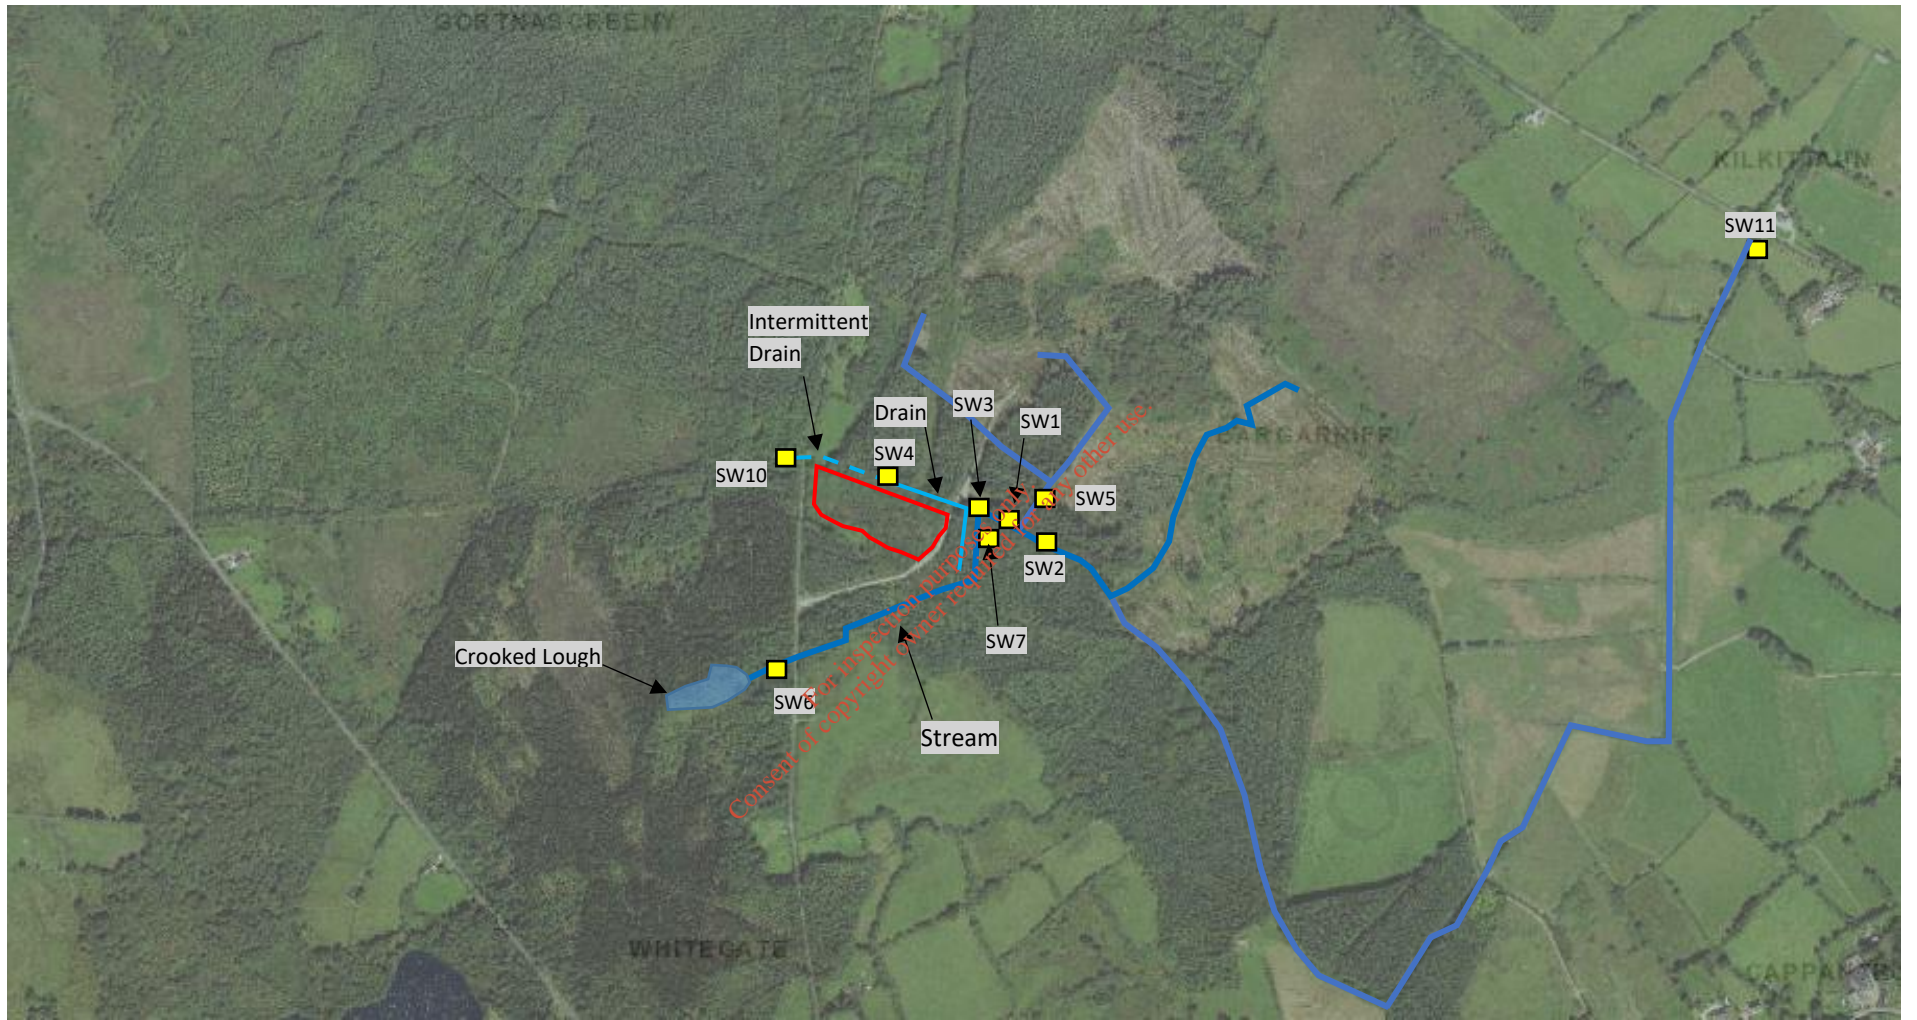
Title:
 Figure 3.3 Surface Water Sampling Points

Surface water sampling locations are shown on Figure 3.3. In 2009 Surface water samples from locations SW-1, SW-2, SW-3, SW-4, SW-5, SW-6 and SW-7. SW-4 is on the drain that runs along the northern side of the landfill which connects to a stream further east. SW-3, SW-2 and SW-1 are sample points further downstream. SW-5 is a sample point on a stream further to the north that joins the stream which runs along the north of the landfill to the northeast of the landfill site. While SW-6 and SW-7 are sample points on a stream to the south of the landfill which drains land further to the southwest of the landfill area.
