Presentation on behalf of The Friends of Rossport

Captain D J Aldridge PhD

Methanol -it's properties as a high-risk material and hazards to human life.

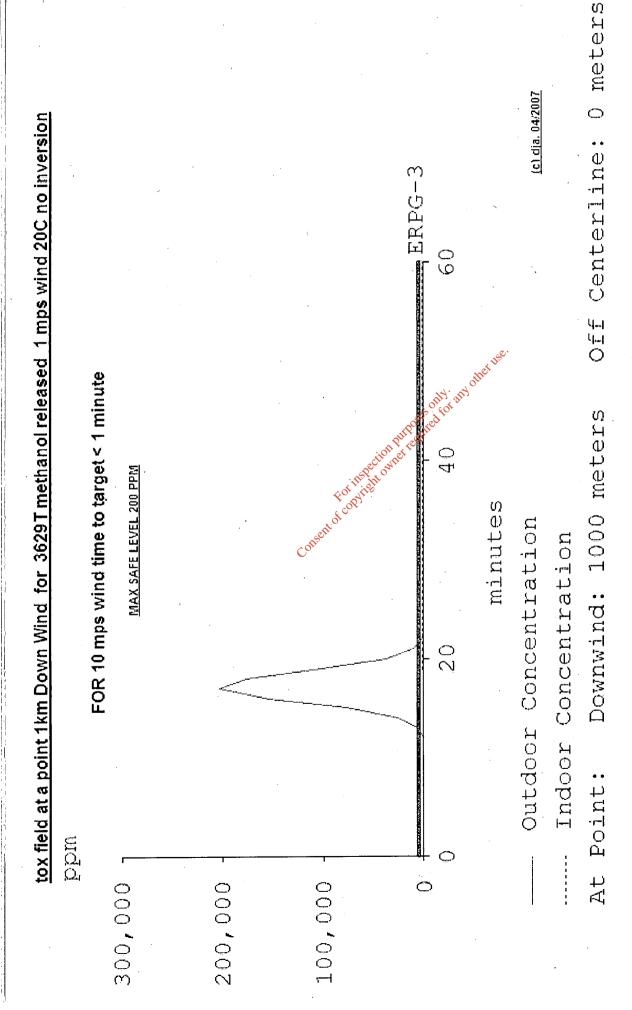
wind speed: 1.0 meters/sec 2.25 miles per hour 20°C no inversion class D stability

blast field 3629T released 10 mps wind 20C no inversion D stability destruction of buildings serious injury likely (c) dja. 2007 (21 kilometers Lines || 11 - ES Q Confidence rsd 8.0 psi S kilometers ر. ئ 2.5

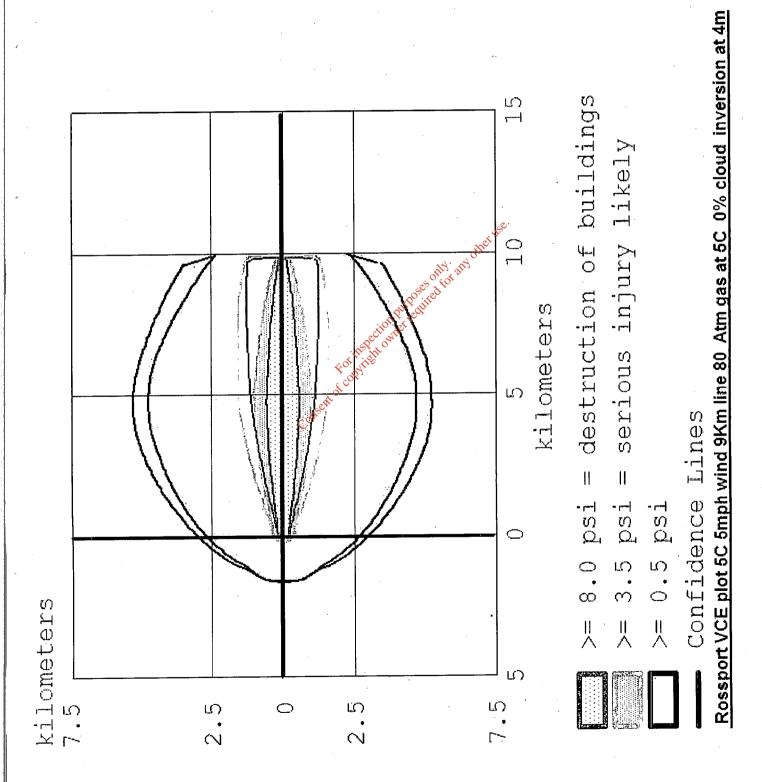
Damage estimates for common structures based on overpressure (Clancey 1972)
