Observations on Waste licence application Reg No. W0231-01, proposed landfill at the Nevitt.

Recent Developments in Mapping of Karst systems using Microgravity

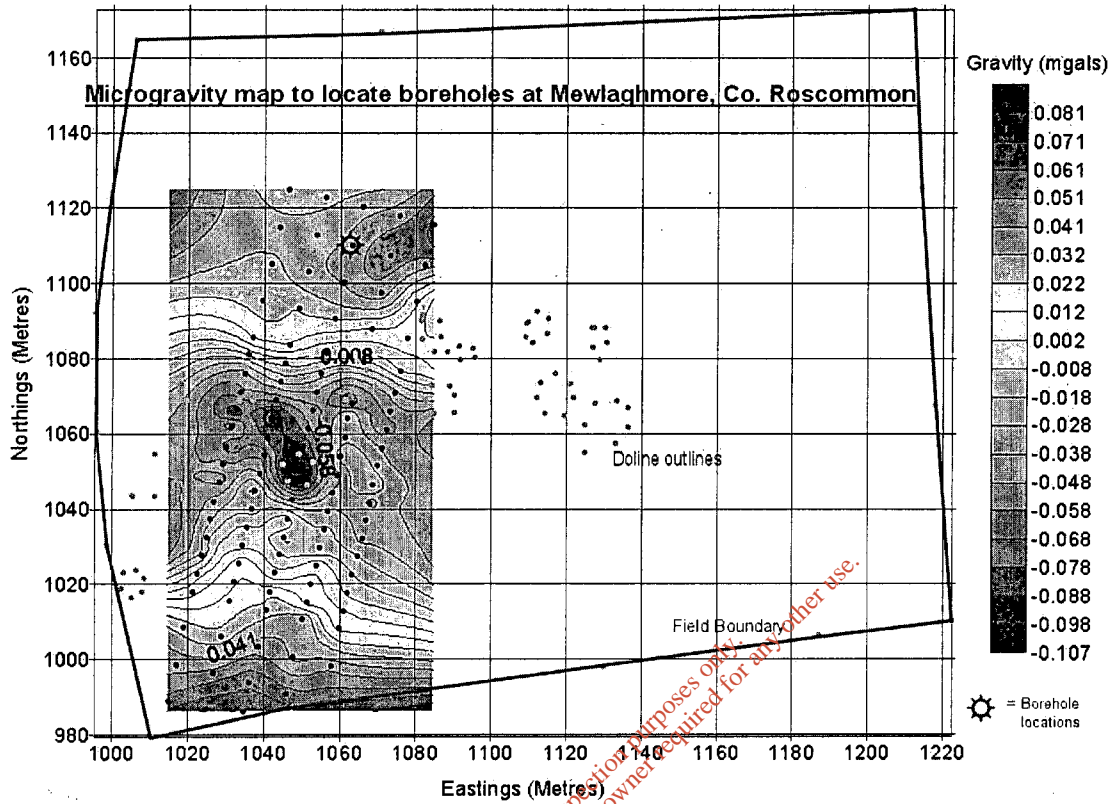
Figure 4: Microgravity, in a grid system at Mewlaghmore showing locations of boreholes

Mewlaghmore 1: This hole was drilled as a control in area where geophysics showed no anomalies. This hole is the most northern borehole marked in figure 4. Drilling revealed 100% core recovery of clean fractured limestone. The limestone had numerous small solutionally widened fissures and cracks all the way through. A fracture zone was encountered between 18.5 and 21.5m with dolomitisation resulting in 40cm of a crumbly gravel material. No core was missing and no cavities were encountered. Plate 1 shows a picture of the core taken from this hole.

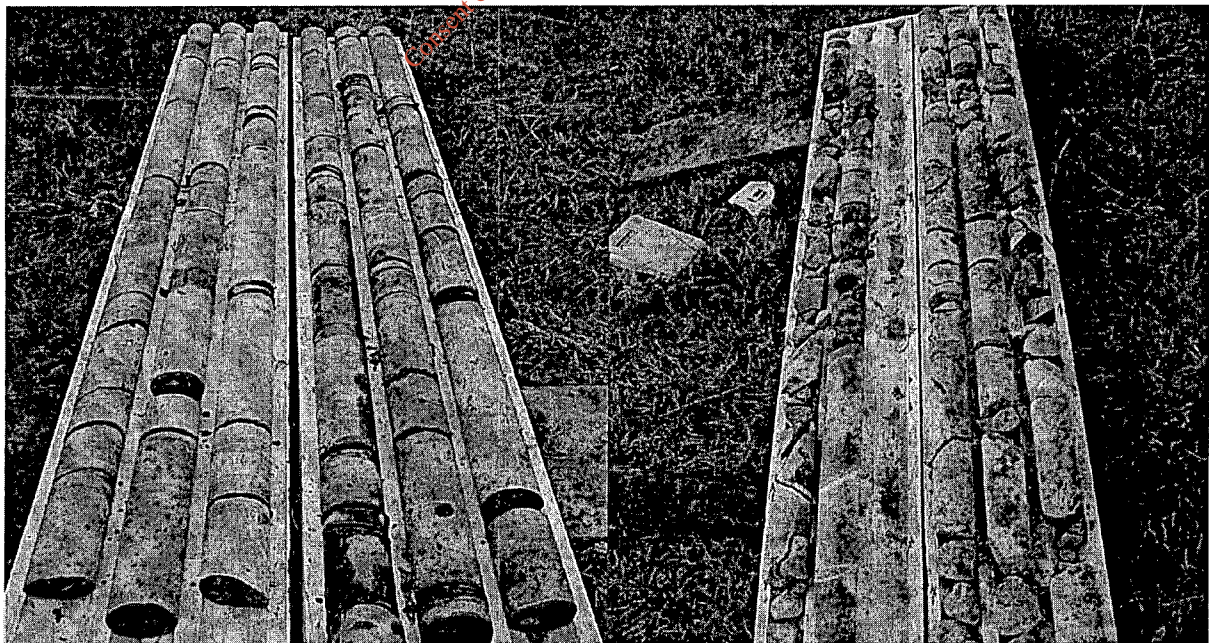
Plate 1: Mewlaghmore 1
Showing 100% recovery with clean fractures

Plate 2: Mewlaghmore 2 Very broken, many
cavities with poor core recovery

Mewlaghmore 2: The location for this hole was picked as an example at the main geophysical anomaly at the side of a large doline. Average core recovery from this hole in total was only 55%. Bedrock was extremely broken and fractured until 24m. A large fracture was encountered at 10m with 60cm of soft sediment and clay layers recovered. Another cavity was encountered at 11.2m with a depth of 1.4m and was presumed to be filled with clay and soft sediment. Another large cavity was encountered at 16.6m with a depth of 1.7m. A major cavity was encountered at 18.6m, with a thickness of 4.5m, where only a few pebbles and gravelly clasts were recovered until 23m. There was 100% recovery for the rest of core. The limestone got increasingly cherty from 30m onwards. Plate 2 shows an example of core taken from this hole.
