**Limerick Gasworks  
Dock Road, Limerick**

**Site Investigation  
General Report  
Volume 2**

**October 2001**

Report No:  
**25837/OR/04B**

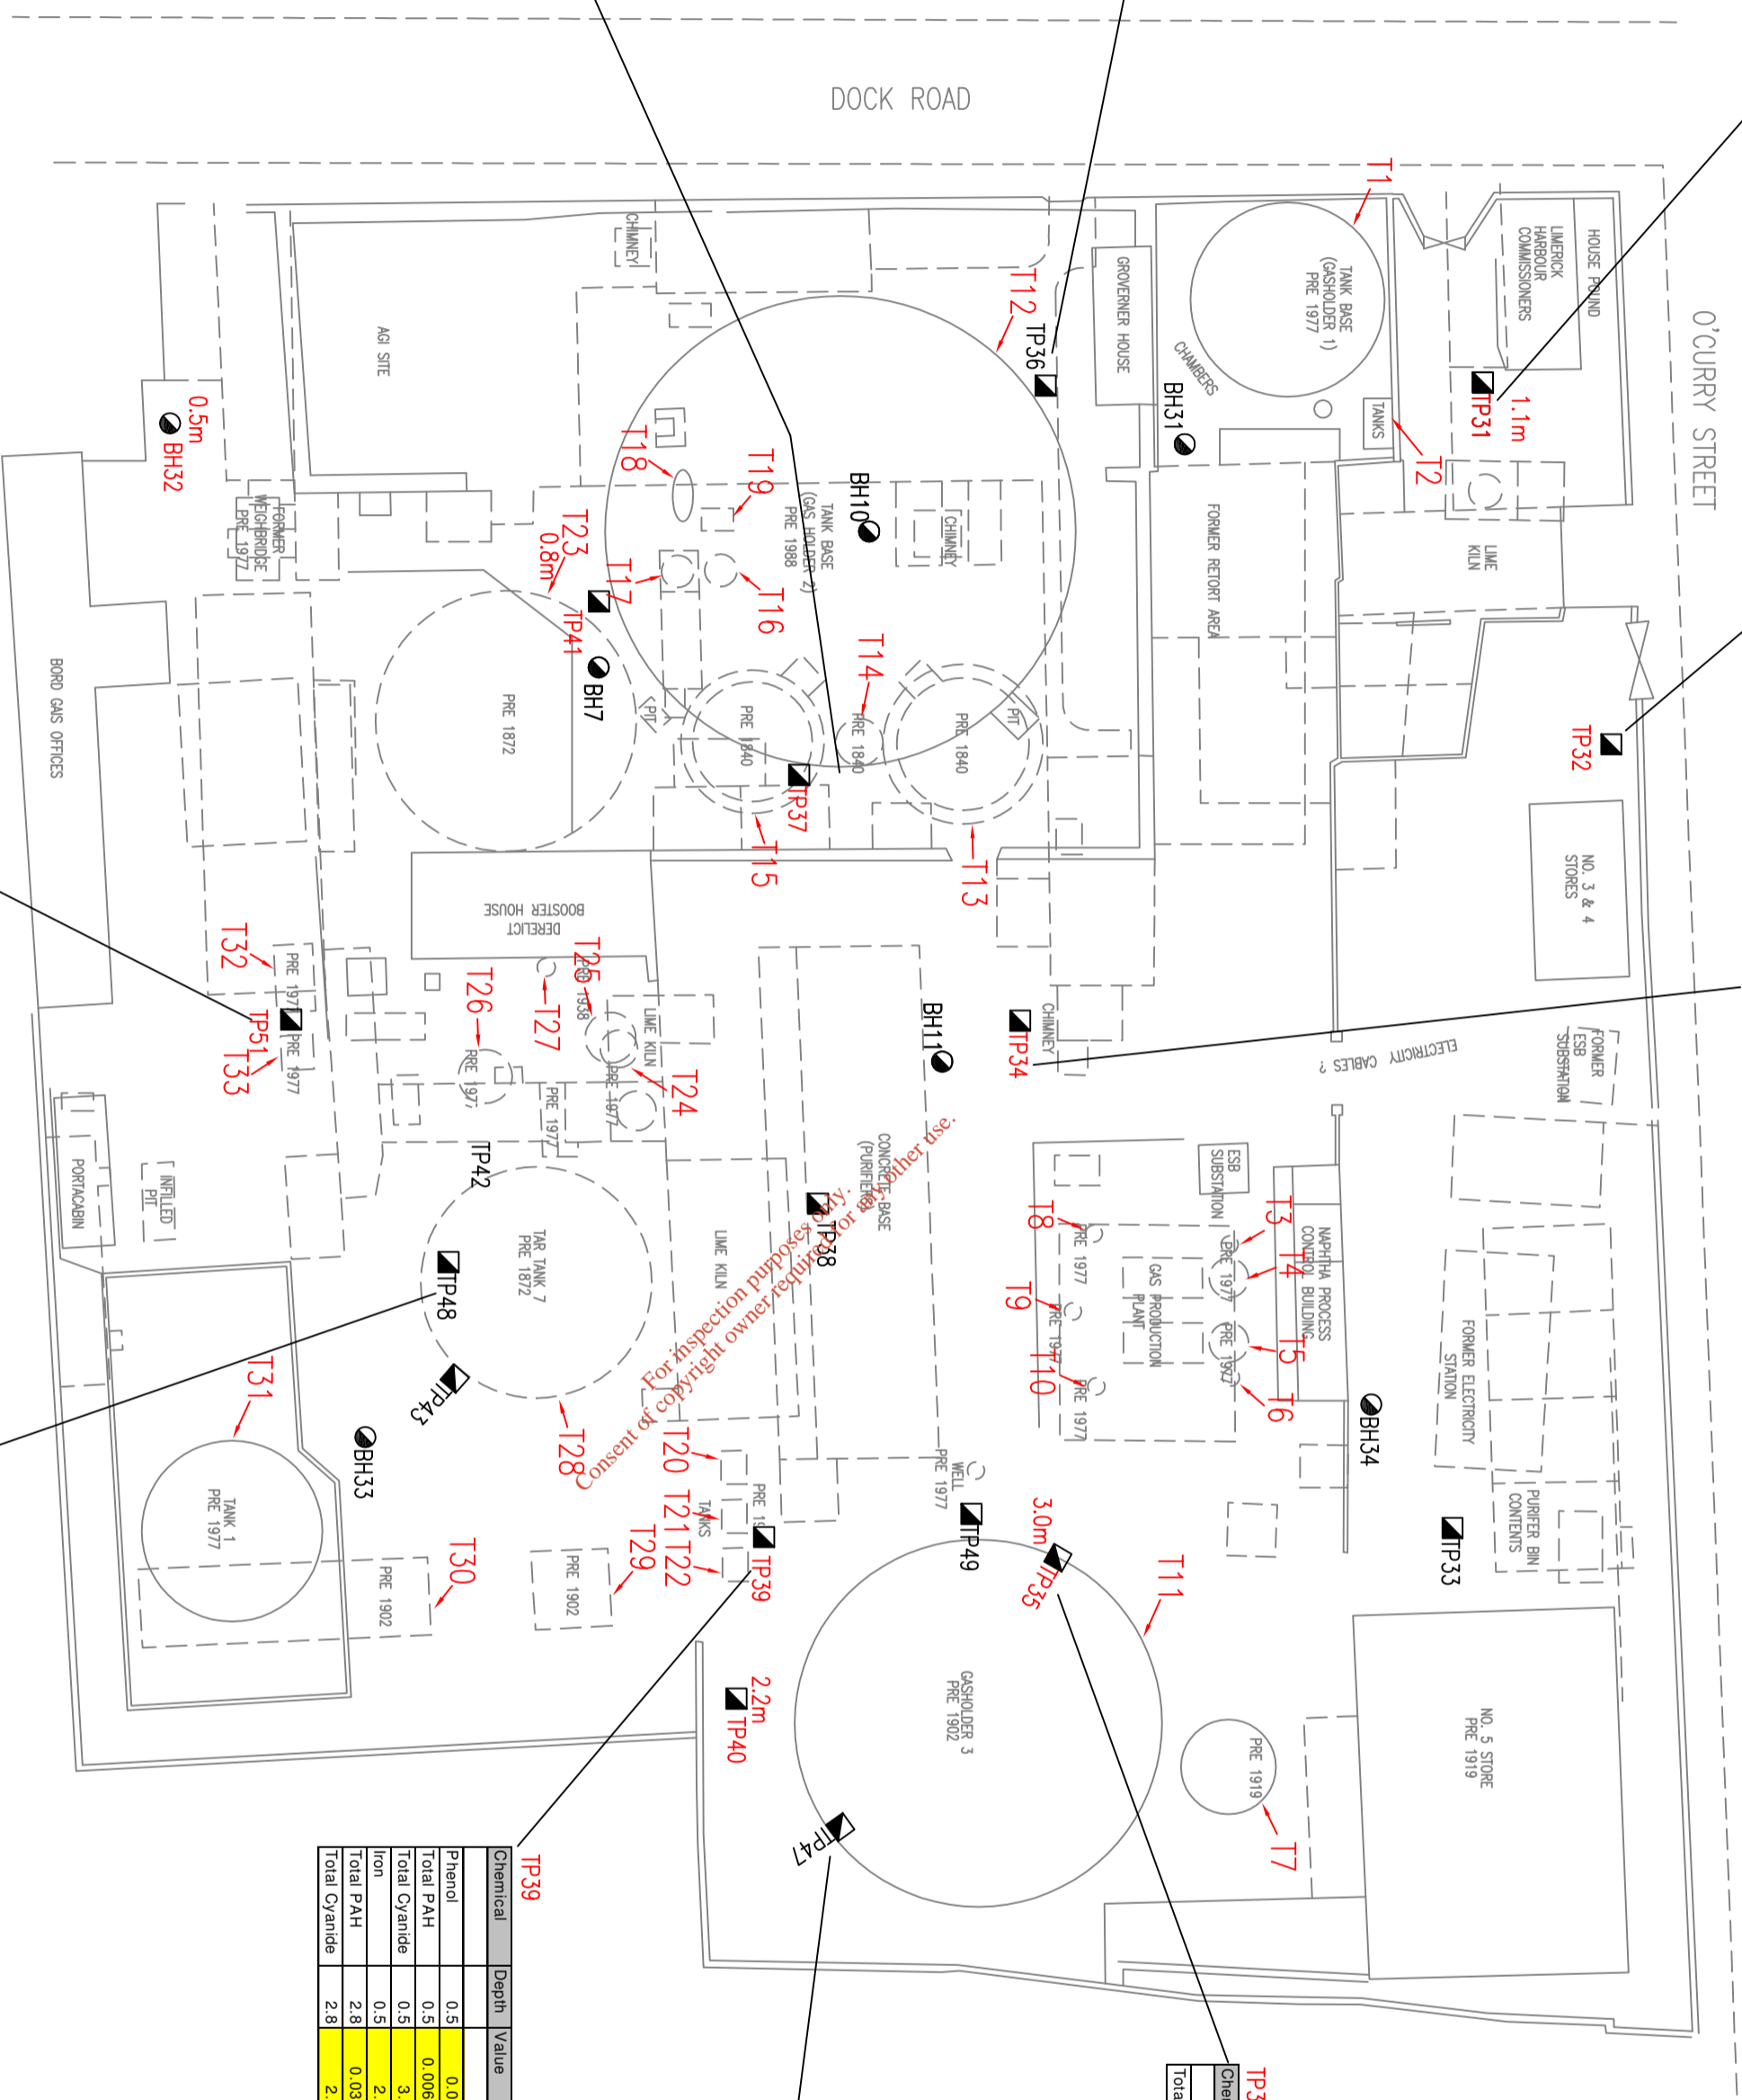
**TP37**

Chemical	Depth	Value	Units
pH	1.1	9.6	
Total Cyanide	1.1	0.6	mg/l

**TP51**

Chemical	Depth	Value	Units
pH	0.3	9.6	
Phenol	0.3	20	mg/l
Total PAH	0.3	0.27	mg/l
Total Cyanide	0.3	0.8	mg/l
BH	1.0	1.1	mg/l
Phenol	1.0	1.2	mg/l
Total PAH	1.0	0.034	mg/l
Total Cyanide	1.0	1	mg/l
