Boliden Tara Mines Limited

IPPC Licence Ref. No. P0 516-01

Annual Environmental Report (AER)

January – December 2011

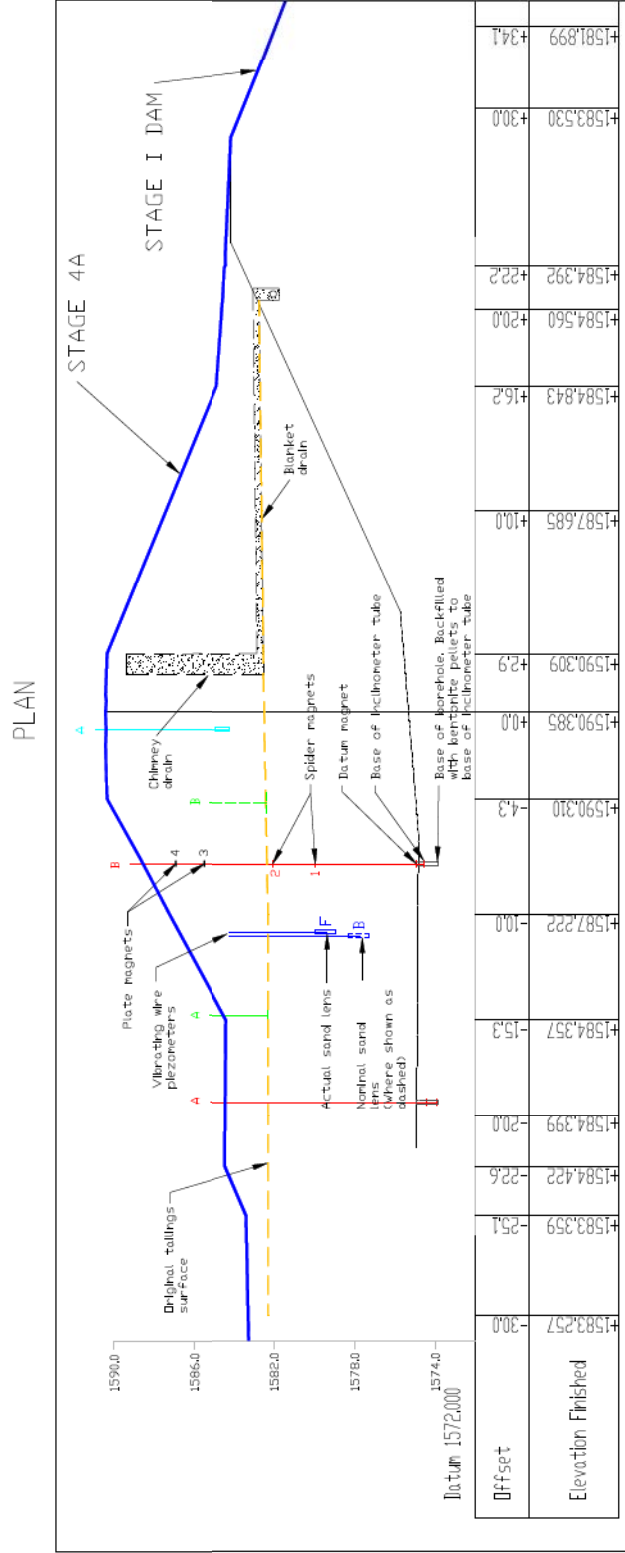
NOTE:
Instruments shown as dashed are obsolete (damaged or buried). Location is schematic.

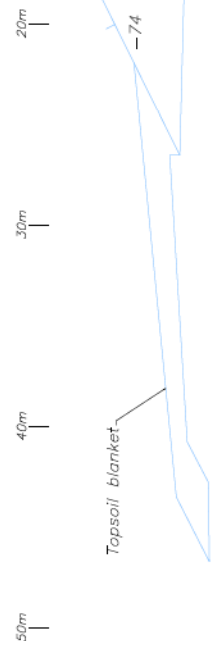
Client	Boilden Tara Mines Limited
Project	Tailings Audit 2011 Randalstown TMF, Eire
Task	Cross-section, Stage III West dam, piezometer Stack 2
Drawn by	RW
Checked by	RW
Reviewed by	RW
Issue	25/04/12
File No.	518728
Project No.	12514150008
Scale	Not to scale
Status	Report Issue
Drawing No.	7b
Rev	-

Piezometer number	Sand Filter Thickness	Tip Level	Standpipe Top Level
3/2/1	1.70	1572.58	1583.54
3/2/2	1.70	1573.29	1583.62
3/2/3	1.50	1570.83	1583.67
3/2/4	1.60	1573.18	1578.00
3/2/5	1.50	1571.17	1578.19
3/2/6	1.50	1567.43	1571.65

Diameter of Borehole: 203mm
I.D. of Standpipe: 19mm

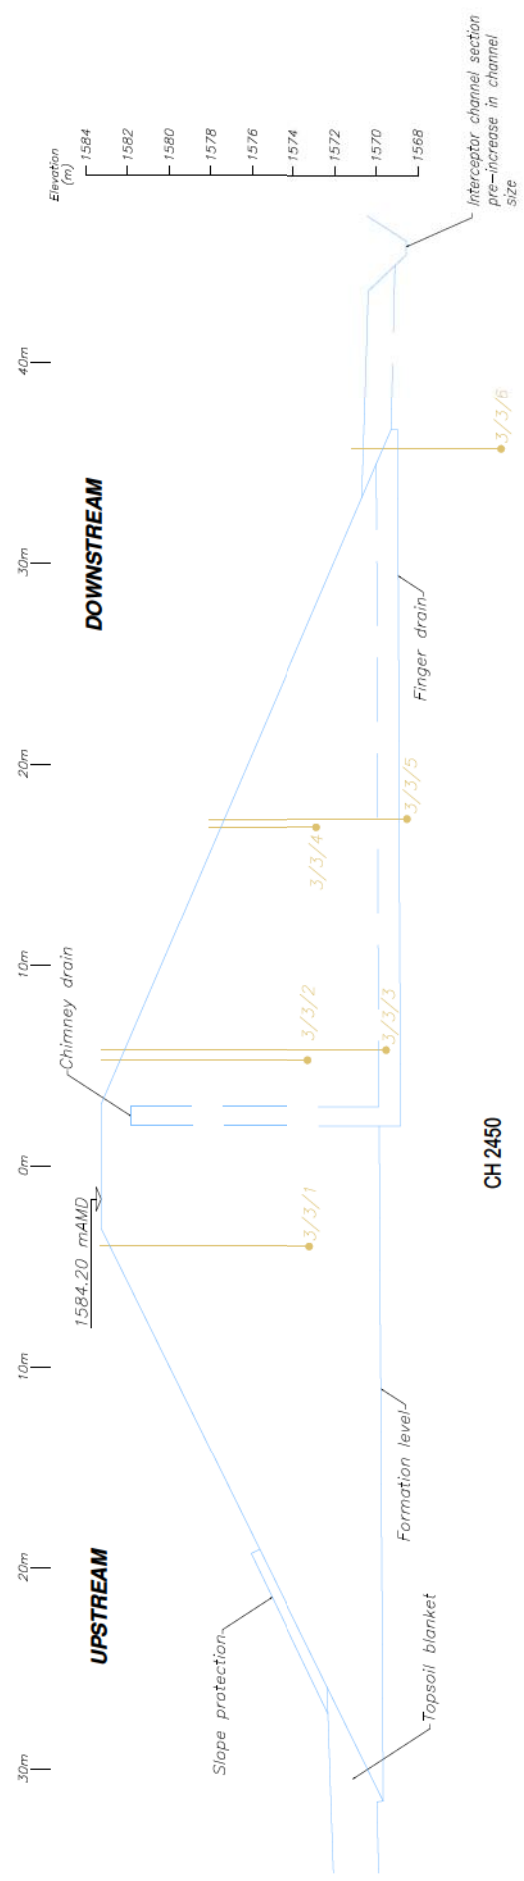
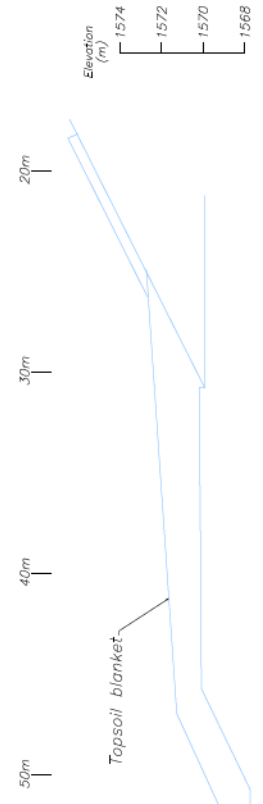
Piezometer number	Sand Filter Thickness	Tip Level	Standpipe Top Level
3/3/1	1.50	1573.70	1583.63
3/3/2	1.50	1573.08	1583.57
3/3/3	1.50	1568.66	1583.52
3/3/4	1.50	1572.51	1578.68
3/3/5	1.50	1567.70	1578.57
3/3/6	1.50	1564.71	1571.35

Diameter of Borehole: 203mm
I.D. of Standpipe: 19mm

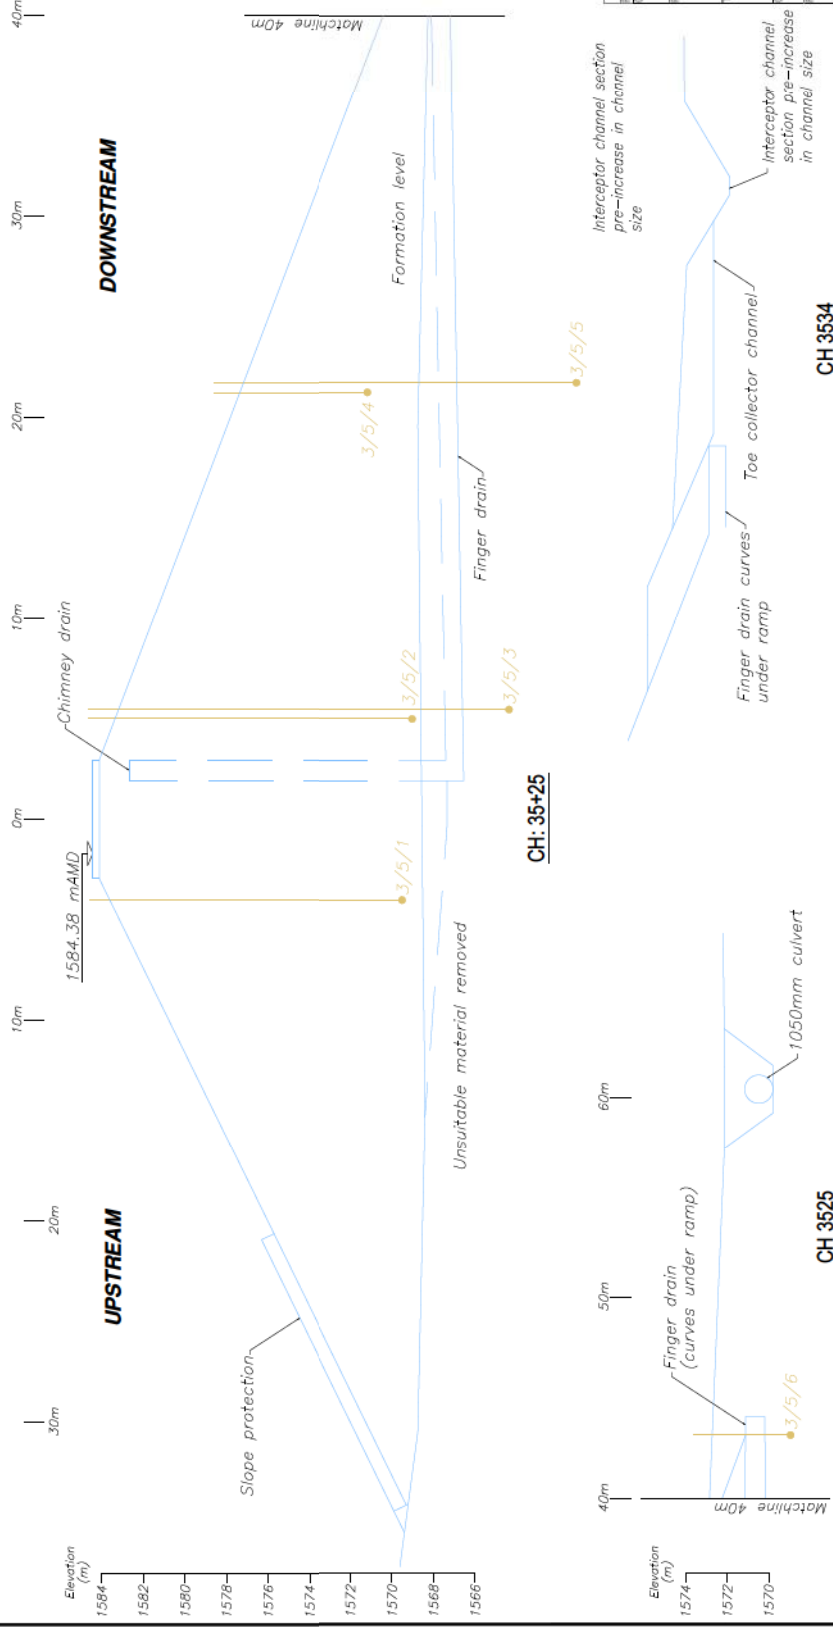
Client	Boildren Tara Mines Limited
Project	Tailings Audit 2011 Randalstown TMF, Eire
Task	Cross-section, Stage III South dam, piezometer Slack 5
Drawn by	PAT
Reviewed by	RW
Checked by	RW
Project No.	518731
Revision	RW
Date	25/04/12
Scale	Not to scale
Status	Report Issue
Drawing No.	7e

Piezometer number	Sand Filter Thickness	Tip Level	Standpipe Top Level
3/5/1	1.50	1568.62	1583.73
3/5/2	1.50	1568.28	1583.50
3/5/3	1.50	1563.60	1583.52
3/5/4	2.00	1570.75	1577.45
3/5/5	1.00	1560.72	1577.56
3/5/6	1.50	1564.72	1569.58

Diameter of Borehole: 203mm
I.D. of Standpipe: 19mm

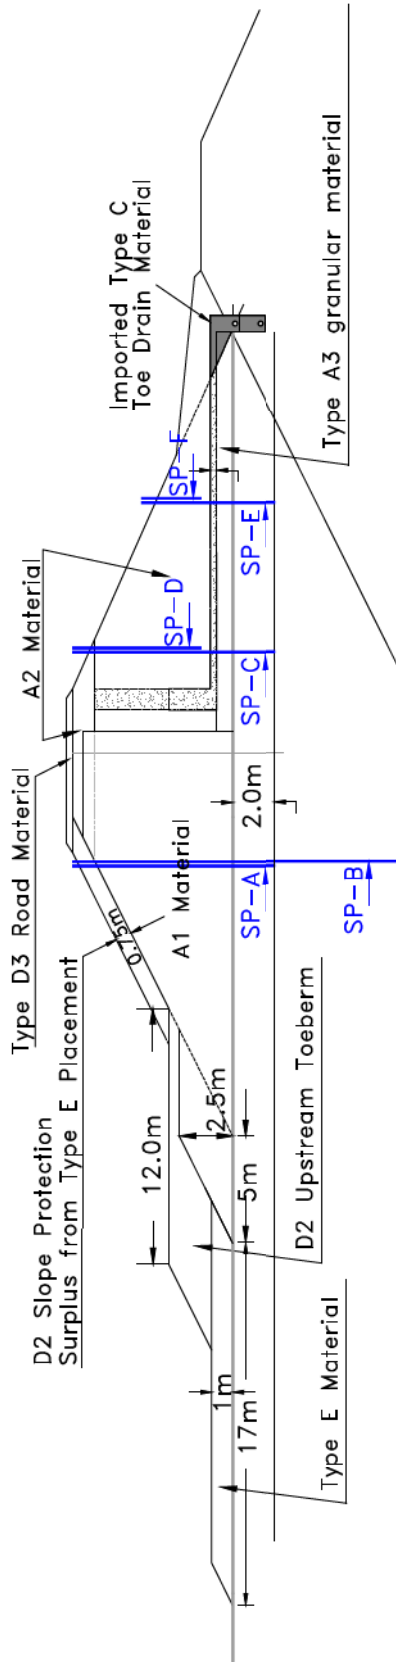
Typical Casagrande Piezometer Cluster Section

The Casagrande standpipe piezometer SP150A indicate a piezometric level of 1584.7 m AMD which has slowly increased and is slightly lower than the vibrating wire piezometers installed in the tailings foundations upstream of the chimney drain. Standpipe piezometer, SP150C, and SP150E indicated maximum piezometric levels of 1583.4 m AMSL and 1583.9 m AMSL respectively. SP150E recorded a maximum piezometric level some 1m higher than that recorded in the vibrating wire piezometers VW150E.
