**Calary Inert Waste Recovery Facility  
Killough Upper  
Kilmacanogue  
Co. Wicklow**

**ENVIRONMENTAL LIABILITY  
RISK ASSESSMENT (ELRA)**

**June 2016**  
**SLR Ref: 501.00180.00109 ELRA Rev 0**

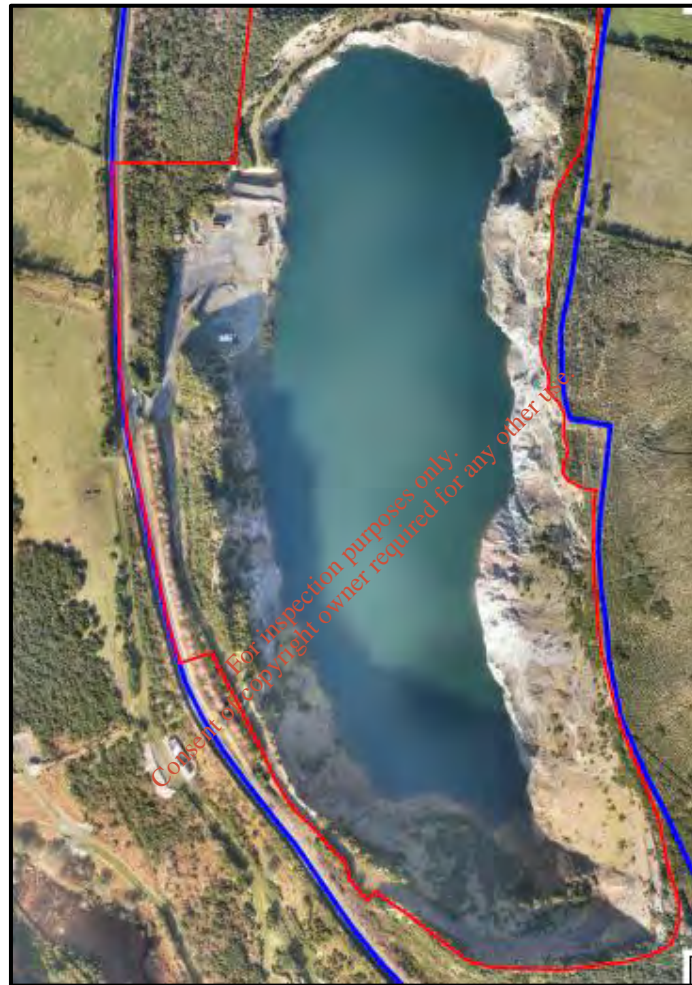
**Plate 1**  
**Aerial View of Calary Quarry**

The existing quarry void covers an area of approximately 9.1 hectares (9.4 acres) and is shown in an aerial view in Plate 1 below.
