## **E.2 Emissions to Surface Water**

Client		
Project <b>MILLENNIUM PARK SERVICES AS-BUILT</b>		
Location <b>MILLENNIUM PARK, BALLYCOOLIN, DUBLIN 11</b>		
Title <b>STORMWATER AND FOUL SEWER LAYOUT</b>		
Project No.	Checked by <b>MD</b>	Drawing No.
File No.	Reviewed by	<b>001</b>
Created by <b>I McC</b>		
<b>FOR INFORMATION PURPOSES</b>		05/05/16
		A
Description	Date	Version
Scale	Not to Scale	May 2016

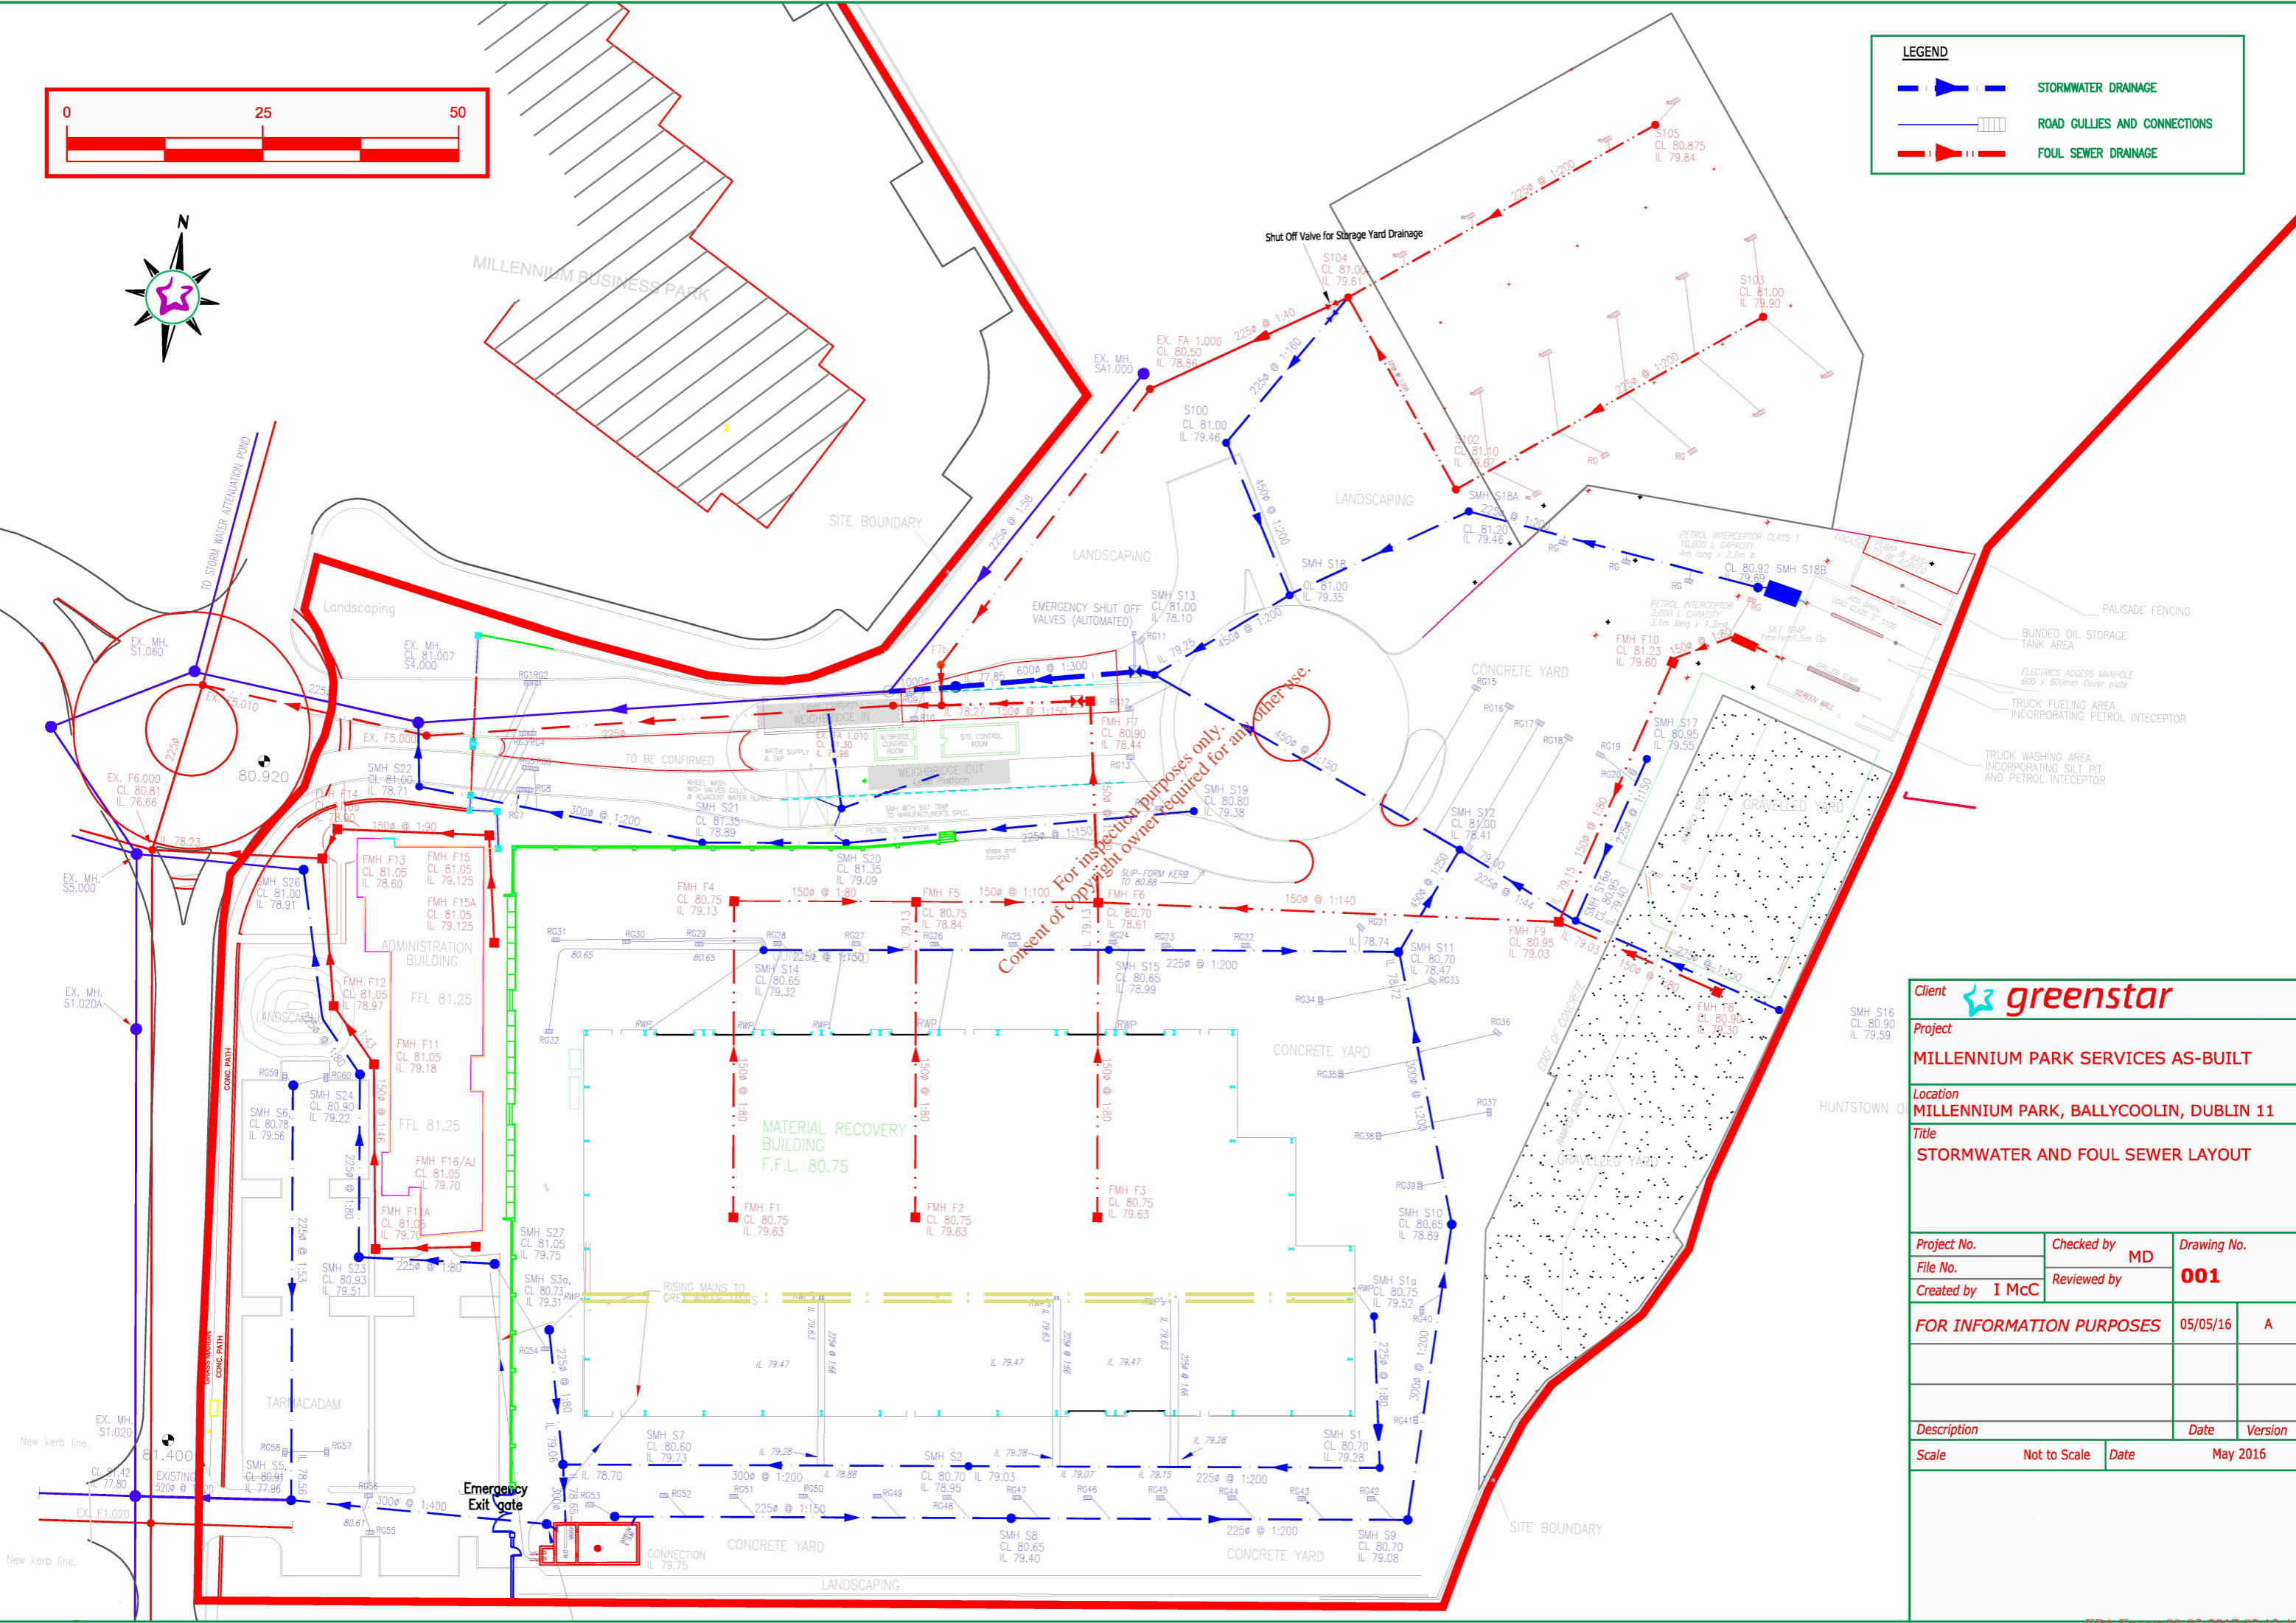
- STORMWATER DRAINAGE
- ROAD GULLIES AND CONNECTIONS
- FOUL SEWER DRAINAGE

Rainwater run-off from the building roofs, car parks and areas of the yard where wastes were not stored, used to discharge to the municipal storm water sewer and the quality was monitored at two locations (SW-1 and SW-2), as shown on Drawing No.001.

Responsibility for addressing the drainage problems rests with the Management Company and, pending the resolution, the surface water run-off from the site has been diverted to the foul sewer. Therefore there are currently no emissions to surface water; however it is intended to recommence emissions to the surface water sewer serving the Business Park once the Management Company has resolved the drainage problems.
