**APPLICATION FOR IPPC LICENCE**  
**REG. NO. P0790-02**

**UPDATED -GROUNDWATER RISK ASSESSMENT**

**GROUNDWATER RISK ASSESSMENT**

Document No: IE565/479,  
Issue No: 01

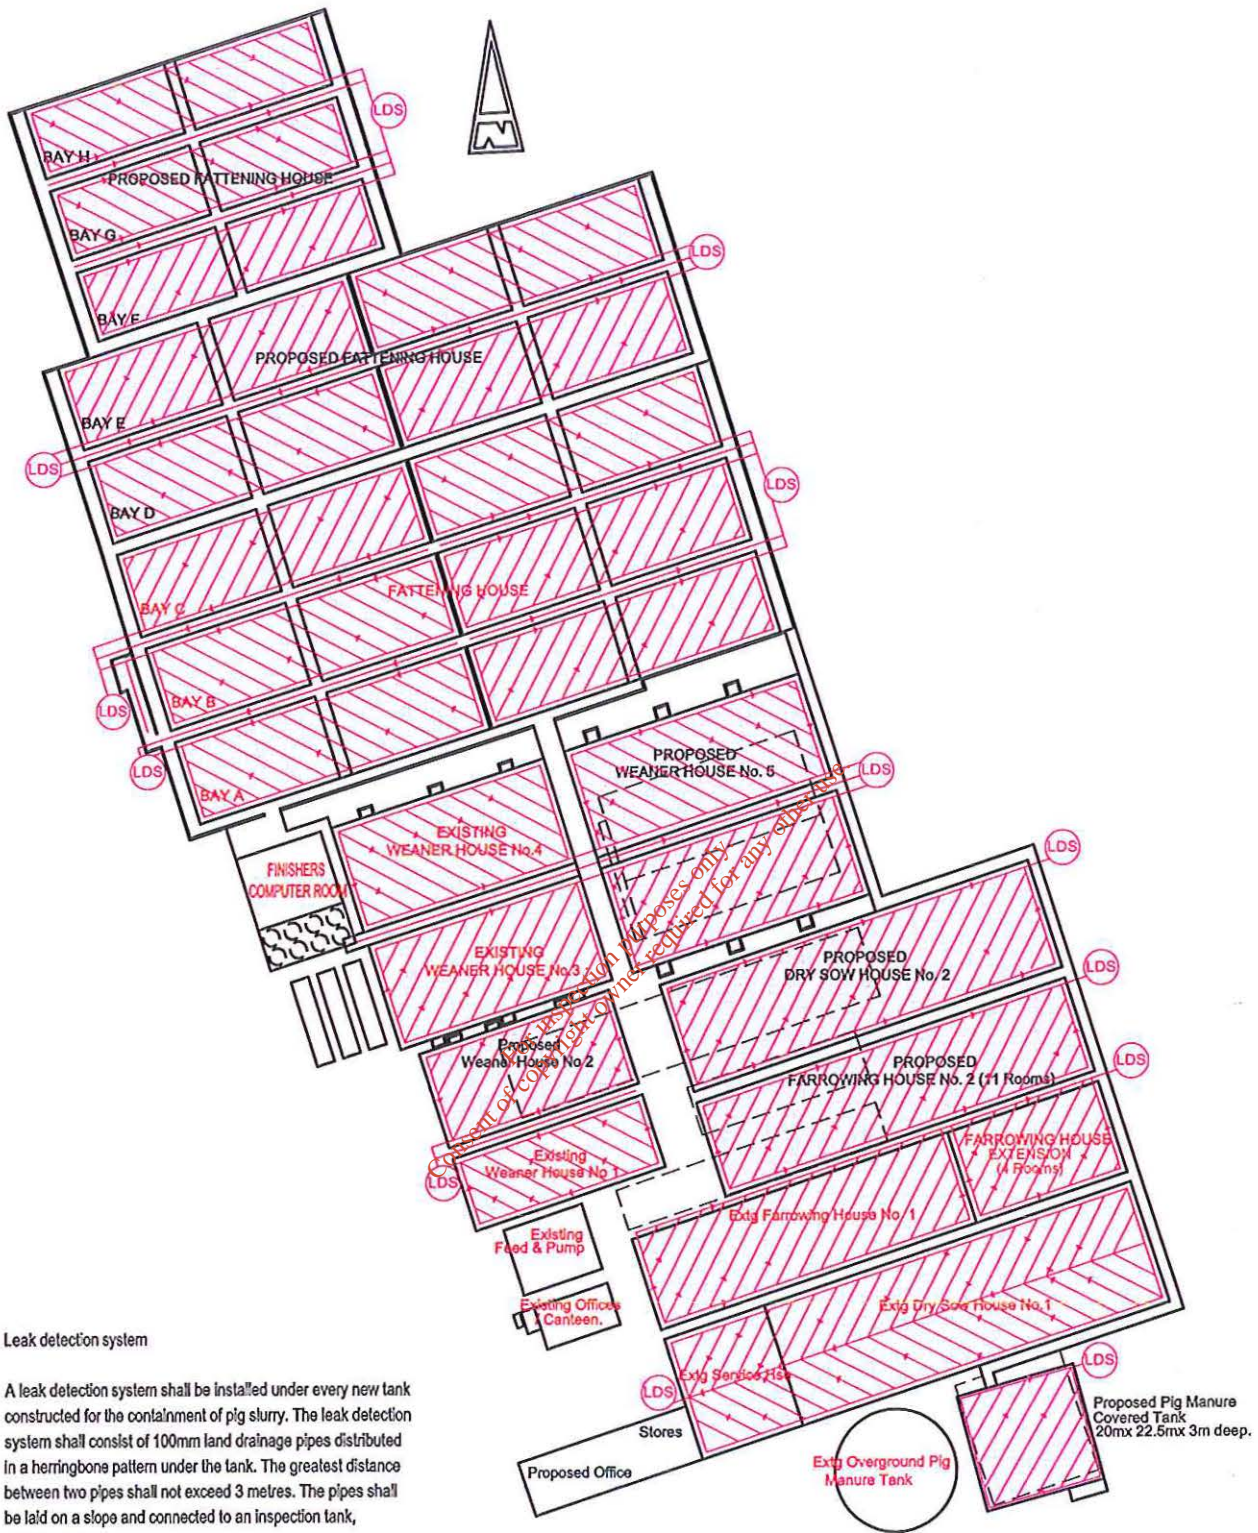
**Leak detection system**

A leak detection system shall be installed under every new tank constructed for the containment of pig slurry. The leak detection system shall consist of 100mm land drainage pipes distributed in a herringbone pattern under the tank. The greatest distance between two pipes shall not exceed 3 metres. The pipes shall be laid on a slope and connected to an inspection tank, of at least 2.5m<sup>3</sup>.

Each tank/building is underlain by a herringbone network of drainage pipe connected to inspection chambers to act as a leak detection system.

All slurry from the proposed pig unit housing will be collected in storage tanks under the slats in each of the pig housing units. These tanks are above ground and underlain by a herringbone leak detection drainage system.
