**ENVIRONMENTAL LIABILITY  
RISK ASSESSMENT  
STARRUS ECO HOLDINGS LTD  
MATERIALS RECOVERY FACILITY  
MILLENNIUM BUSINESS PARK  
BALLYCOOLIN  
COUNTY DUBLIN**

**INDUSTRIAL EMISSIONS LICENCE NO. W0183-01**

**March 2017**

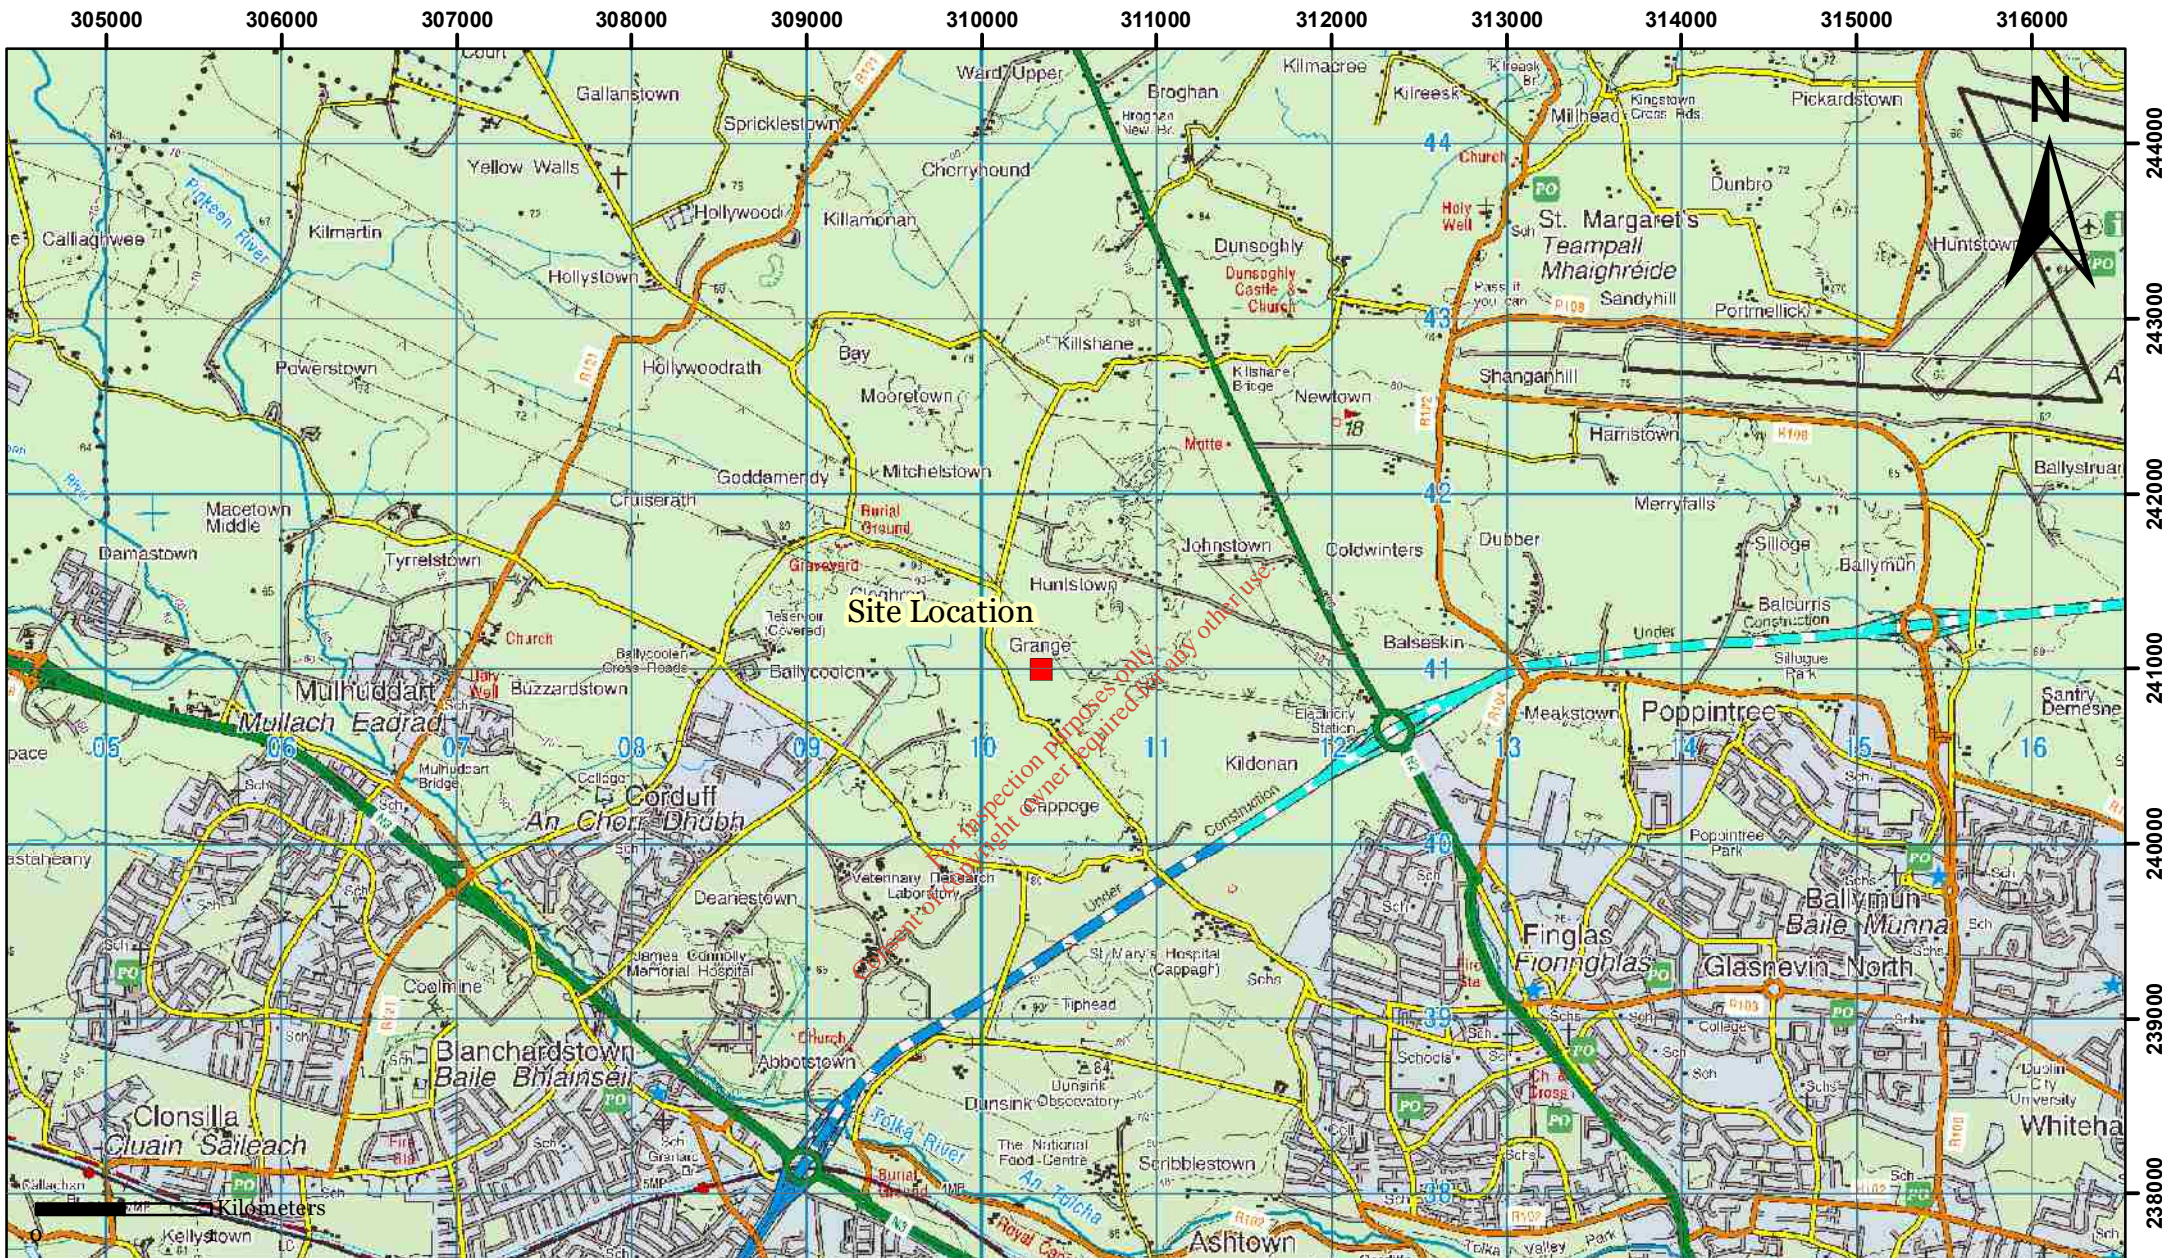
Figure 3.1

Details:  
■ Site Location

The installation occupies 4.45 hectares (ha) in the east of the Millennium Business Park, Ballycoolin, Dublin 11 (Figure 3.1). It is intended to develop the facility in a number of Phases. Phases 1 and 2 opened in July 2006 and involved the construction of the Materials Recovery Facility (MRF) building and supporting ancillaries as shown on Figure 3.2.
