**Environmental Protection Agency (Ireland)**

**Boliden Tara Mines Tailing Management  
Facility (TMF) Industrial Emission Licence  
Review**

**Assessment of Proposed Stage 6 TMF Extension  
Expert Report**

**Document No. L116-17-R2418**

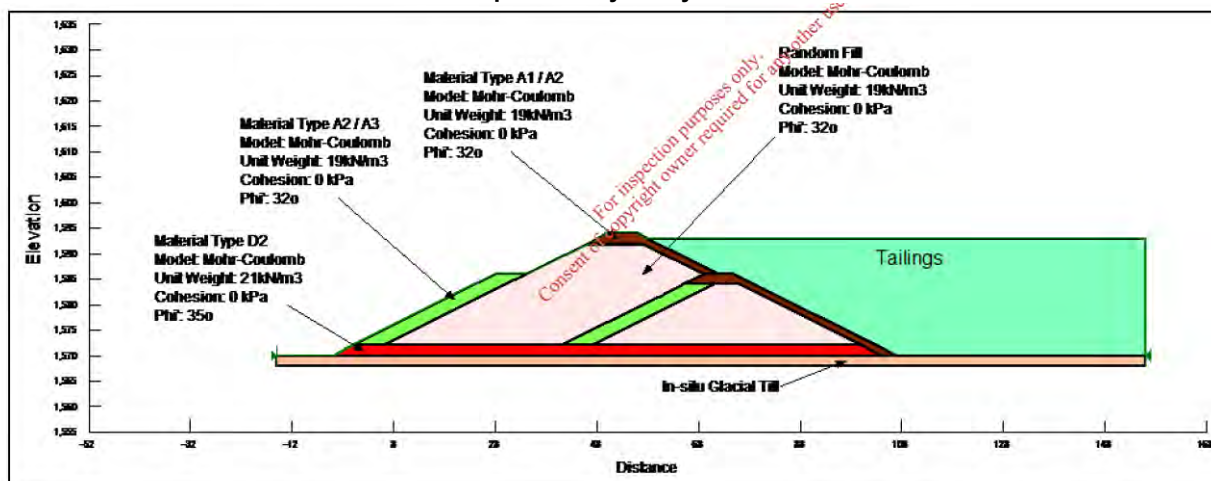
Figure 5.1  
 Slope Stability Analysis Model

*“The model geometry is based on a typical cross-section of perimeter dam wall at full height (67.29 m AOD) including the bench at 59.29 m AOD.....The geotechnical strength parameters adopted in the stability modelling are presented in the table 3.10 and the geometric configuration presented in Figure 3.14.”*

The stability of the TMF wall for each option was considered under the following conditions:

- Long-term downstream embankment stability, with tailings level 1 m below the crest. The HDPE liner was assumed to be intact and an assumed phreatic surface was drawn down through the embankment by the downstream drainage blanket and the rock used in downstream construction.
- Long-term downstream embankment stability, with tailings level 1 m below the crest. The HDPE liner was considered to undergo complete failure and the drainage system was no longer free draining and the phreatic surface exits the dam wall in the slope at one third of its height. This is a very extreme scenario which is unlikely to develop.
- Further analyses were undertaken using pseudo-static conditions corresponding to a 0.06 g acceleration for the liner intact."

- *“The factor of safety for the static and pseudo-static cases assuming the internal drainage system is operational are satisfactory.*
- *Where the drainage system is non-operational, the factor of safety for the static condition is satisfactory.*
- *In the statistically unlikely event of an earthquake, the factor of safety is 0.99 which under these conservative conditions, is acceptable.”*

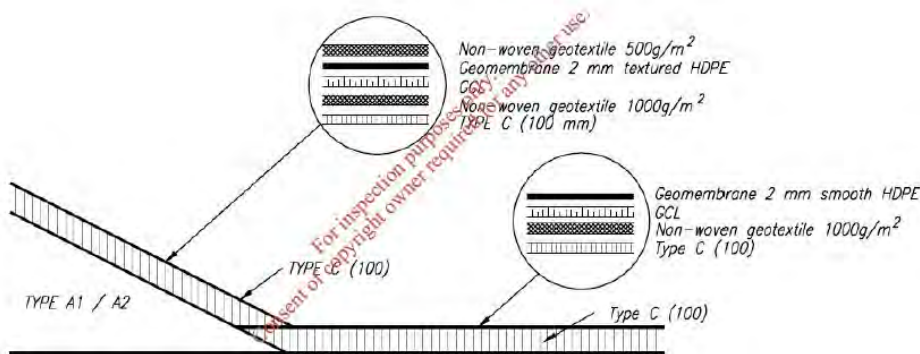
**ANCHOR TRENCH DETAIL**

**TYPICAL SECTION CONSTRUCTION**  
**PLATFORM PHASE I**

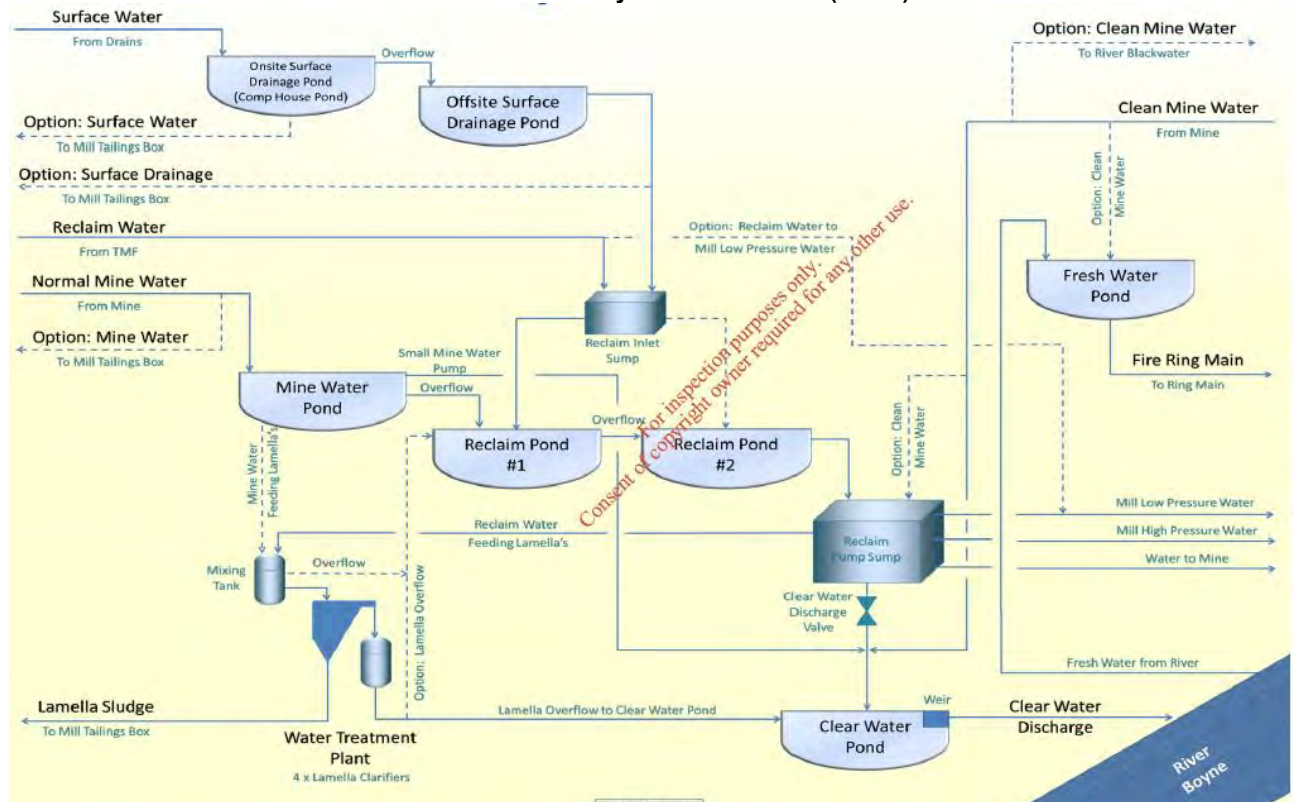
**Figure 5.4**  
**Tara Mines Water Systems Flowsheet (Ref. 6)**

A schematic describing the Tara Mines Water System is included in the Attachment D to the IEL application. The document identifies “three sources of water that are considered process water. These are as follows:

- Water ingress to the mine that is pumped out to maintain a suitable dry working environment
- Surface run-off
- Water from processing plant.

The discharge from the Clear Water Pond to the River Boyne is via a weir structure, which measures and controls the discharge.”

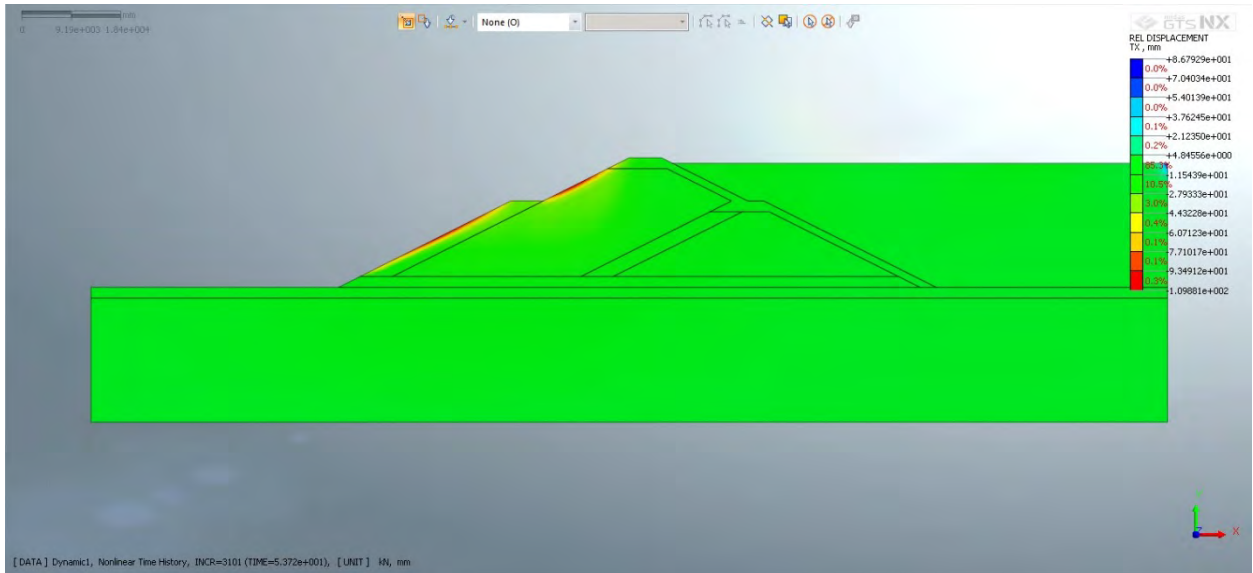
Figure 7: Run 1: Post-Earthquake Horizontal Displacement

Figures 7 to 10 present the results for the dynamic analysis using Ground Acceleration Time History 1 as the dynamic loading condition, i.e. Run 1.

Figures 7 and 8 show the predicted post-earthquake displacement in both horizontal and vertical directions at the final time step.

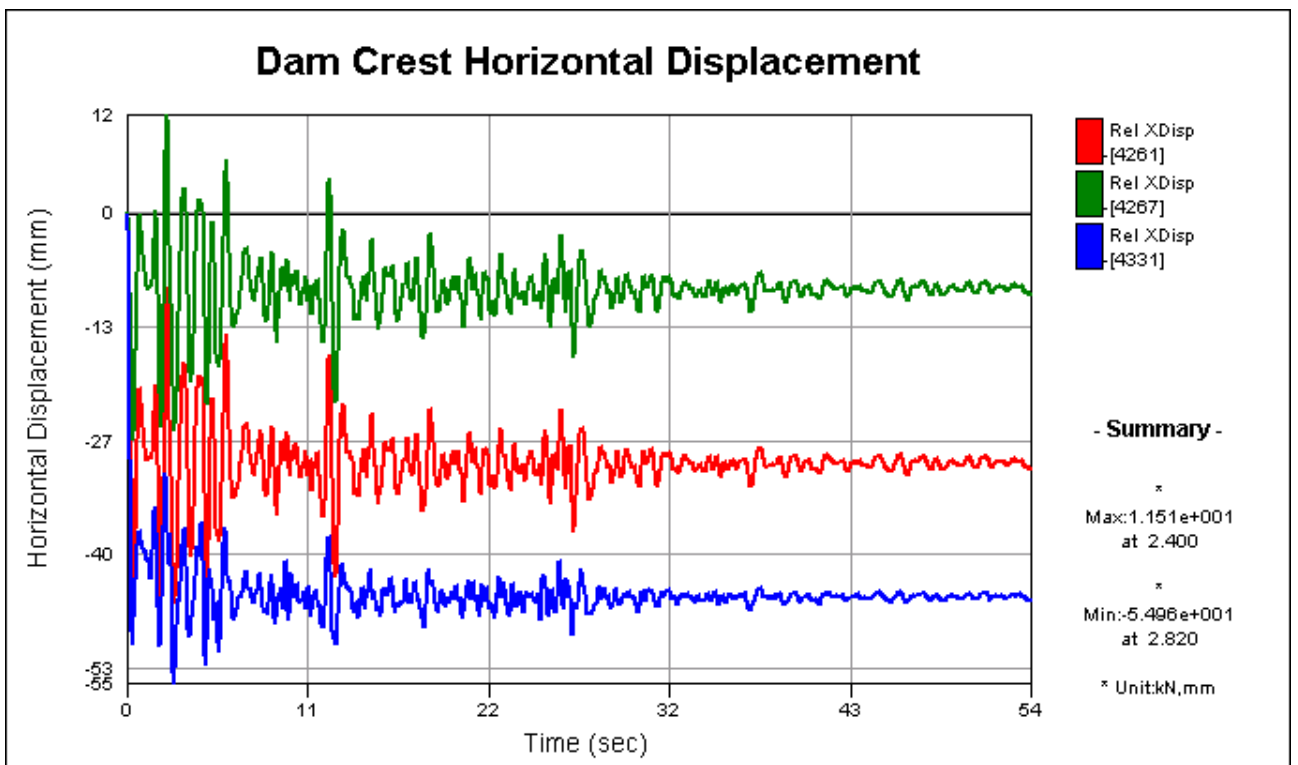
Figure 10: Run 1: Dam Crest Horizontal Displacement History Plot

cohesion for the fill material of the dam. Following the shake of an earthquake event (even with a not very high PGA), some movements or perhaps local slumping near the surface of the dam is to be expected and considered acceptable. The vast majority of the dam and the tailings would experience insignificant movements which is considered satisfactory. Figure 9 shows very small plastic strain concentration near the surface of the dam which further confirms the damage would be superficial. Figure 10 presents the dam crest horizontal displacement history during the shake.

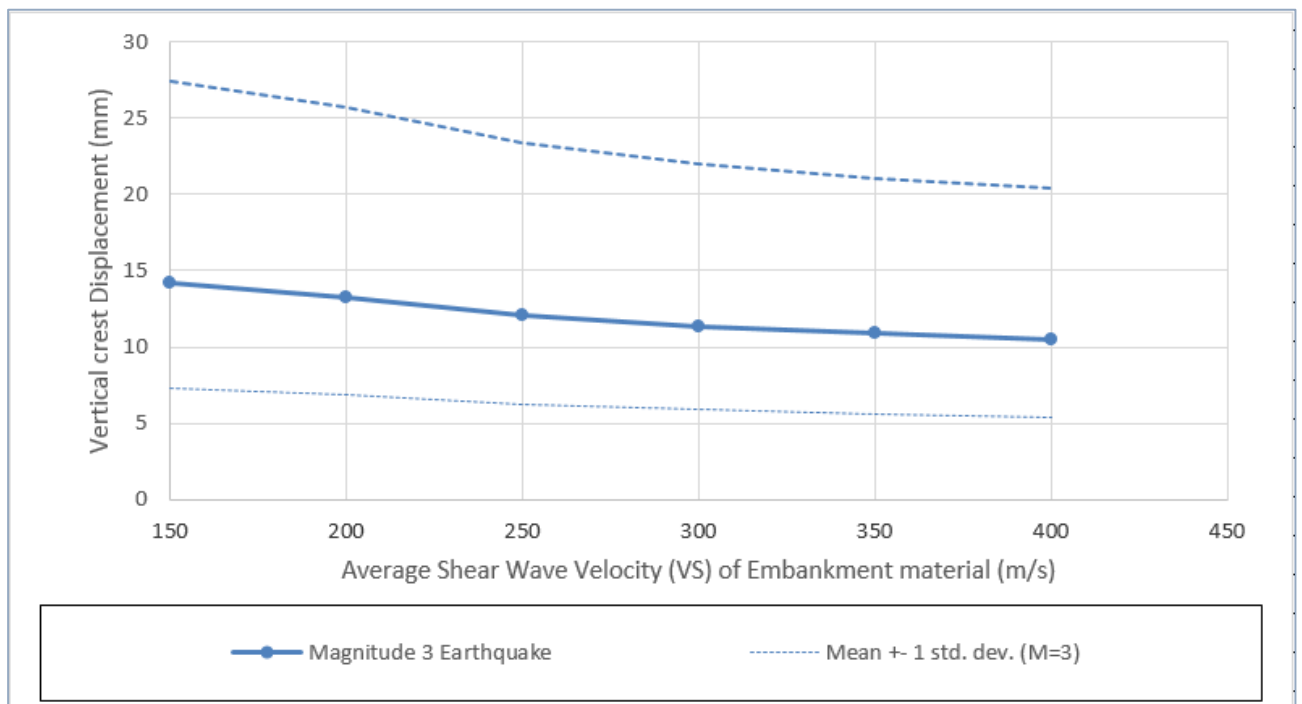
Figure 20: Crest Settlement

For a magnitude of 3, the expected crest settlement is likely to be of the order of 11 mm to 14 mm with a standard deviation of between a lower bound value of 5 mm and an upper bound value of 27 mm. If the magnitude was increased to 4, the expected crest settlement would be in the order of 14 mm to 18 mm and for a magnitude of 5, the expected crest settlement would be in the order of 18 mm to 25 mm

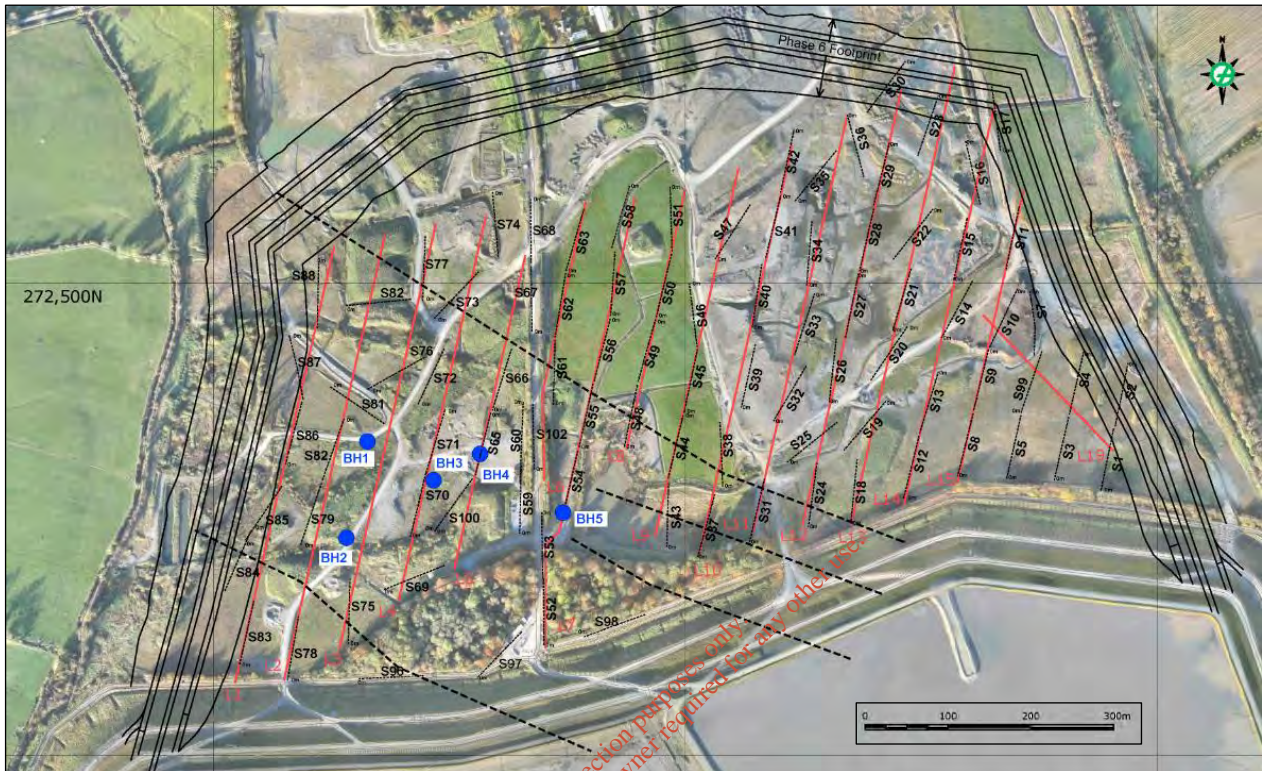
Figure 4: Location of Boreholes (plotted over recent aerial photograph of the Stage 6 TMF footprint)

Figure 4 below presents the locations of the investigative boreholes plotted over a recent aerial photograph of the proposed Stage 6 extension to the TMF.

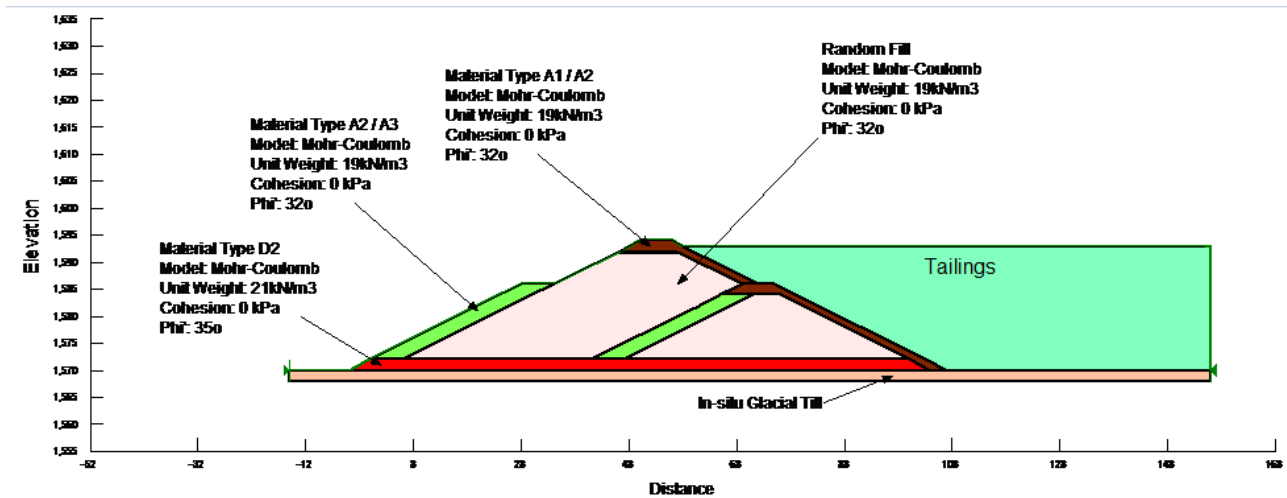
Figure 7: Model with material details

The geotechnical strength parameters adopted in the stability modelling are presented in the following table and the geometric configuration presented in Figure 7.

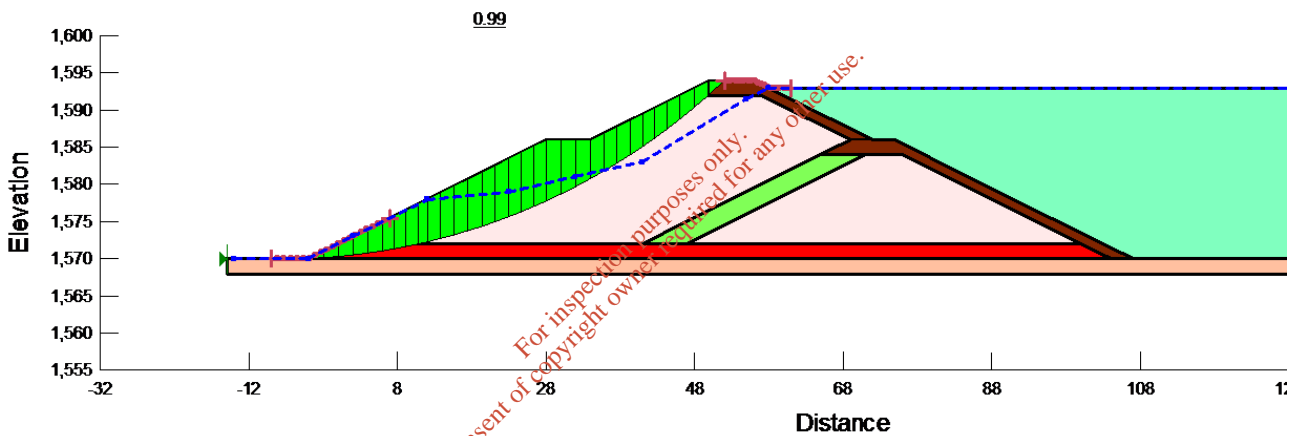
Figure 11: Pseudo - Static Analysis with Drainage Blanket blocked (Phreatic Surface at 1/3 Dam height)

The results of the stability analyses are presented in Table 14 below in the form of the FoS for the most critical slip surface and in Figures 8 to 11. The required minimum FoS was exceeded under all conditions analysed.

4	Long-term, tailings 1m below crest, phreatic surface exists 1/3 dam height. Ground Acceleration 0.06g. Pseudo static condition.	Downstream	0.99
---	---	------------	------

The factor of safety for the static and pseudo-static cases for the internal drainage system operational are satisfactory. Where the drainage system is non-operational, the factor of safety for the static condition is satisfactory. However, if an earthquake occurs, then the factor of safety is 0.99 which under these conservative conditions, is acceptable. As the dam wall incorporates a downstream drainage blanket and an upstream zone of Type A1 and A2 low permeability material together with the lining system, it is very unlikely that the phreatic surface would exit at a point one third of the dam height.

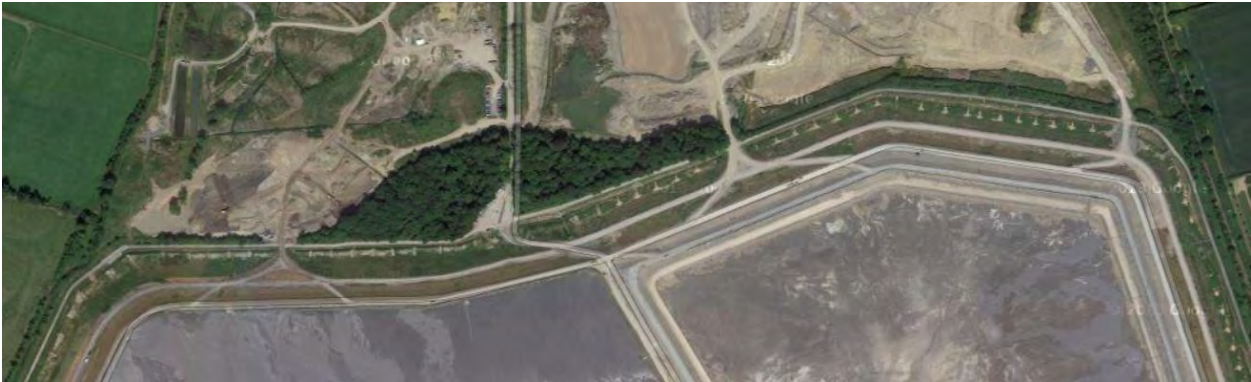
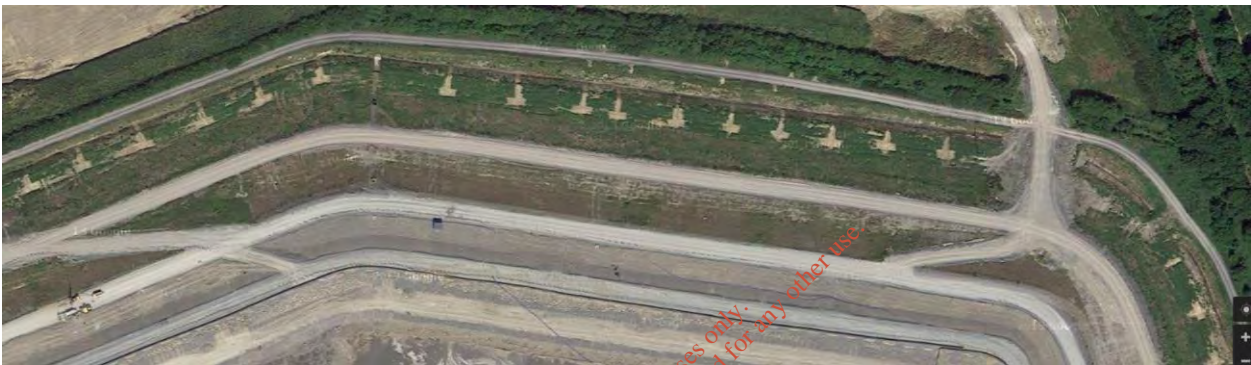
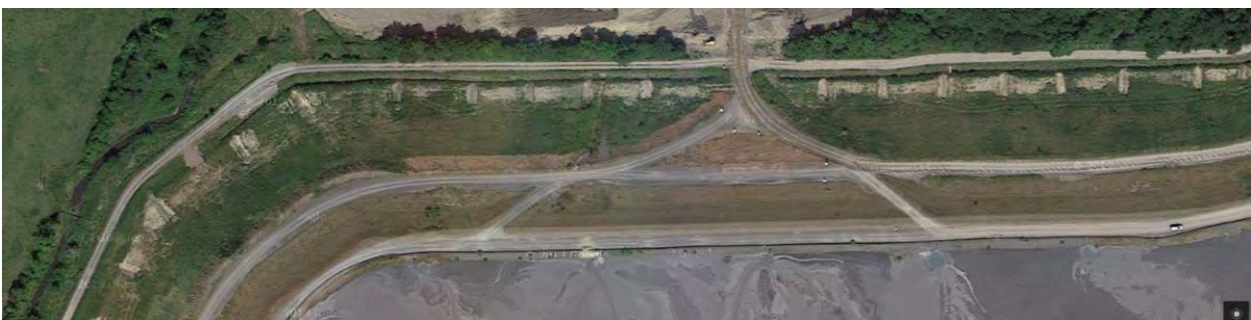
Photos showing locations of finger channels on the downstream side of the existing northern wall to be backfilled

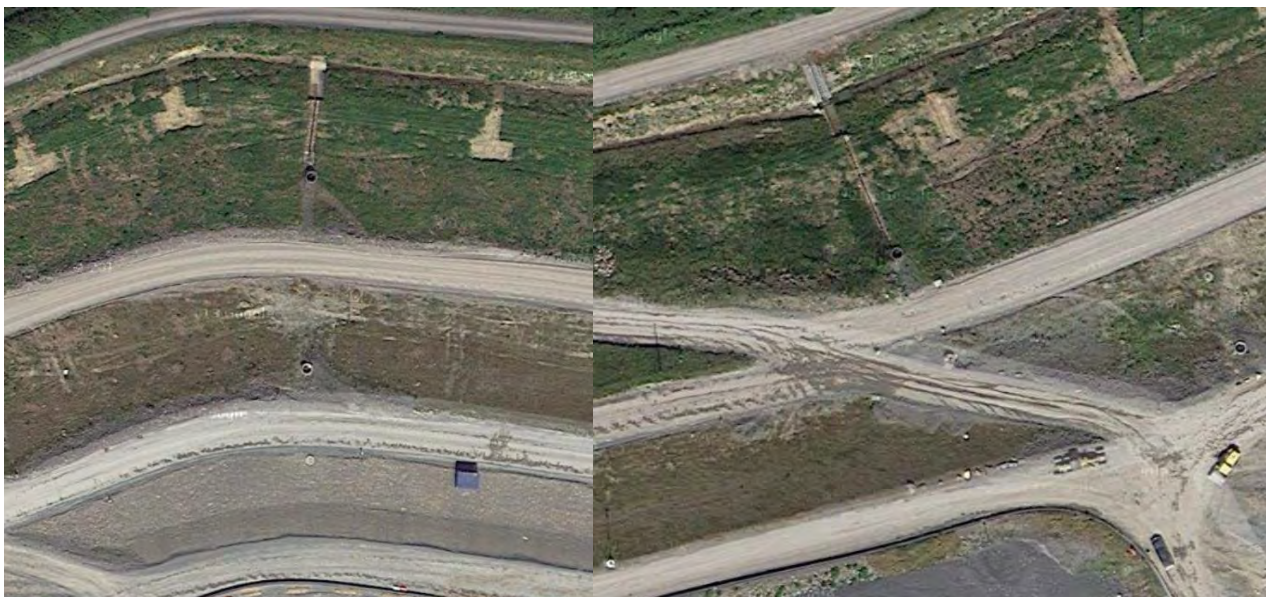
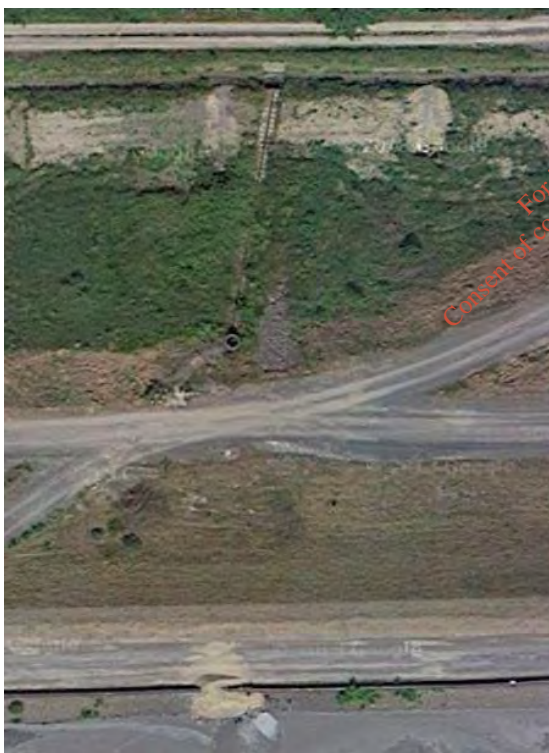
Photos showing locations of chutes and manholes on the downstream side of the existing northern wall to be backfilled

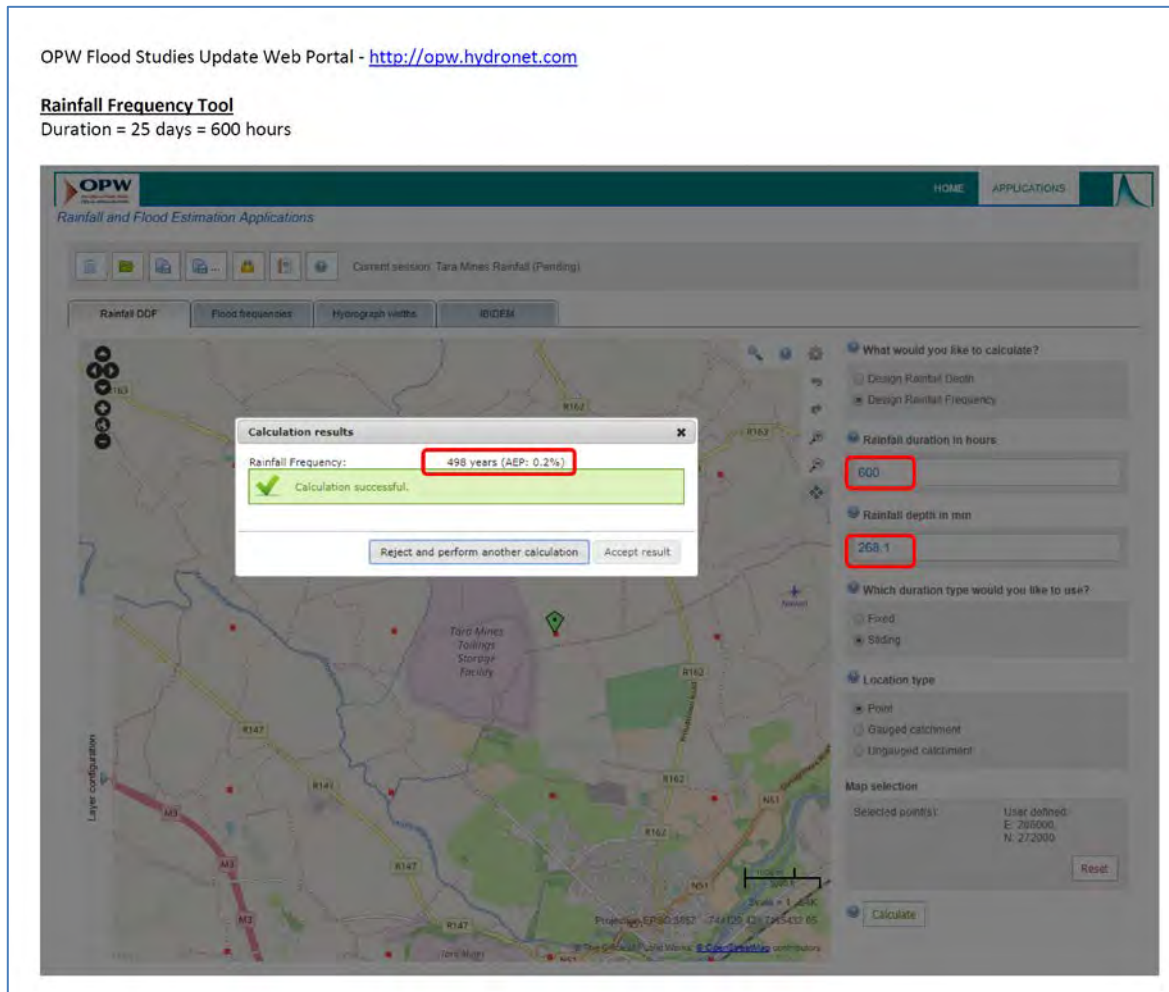
Duration = 25 days = 600 hours

Figure 1 OPW Rainfall and Flood Estimation data

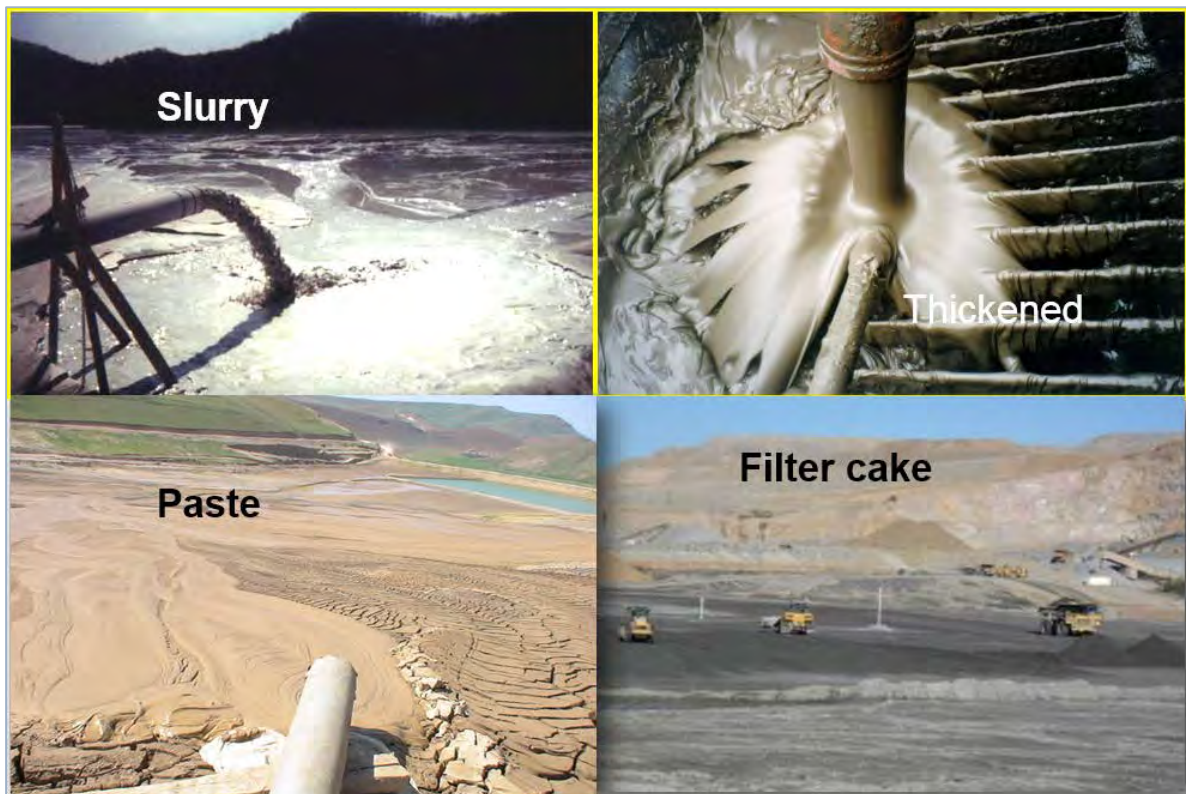
**Figure 1: Consistency of Tailings Disposal Alternatives**

Alternative Options	Tailings Disposal Plan	Solids content %
Option1	Slurry Deposition	10 to 60
Option 2	Thickened Tailings	60 to 70
Option 3	Surface Paste Tailings	70 to 80
Option 4	Filtered Tailings	80 to 90

The consistency of each alternative method is illustrated in Figure 1.
