Tier 1 - Landfill Risk Assessment

Churchtown, Co. Limerick County Council

EPA Ref: S22-02465

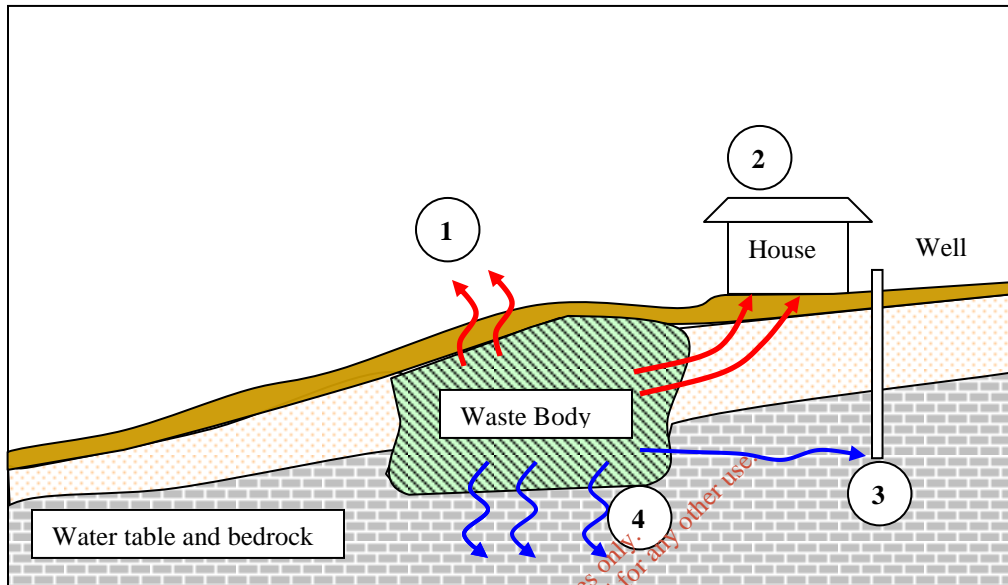
Figure 3: Conceptual Site Model for Churchtown Landfill Site

The conceptual site model (CSM) for Churchtown landfill site is shown below:

The Source-Pathway- Receptors linkages for Churchtown are:

1. Vertical migration of landfill gas to nearby houses
2. Lateral migration of landfill gas to nearby houses.
3. Migration of leachate to private wells
4. Migration of leachate to the underlying aquifer

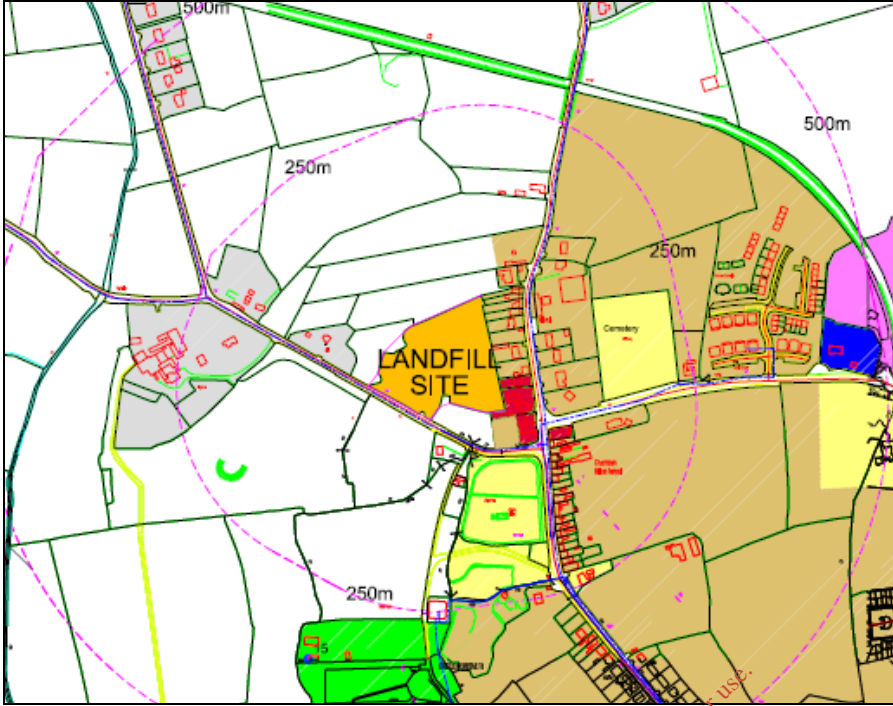
Figure 4 : Site Plan showing houses within 250 metres of Landfill

The location of properties within 250 m and 500 m of the site is shown below:

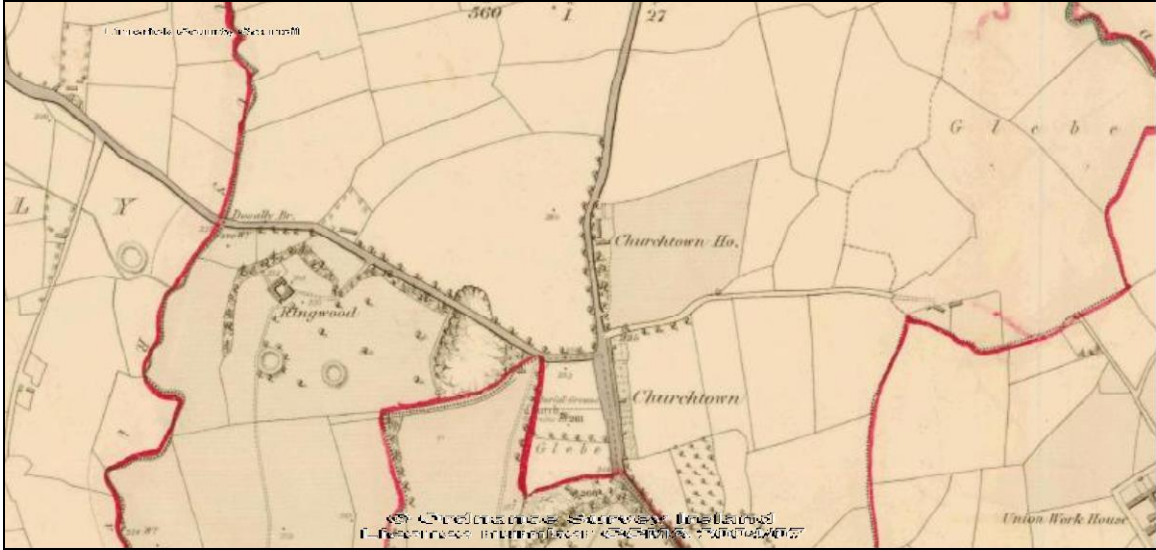
Map 1: c 1840 - No Quarry at Churchtown
