# Grange Castle Golf Club

## Closure, Restoration and Aftercare Management Plan

Client:	South Dublin County Council
Project Title:	Grange Castle Golf Club
Document Title:	Closure, Restoration and Aftercare Management Plan
Document No:	MDR1223Rp0008 F01

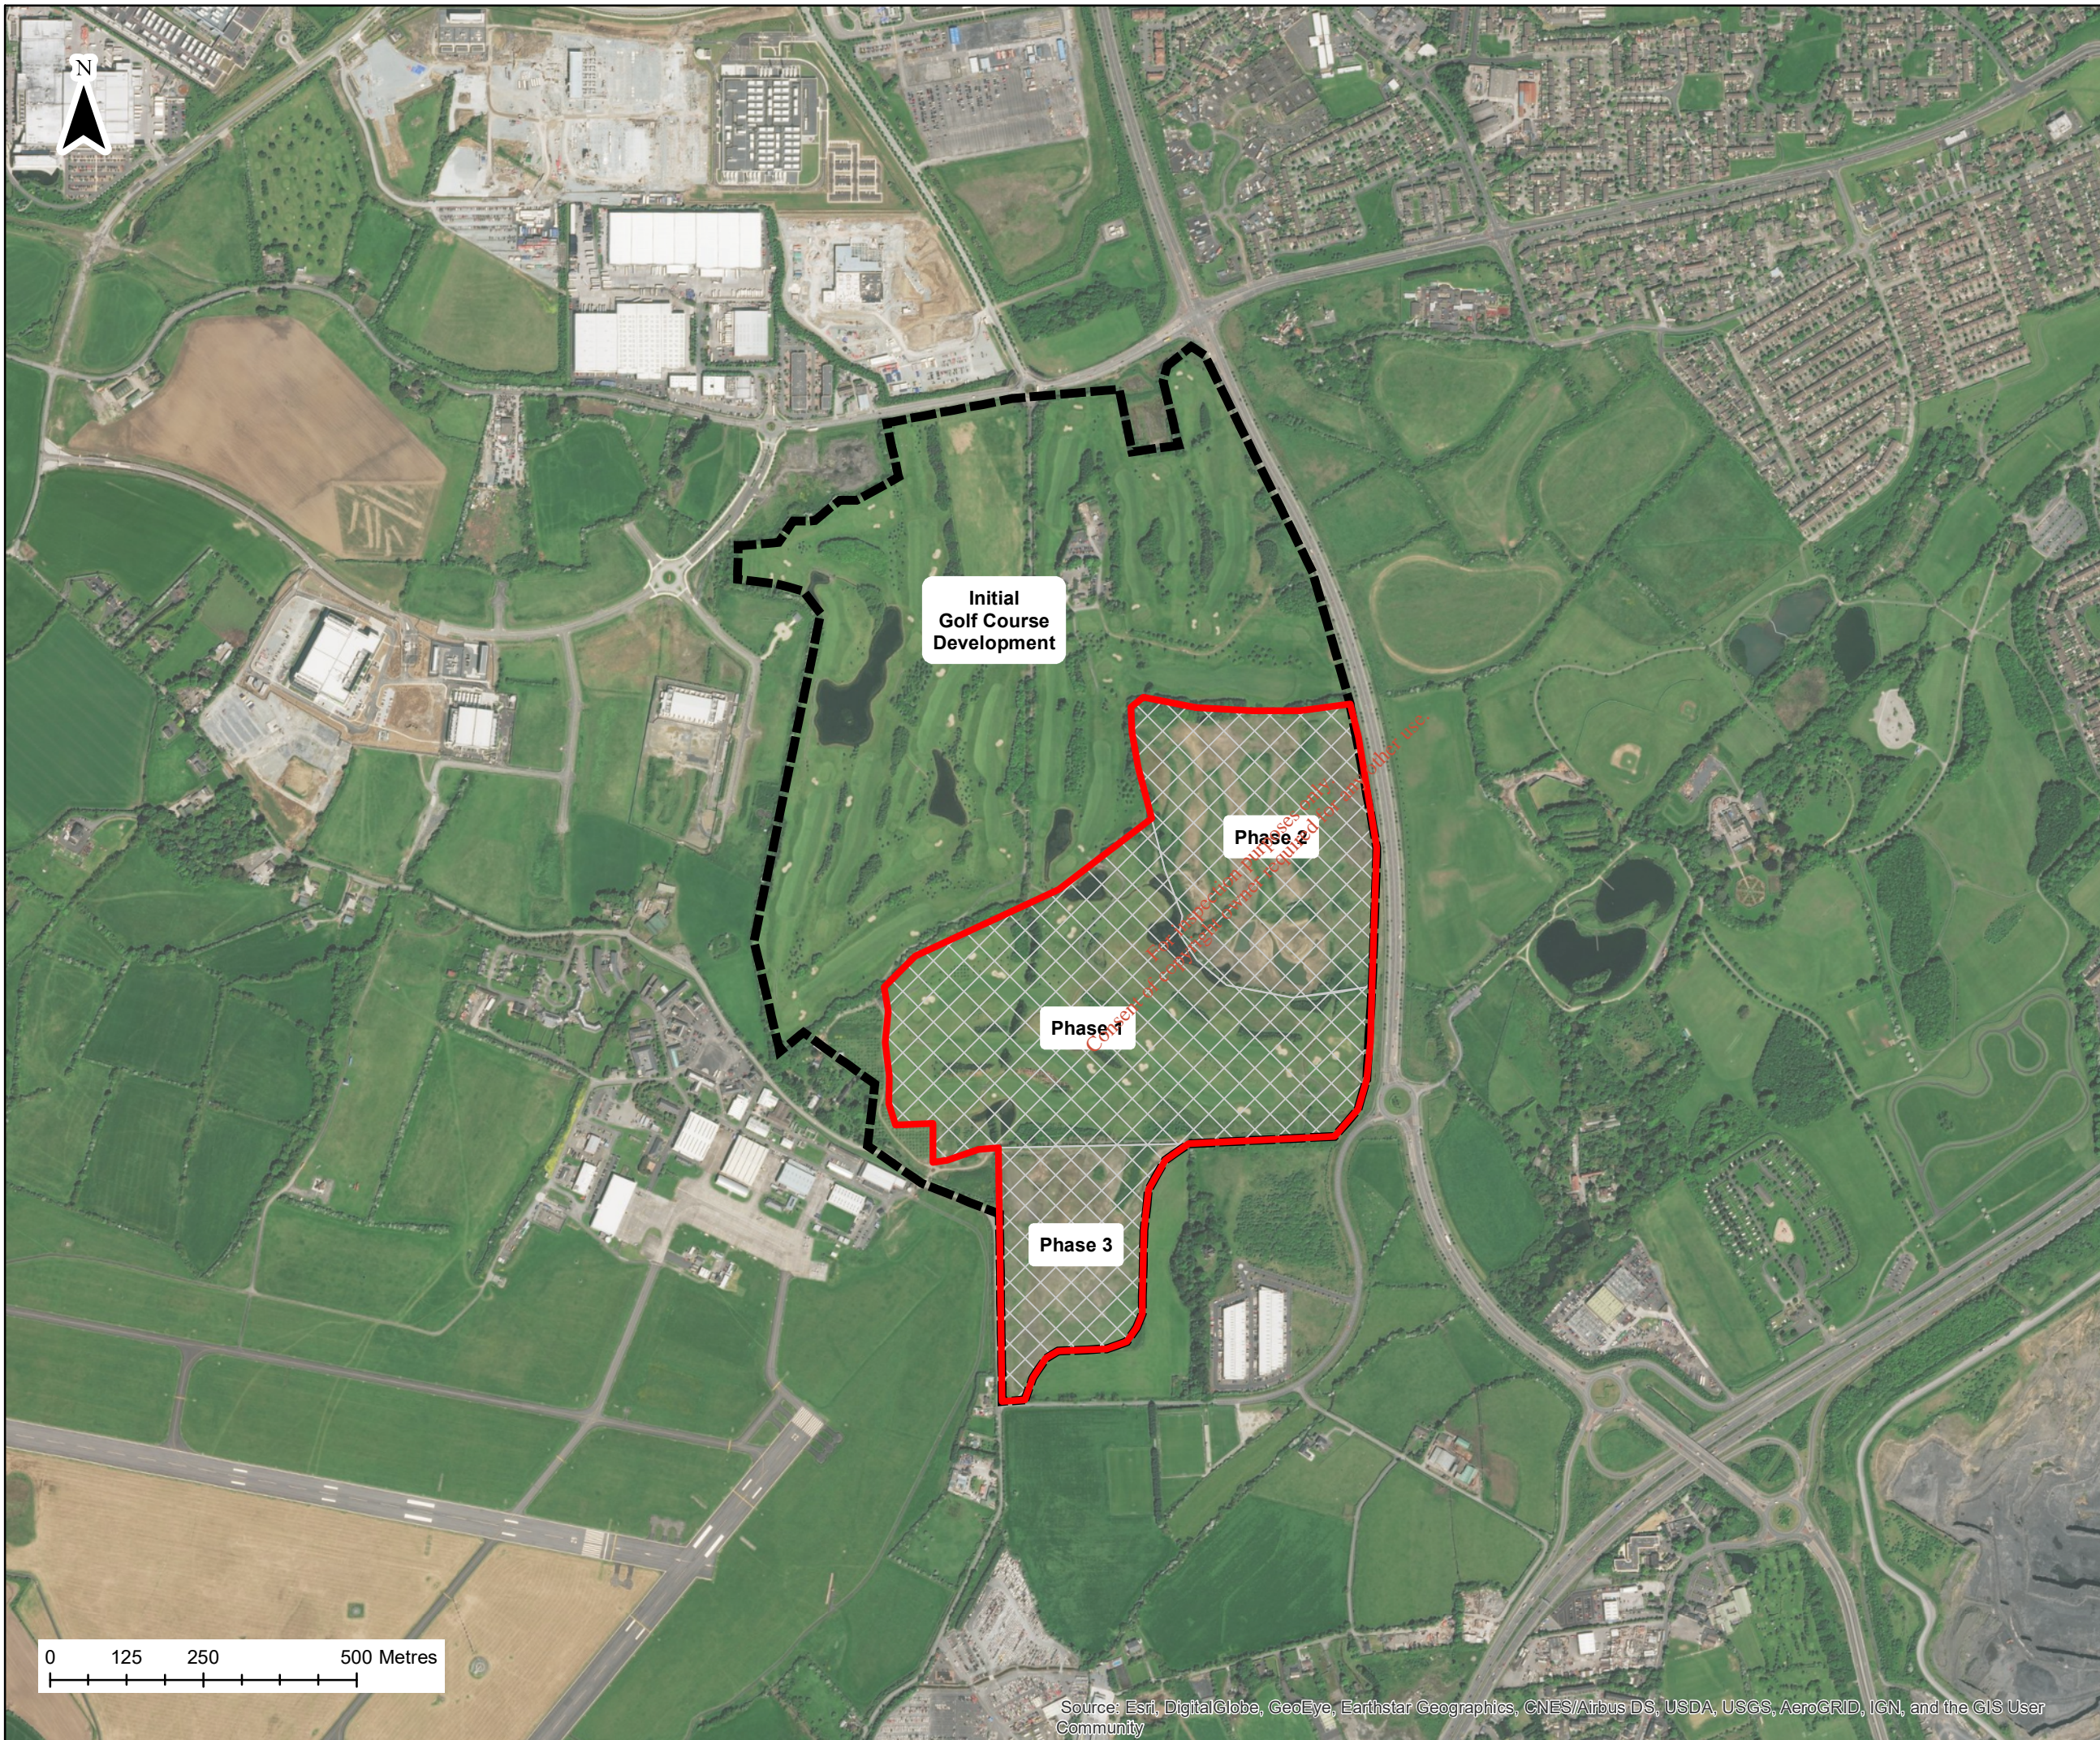
Figure: 2.1

Title  
**Site Plan**

Site Boundary (covered by Waste Licence)
-

Grange Castle Golf Club Boundary
