**TIER 3 RISK ASSESSMENT  
HISTORIC LANDFILL AT CLAREMORRIS, CO. MAYO**

Prepared for: Mayo County Council

**Abstract:** This report represents the findings of a Tier 3 risk assessment carried out at Claremorris Historic Landfill, Co. Mayo, conducted in accordance with the EPA Code of Practice for unregulated landfill sites.

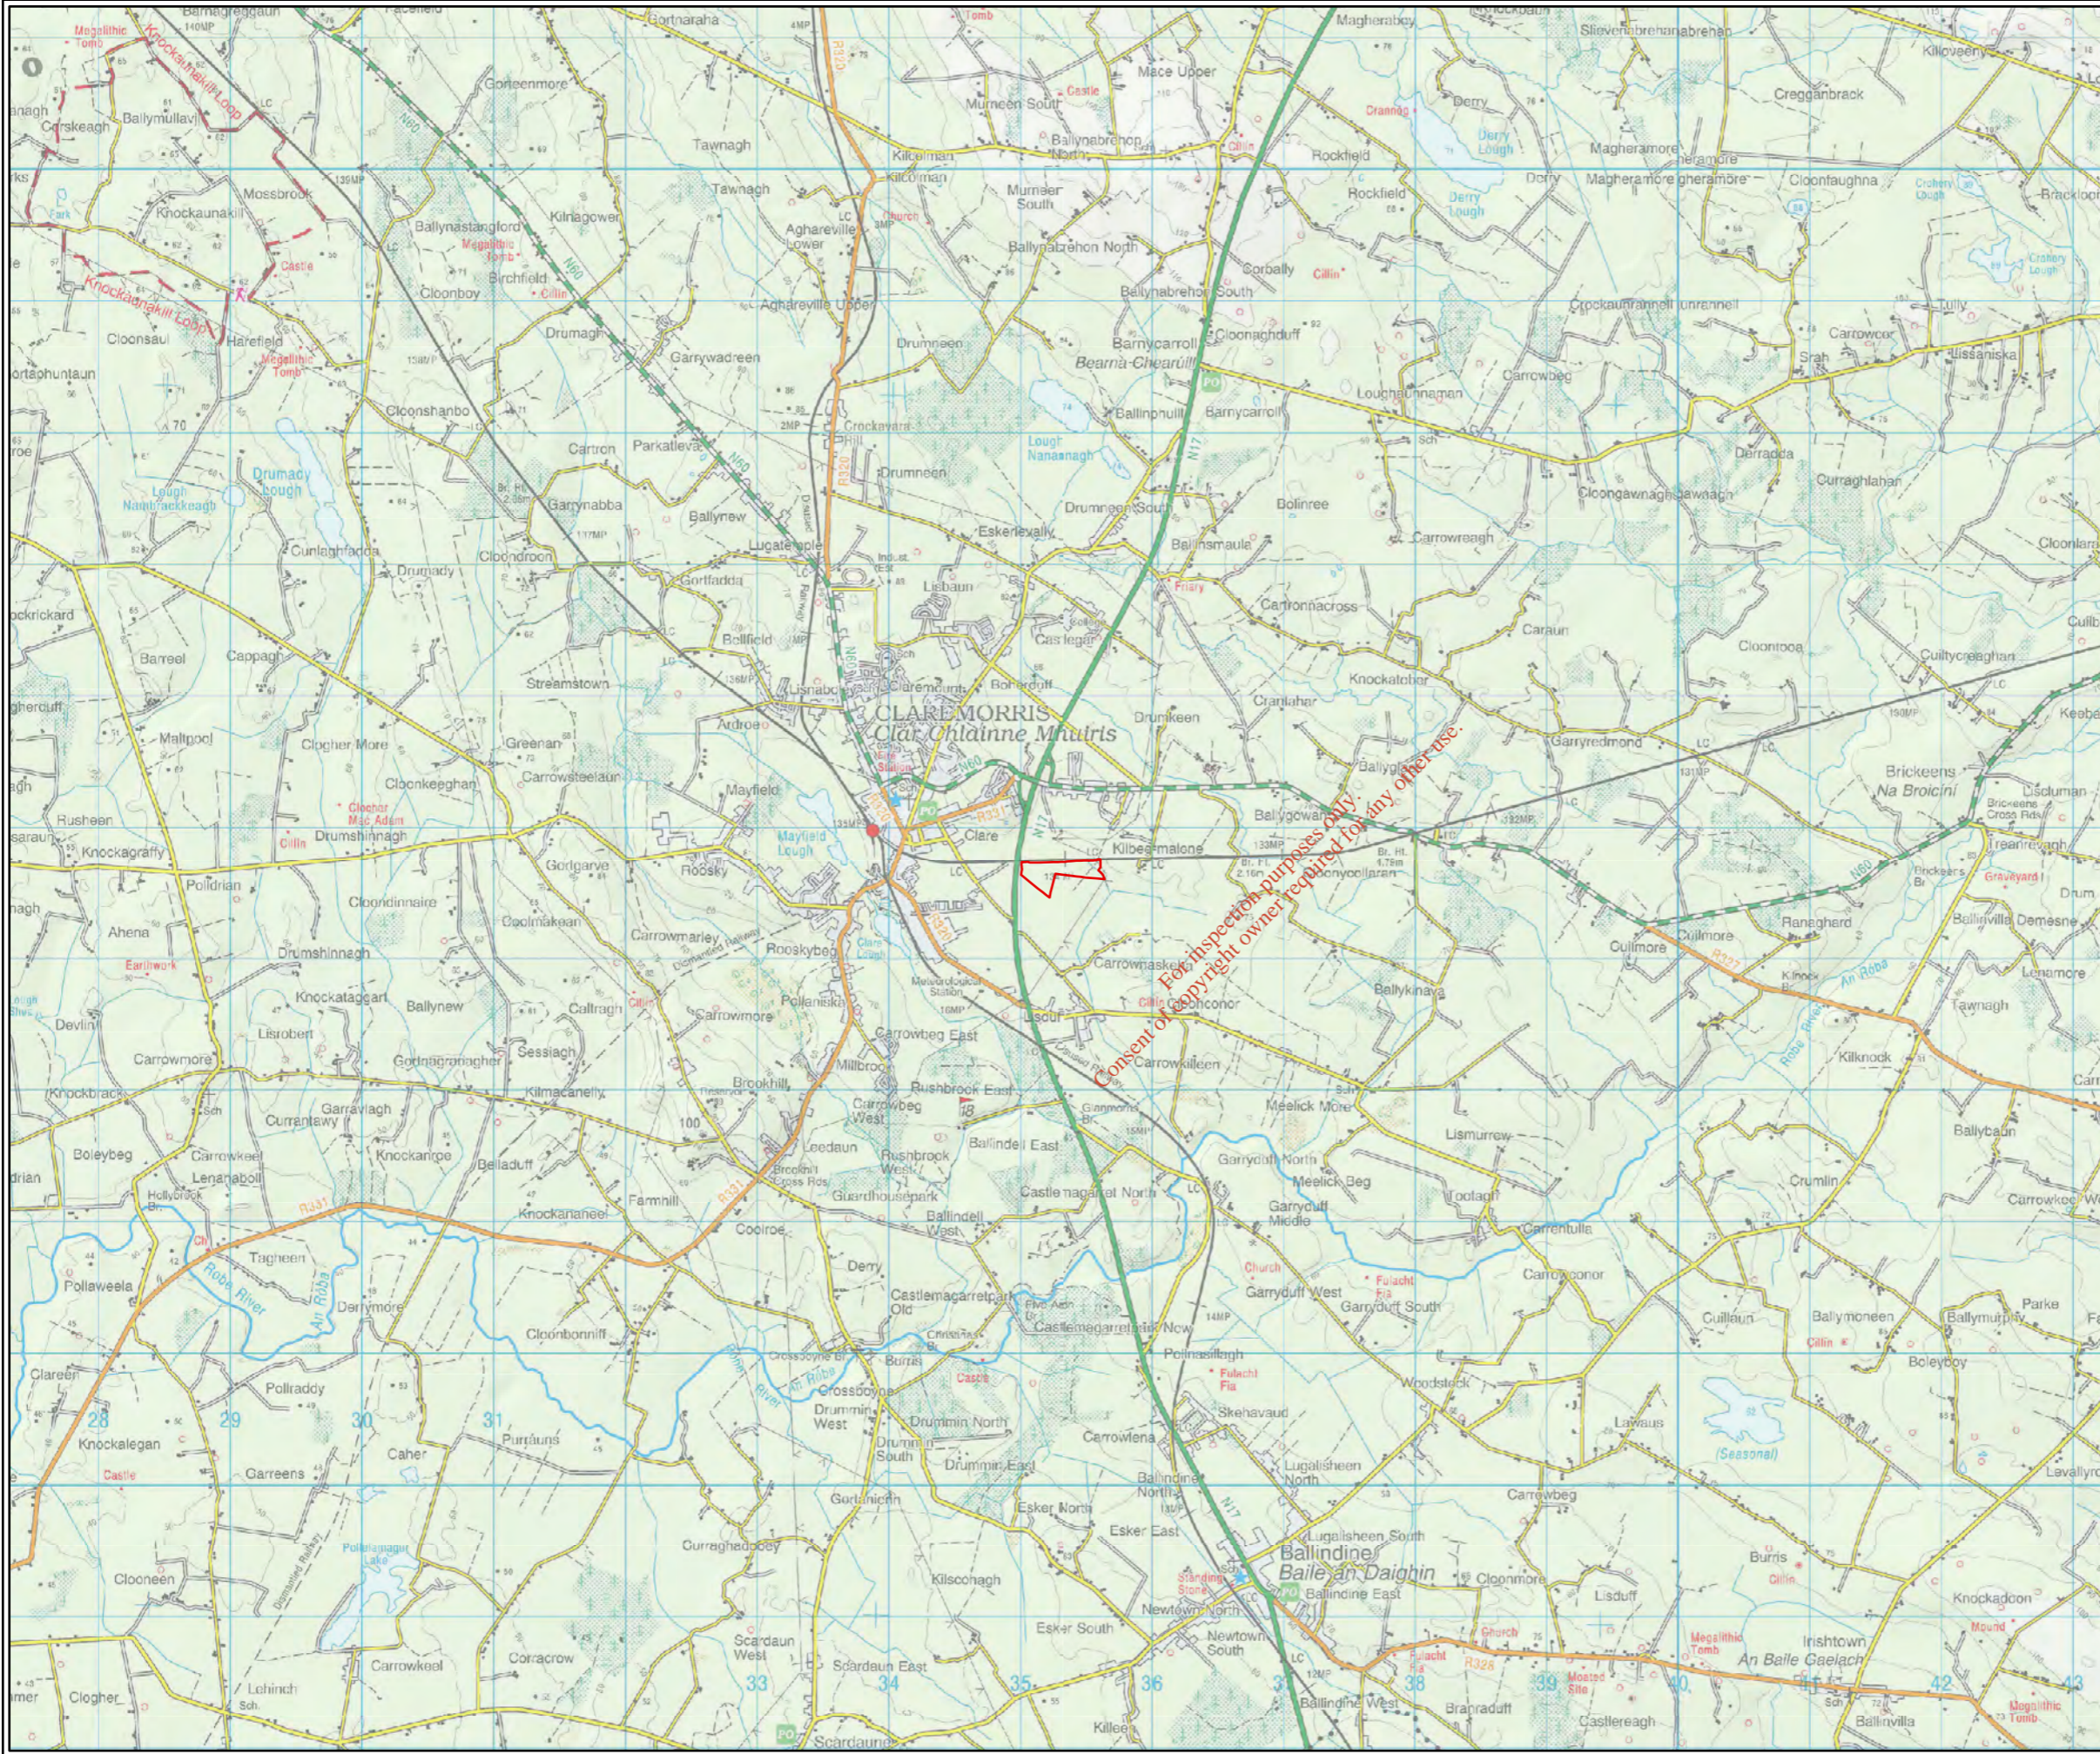
<b>TITLE:</b>	
Site Location	
<b>PROJECT:</b>	
Claremorris Tier 3 and Remediation Plan	
<b>FIGURE NO:</b>	
2.1	
<b>CLIENT:</b>	
Mayo County Council	
<b>SCALE:</b>	<b>REVISION:</b>
1:50,000	0
<b>DATE:</b>	<b>PAGE SIZE:</b>
13/01/2020	A3

Site Boundary

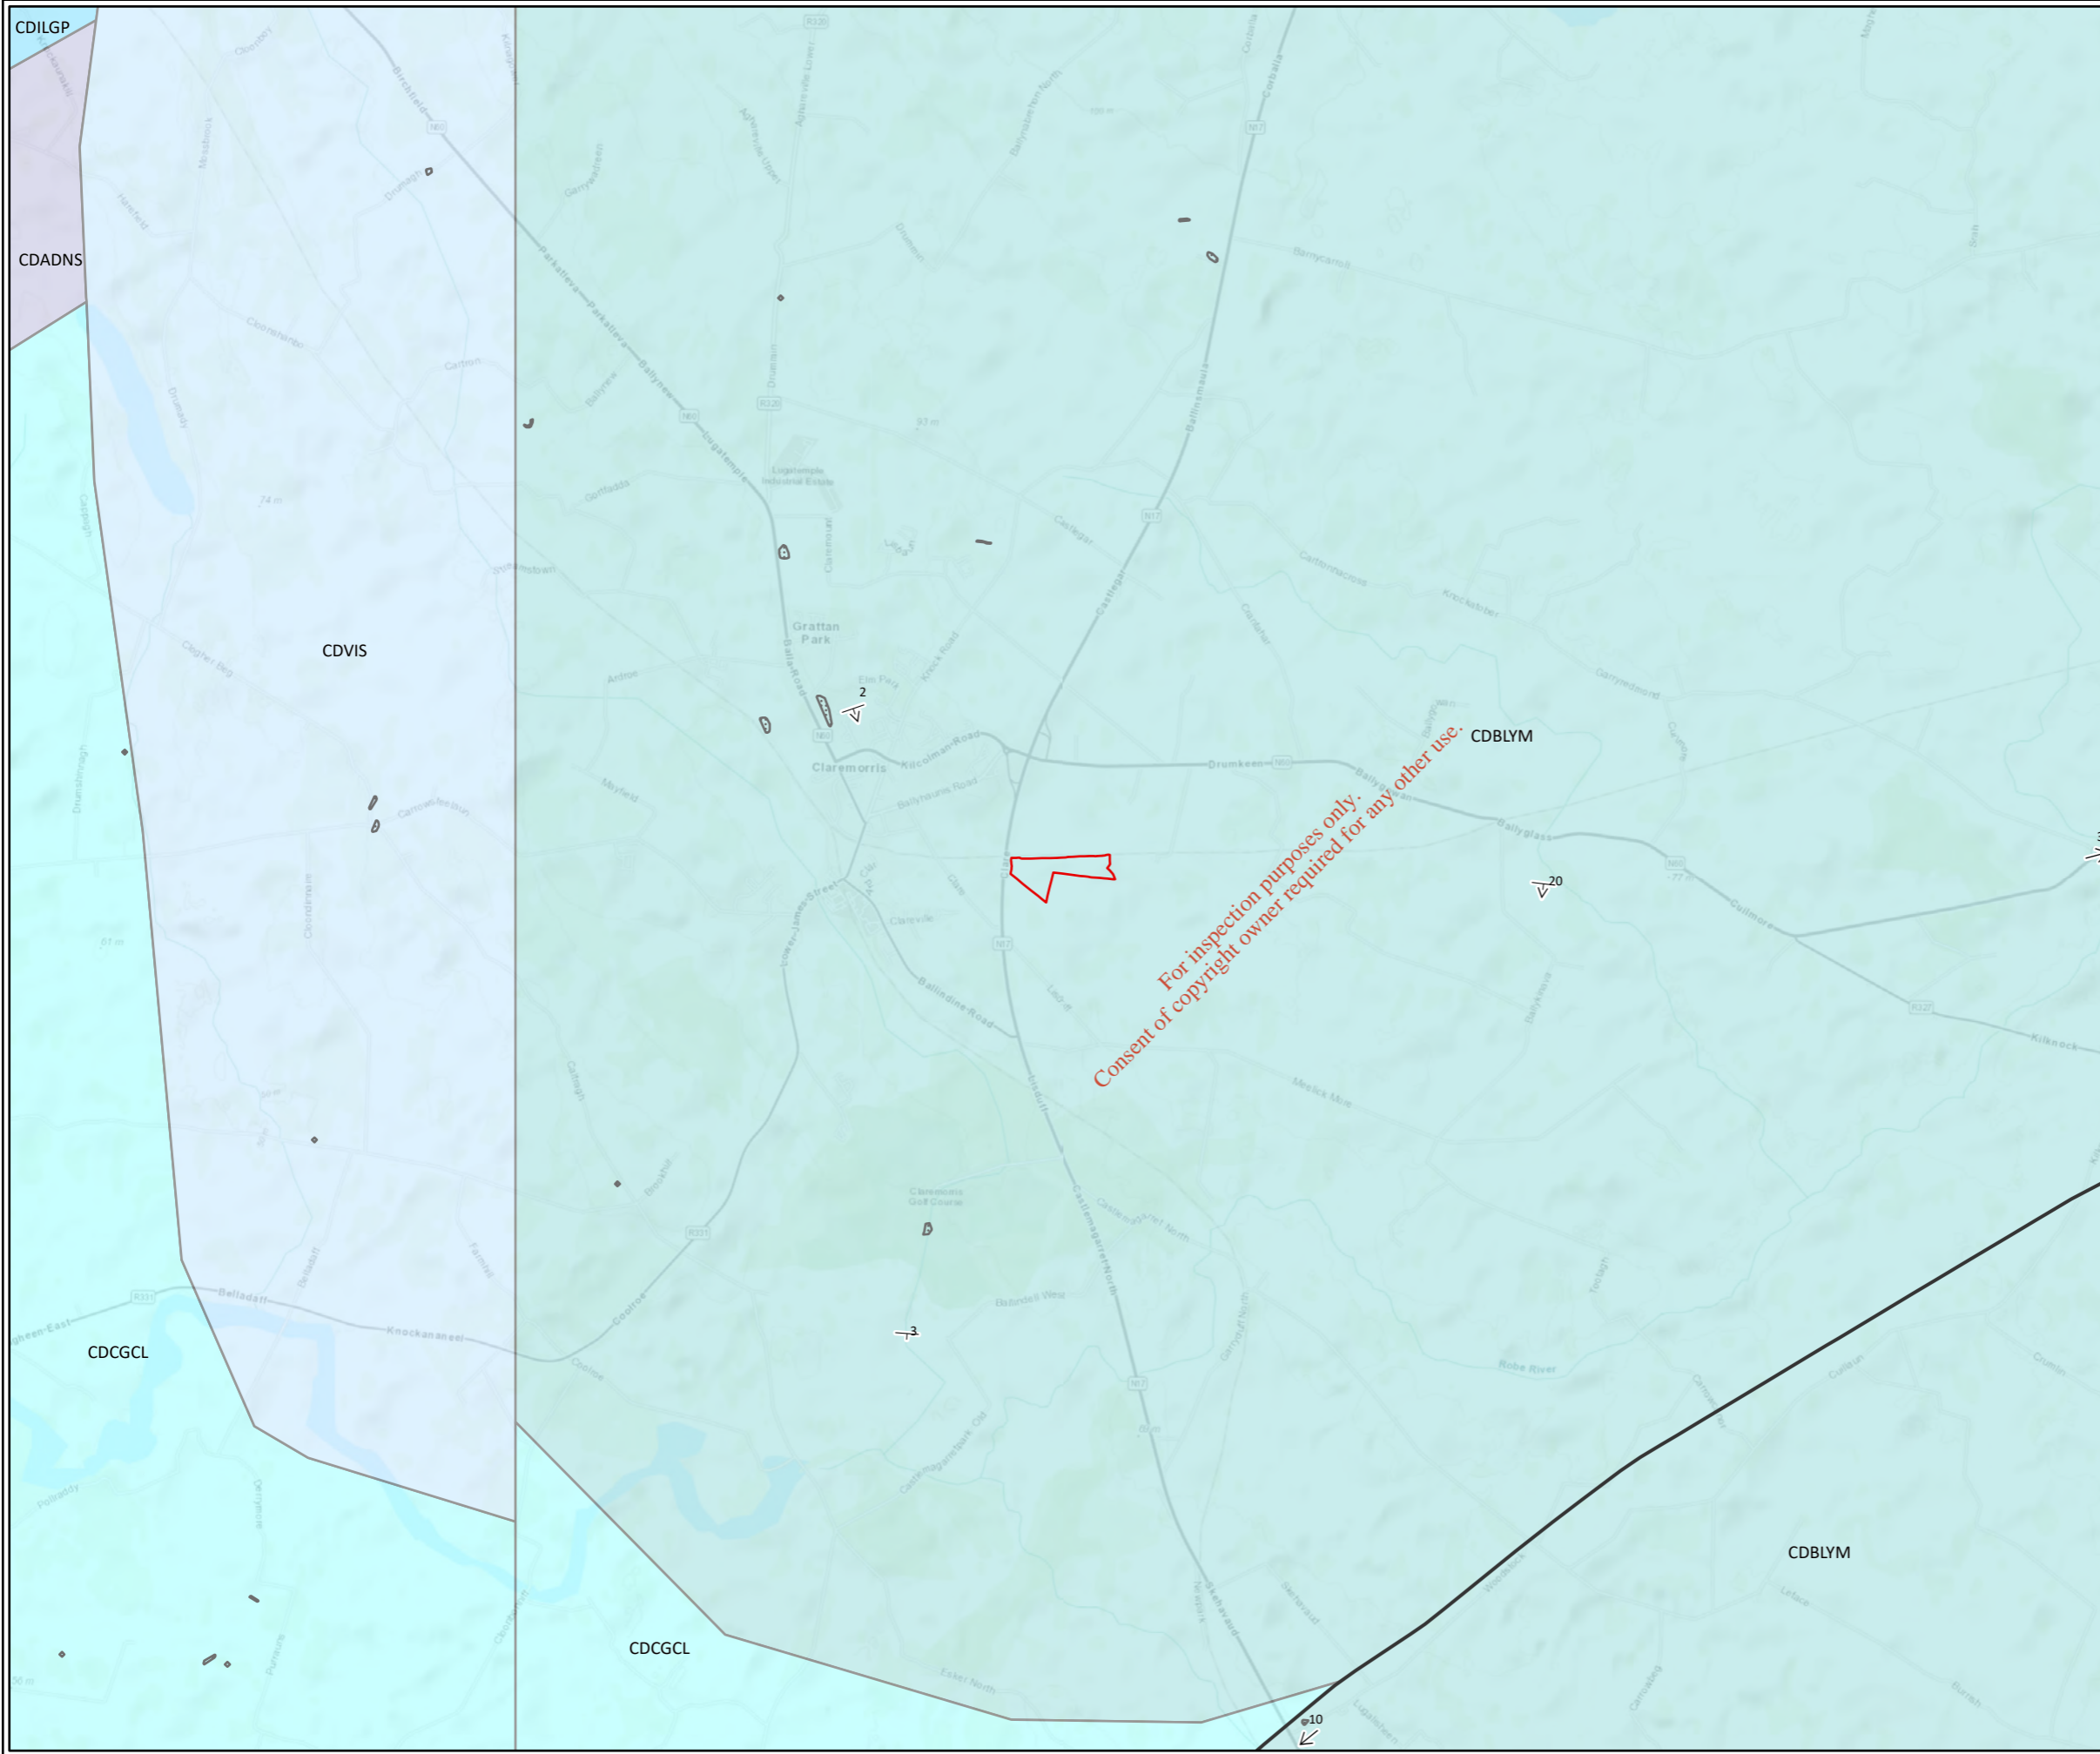
- Site Boundary
- Dip of bedding or main folia on, old GSI data
- Strike and dip of bedding, right way up
- Strike and dip of bedding, way up unknown
- Fault
- Bedrock Outcrop
- Bedrock Geology**
- Ardnasillagh Formation
- Ballymore Limestone Formation
- Cong Canal Formation
- Illaunagappul Formation
- Visean Limestones (undifferentiated)

The GSI online 1:100,000 scale bedrock geology map, shows the bedrock beneath to be found on a single formation. The entirety of the site and surrounding area are underlain by the Ballymore Limestone Formation (CDBLYM) which is generally made up of dark fine-grained limestone and shale. No areas of bedrock outcrop are shown within or in the immediate vicinity of the site.

The bedrock geology is presented in Figure 2-3.

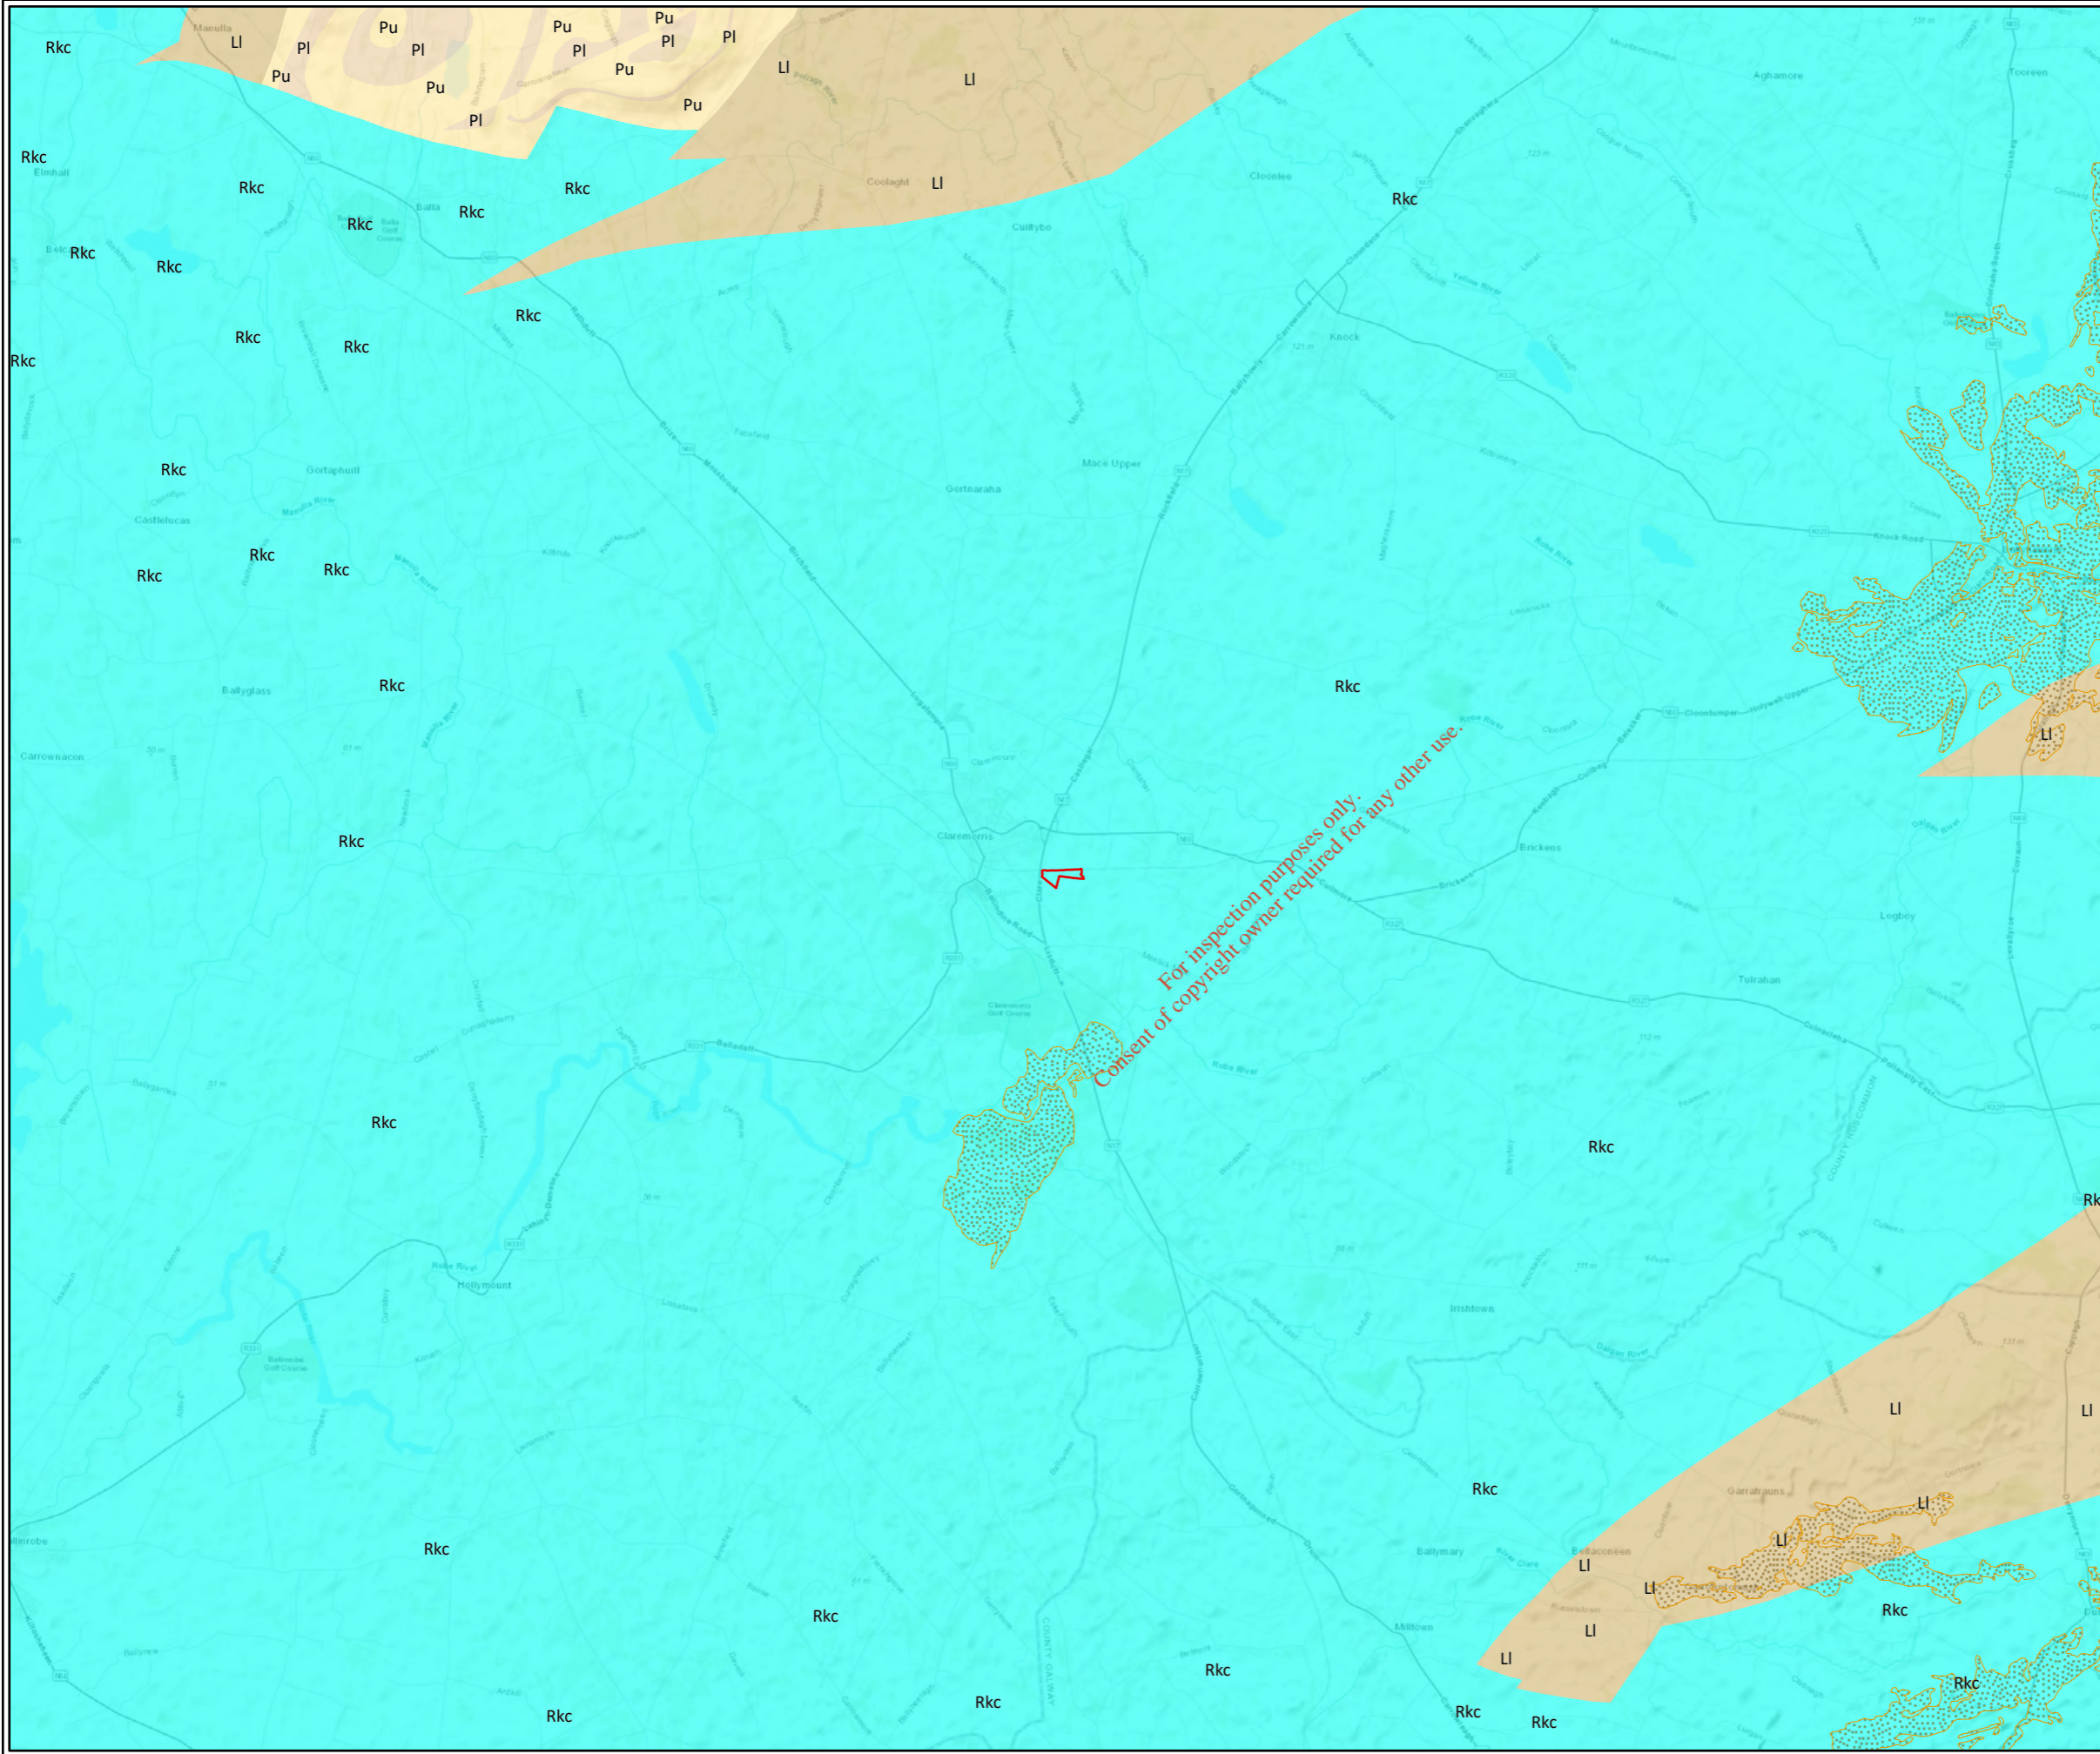
<b>TITLE:</b>	Aquifer Classification	
<b>PROJECT:</b>	Claremorris Tier 3 and Remediation Plan	
<b>FIGURE NO.:</b>	2.4	
<b>CLIENT:</b>	Mayo County Council	
<b>SCALE:</b>	1:100,000	<b>REVISION:</b> 0
<b>DATE:</b>	13/01/2020	<b>PAGE SIZE:</b> A3

- Site Boundary
- Sand and Gravel Aquifers**
- Locally important gravel aquifer
- Bedrock Aquifers**
- LI: Locally Important Aquifer - Bedrock Mod  
Productive Locally
- PI: Poor Aquifer Bedrock Generally  
Unproductive except Locally
- Pu: Poor Aquifer Bedrock Generally  
Unproductive
- Rkc: Regionally Important Aquifer -  
Karsted (conduit)

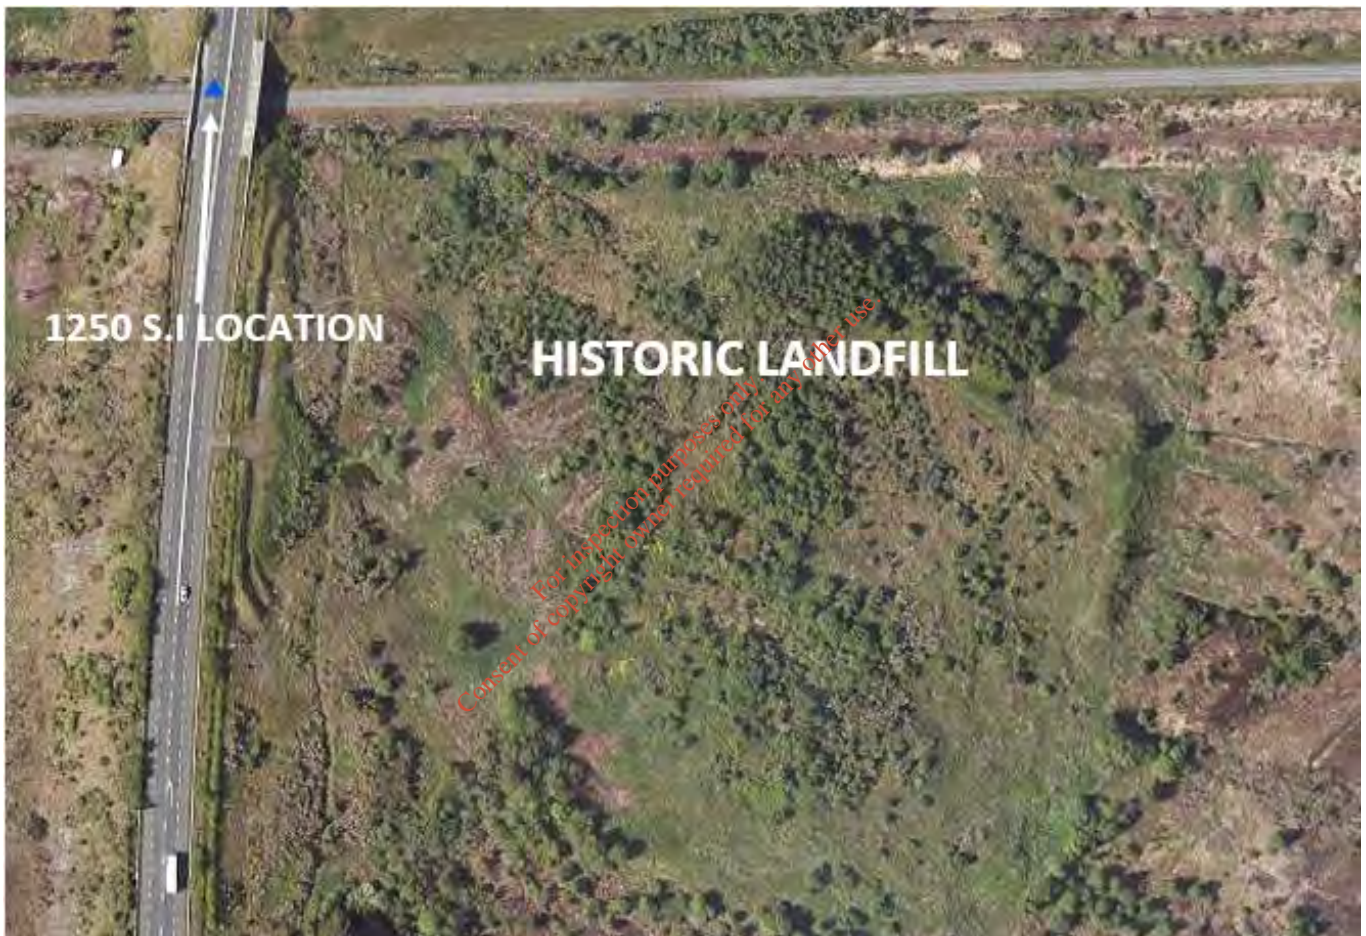
**Figure 2-10: GSI Geotechnical Boreholes (Blue Triangle)**

The review highlighted two boreholes located close to the site for the then proposed (now existing) railway overbridge. The boreholes are referred to as 1250R and 1250L indicating their chainage location. The approximate location of these boreholes according to the GSI is shown in Figure 2-10 below.

*Two holes were bored at this location. In borehole 1250R, 1.00 metres of filling overlies a 2.00 metres peat stratum. Coarse compact gravel was noted from 3.00 to 3.80 metres with Limestone rock found at 3.80 metres.*

*In Borehole 1250L, fill and peat again occurred to a depth of 1.40 metre, overlying a firm stiff gravelly clay. Gravel was noted from 2.70 to 3.70 metres with refusal (probably rock) at 3.70 metres.*

*Diamond drilling methods were used to recover NQ (50mm) core at both locations. At 1250R good quality core was recovered from 3.70 metres below ground level to 7.00 metres, while at Borehole 1250L solid rock core was recovered from 4.90 to 6.70 metres. Some weathered rock was noted in Borehole 12501. above the solid horizon.*
