Please find response to notice in accordance with Reg. No. H0223-01 - Regulation7(4) of the Waste Management (Certification of Historic Unlicensed Waste Disposal and Recovery Activity) Regulations, 2008 - Digby Bridge Landfill

Digby BridgeRegulation 7(4) Notice H0223-01

# Digby Bridge Landfill – Updated List of Figures

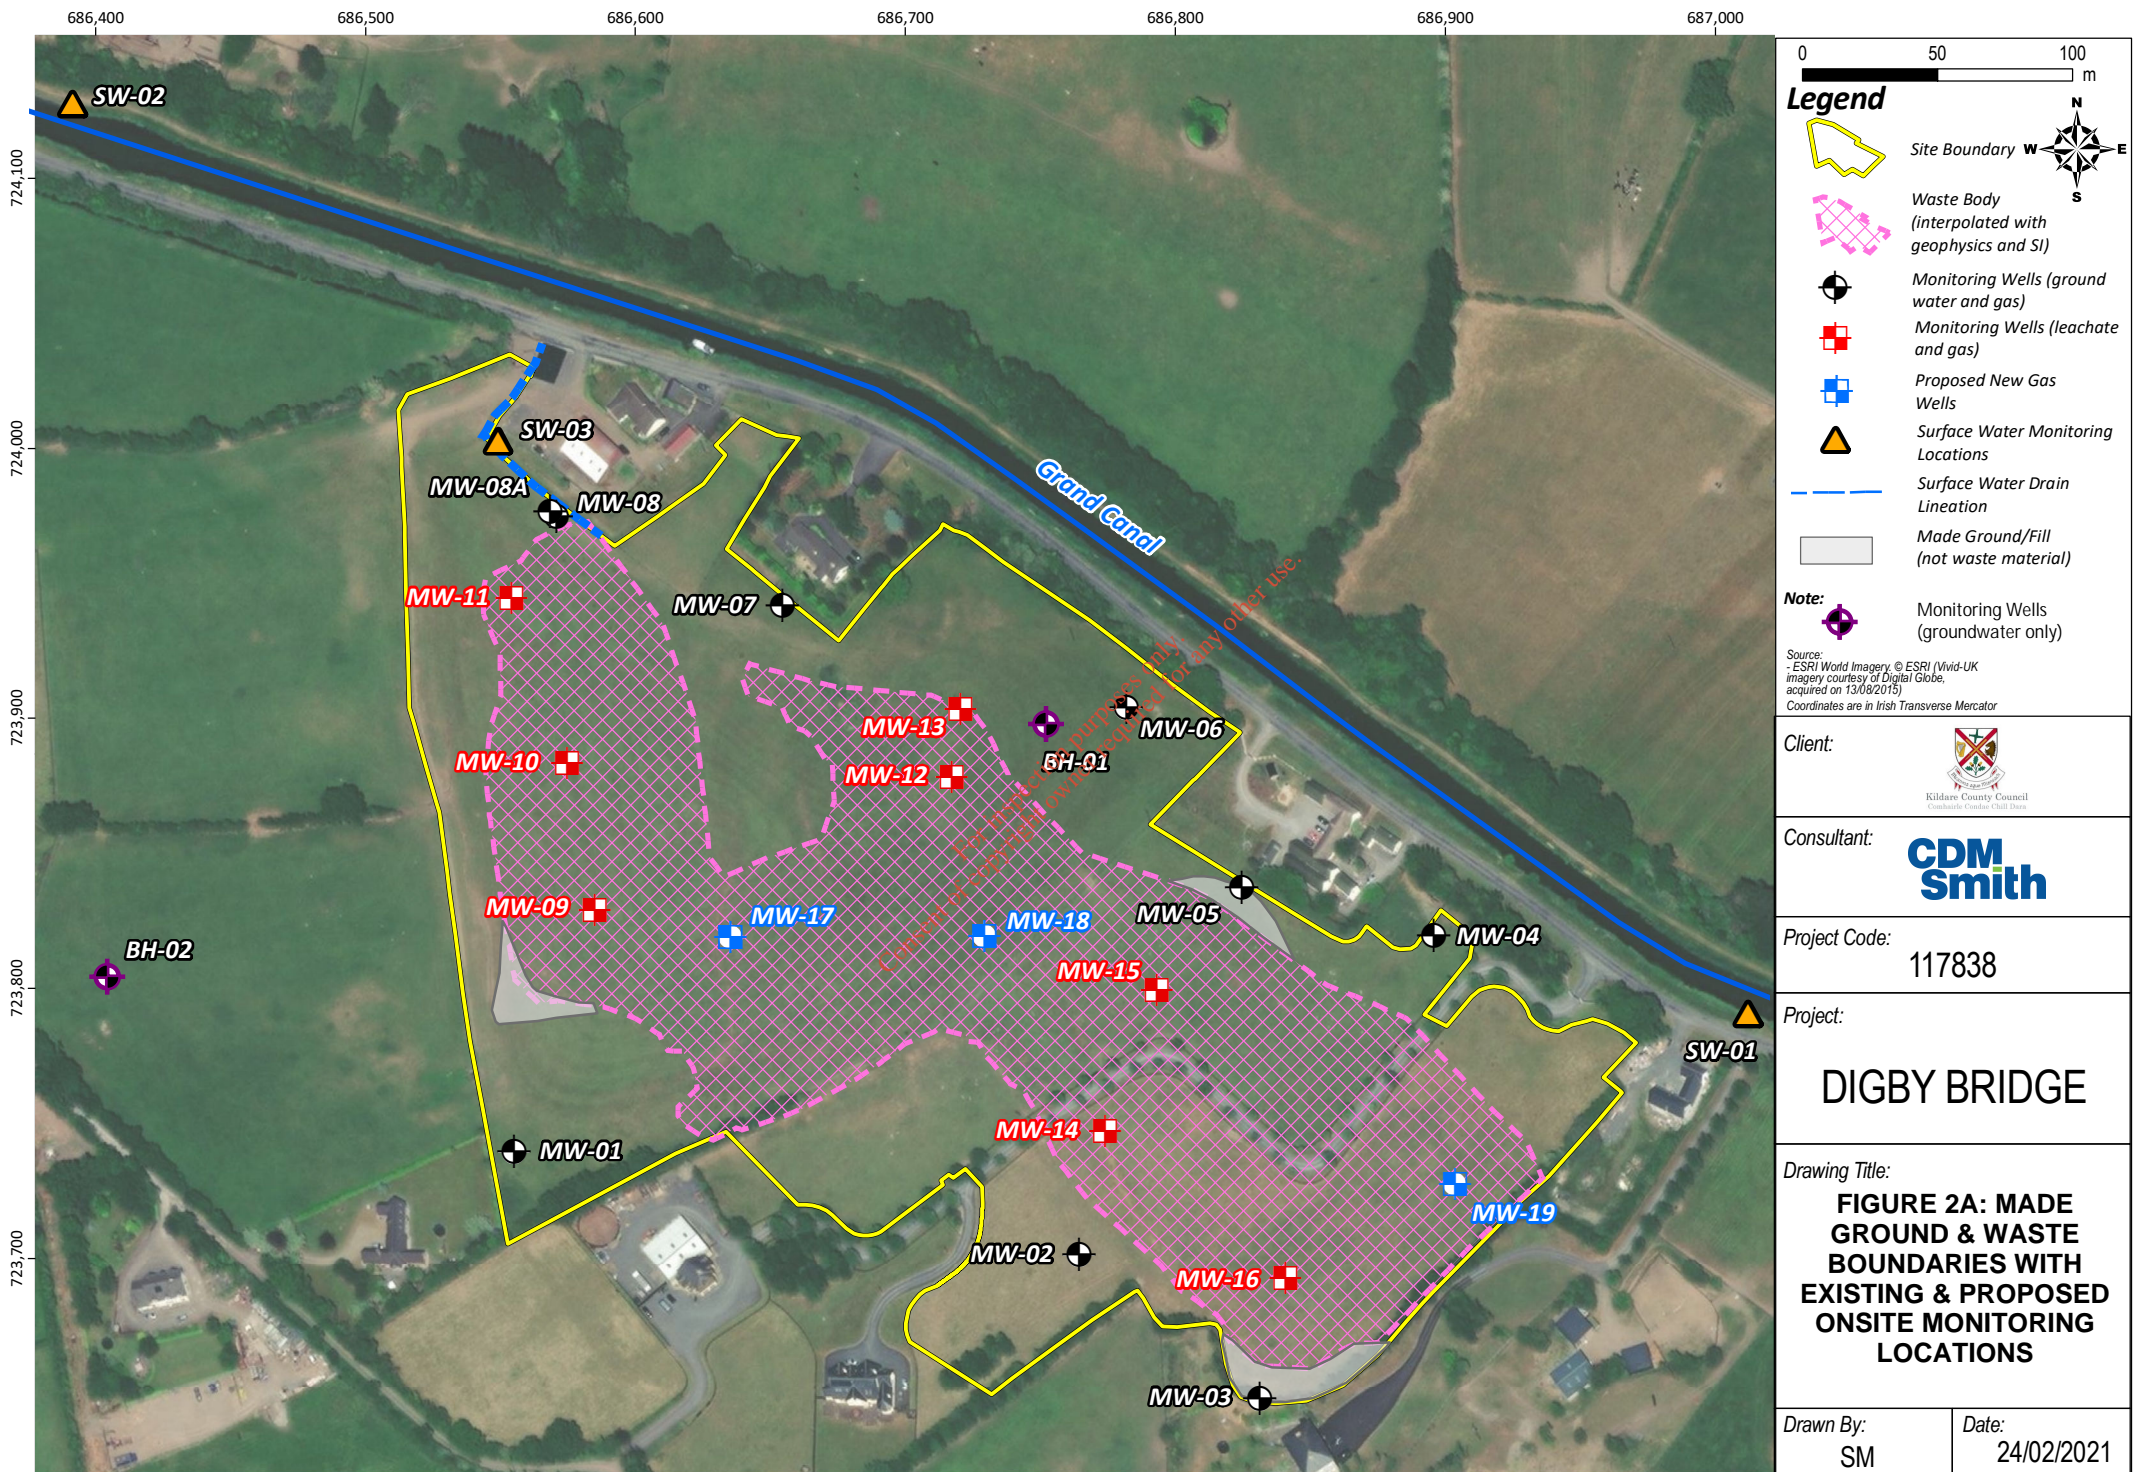
**Encl.** FIGURE 2A: MADE GROUND & WASTE BOUNDARIES WITH EXISTING & PROPOSED ONSITE MONITORING LOCATIONS  
Digby Bridge Landfill – Updated List of Figures

5. Please see 'Figure 2A: Made Ground & Waste Boundaries with Existing & Proposed Onsite Monitoring Locations'. This shows the extent of the waste body with the following elements interpolated:

- (i) the extent of "Made Ground/ Fill (not waste material)" referred to in Section 3.2.2 of the Tier 2 Assessment;
  - (ii) the existing and proposed monitoring locations for gas, leachate, groundwater and surface water (note SW-03 is included but it was not sampled as it was found to be dry on all sampling rounds). There are also proposed additional offsite groundwater monitoring locations shown in the Remediation Plan, on 'Figure 3: Groundwater Remedial Plan'; and,

- (iii) the site boundary around the entire site.
6. The only ditch that was discovered in the Site Investigation, as described in the Tier 3 Assessment, Volume 2 Section 2.3 was: *A shallow drainage ditch is present at the north-western margin of the site alongside a single farmyard and dug to divert surface runoff from the landfill away from the farmyard. The only discharge evident was an overflow from the ditch onto the adjacent road was witnessed, where it pooled.* 'Figure 2A: Made Ground & Waste Boundaries with Existing & Proposed Onsite Monitoring Locations' shows the location of this ditch.

**Figure 2A: Made Ground & Waste Boundaries with Existing & Proposed Onsite Monitoring Locations – New drawing provided as part of response to Regulation 7(4) – Feb 2021.**
