## **Kerry County Council**

► Tier 1 Review Report — Listowel •

November 2013

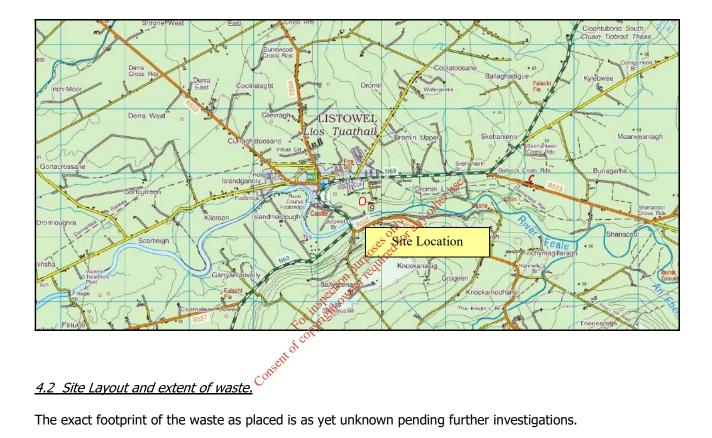
#### Site Location

The unregulated closed site is located in the townland of Ballygowlogue, Listowel.

The site is bounded on three sides by parkland and to the south by a municipal storage area.

The site is known as Listowel closed landfill.

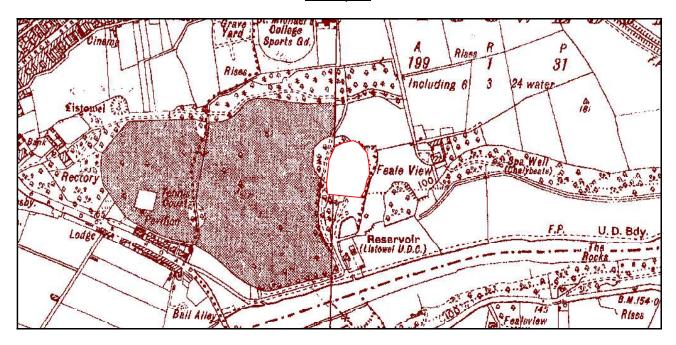
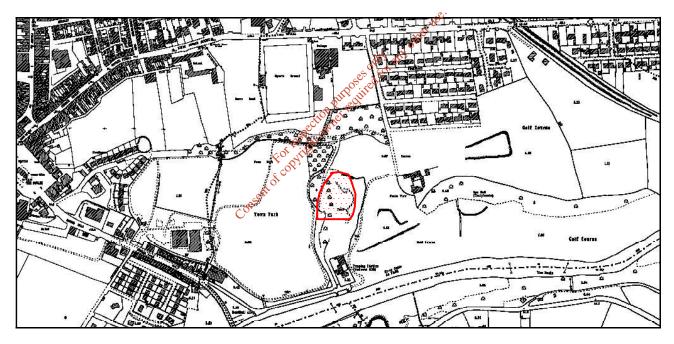
#### Site Layout

The exact footprint of the waste as placed is as yet unknown pending further investigations.

The extent is therefore taken as the full area of location where the activity took place which is approximately The An Foras Forbatha Report indicates a footprint 1.01 Ha (this figure is used in the risk assessment).

The grid reference to the approximate centre of the property holding is 99,700/133,476

The following layout map outlines the surrounding land use and geographic features.

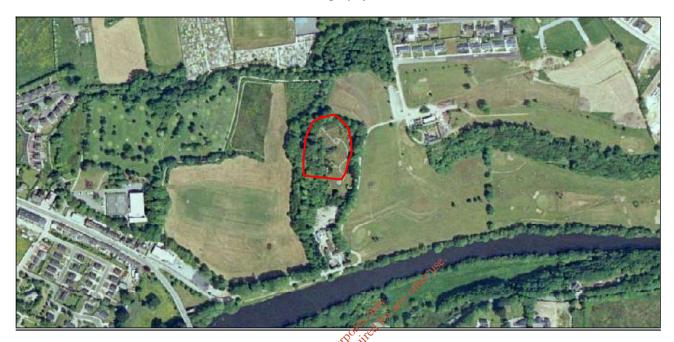
#### Aerial Photography - 2004

There are sets of available aerial photography from 1995 to 2004. These are presented in the following pages

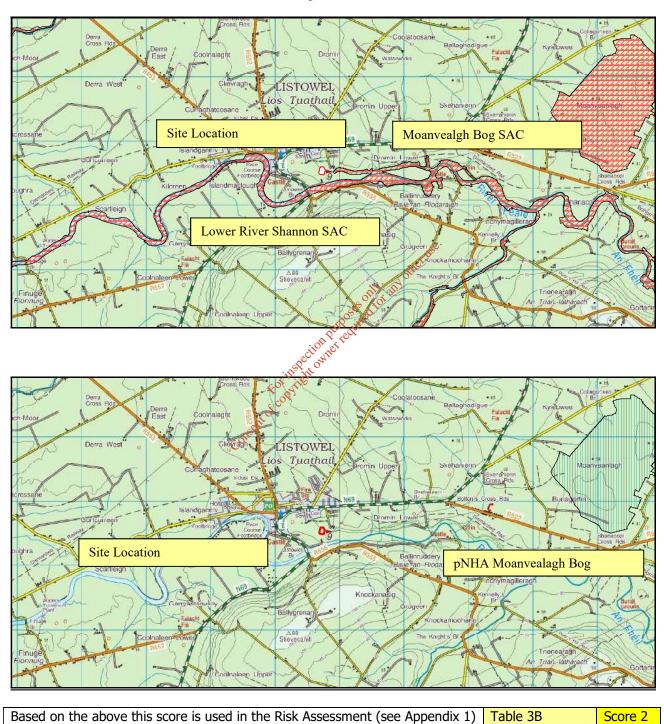
#### **Designated Sites**

The site is 142m from the Lower River Shannon SAC and 3.59km west of Moanvealagh Bog SAC which is also a pNHA.

The designation is current to September 2011.

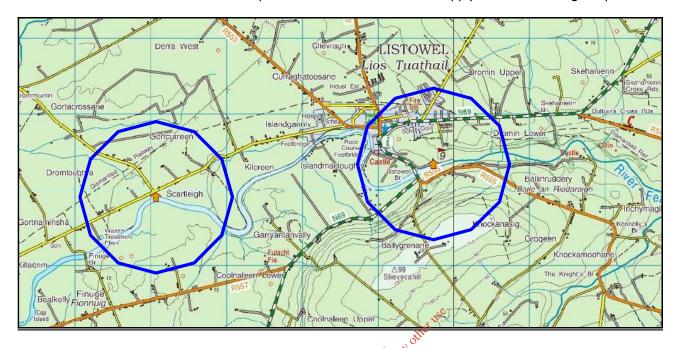
The site is located 3.59 km from the edge of Scartleigh surface water abstraction point and within 140m of the disused Listowel Town Source. As a precaution the Listowel Town Supply is taken as being in operation.

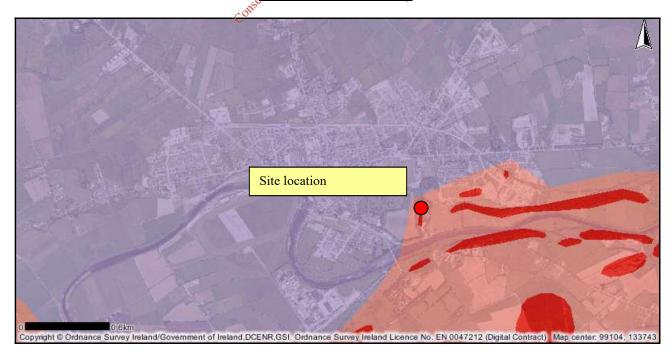
### <u> Sroundwater Vulnerability</u>

The site is located in an area that is high (HL).

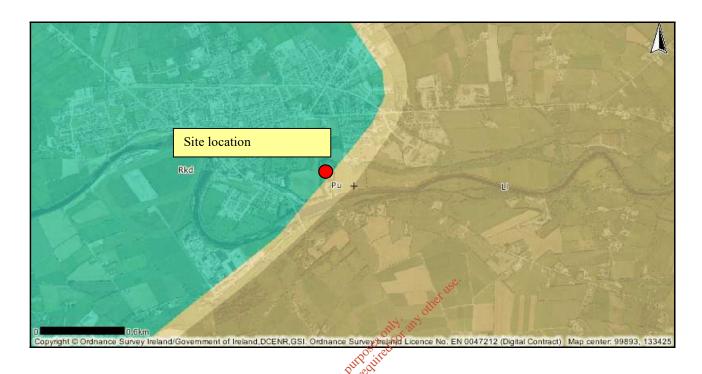
#### Aquifer Status

The Rkd status implied that the bedrock aquifer is regionally important – this is conservative designation.
