**DB5 Data Centre**

## Geotechnical Interpretative Report

REP/GE/001-258064

Issue 3 | 23 April 2018

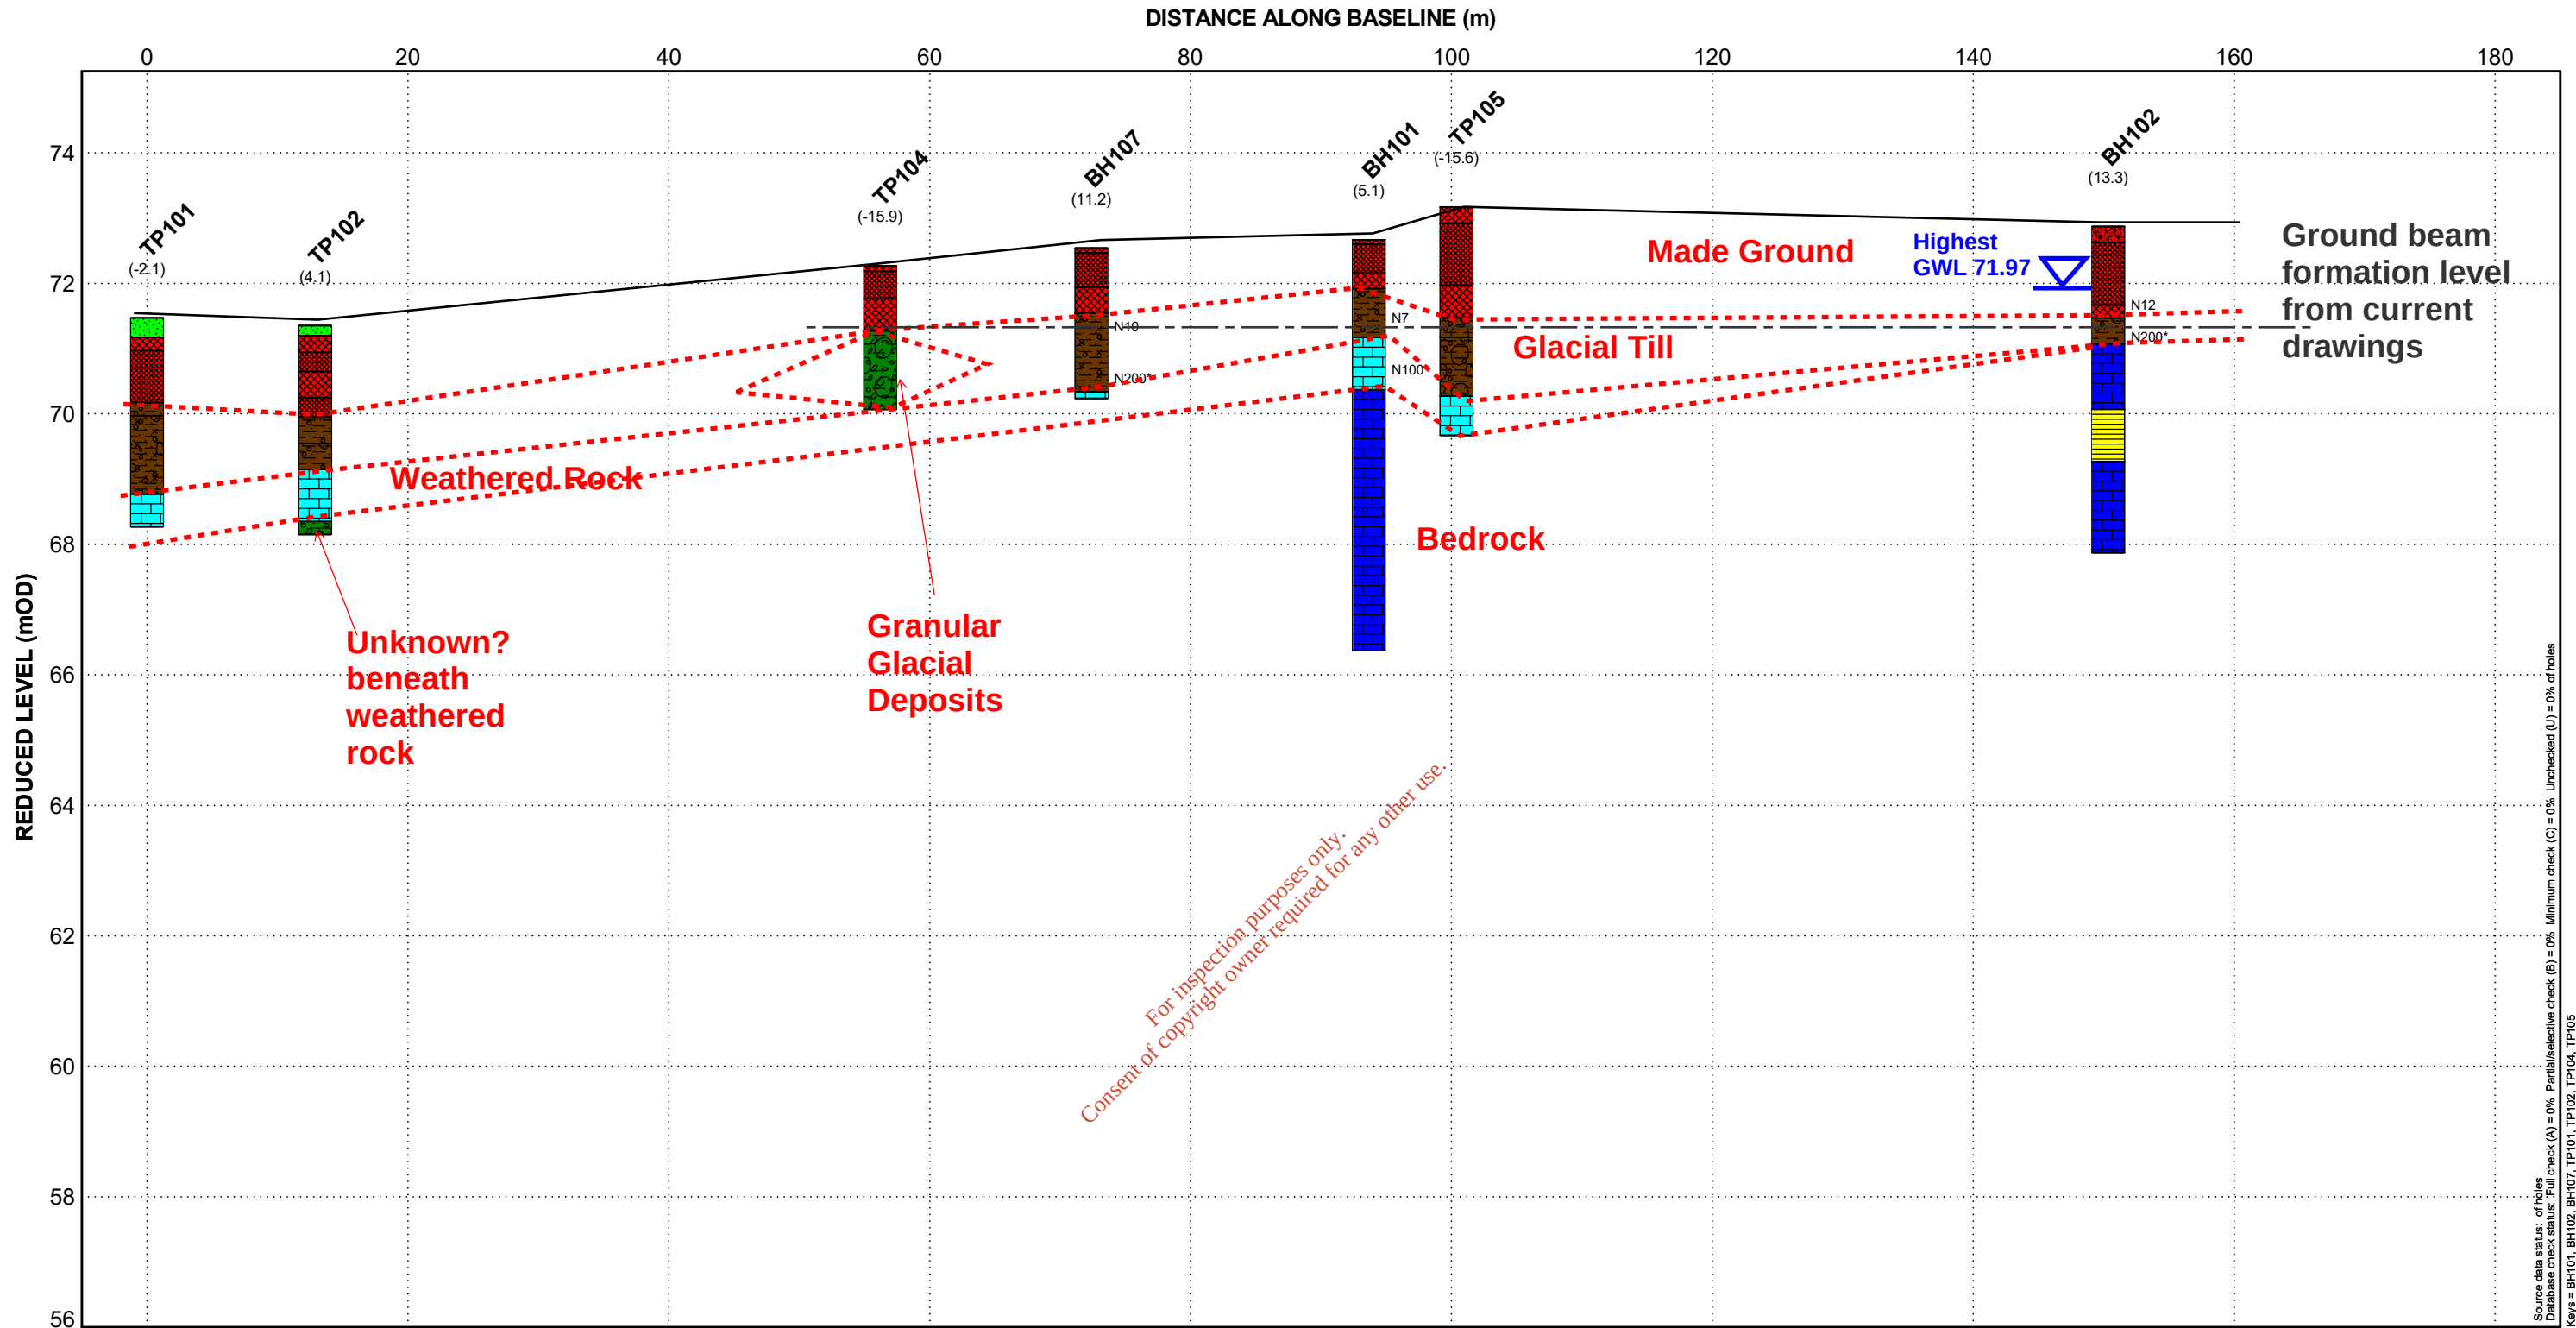
- Topsoil [TOP]
- Made Ground [MG]
- Brown Boulder Clay [GTD]
- Gravel [GR]
- Weathered Rock [WrR]
- Limestone [RCK]
- Obstruction [Obs]
- Mudstone [Mud]

The section location plan and geological sections showing the ground conditions of the site are shown in Figures 22 to 25.

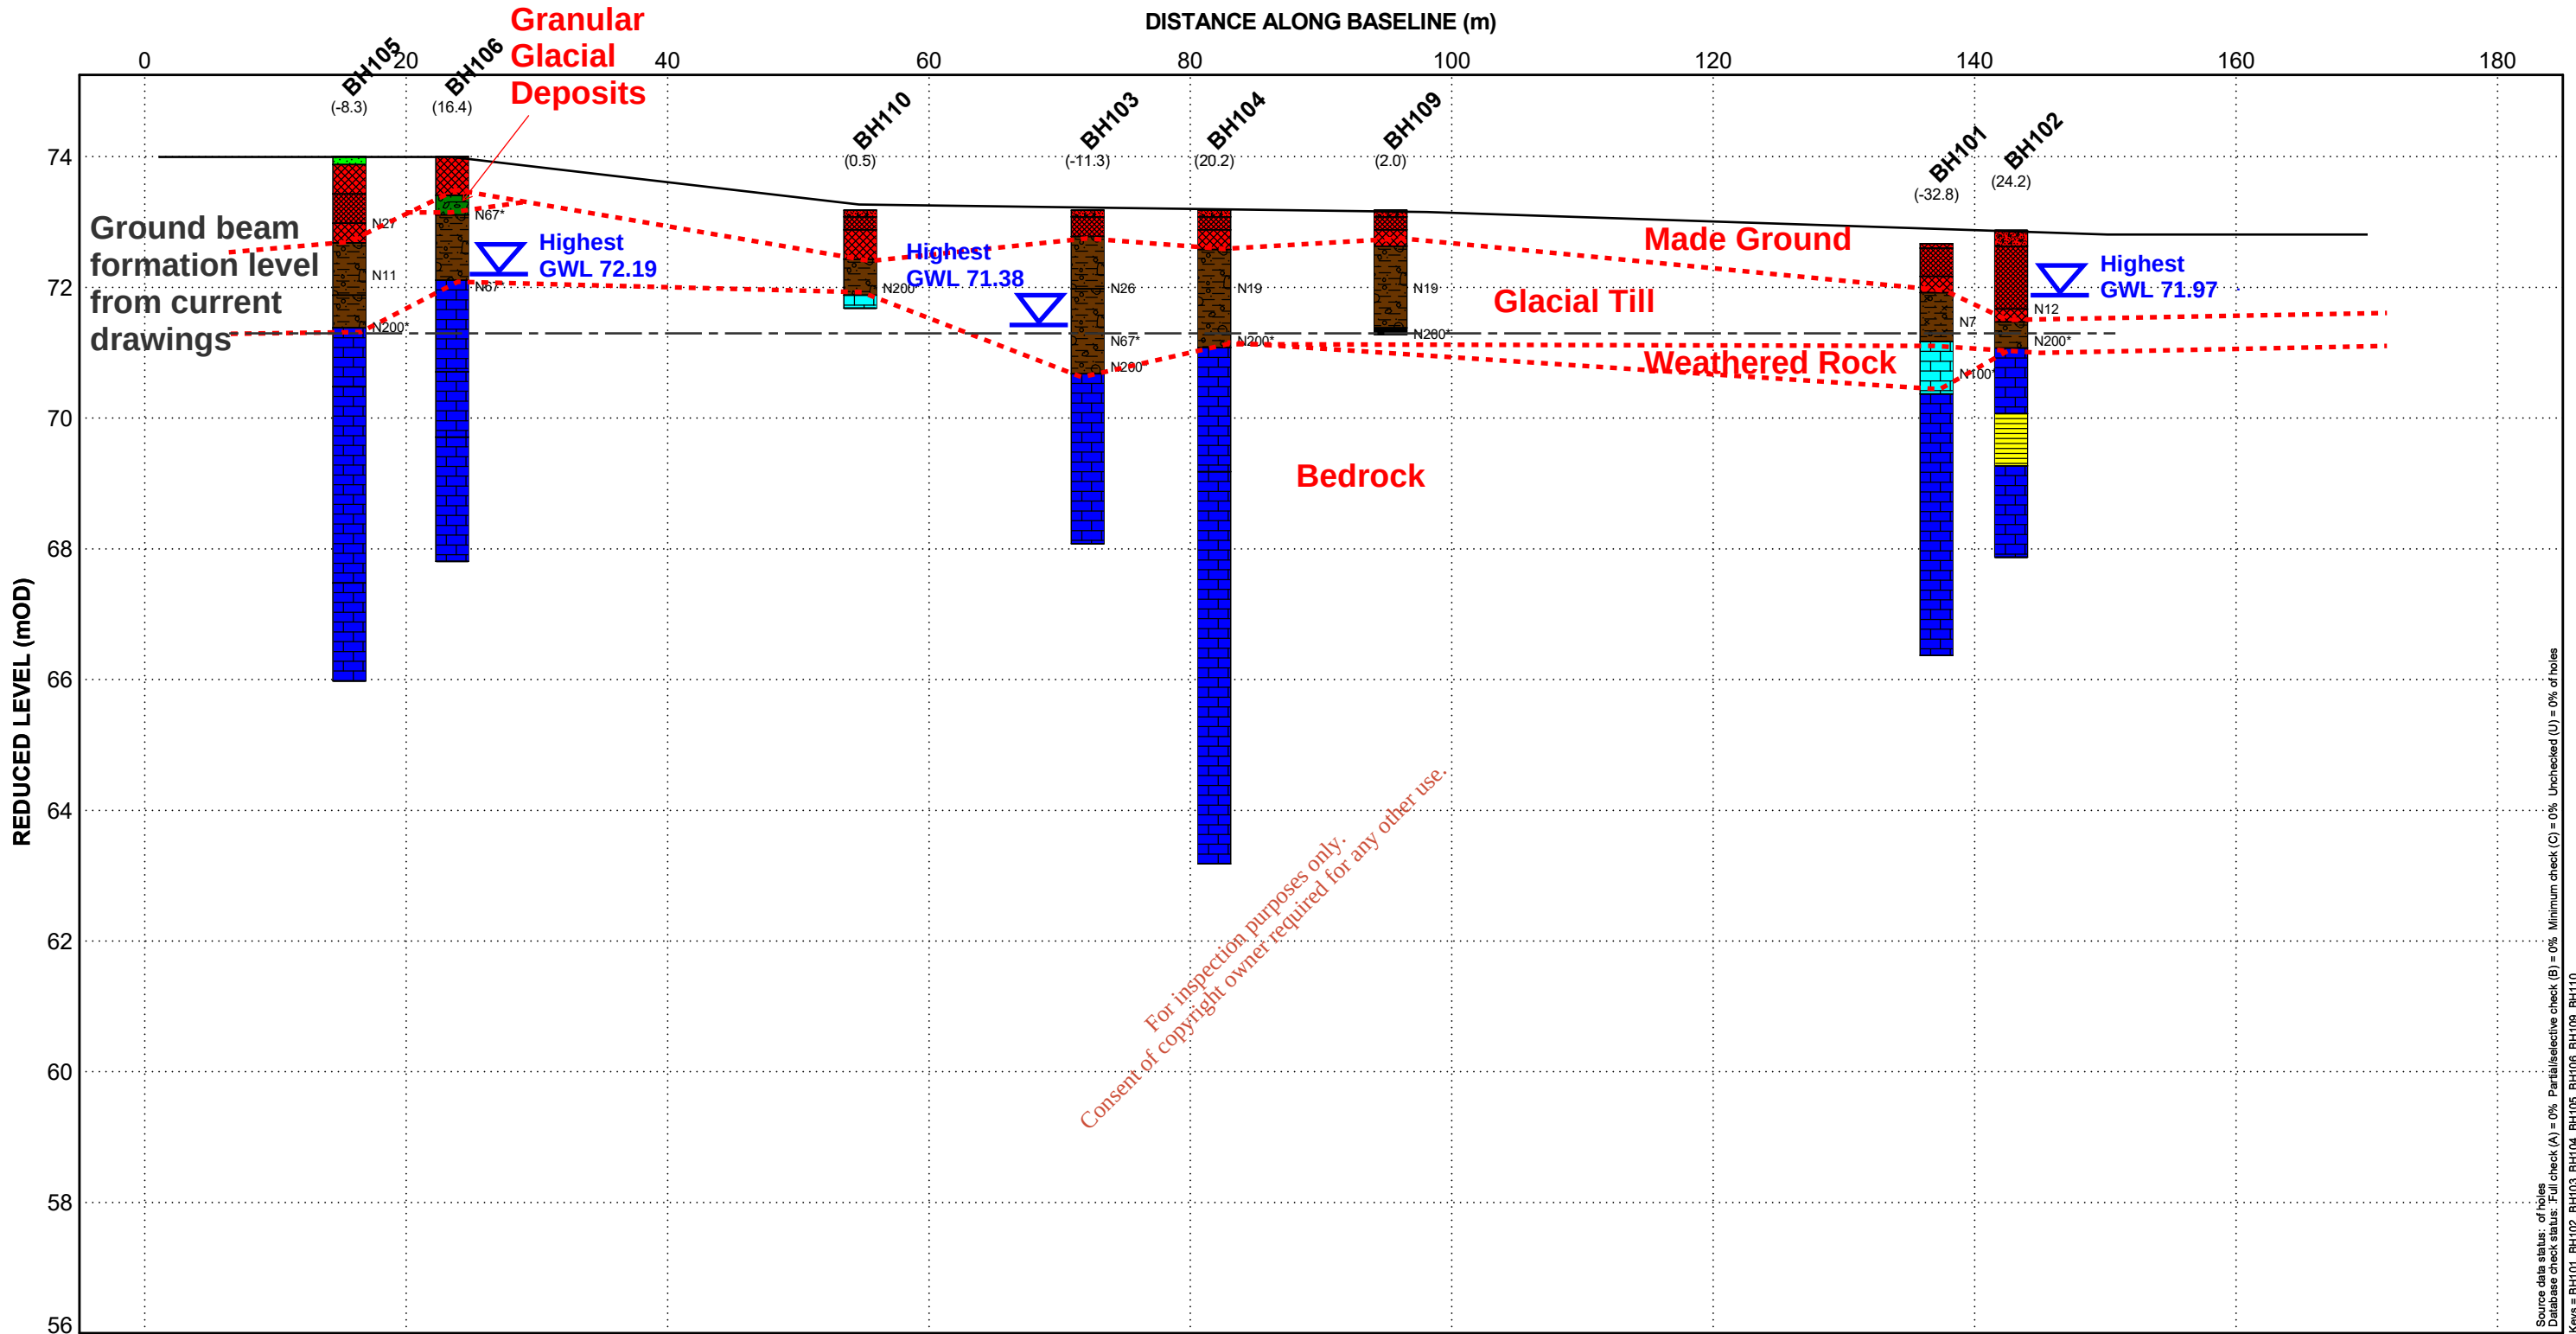
- Topsoil [TOP]
- Made Ground [MG]
- Brown Boulder Clay [GTD]
- Gravel [GR]
- Weathered Rock [WrR]
- Limestone [RCK]
- Obstruction [Obs]
- Mudstone [Mud]

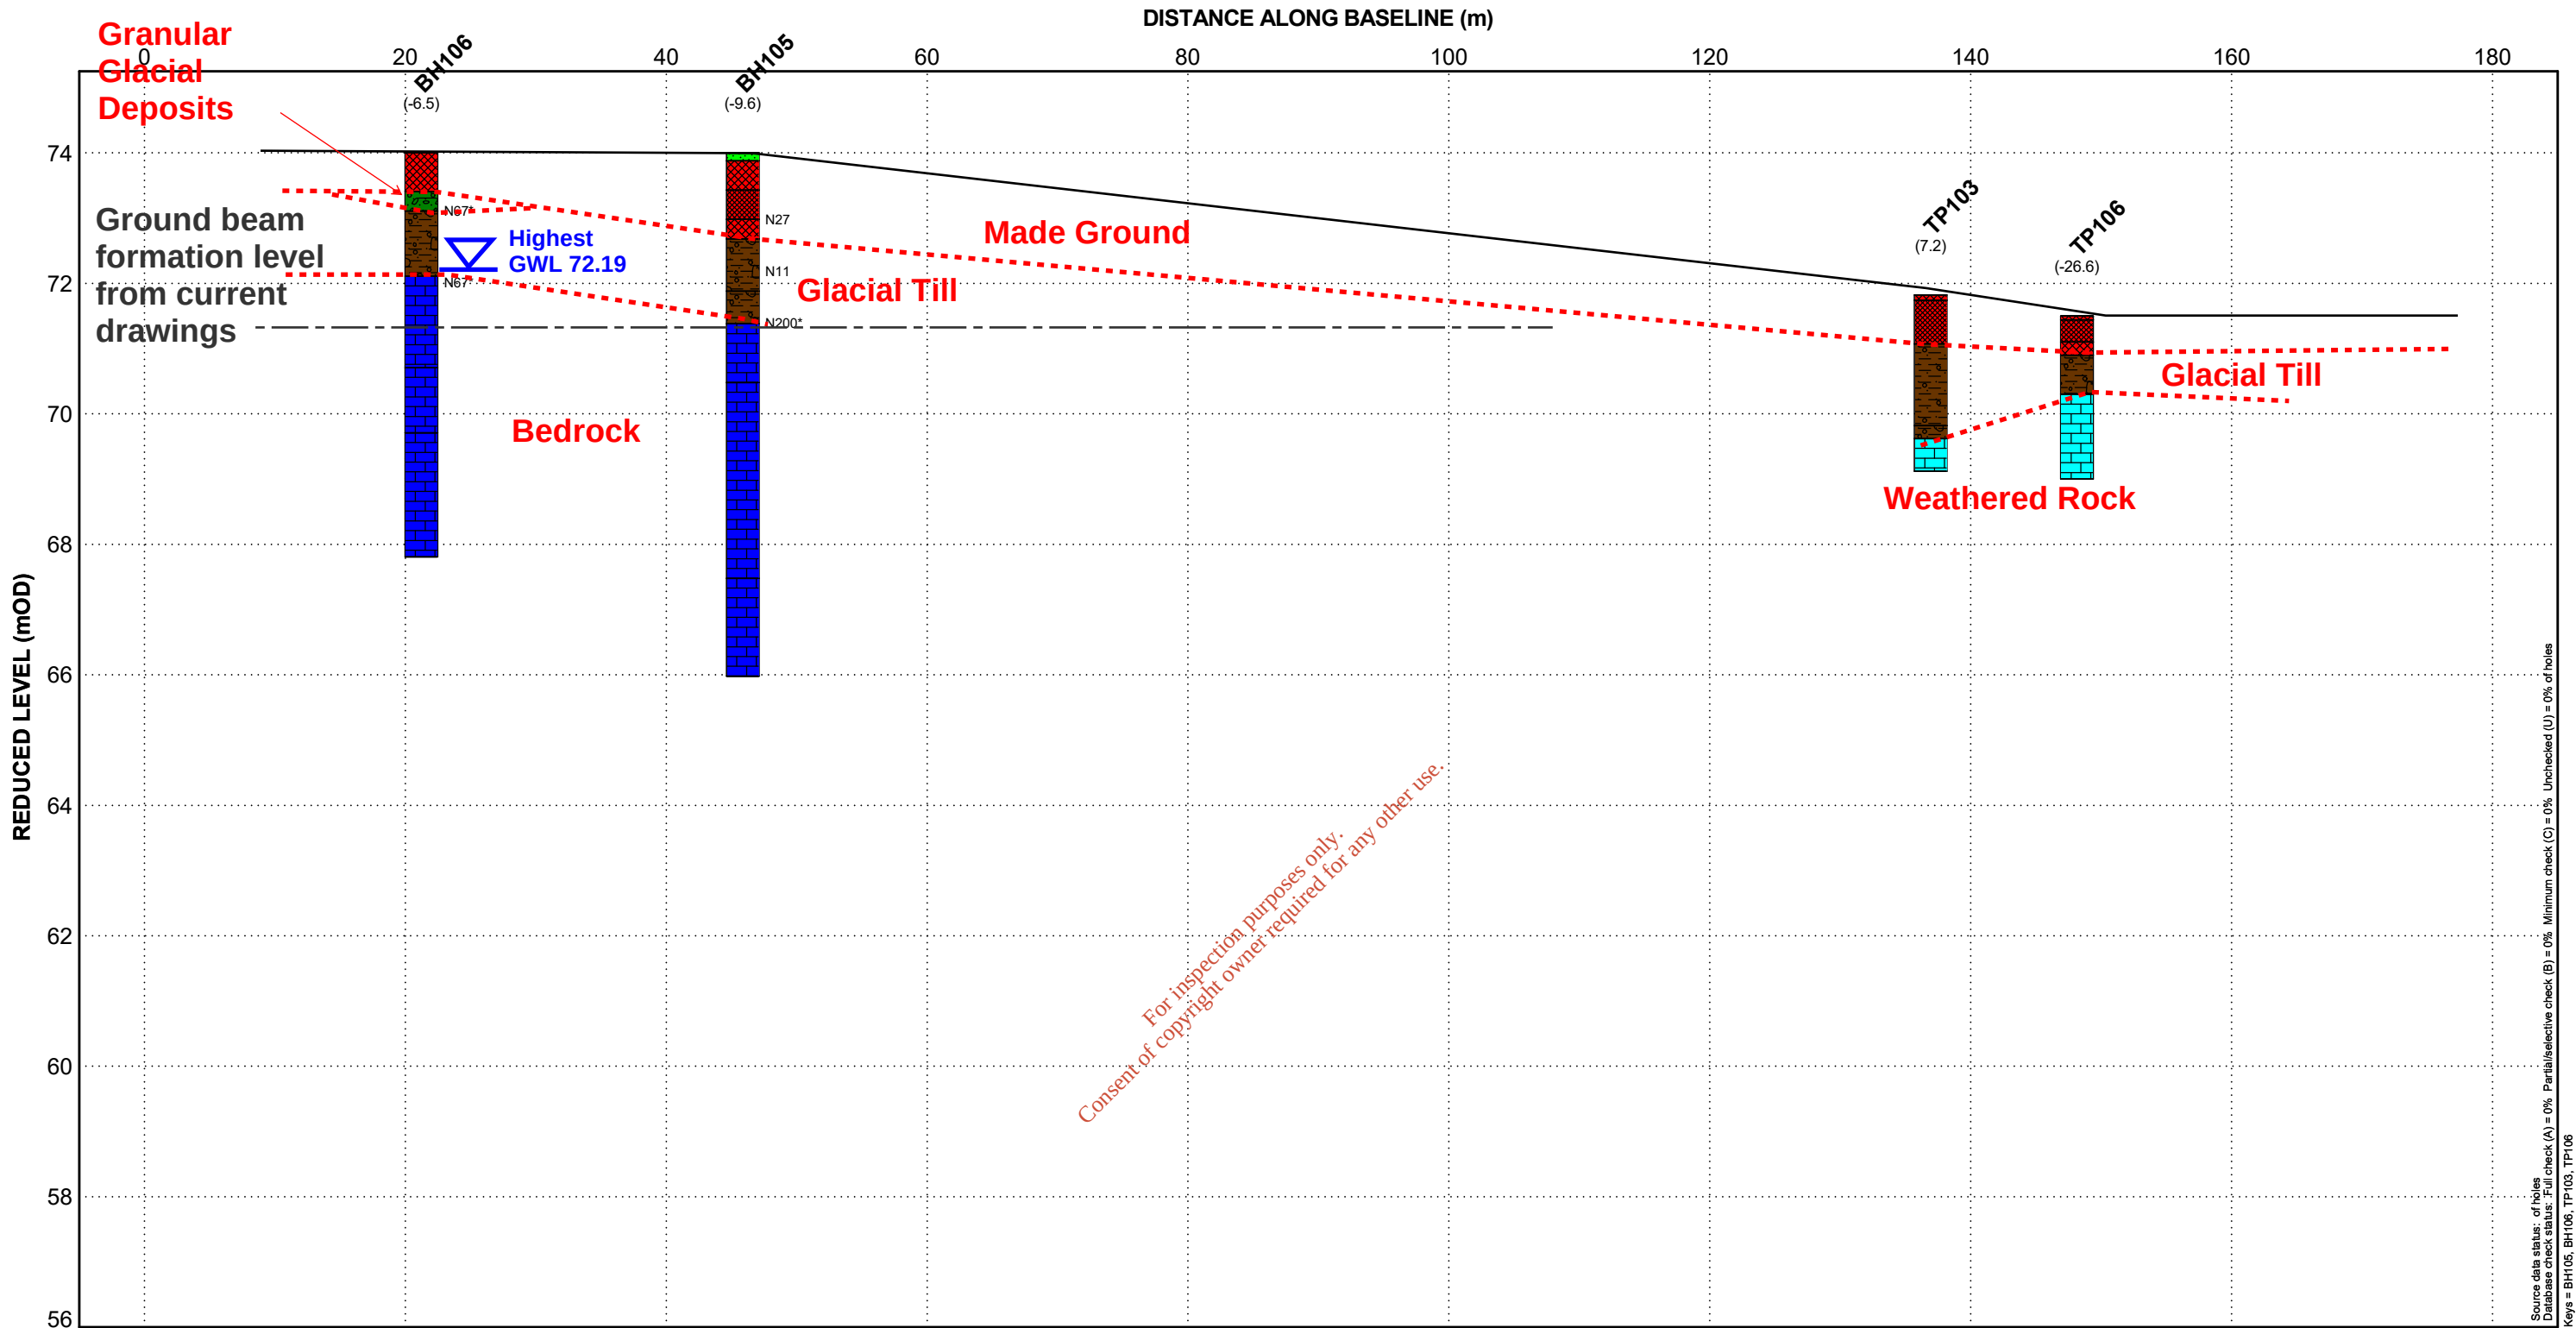
- Topsoil [TOP]
- Made Ground [MG]
- Brown Boulder Clay [GTD]
- Gravel [GR]
- Weathered Rock [WrR]
- Limestone [RCK]
- Obstruction [Obs]
- Mudstone [Mud]

Based on drawings and Figure 25, the southern part of the area of attenuation crates will be founding on weathered rock. Limestone bedrock becomes shallower moving northwards so the northern portion of the area of the crates may be approximately 1m into competent limestone bedrock at invert level. Rock will require ripping or hydraulic breaking for removal.

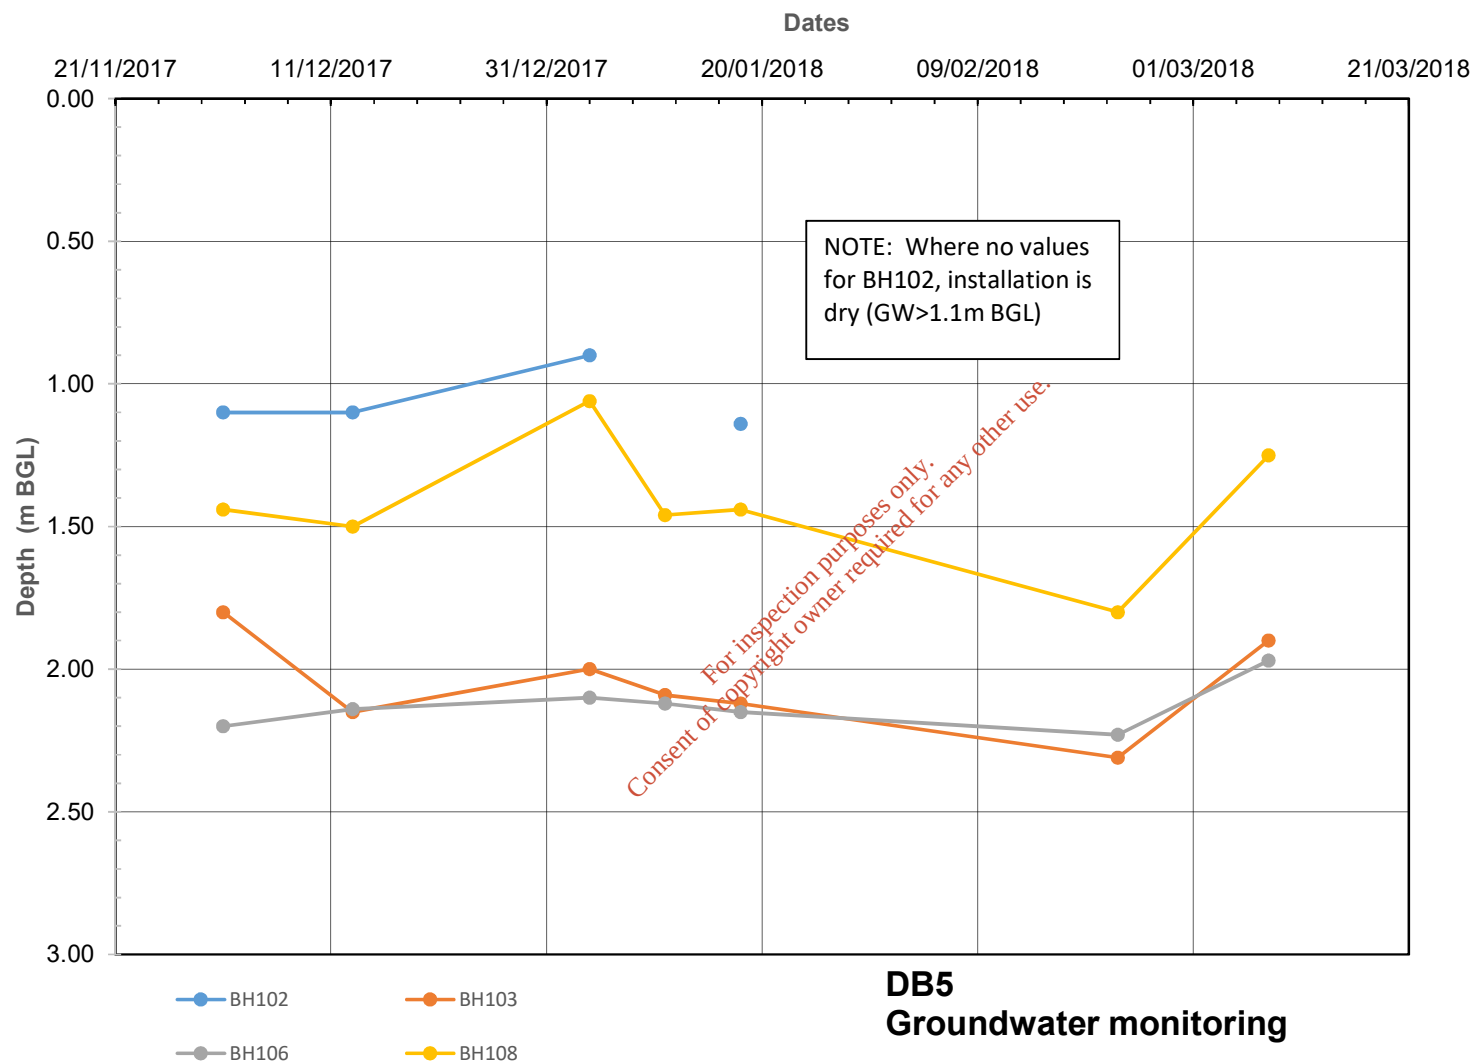
**Figure 42**

Figure 42: Groundwater Monitoring (mBGL)

Groundwater monitoring to date is summarised in Table 5 below. Groundwater levels were at their highest in early January 2018 and again is rising back towards those values in early March 2018, ranging from 0.9m to 2.3m BGL (or 70.9mOD to 72.0mOD). Groundwater monitoring to date is shown on Figures 42 and 43.

Based on nearby groundwater monitoring at BH106 (Figure 25) and water ingress noted in TP103 and TP106, excavations for the attenuation tank and crates will be **below** the water [table and below groundwater levels estimated under extreme rainfall events](#), potentially up to approximately 2m below groundwater levels recorded in BH106 (Figures 42 and 43).

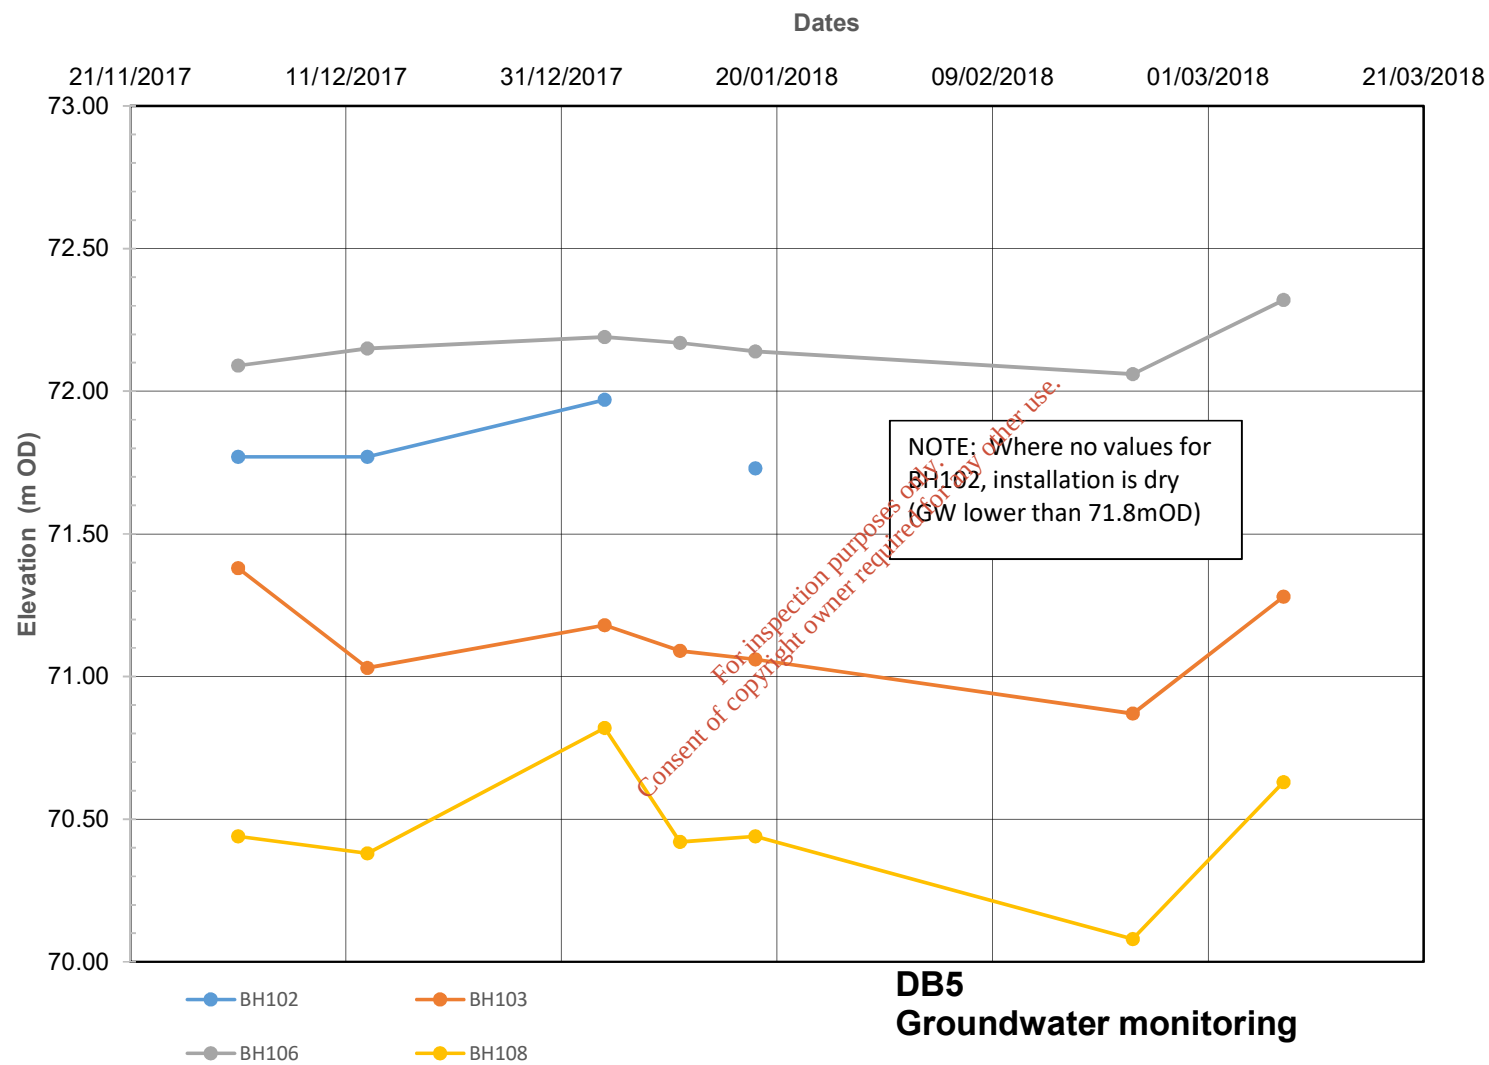
**Figure 43**

Figure 43: Groundwater Monitoring (mOD)
