Huntstown Inert Waste Recovery Facility North Quarry, Huntstown Finglas, Dublin 11

NVIRONMENTAL LIABILITY RISK ASSESSMENT (ELRA)

August 2015 SLR Ref: 501.00180.00111 ELRA Rev A

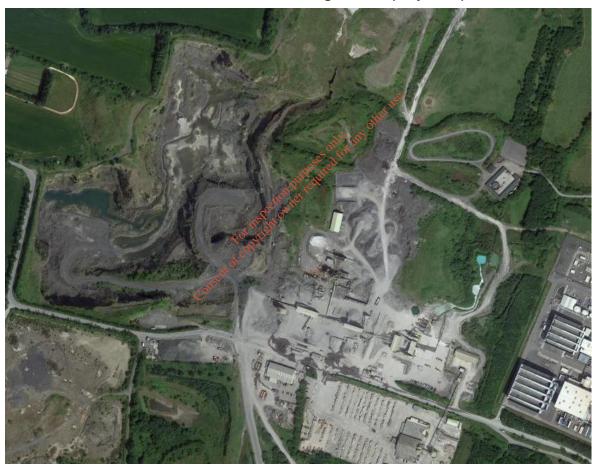
Plate 1
Aerial View of Site from Google Earth (July 2013)

The existing quarry void covers an area of approximately 11.2 hectares (27.0 acres) within the licensed site area and is shown on Plate 1 below, in an aerial view from Google Earth dated July 2013.

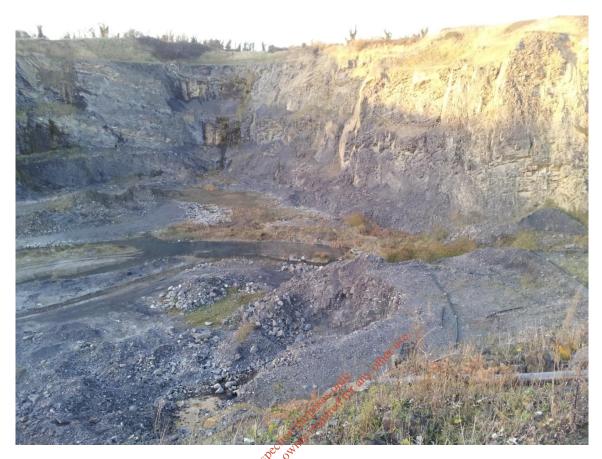
The existing floor level in the quarry lies at approximately 38mOD to 39mOD and its depth from the original (surrounding) ground level therefore varies from 24m to 28m along its eastern face and 42m to 47m along its western face.

The proposed recovery of inert soils at the North Quarry will provide for complete backfilling of a large open void above the groundwater table, facilitate the restoration of the lands to agricultural use and improve protection to the underlying groundwater resource, which is currently classified as 'extremely vulnerable' due to the absence of any protective soil cover. Plate 2 overleaf shows the guarry void in December 2013.
