NEW BOLIDEN

BOLIDEN TARA MINES DAC

Environmental Liabilities Risk Assessment

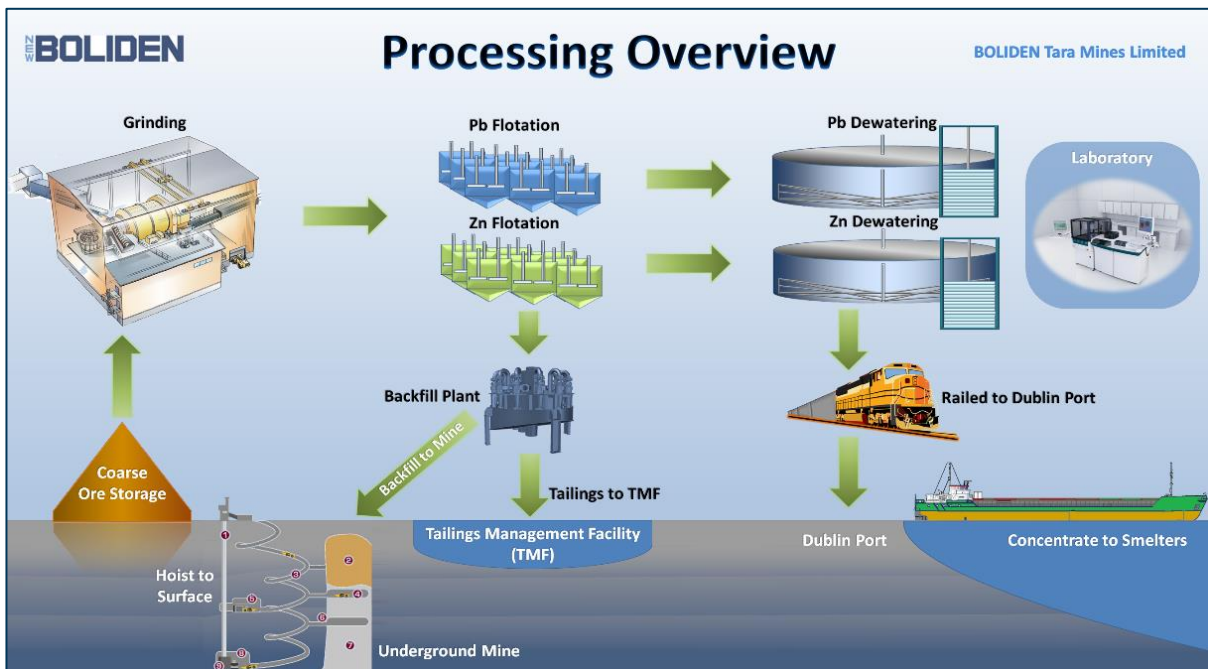
Figure 1.2 Process Overview

Orebody development at this mine commenced in 1973, with production beginning in 1977. Mining continues today at a rate of c.2.5 million tonnes of ore per year. Ore production encompasses the drilling, blasting and removal of the ore from underground deposits. Broken ore is primary crushed underground to less than 150 millimetres before being hoisted to the surface. Ore is then fed to an autogenous grinding mill which grinds the ore to a fine powder which is then pumped as aqueous slurry to metallurgic flotation cells. Within the flotation cells, galena (Lead sulphide) and sphalerite (Zinc sulphide) are differentially separated, while undesirable minerals such as pyrite are depressed. Differential flotation and selective depression of minerals are enhanced by chemical additives to the flotation circuit feed.

pumped as a mixed liquor (solids and water) to a Tailings Storage Facility (TSF) (also known in the industry as tailings dam, tailings pond). On an annual basis approximately 1.2 million tonnes of tailings are deposited for permanent storage in the TSF.

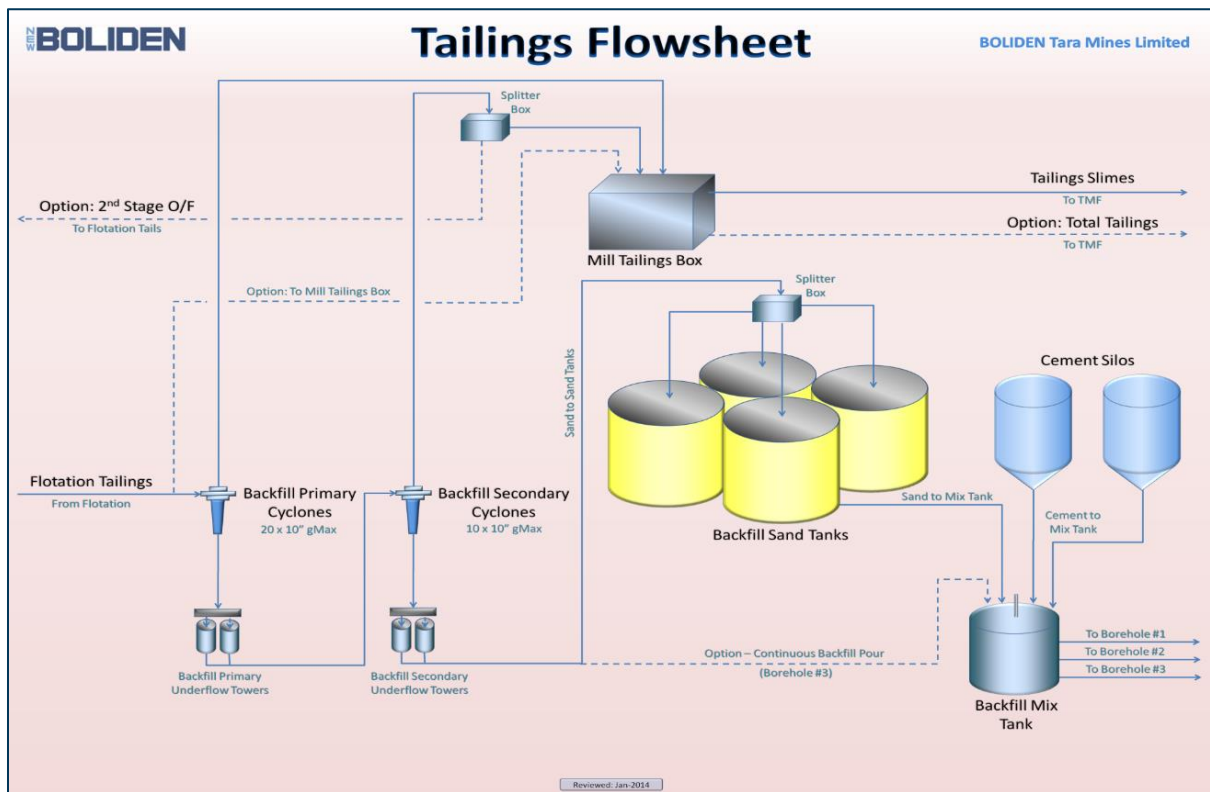
Figure 1.11 Backfilling Flow Diagram

The voids left by the mining of stopes and pillars are filled with cycloned sand, which is produced in the concentrator from tailings and directed to the stopes through surface pipelines and boreholes that connect with the haulage levels. This operation is an essential part of the mining cycle, and close scheduling is required to meet production targets. The recovery of approximately 45% of the coarser mill tailings for backfill provides sufficient material to replace the ore mined from the stopes and pillars. Maximum fill recovery and utilisation also ensure efficient use of the available volume of the surface tailings management facility.

To facilitate the mining of pillars between the sand-filled stopes, the sand is given cohesion, by the addition of cement at dosage rates of between 3% and 9%, depending on planned exposures. Pillar voids are usually filled with un-cemented sand and/or waste rock. A blended cement consisting of 90%-95% ground granulated blast-furnace slag and 5%-10% normal Portland cement is used. Each stope filling operation is carefully planned to optimise future ore recovery from the pillars, and the economics of designed cement additions are continually analysed.

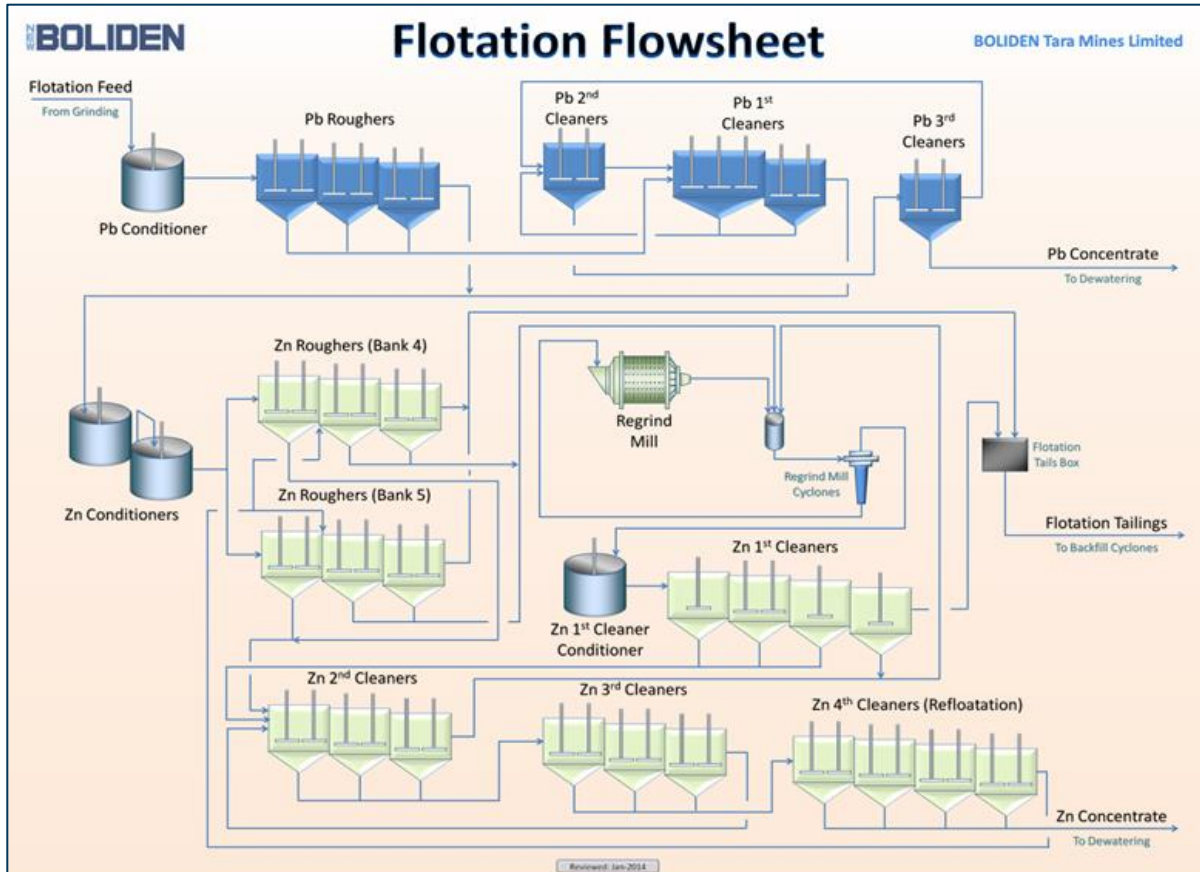
Figure 1.13 Flotation Flow Diagram

The flotation circuit consists of a series of tank-like cells in which there is a rotating agitator, which stirs the mixture of ground ore and water. Chemical reagents are added, one of which promotes frothing. Other agents alter the surface properties of the mineral particles and cause them to be attracted to bubbles generated by forcing air through the mixture by the agitators. These bubbles, coated with mineral particles, rise to the top of the mixture as a froth, and overflow the lips of the cells into collection troughs or launders.

Different combinations of reagents are used to selectively remove different minerals. Lead minerals are removed in the lead circuit and the remaining material is transferred to the zinc circuit for the removal of the zinc minerals.

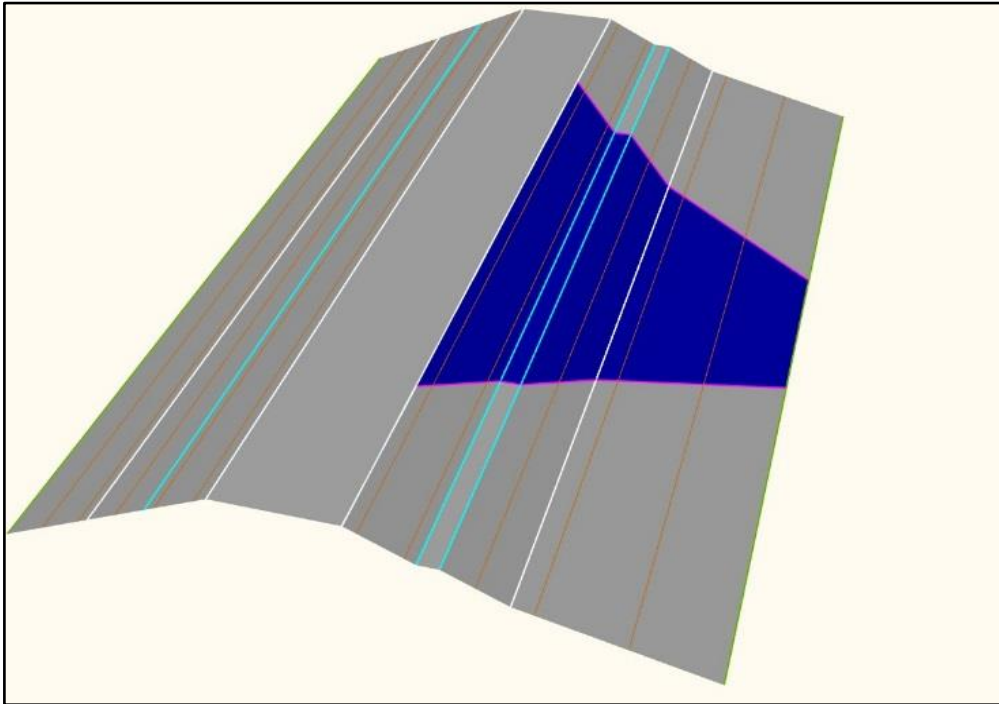
3D Model of TMF Breach Clean-out for Repair
