TUAM HISTORIC LANDFILL - H0192-01

Response To Request For Information

Prepared for:
Galway County Council

Date: October 2022

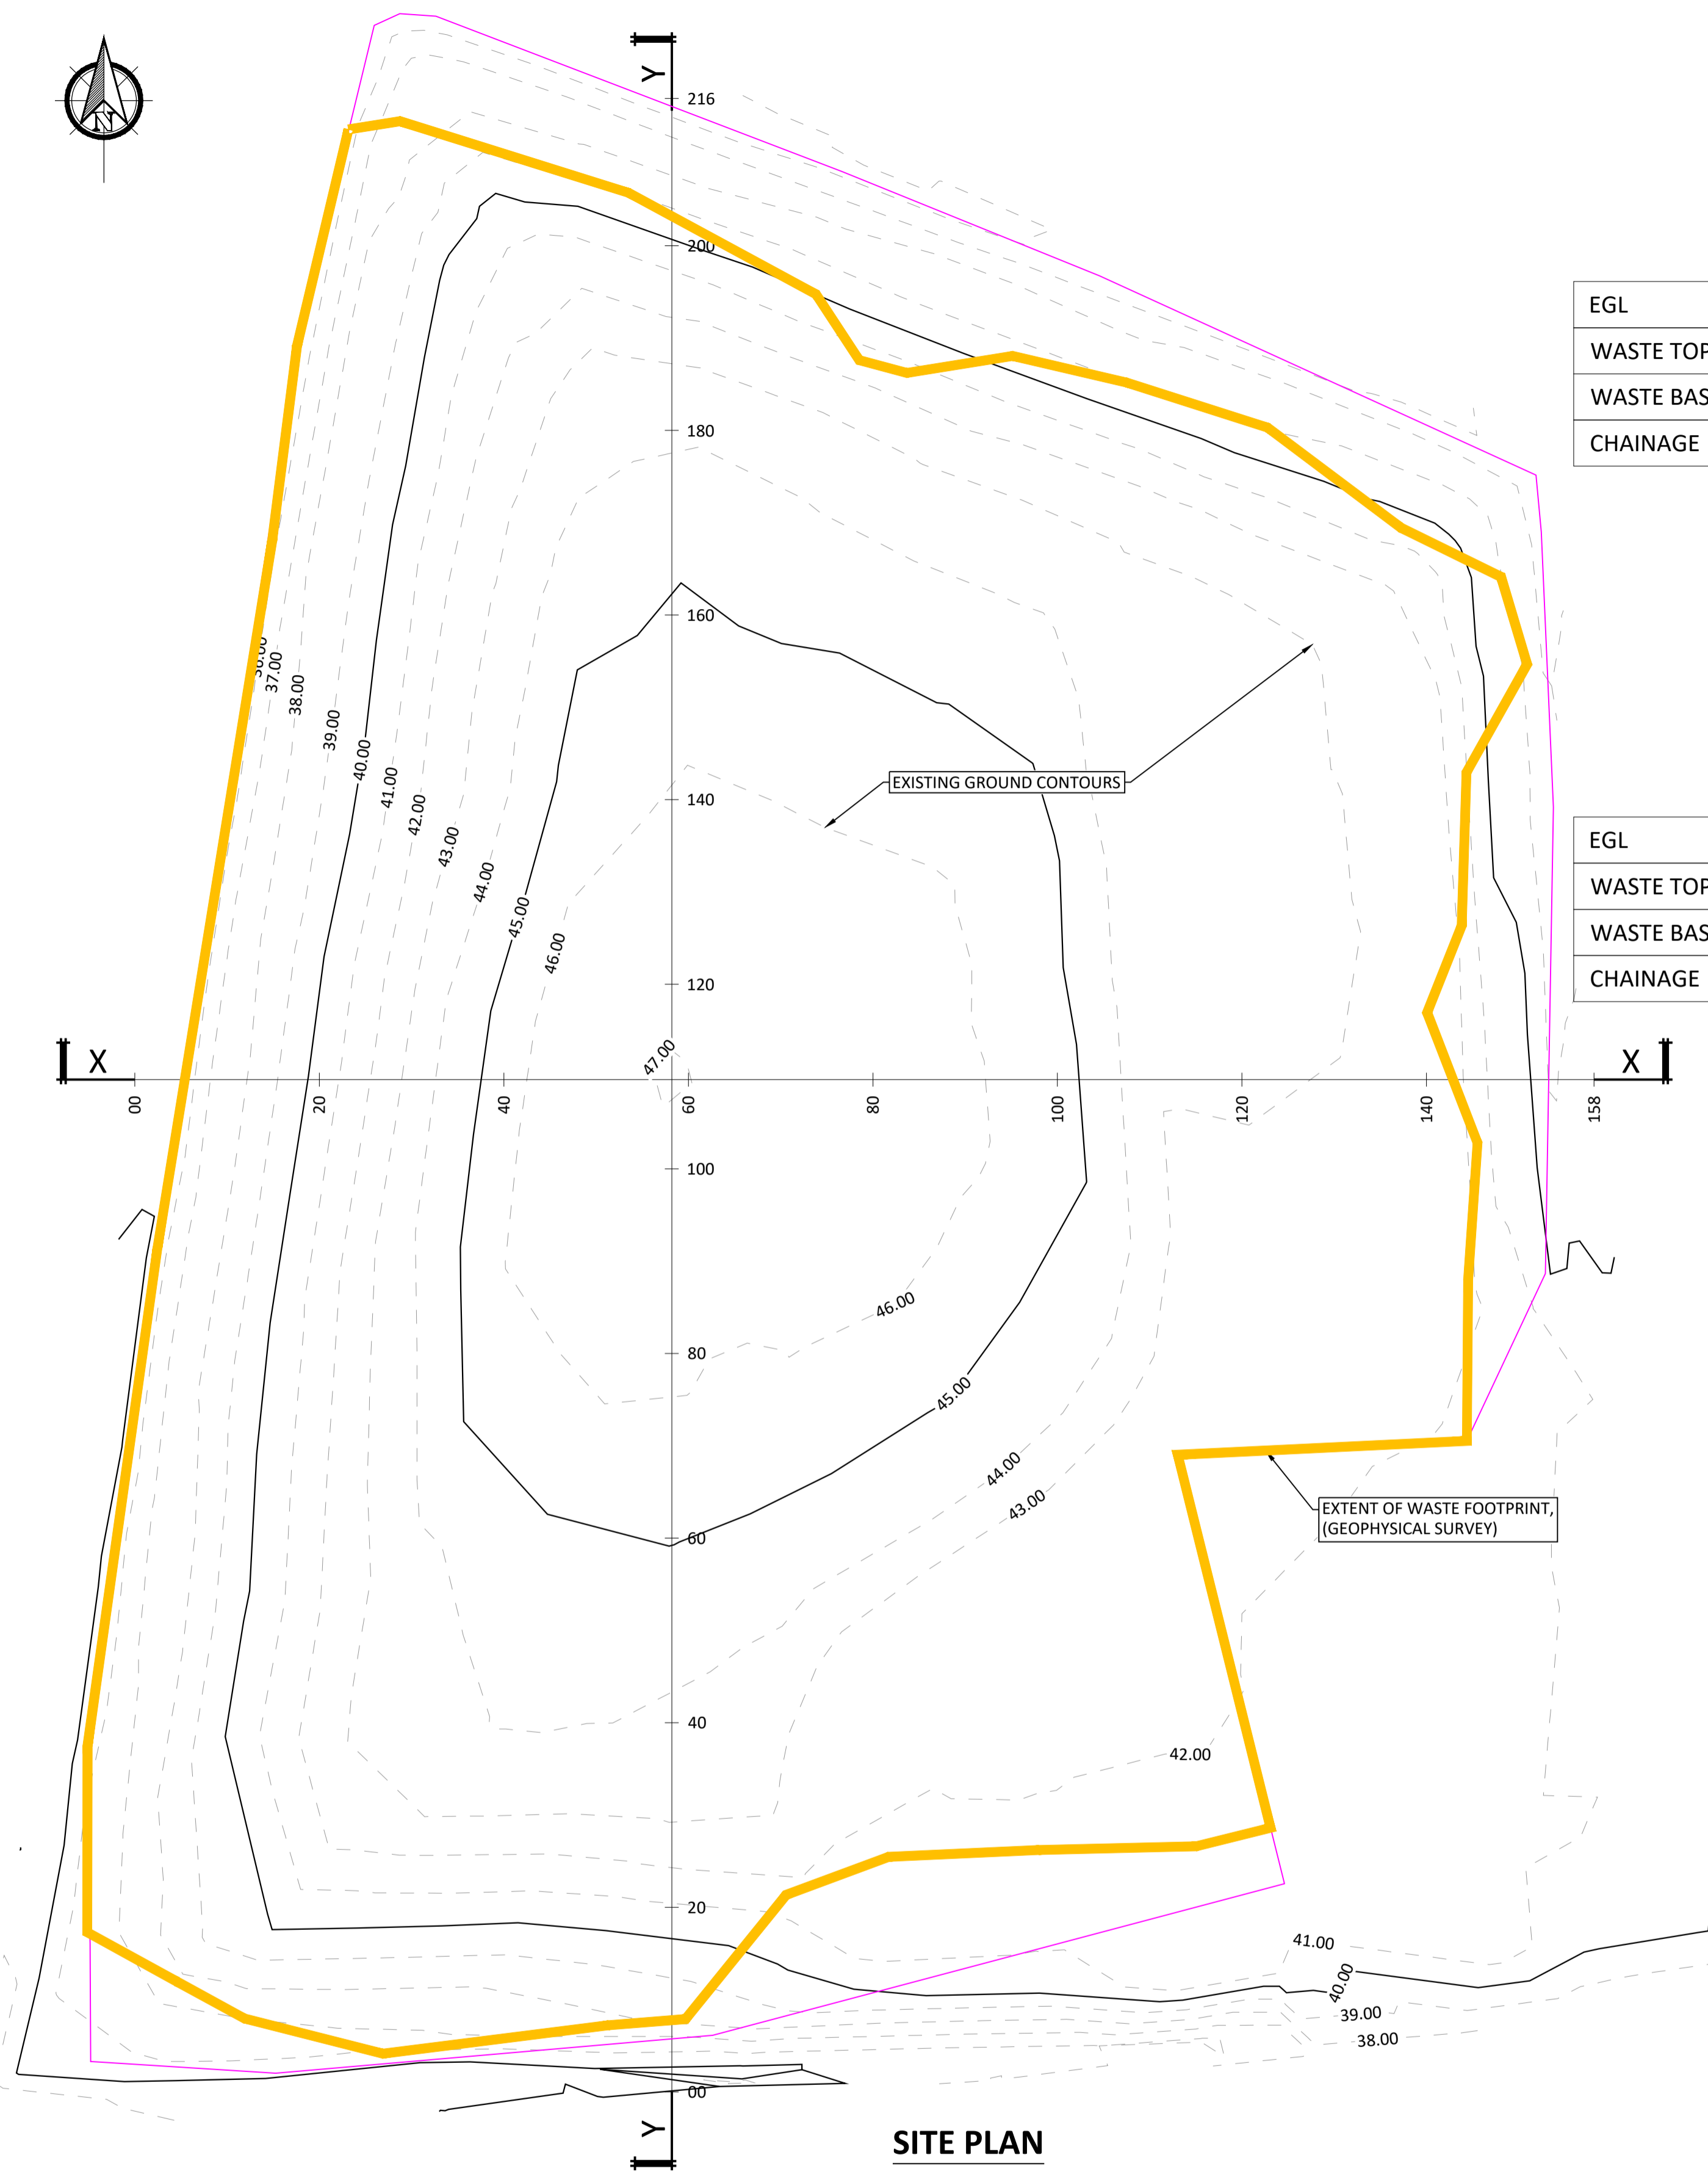
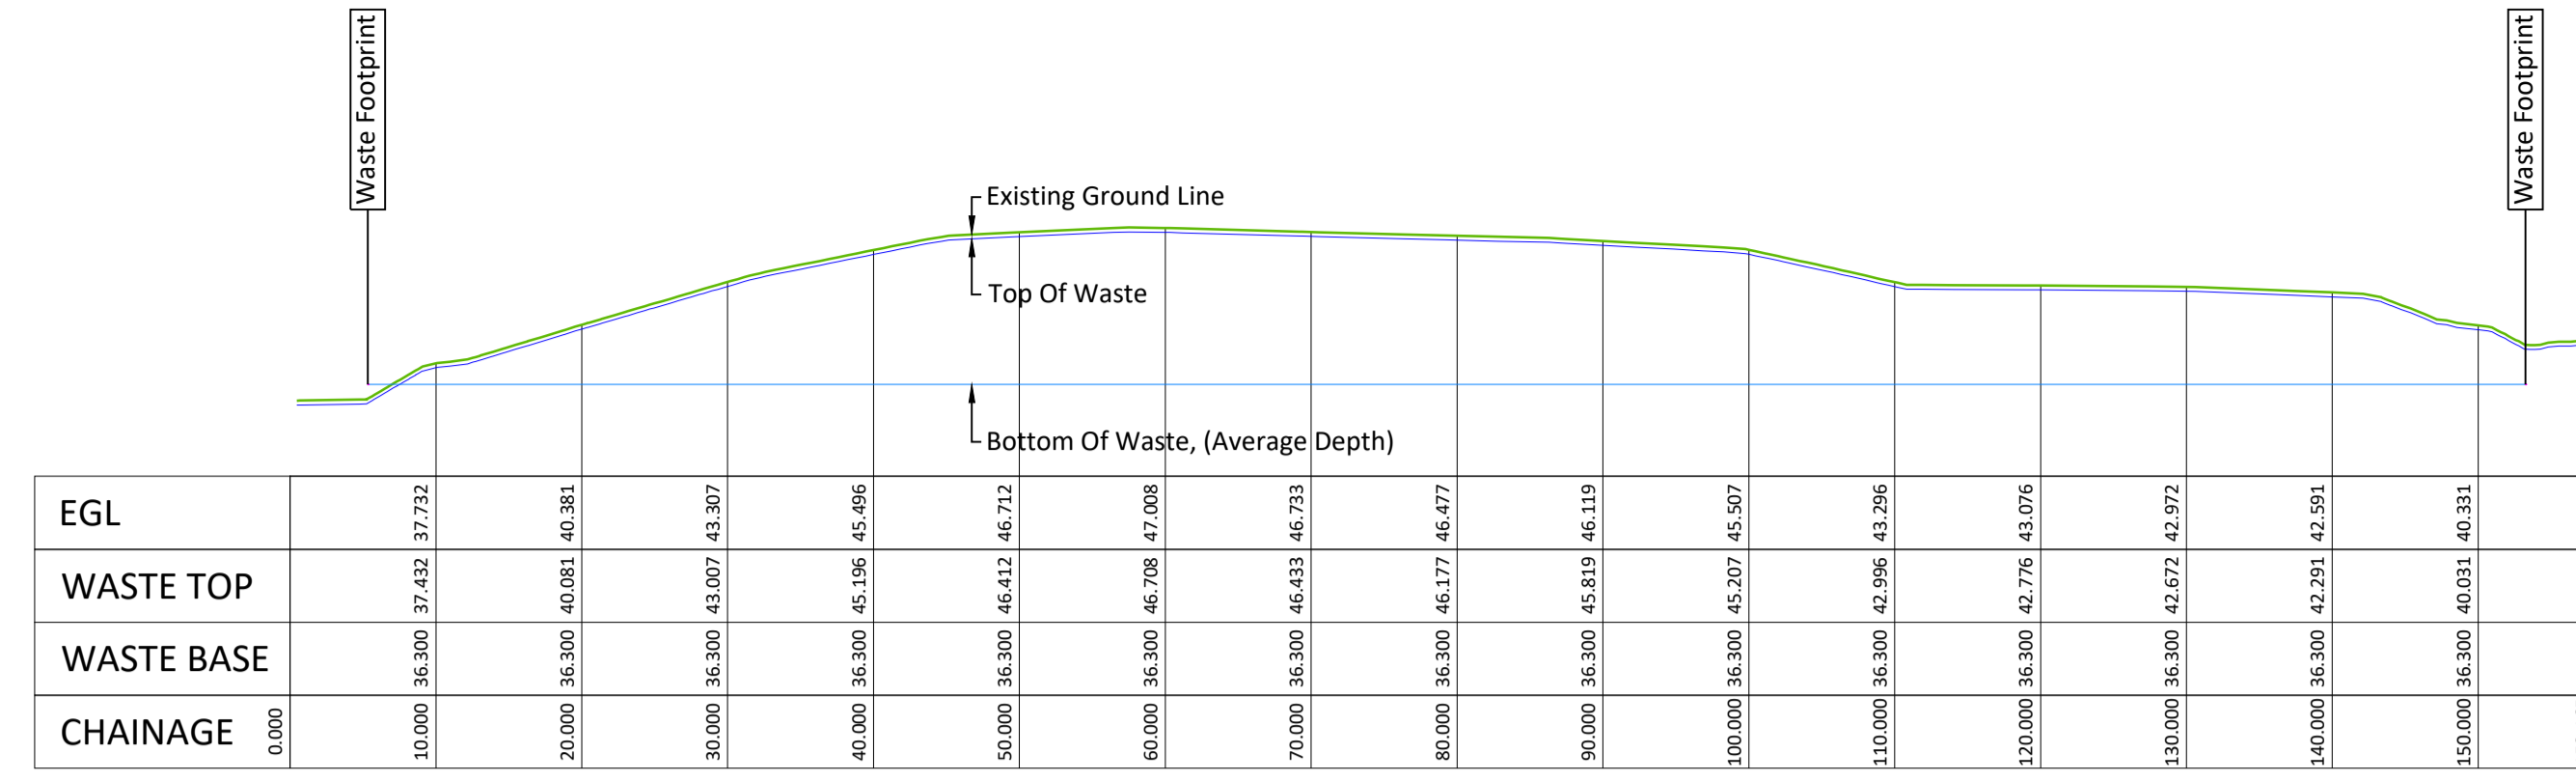
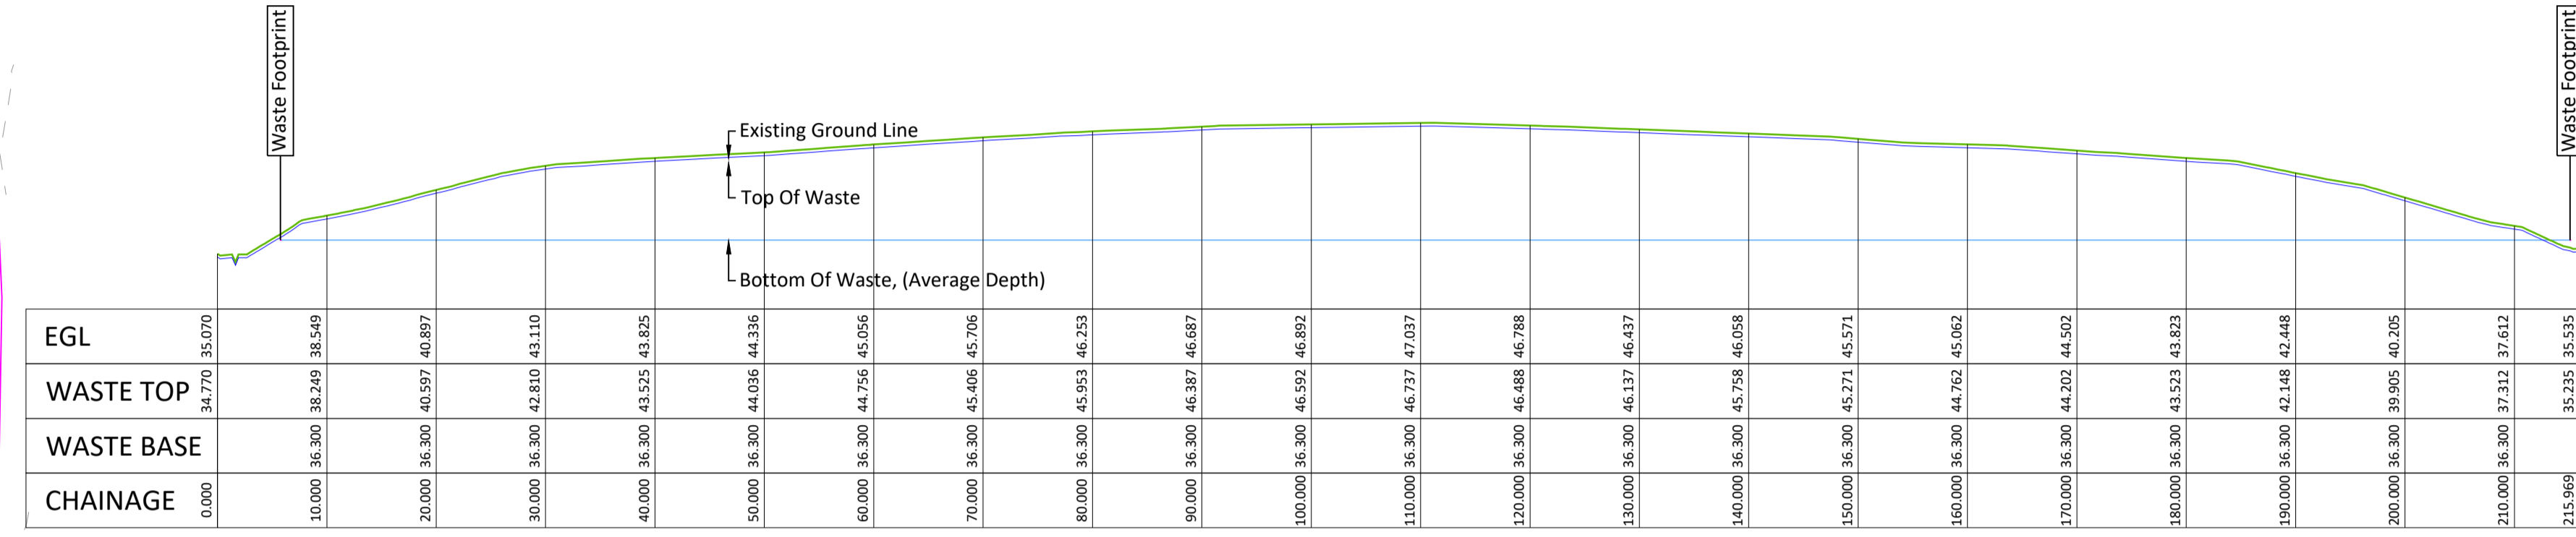
SITE PLAN
Scale 1:500

SECTION X-X

SECTION Y-Y

The results of the updated waste volume calculation are presented in Drawing No. P22-065-0600-0001 below.

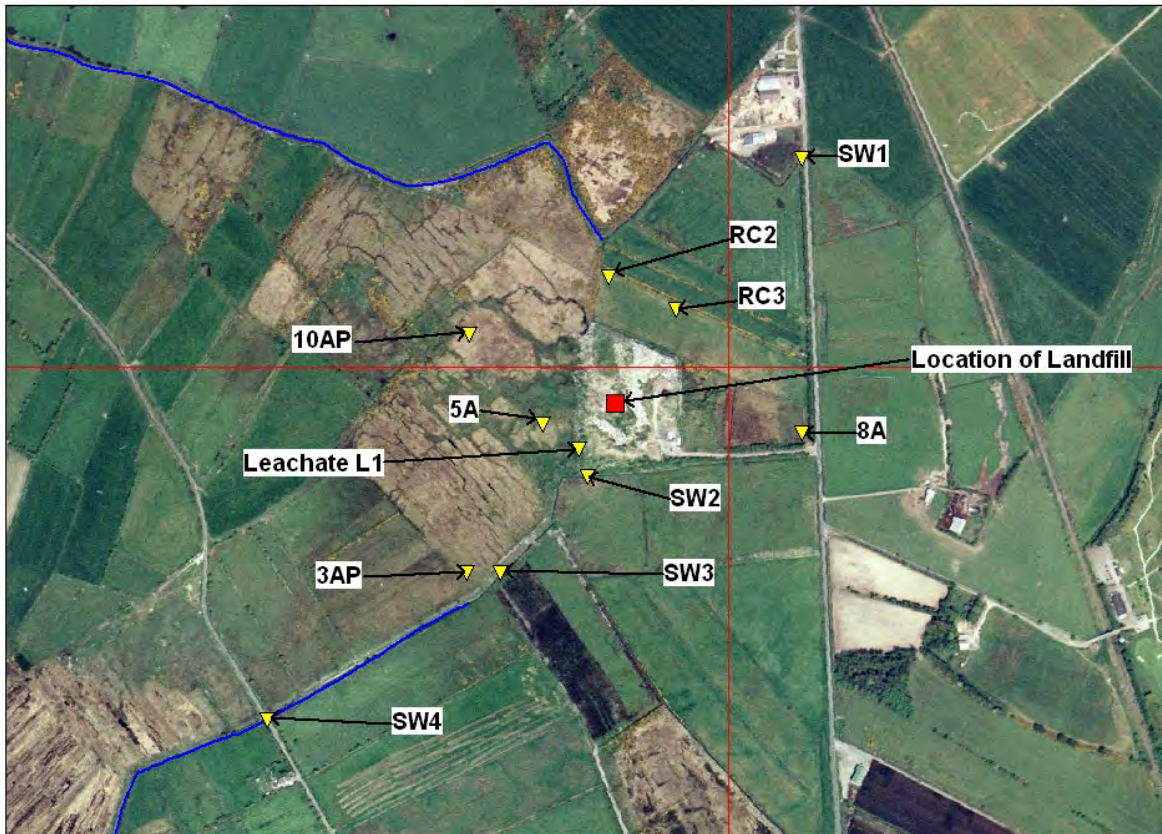
Figure 2-1: Location of Historic Landfill and Monitoring Stations provided by GCC

Map showing the location of Tuam landfill and monitoring locations

Surface water monitoring locations have been chosen to match the historic surface water monitoring done since 1998, See Figure 2-1.

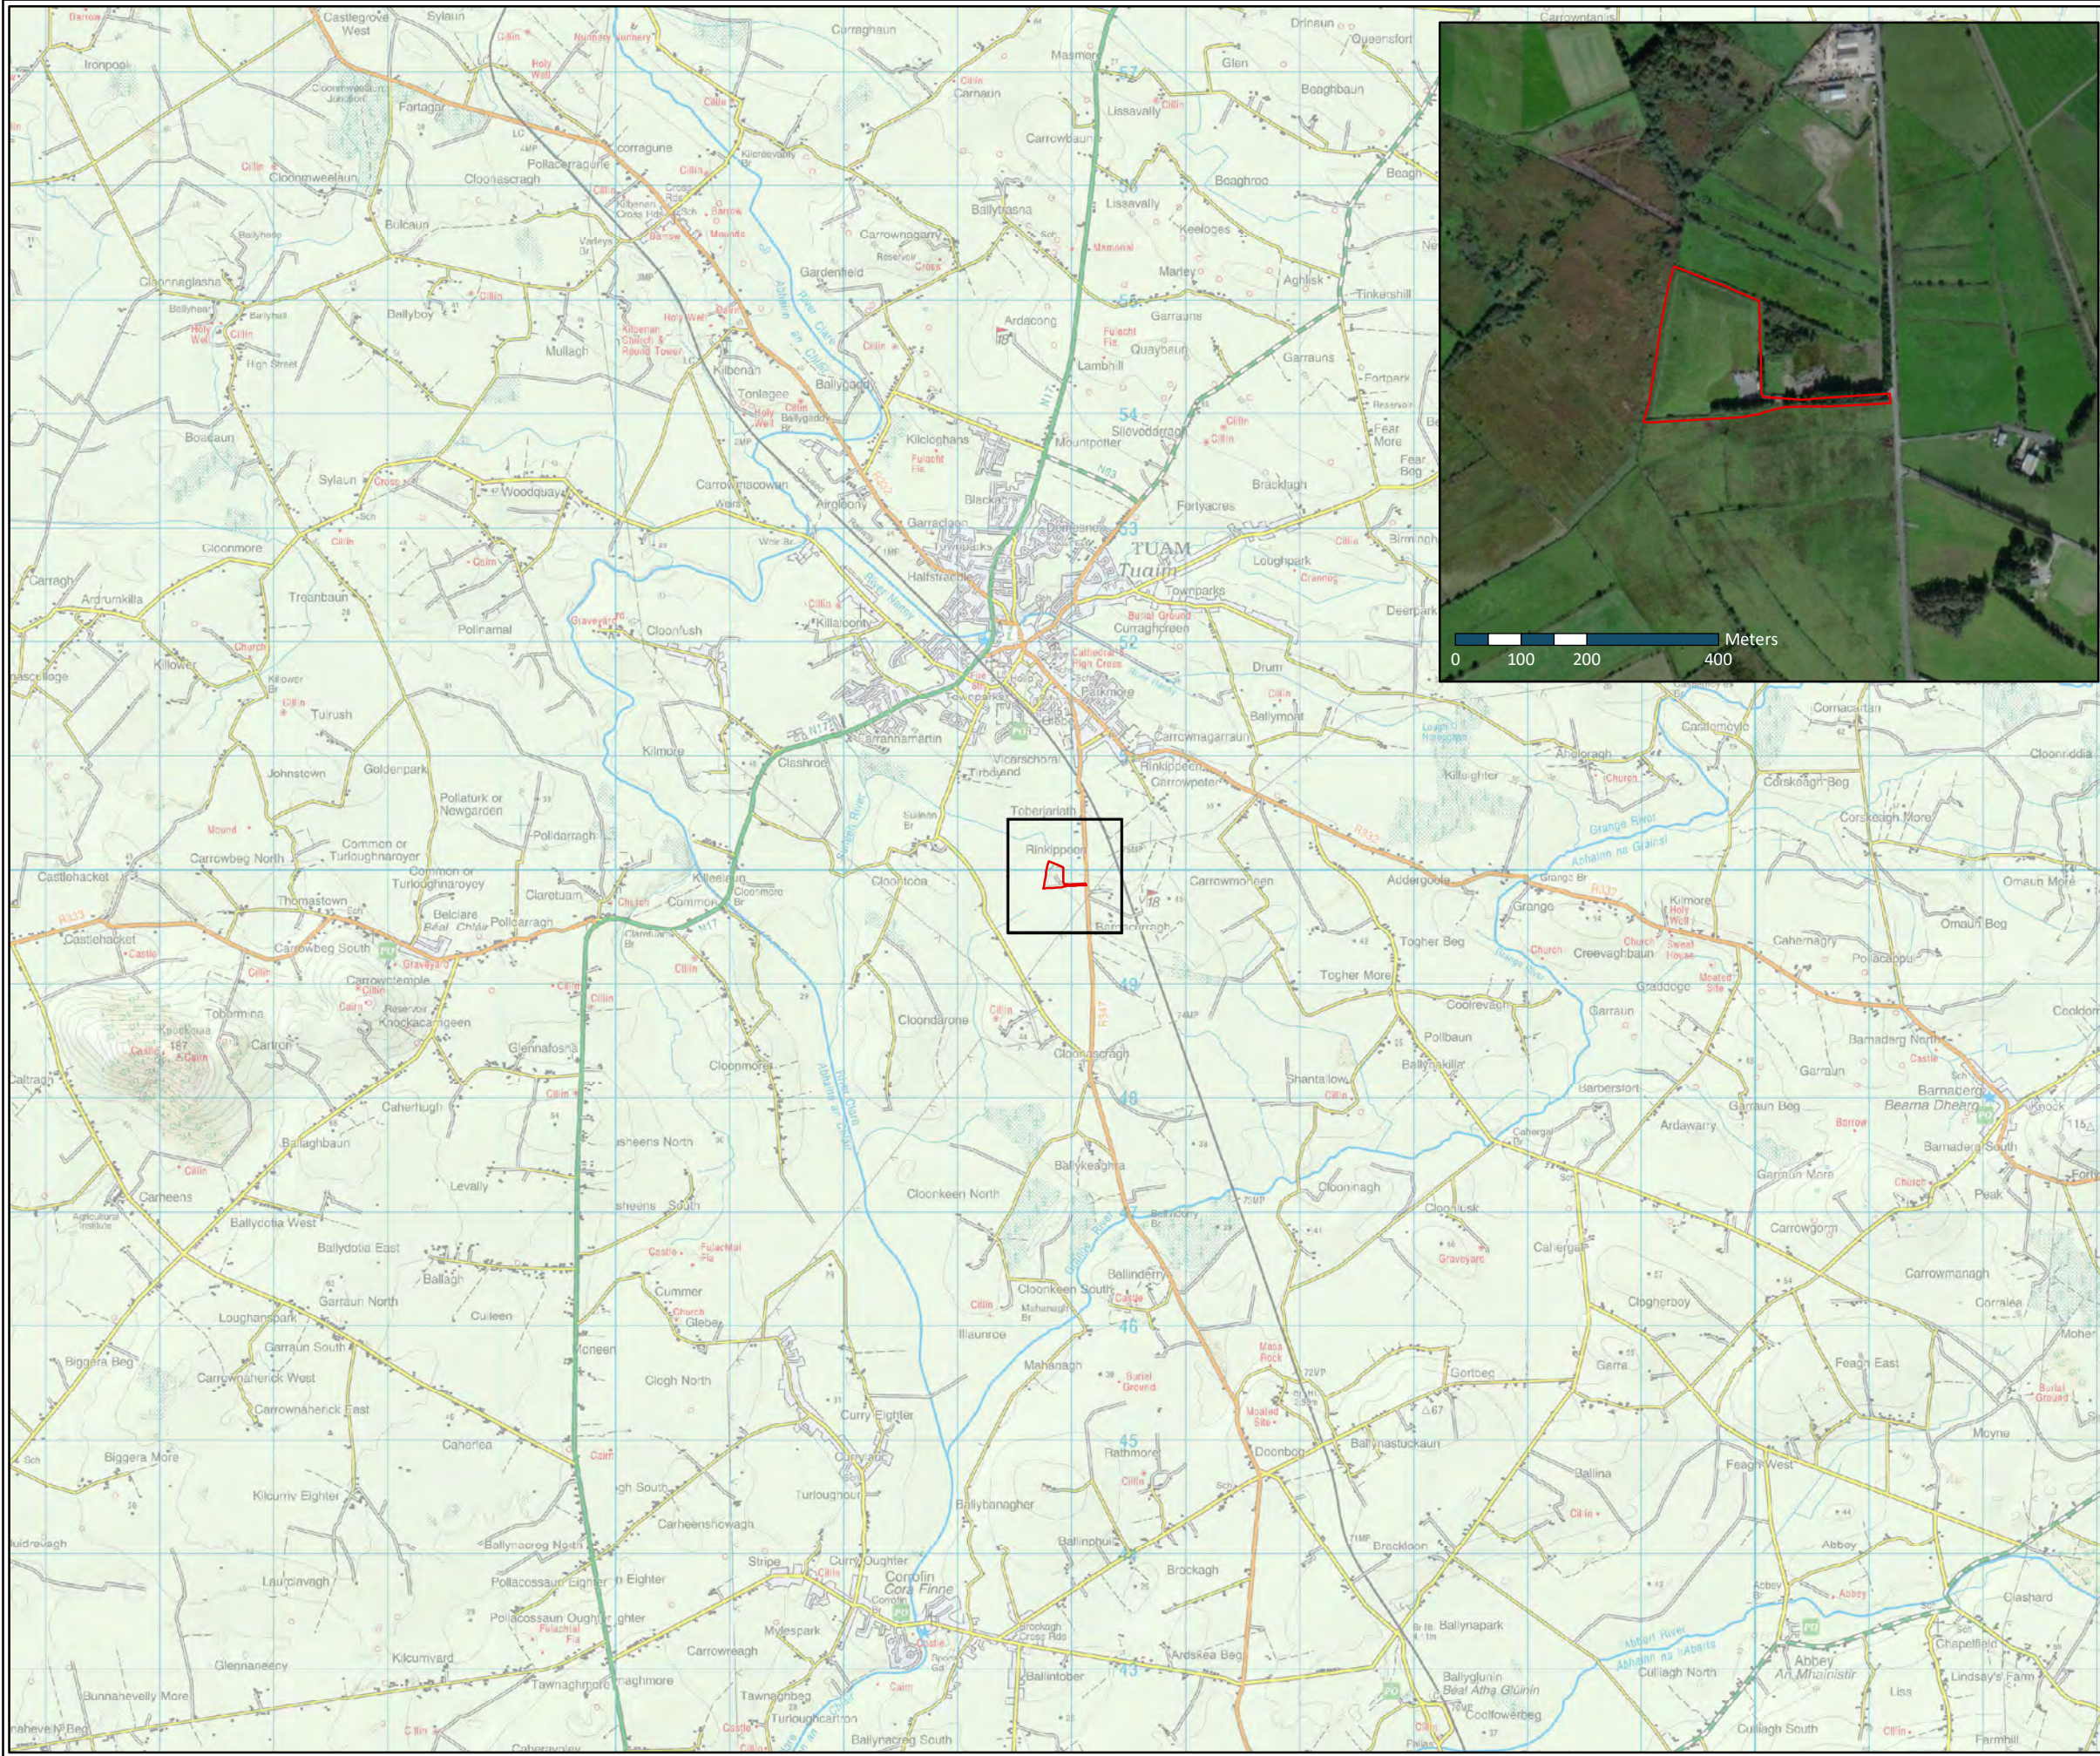
Site Boundary

The site boundary shown in Figure (no figure number given) titled 'Site Location Plan' dated 21/09/2020 of the Geotechnical Report was initially assumed as the site boundary. The site boundary was updated after site investigations were undertaken and is reflected as per Figure No. 1.1 'Site Location' dated 18/10/2021, this is the correct site boundary.

The definitive site boundary can be found in Figure No. 1.1 'Site Location', Appendix 3 of this report.

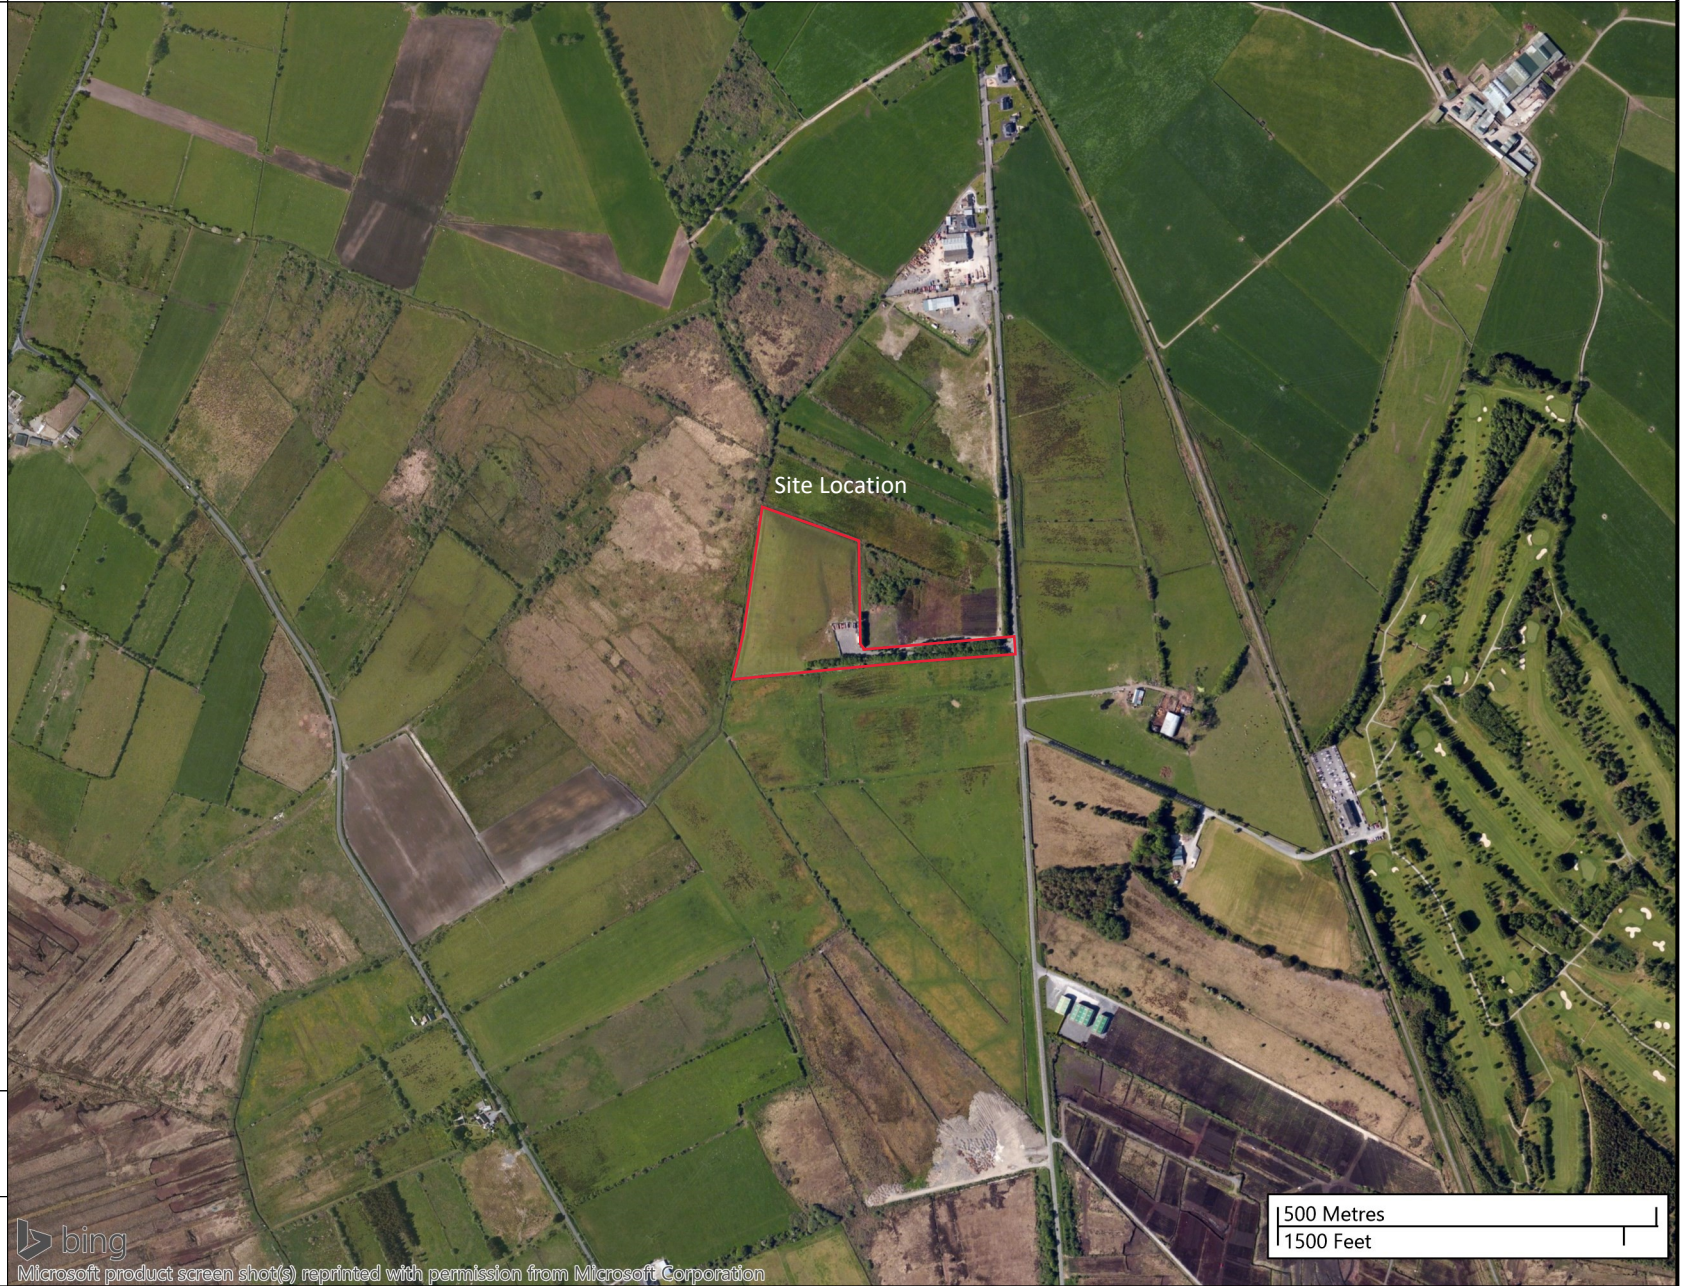
Title:
Site Location Plan

Last Revised:
21/09/2020

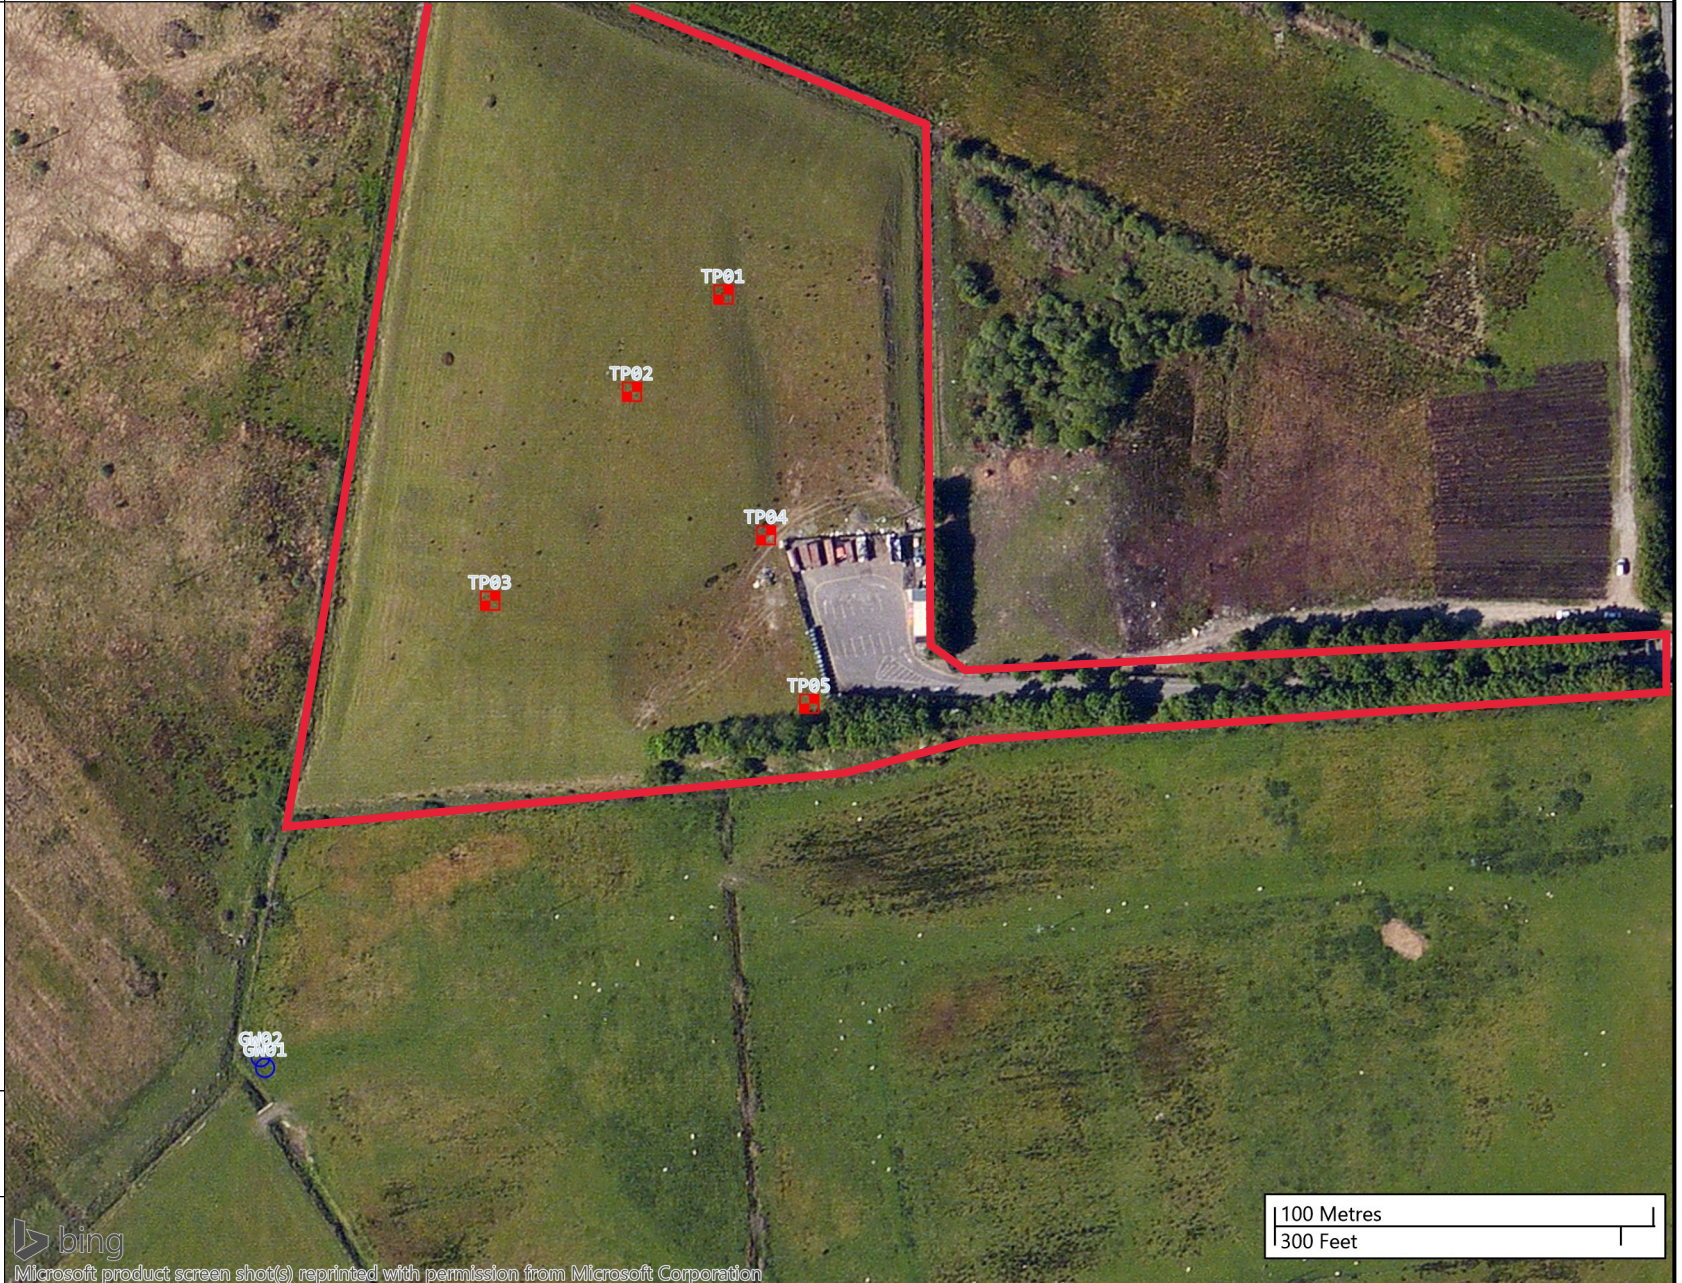
Title:
Exploratory Hole Location Plan

- Locations By Type - RO
- Locations By Type - TP
