**ENVIRONMENTAL LIABILITY
RISK ASSESSMENT
STARRUS ECO HOLDINGS LTD
MATERIALS RECOVERY FACILITY
MILLENNIUM BUSINESS PARK
BALLYCOOLIN
COUNTY DUBLIN**

INDUSTRIAL EMISSIONS LICENCE NO. W0183-01

Project		Environmental Liability Risk Assessment		
Client		Starrus Eco Holdings Ltd		
Report No	Date	Status	Prepared By	Reviewed By
17138070101	12/03/2017	Draft	Billy Hamilton BSc, MLitt	Jim O'Callaghan MSc, CEnv, MCIWM, IEMA
	24/03/2017	Final		
	05/04/2017	Final Rev A

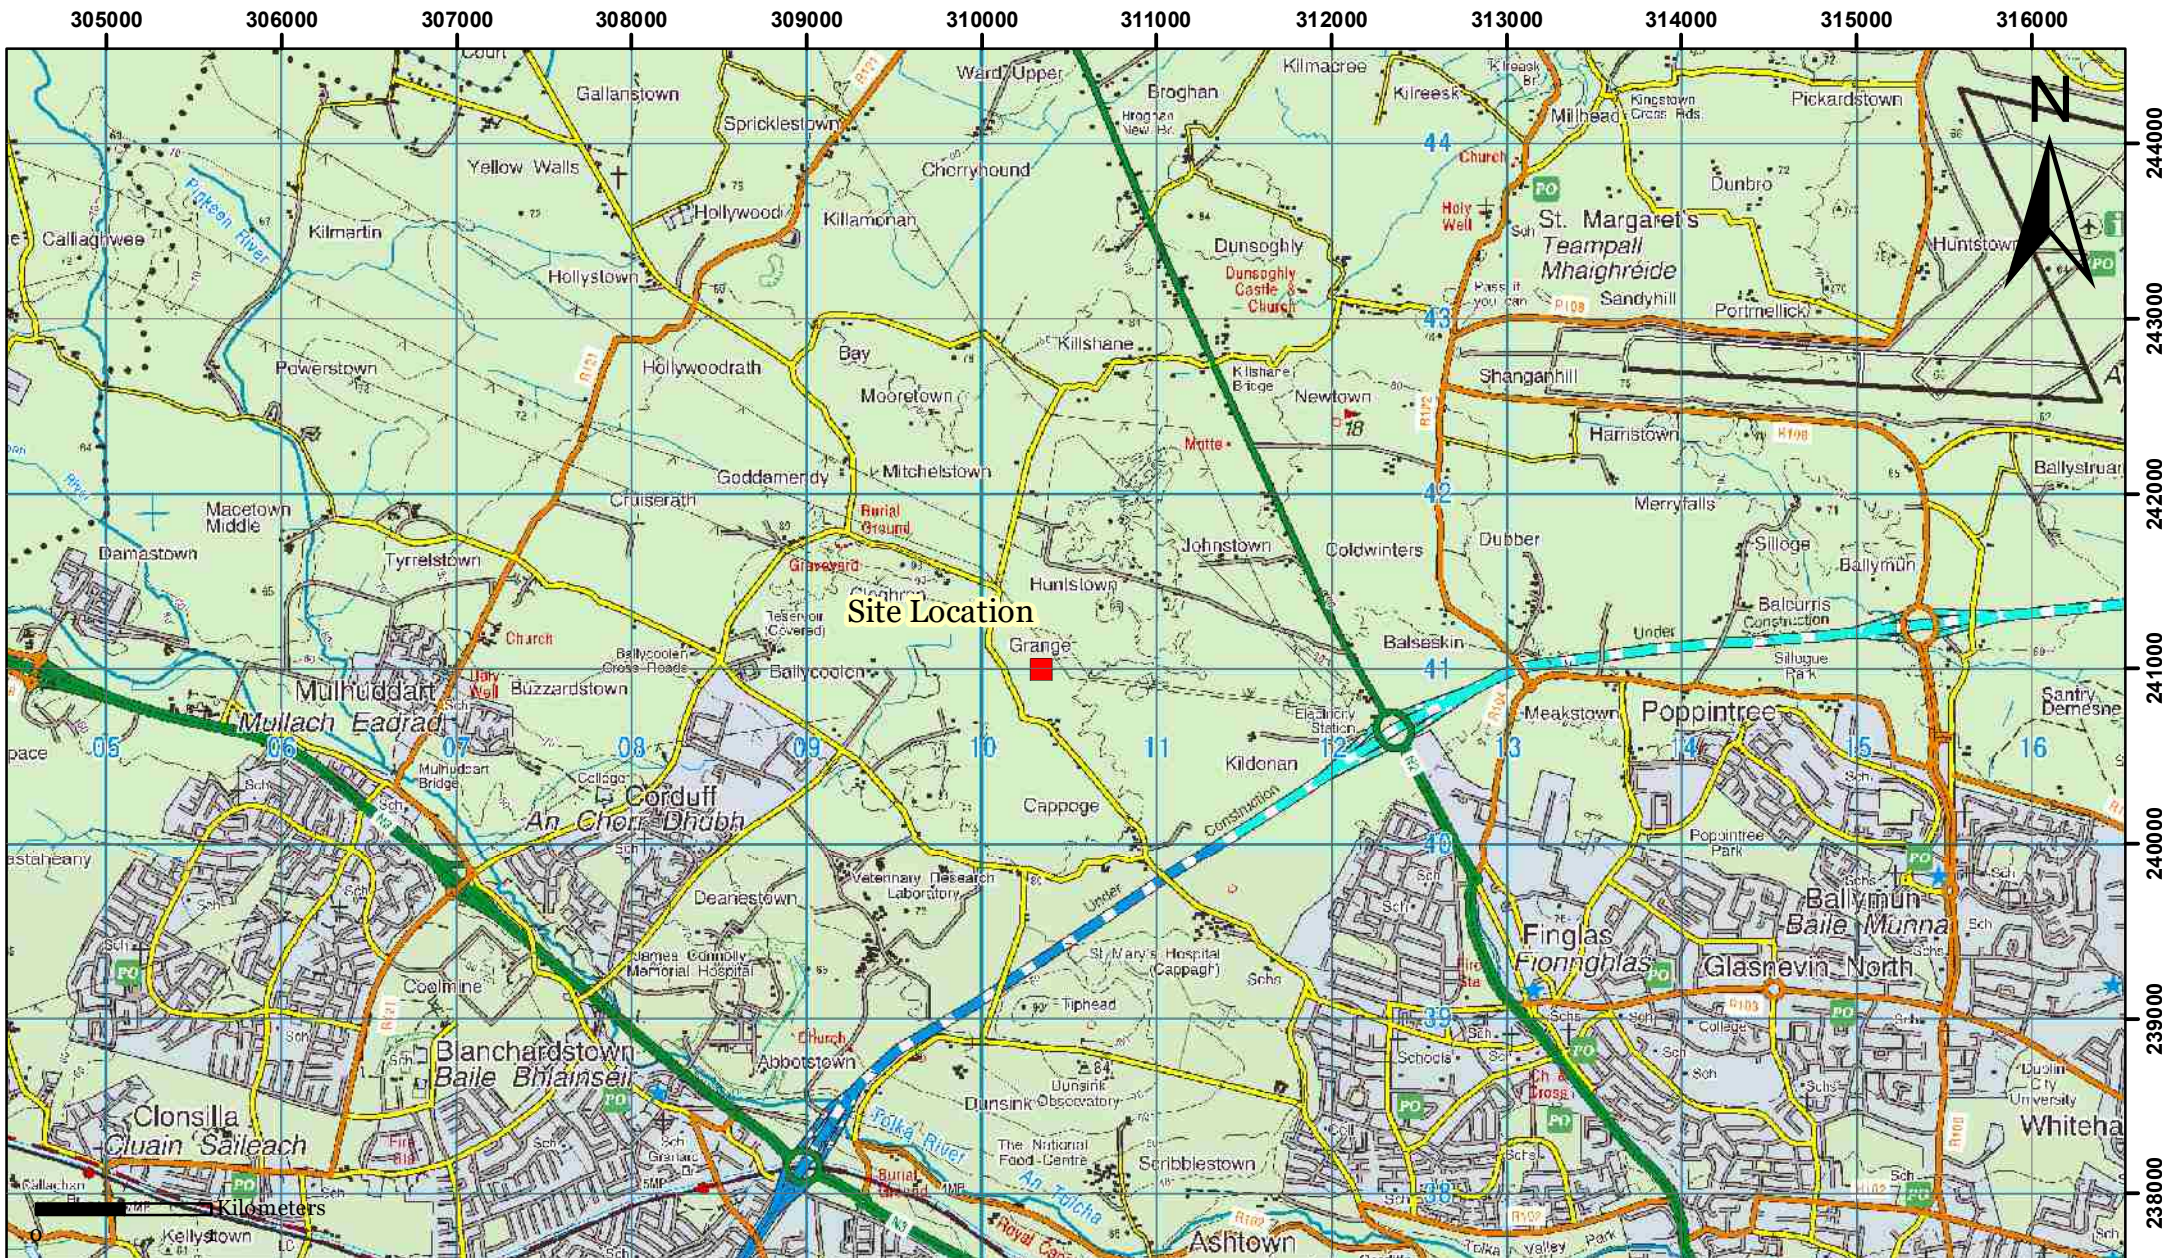
Figure 3.1

The installation occupies 4.45 hectares (ha) in the east of the Millennium Business Park, Ballycoolin, Dublin 11 (Figure 3.1). It is intended to develop the facility in a number of Phases. Phases 1 and 2 opened in July 2006 and involved the construction of the Materials Recovery Facility (MRF) building and supporting ancillaries as shown on Figure 3.2. The licence allows for the construction of a biowaste treatment building but this has not yet been constructed. The Business Park (Park) is accessed via the Cappagh Road, the entrance to the installation is off an internal road within the Park.
