Port of Waterford
Navigation Maintenance Dredging Programme 2026-2033
Underwater Archaeological Impact Assessment

Issued

26/01/2024

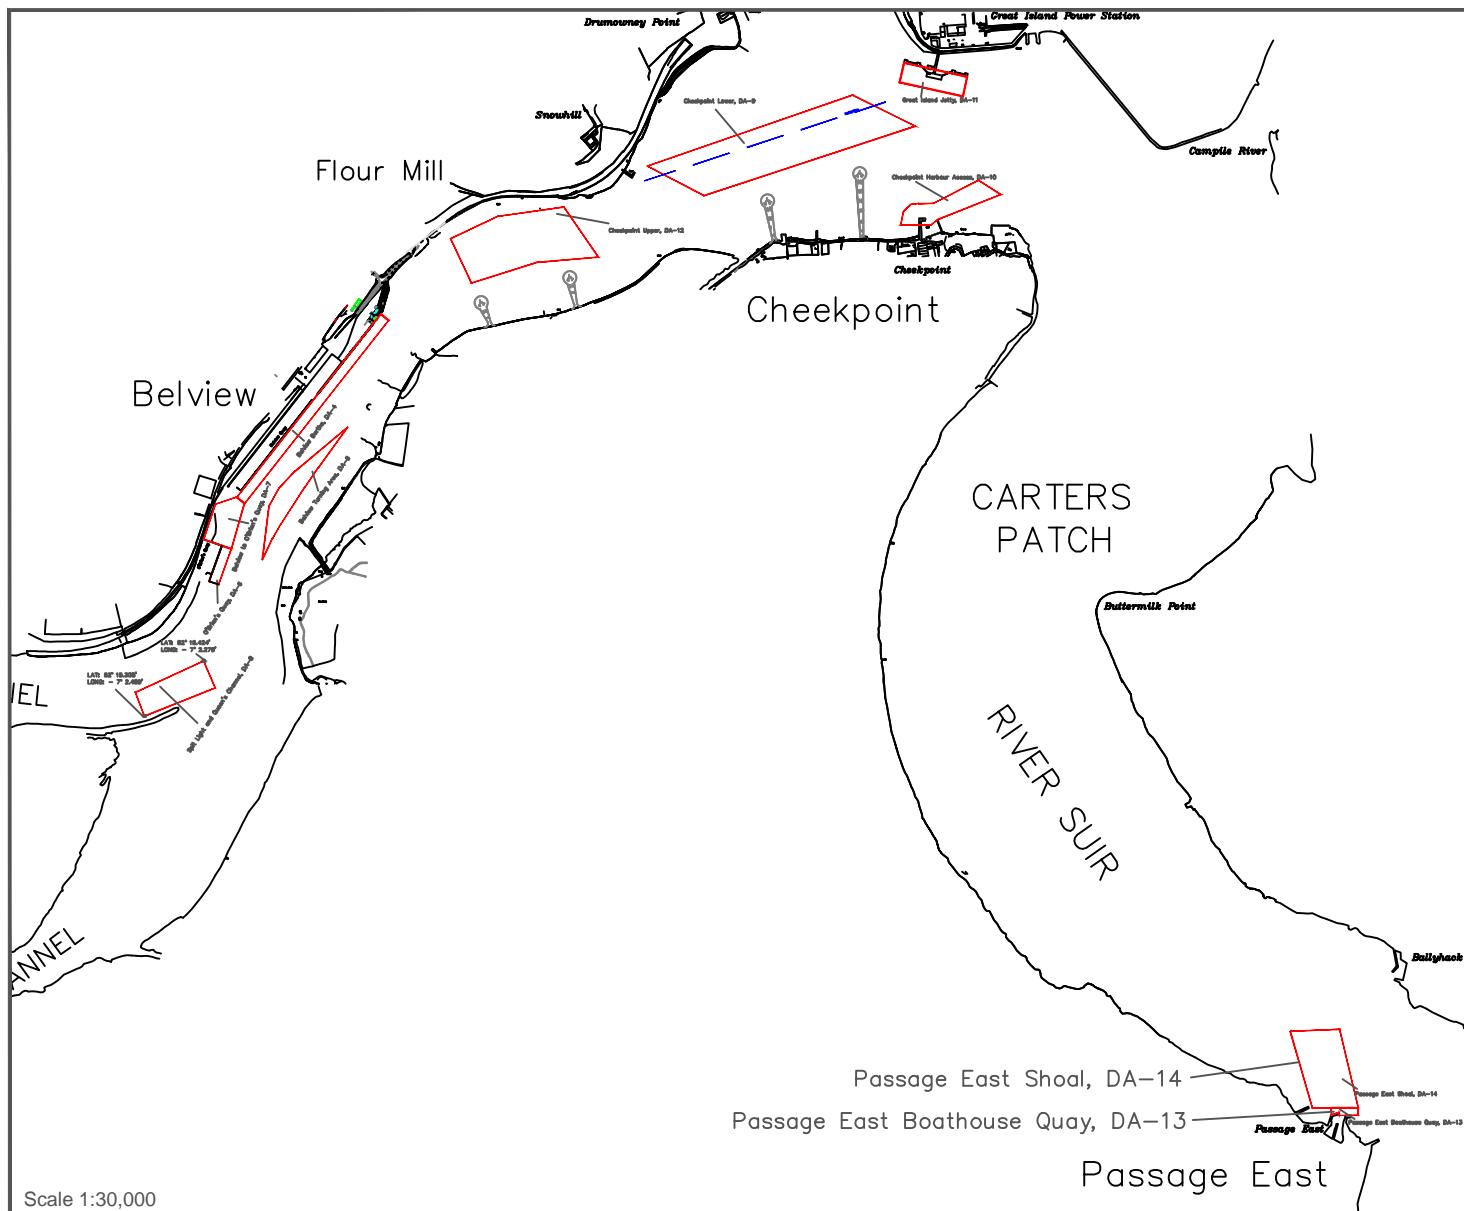
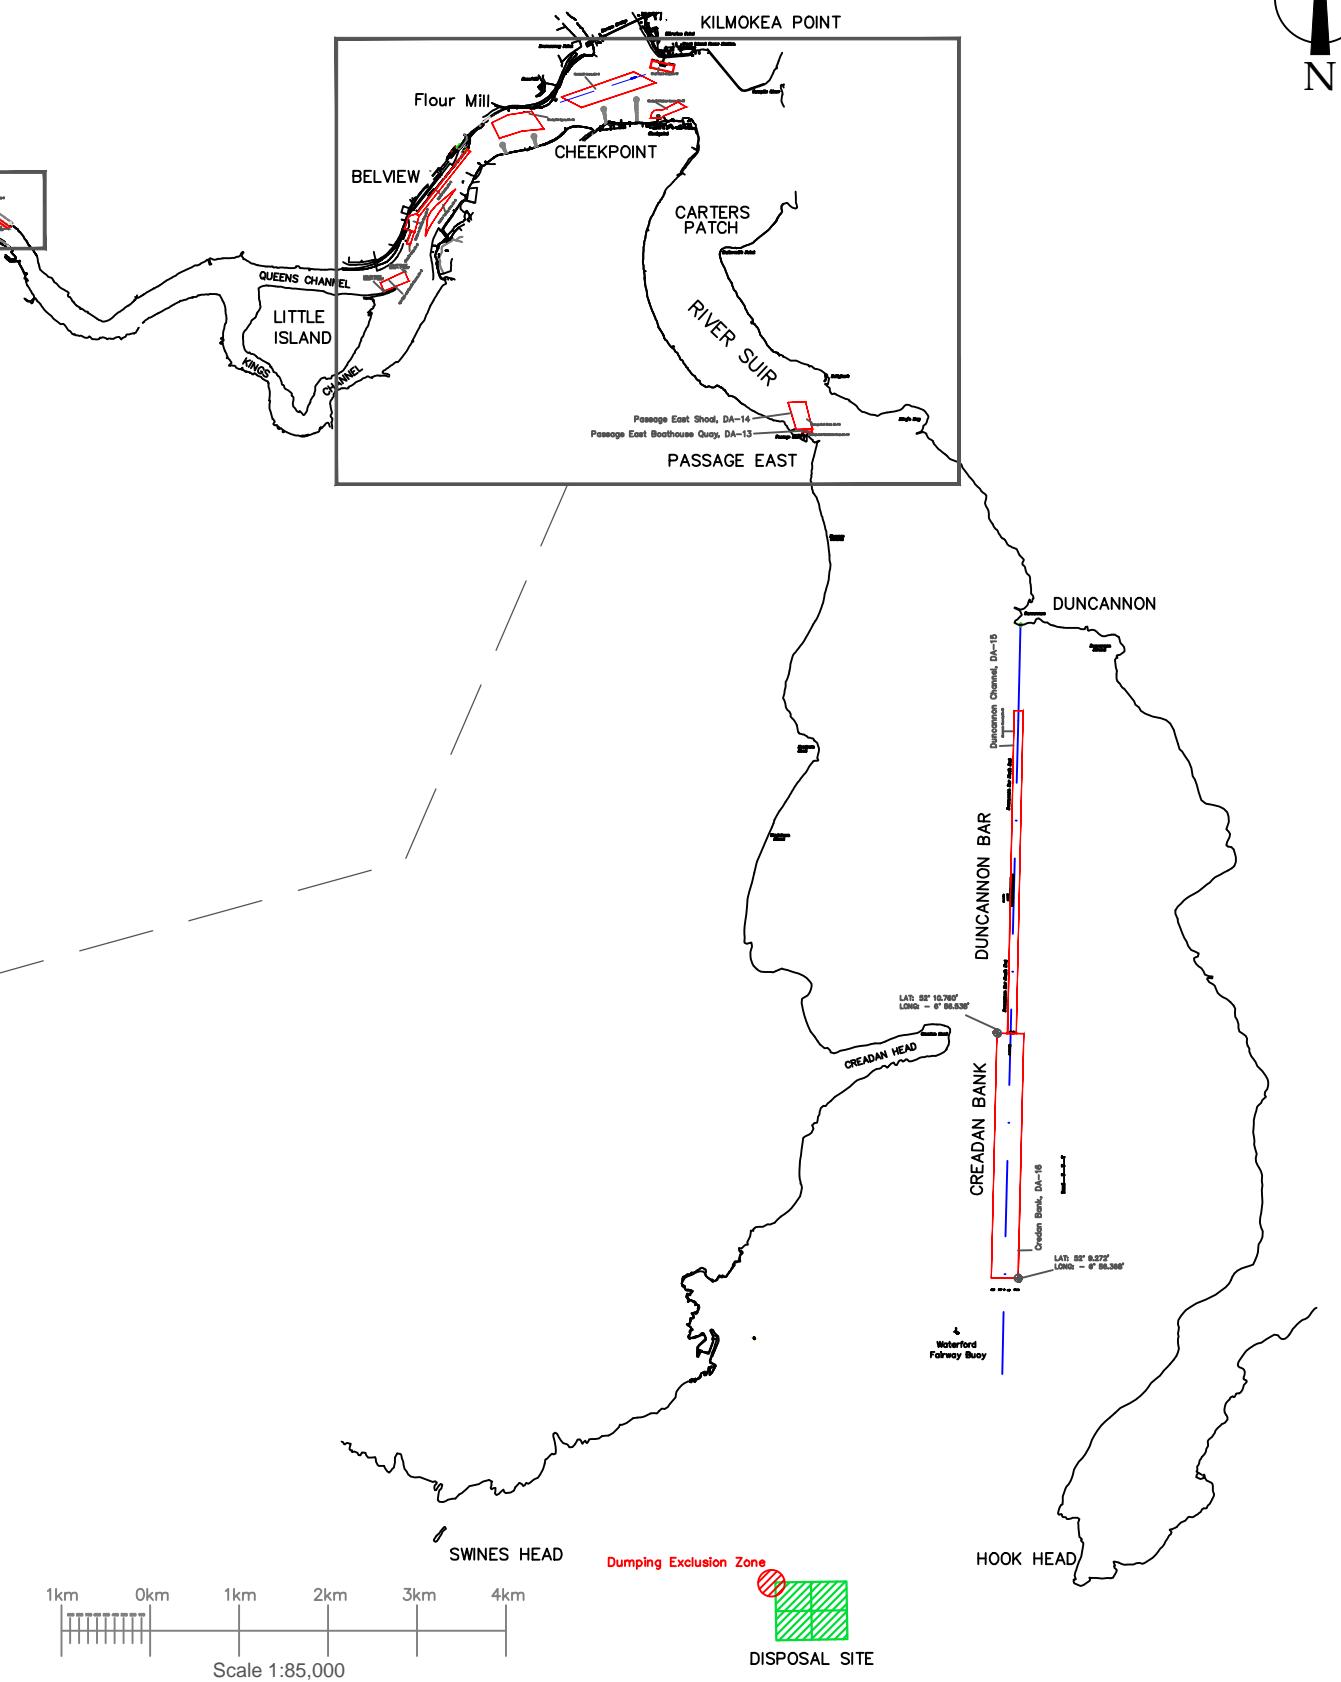
Source: details extracted from Project Drawing supplied by the client
[Dredge Area Overview_R2- 636_Consultation_PreApp, September 2022, Anthony D. Bates Partnership LLP].
