Date:27th July, 2022To:licencing@epa.ieCC:Alison McCarthy, EPAFrom:Francis O'Beirn, Marine InstituteRe:S0004-03 – Dublin Port Company DAS Maintenance Dredging Application (MI Observations

on Spoil Site Conditions)

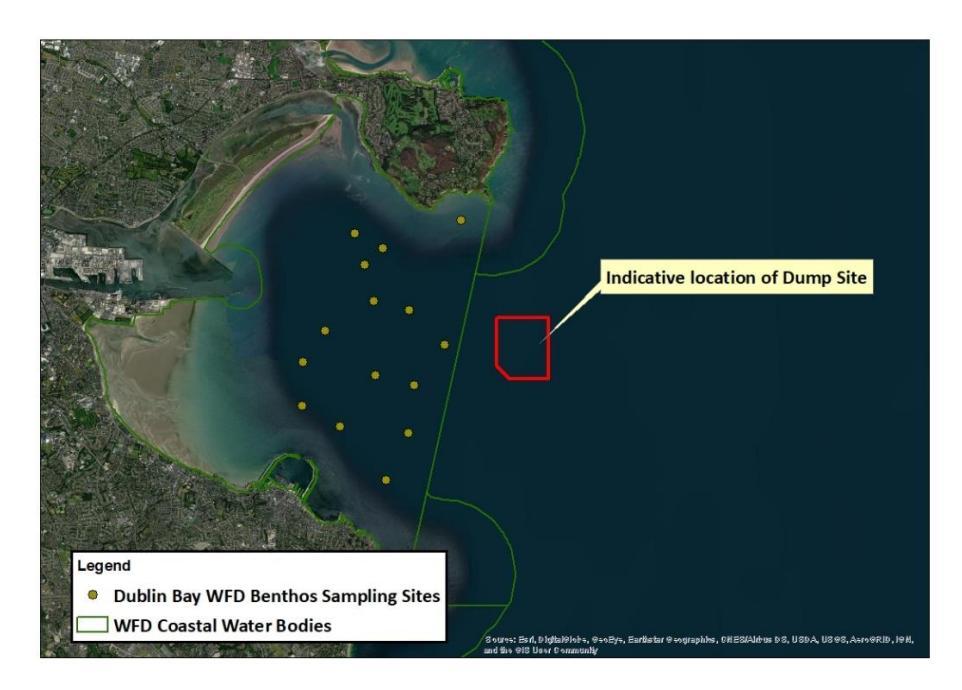
Figure 1. Dublin Bay Water Framework Directive benthos macro-invertebrate sampling points (n=15). General location of spoil site is also provided.

WFD Sampling of the bay is carried out as part of the Marine Institute Winter Environmental Survey where 15 sites are sampled (Figure 1), infaunal macro-invertebrates are analysed (identified and enumerated) and the status of the benthos in the bay is calculated using the Invertebrate Quality Index (IQI)⁶.
