ANNUAL ENVIRONMENTAL REPORT 2011

<u>Reporting Period 1st January – December 31st 2011</u>

Waste Transfer Station, John F. Connolly Road. Churchfield Industrial Estate, Cork Tel:- 021 4310333 Fax:- 021-4323068 E-mail:- <u>info@ashgroverecycling.ie</u>

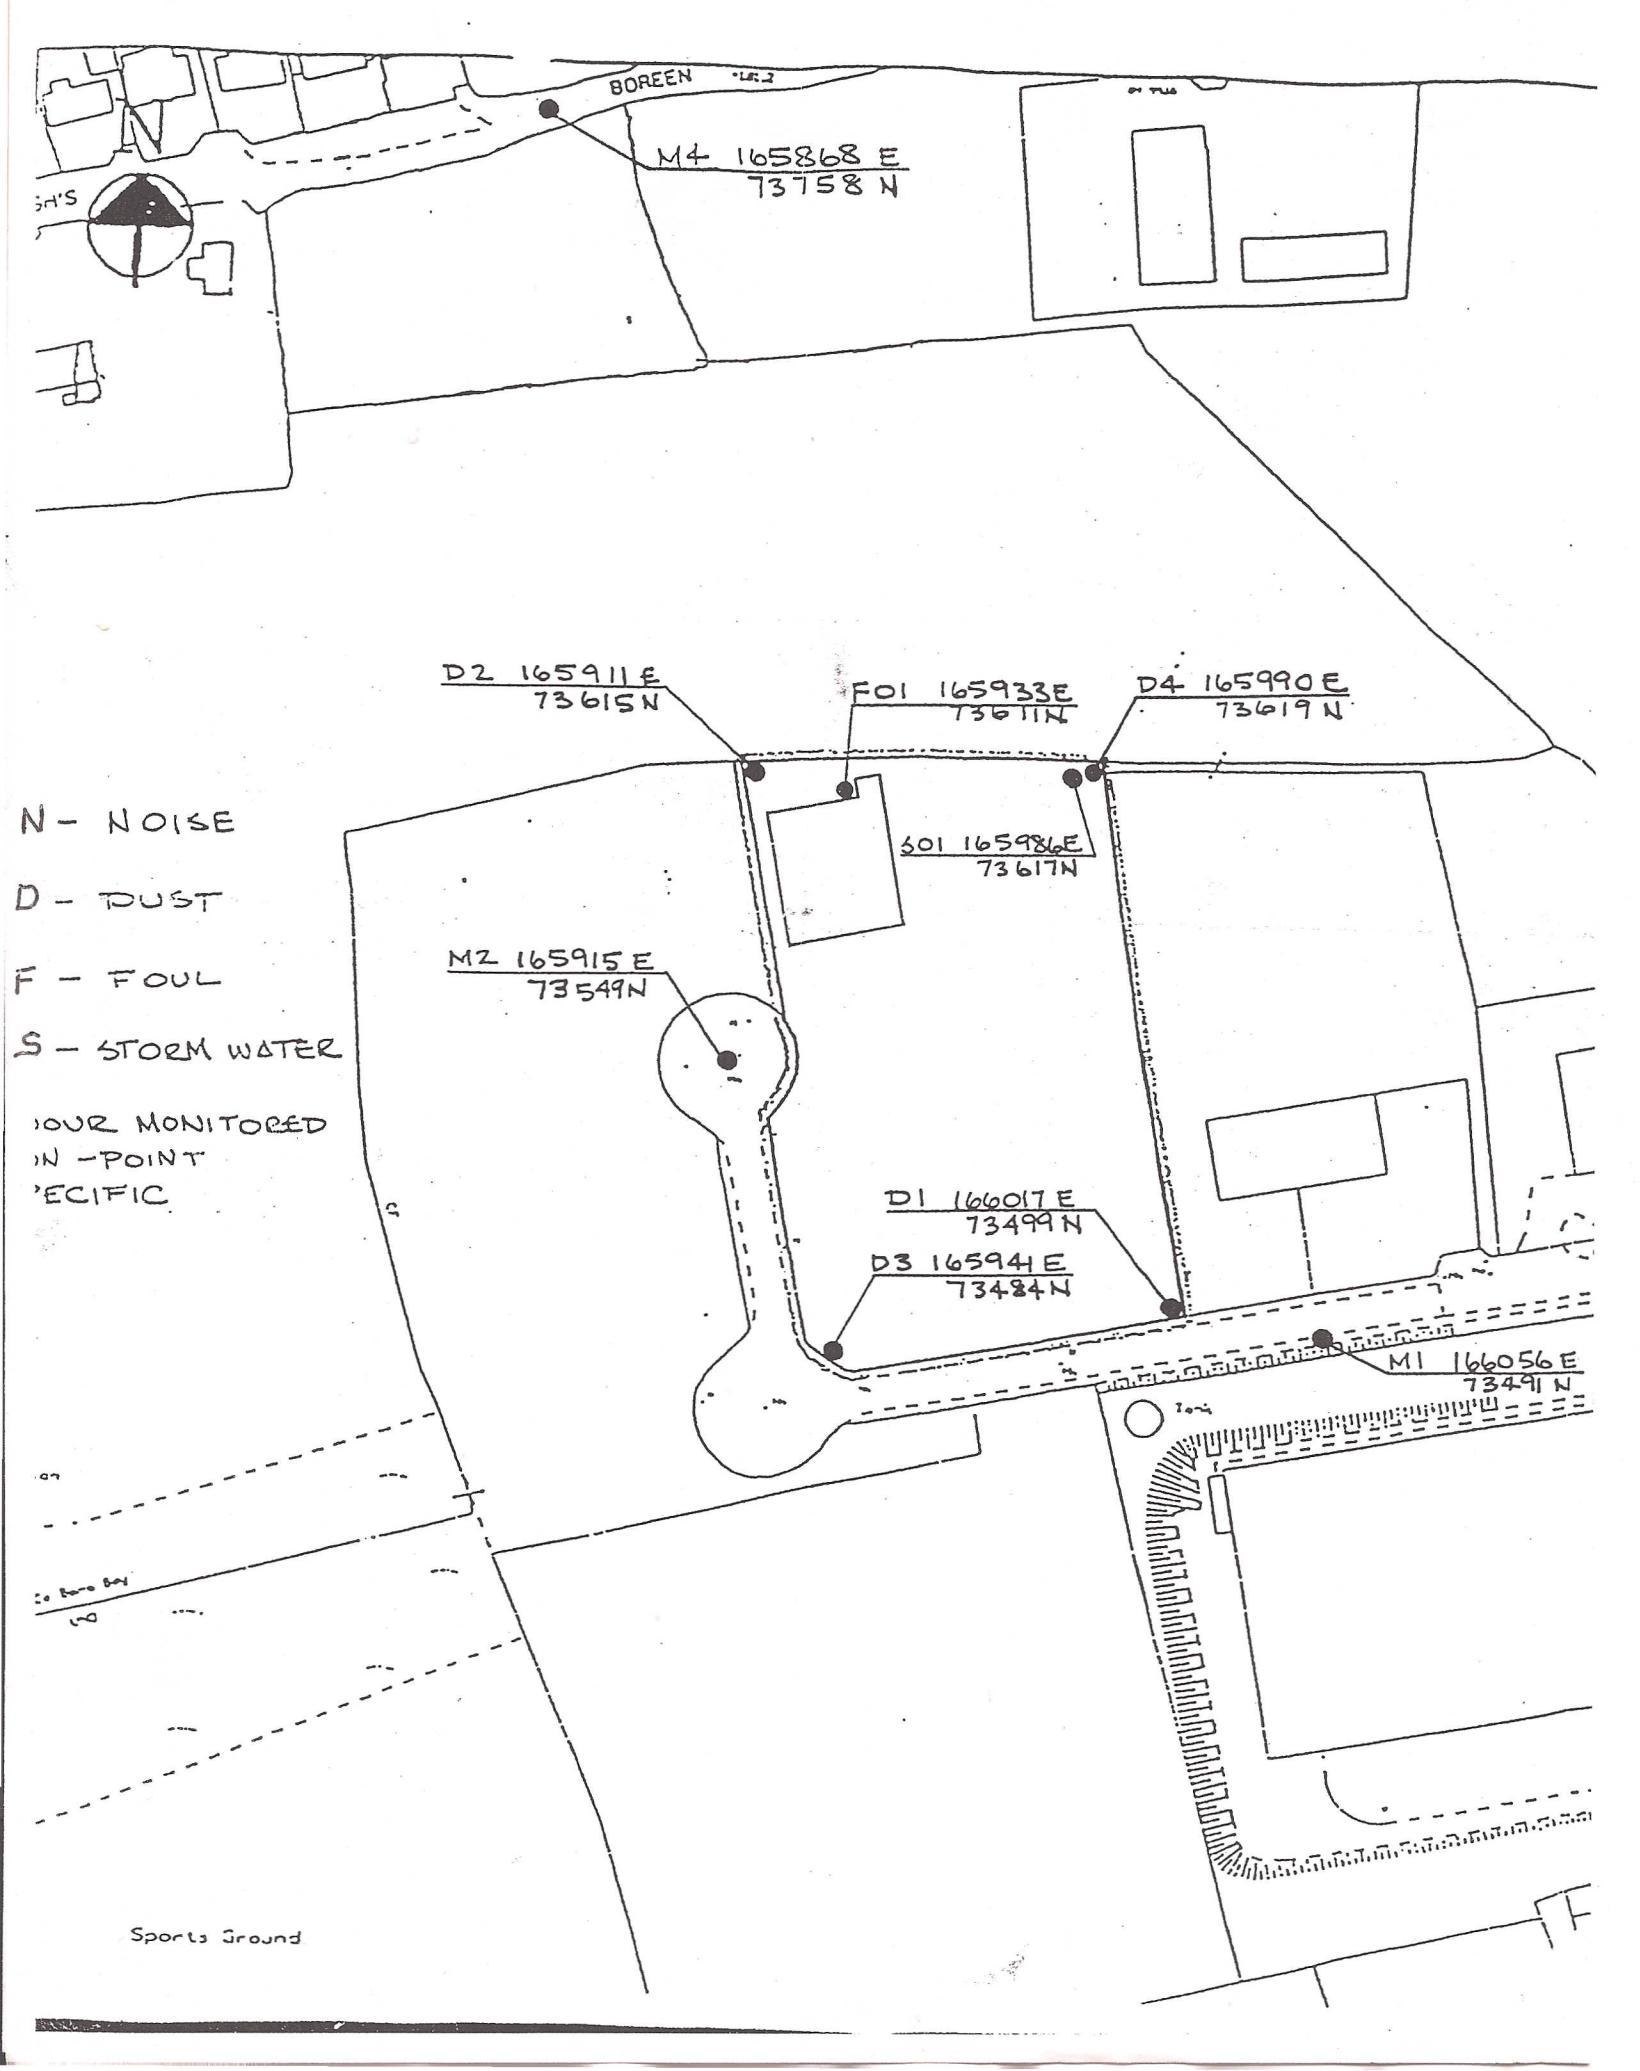
FIGURE 1: NOISE MONIT(

Noise monitoring is carried out at four locations of the site. Refer to noise monitoring locations in Appendices.
