Cork County Council

Doherty Environmental

Habitats Directive Screening Assessment

Clonakilty Landfill

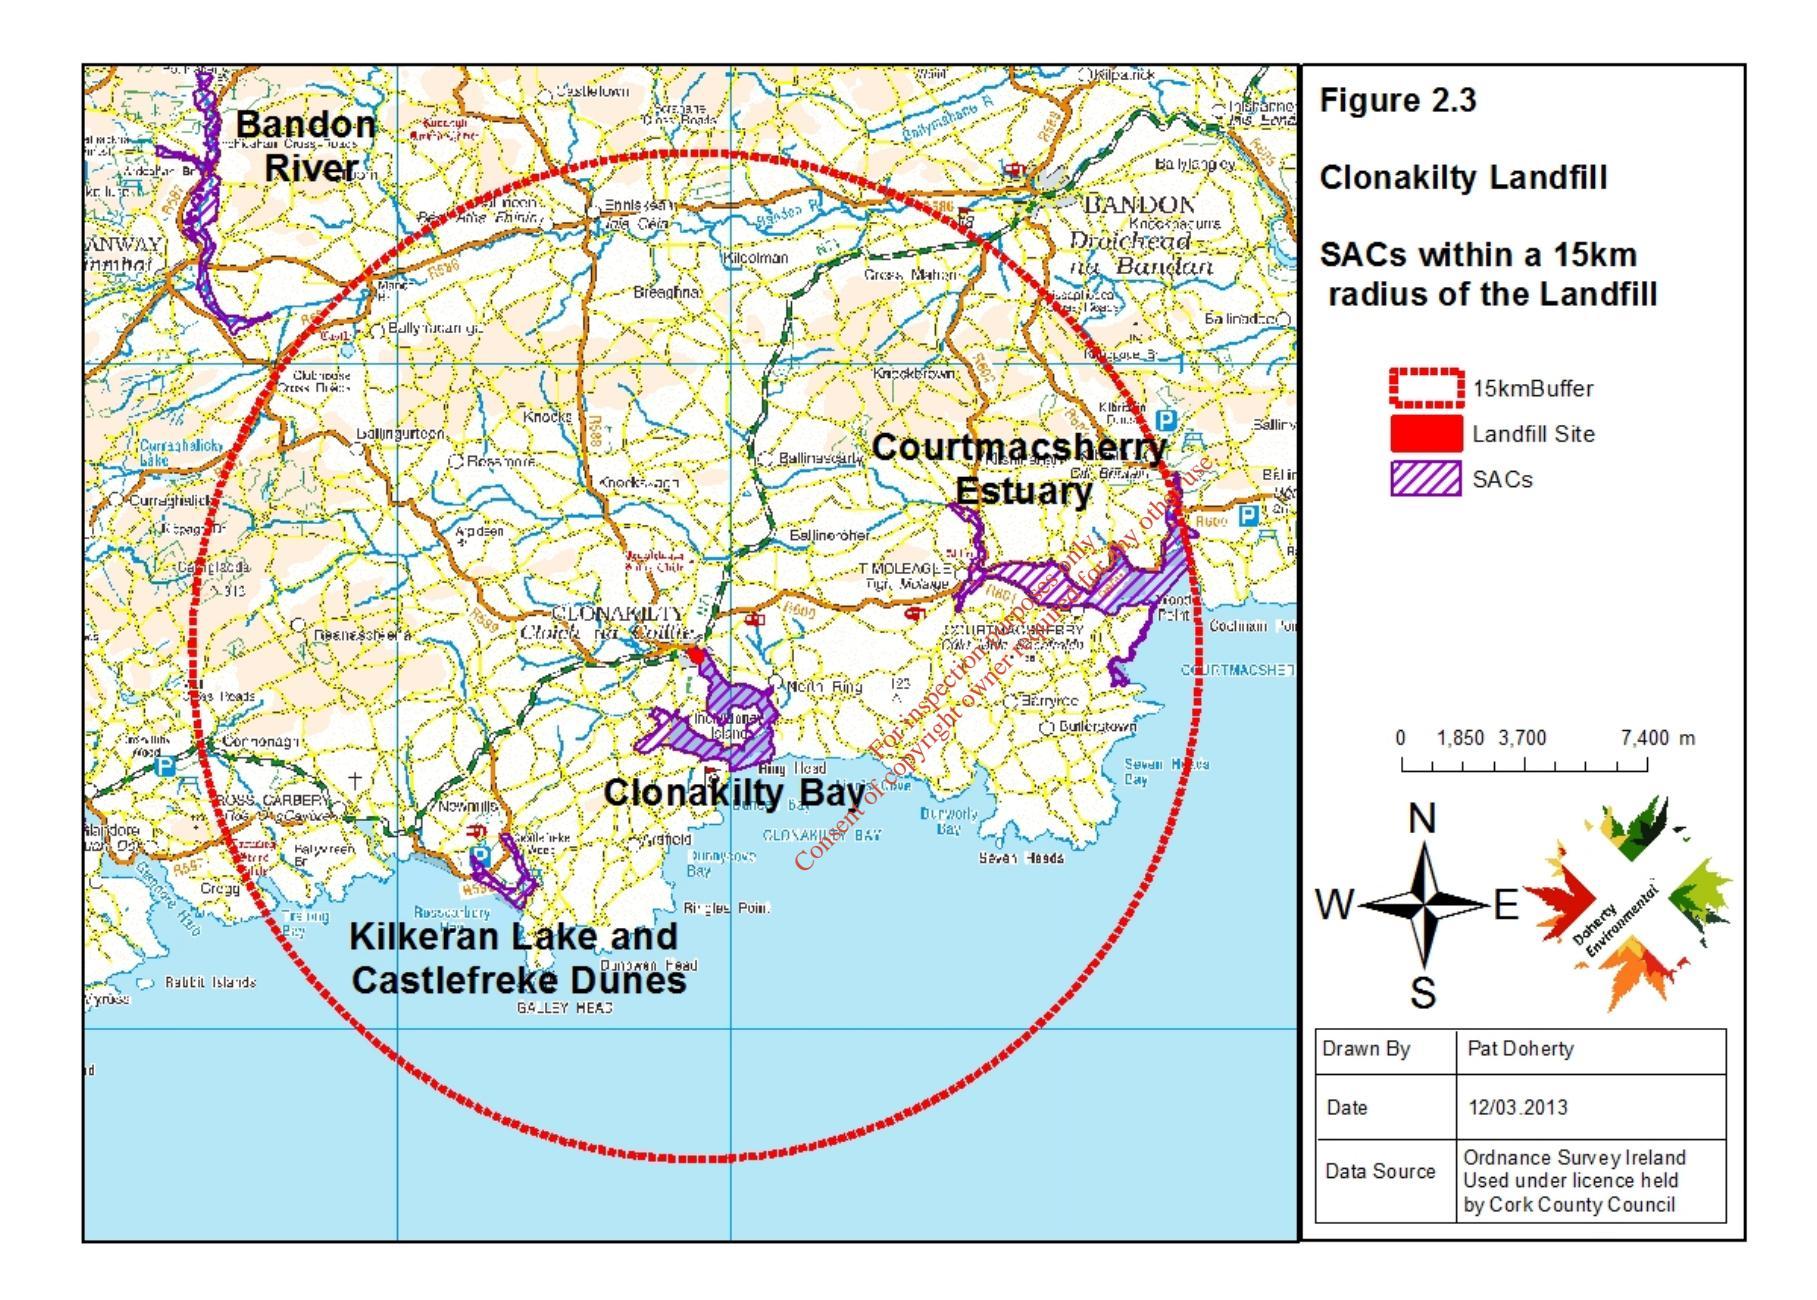
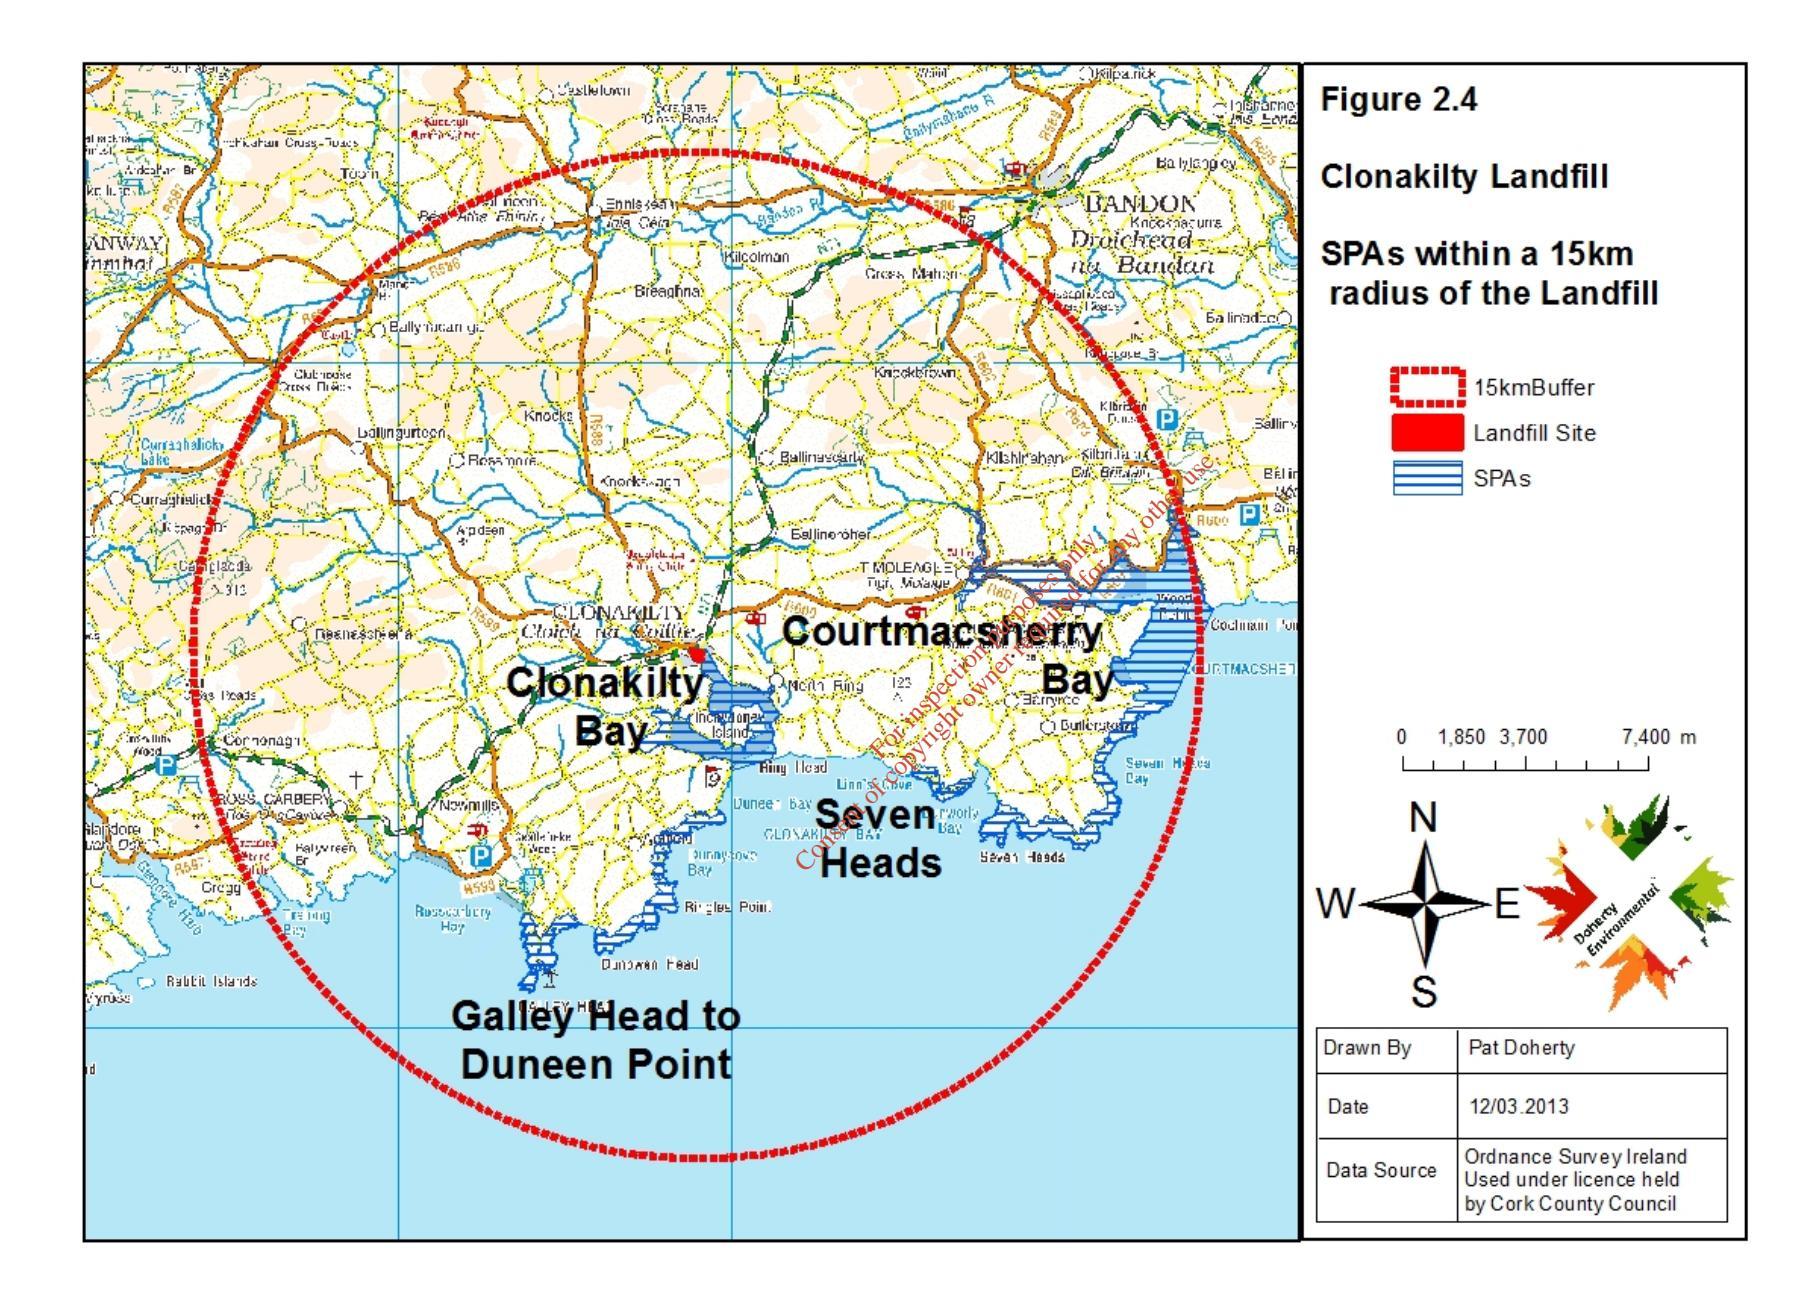
Current guidance on undertaking EU Habitats Directive Article 6 Assessments advises that all European Sites occurring within a 15km radius of a project site should be included within a Screening Assessment (Scott Wilson *et al.*, 2006; DOEHLG, 2010). Three SACs and three SPAs occur within the surrounding 15km radius of the site. These sites as shown in Figures 2.3 and 2.4 below.

Clonakilty Bay SAC and SPA are the only European Sites occurring within the vicinity or downstream of a potential impact pathway. All other European Sites occurring within a 15km buffer of the landfill are not linked to the landfill or contaminant/hazard sources such as leachate by impact pathways. Thus the remainder of this Screening Assessment focuses on the potential for leachate migration from the Clonakilty Landfill to result in likely significant effects to the Clonakilty Bay SAC and SPA. All other European Sites are screened out at this stage of the assessment.
