Kiltha River, Castlemartyr, Co. Cork

Incident Report and Observations

(Further Discharges into the Kiltha River from
Castlemartyr Waste Water Treatment Plant - February and March 2012)

Produced by: Womanagh Angling & Development Association

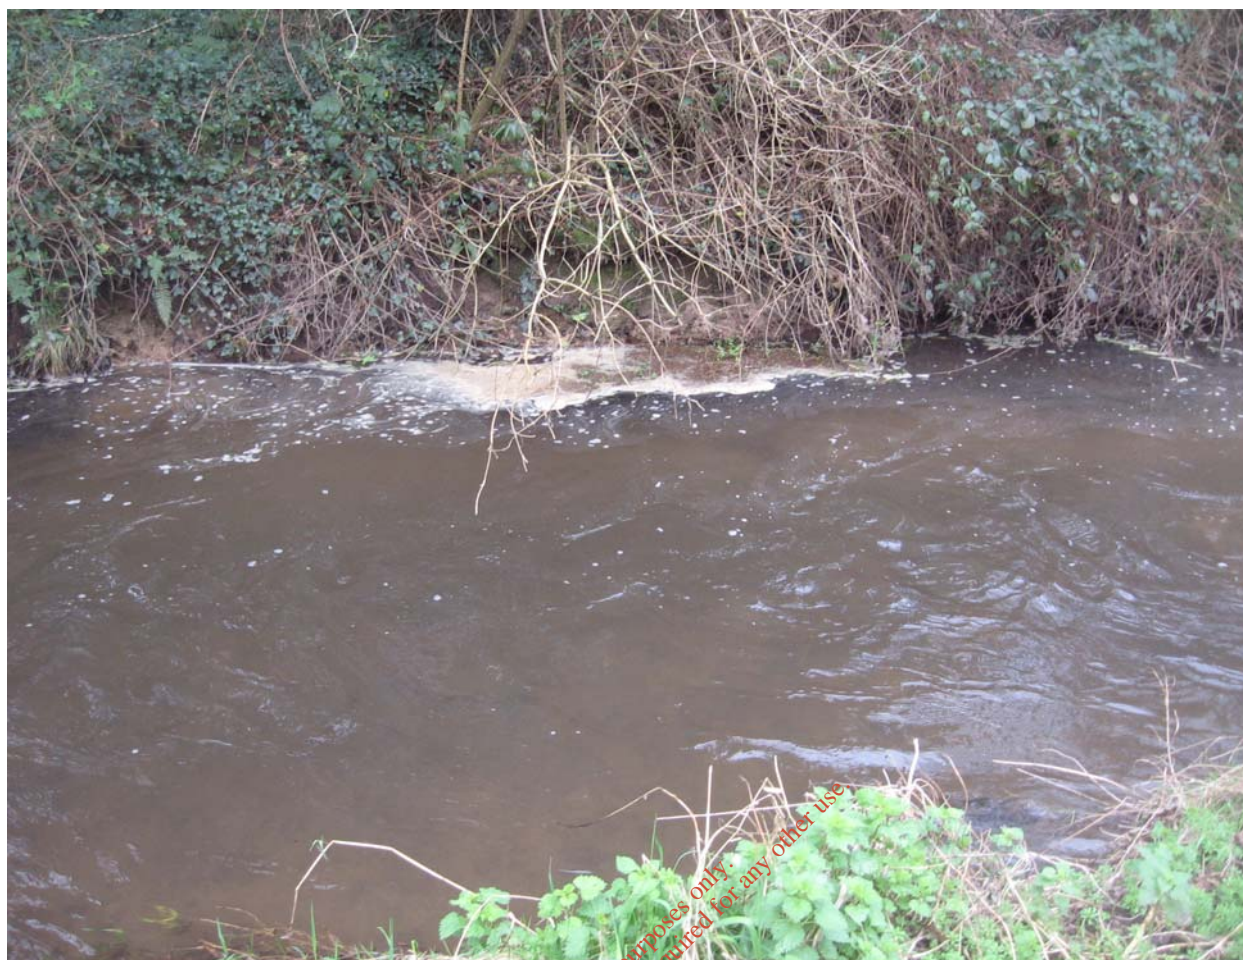
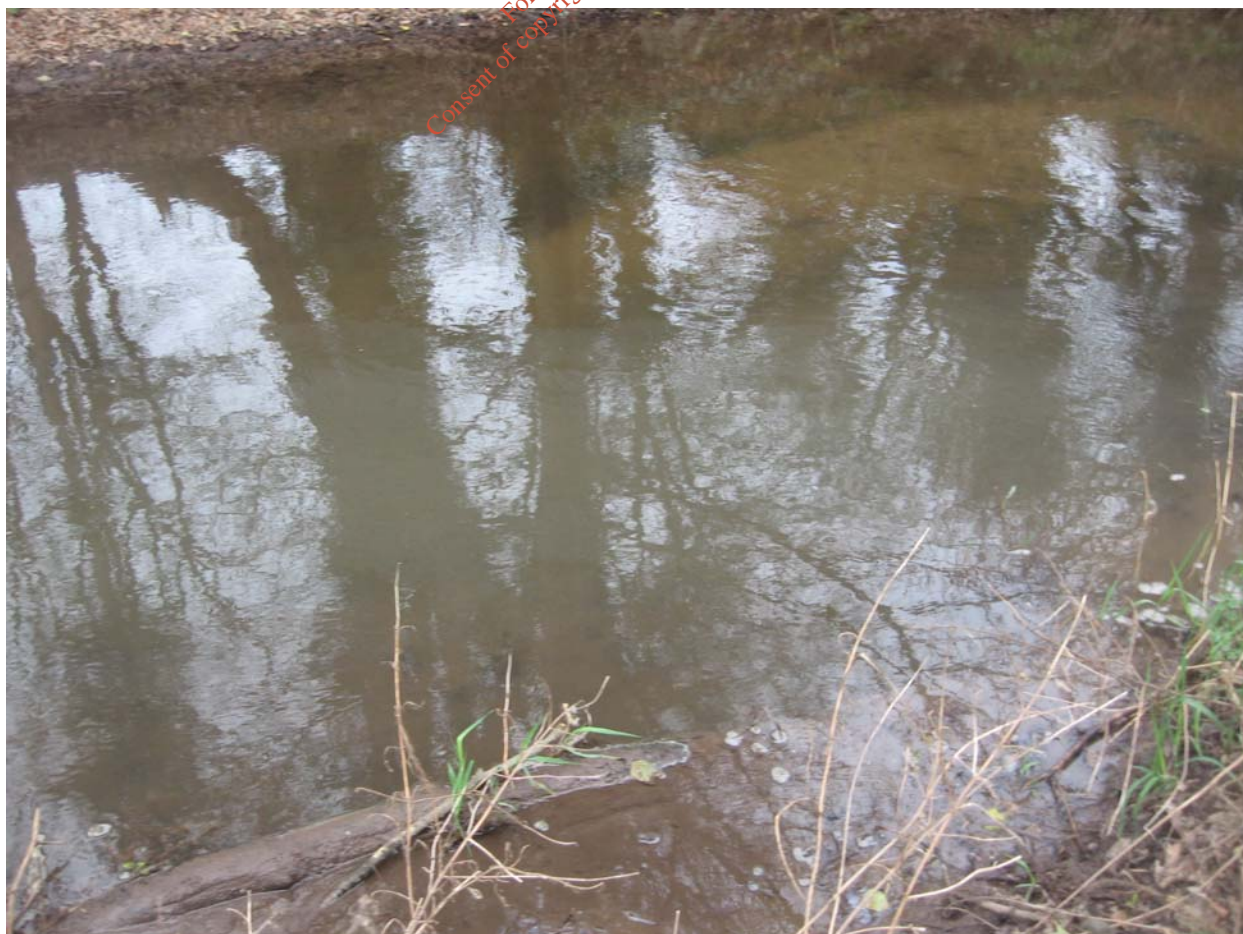
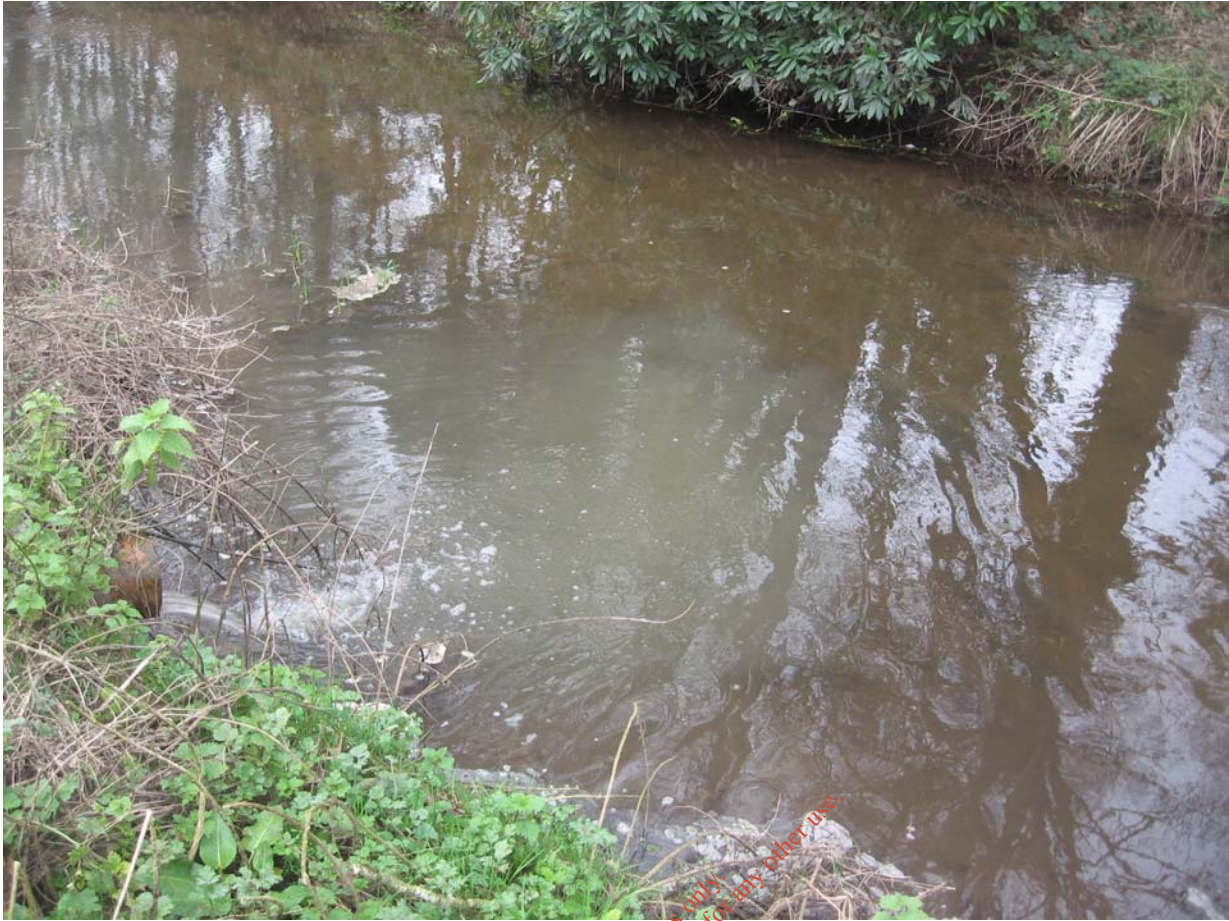
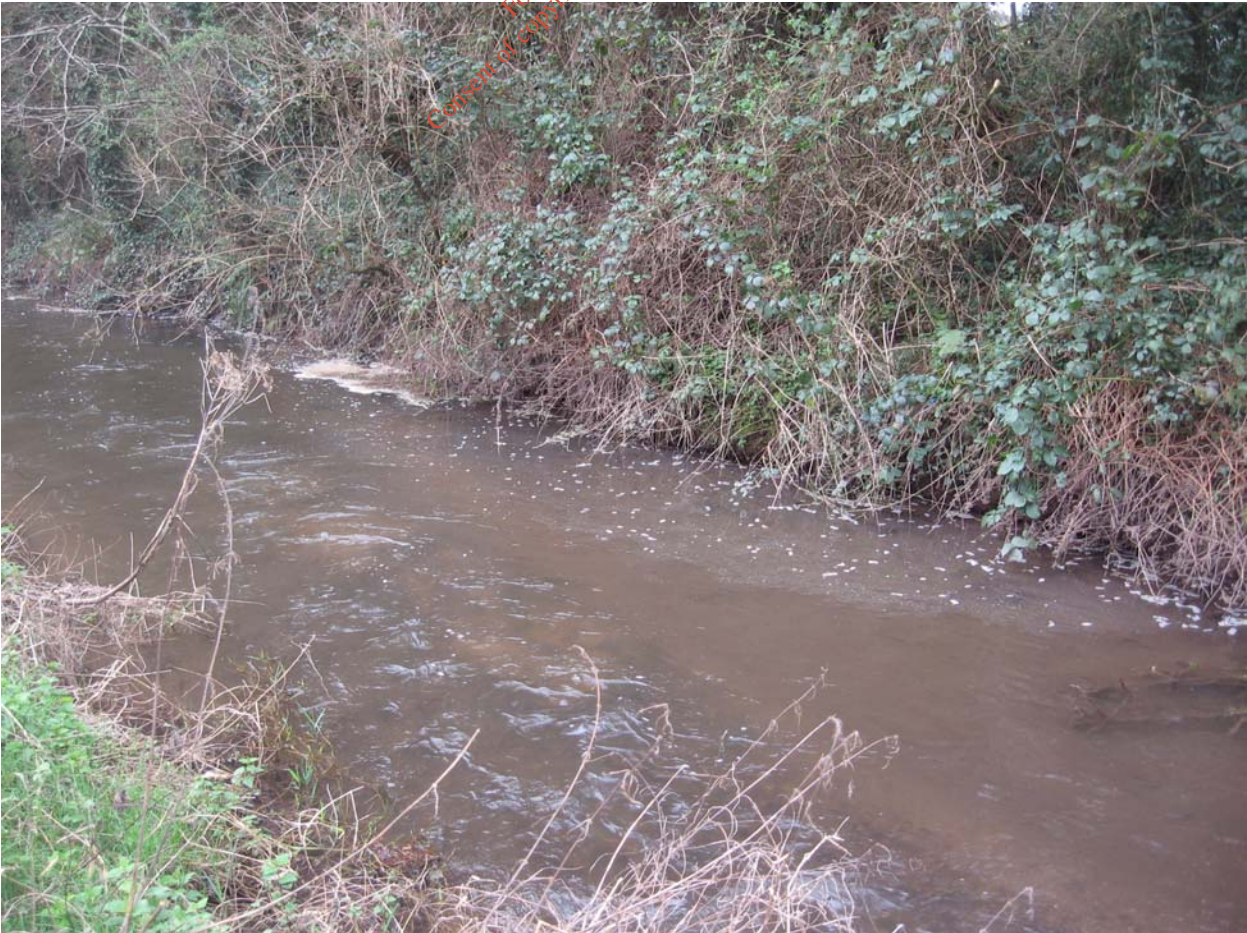
February 2012

Unfortunately for the past number of weeks we have noticed deterioration in the quality of water discharged in to the river along with seriously noxious discharge to the drains surrounding the plant which is open to the public. (photographic proof attached)

I would ask you to please ensure the pollution of our river and wood ceases immediately and that more robust processes are adopted to ensure these problems are adressed once and for all.

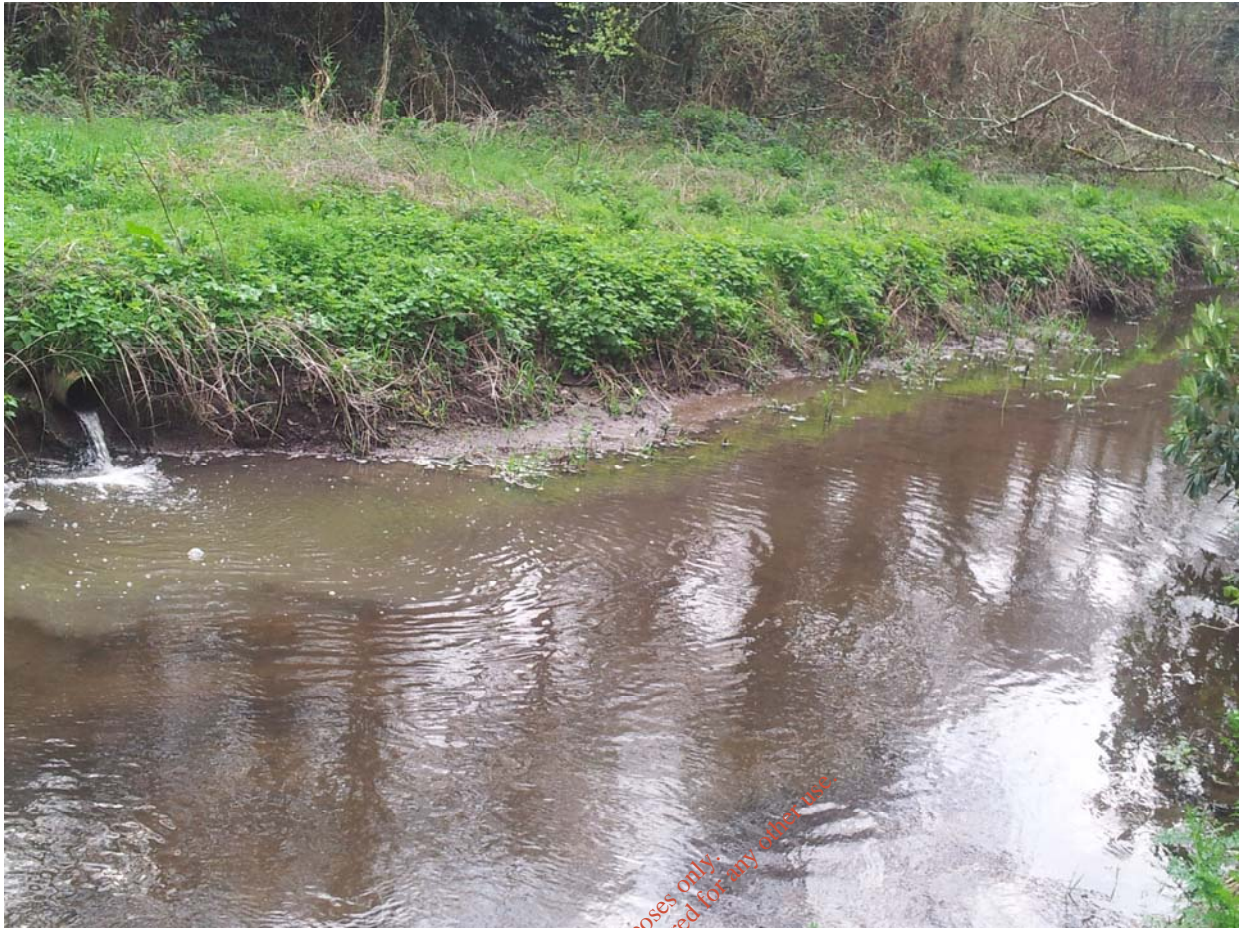
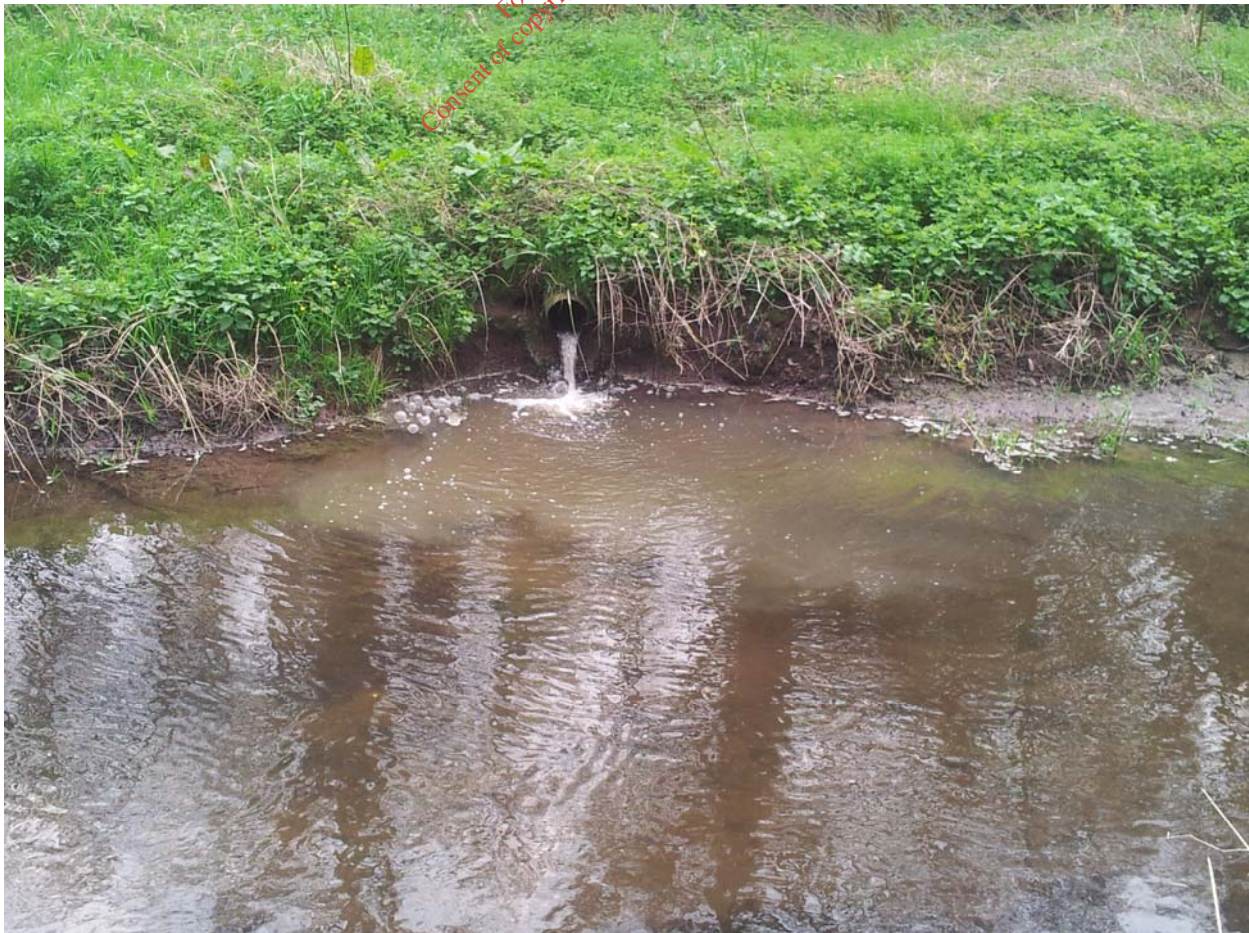
22nd March 2012 - Photos referred to in email of same date.

please find attached photographs from the outflow of Castlemartyr WWTP taken today 22.03.12 From looking at the photographs the discharge to the river would not seem to me to be of an acceptable quality. I would be interested to see the results of the monitoring system from the 24 hour period including today.

If the monitoring system indicates that the quality of discharge from today is within accepted limits then the reliability of the monitoring system must be questioned.

I am not aware of any period of heavy rainfall in recent days to which this problem could be attributed.
