Project  
**KERRIFFSTOWN LANDFILL  
REMEDIATION PROJECT**

Drawing title  
**FIGURE 4.7  
CROSS SECTIONS  
FOR THE PROPOSED PROJECT  
(SHEET 2 OF 2)**

Drawing number  
**32EW5604-00-025**

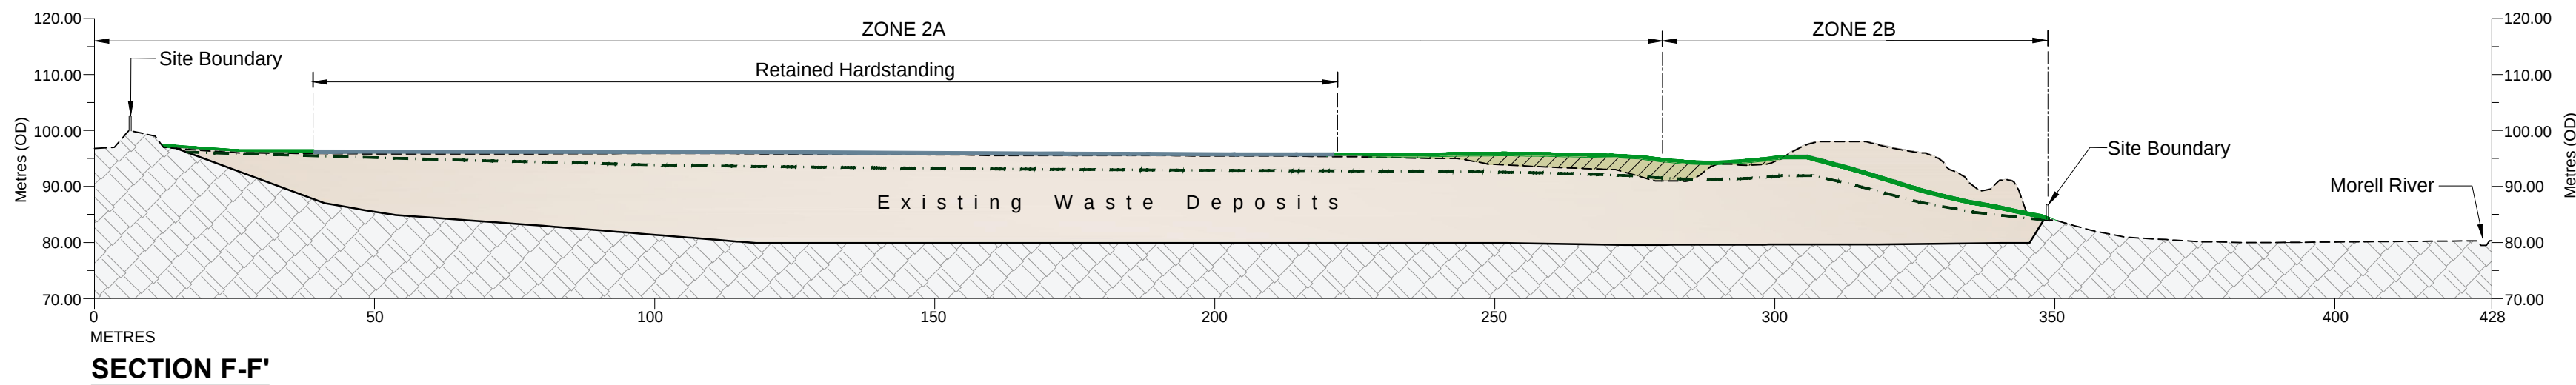
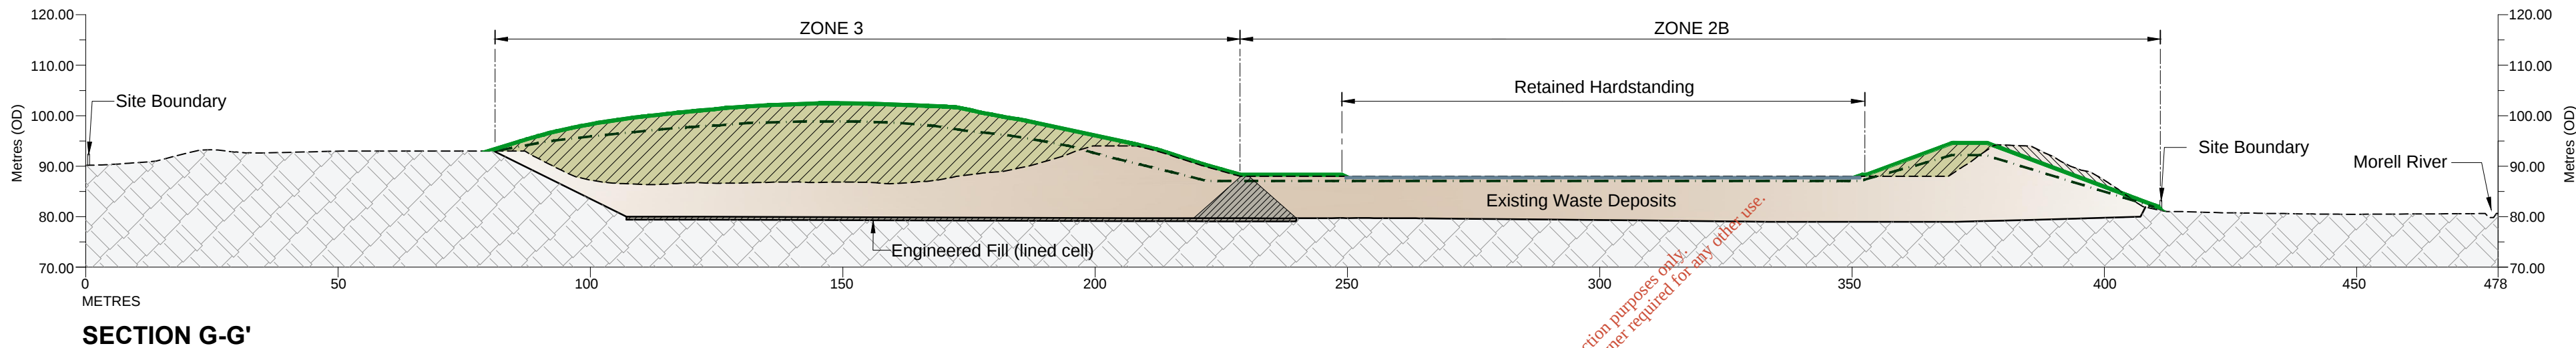
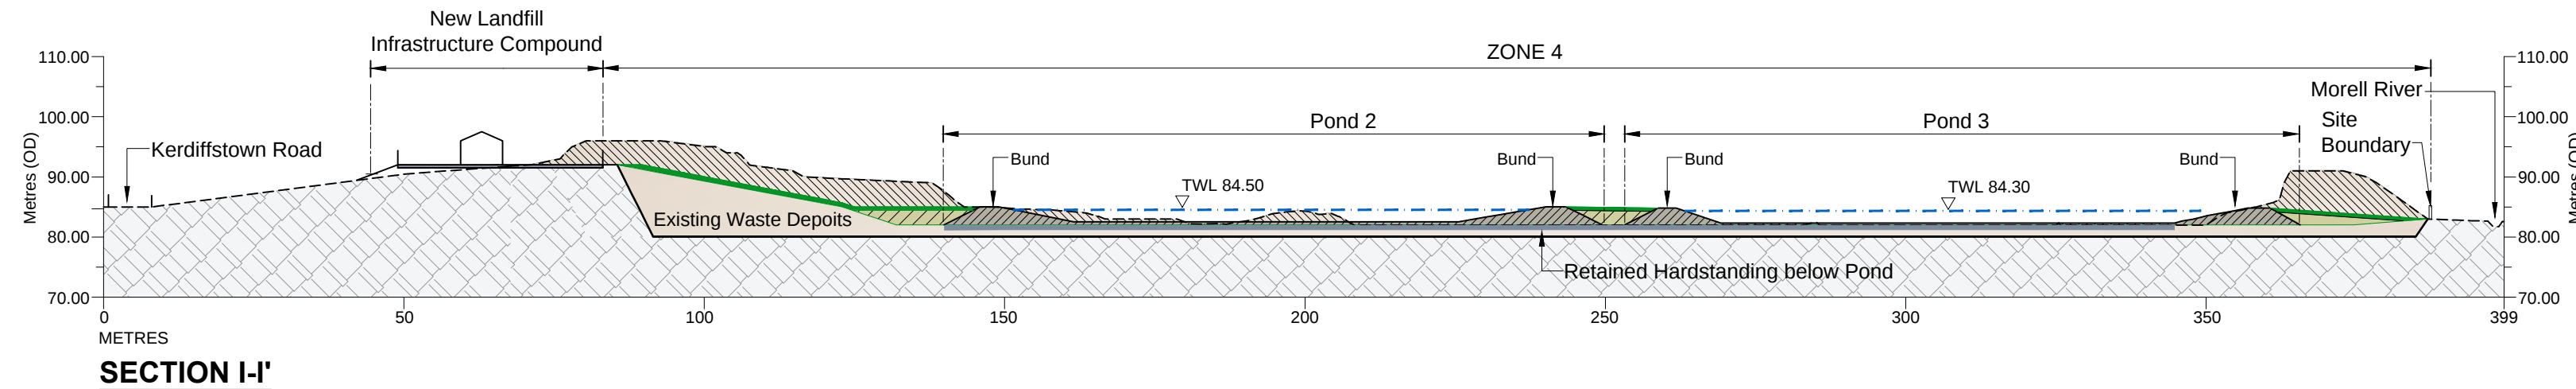
FIGURE 4.7

- Existing Ground Profile
- Base of Waste Profile
- Remediation Capping Profile
- Retained Hardstanding Restoration Profile
- Post Settlement Surface Profile
- Pond Top Water Level
- Existing Waste Deposits
- Areas of Cut (Waste)
- Areas of Fill
- Areas of Fill (Engineered)
- Natural Strata
