5. Constraints Inventory, Predicted Impacts & Suggested Mitigation

5.1 Archaeological Monuments Constraints Inventory (figs 19-23; Table 5)

ÆGIS ARCHAEOLOGY LIMITED
REF.: 62-37

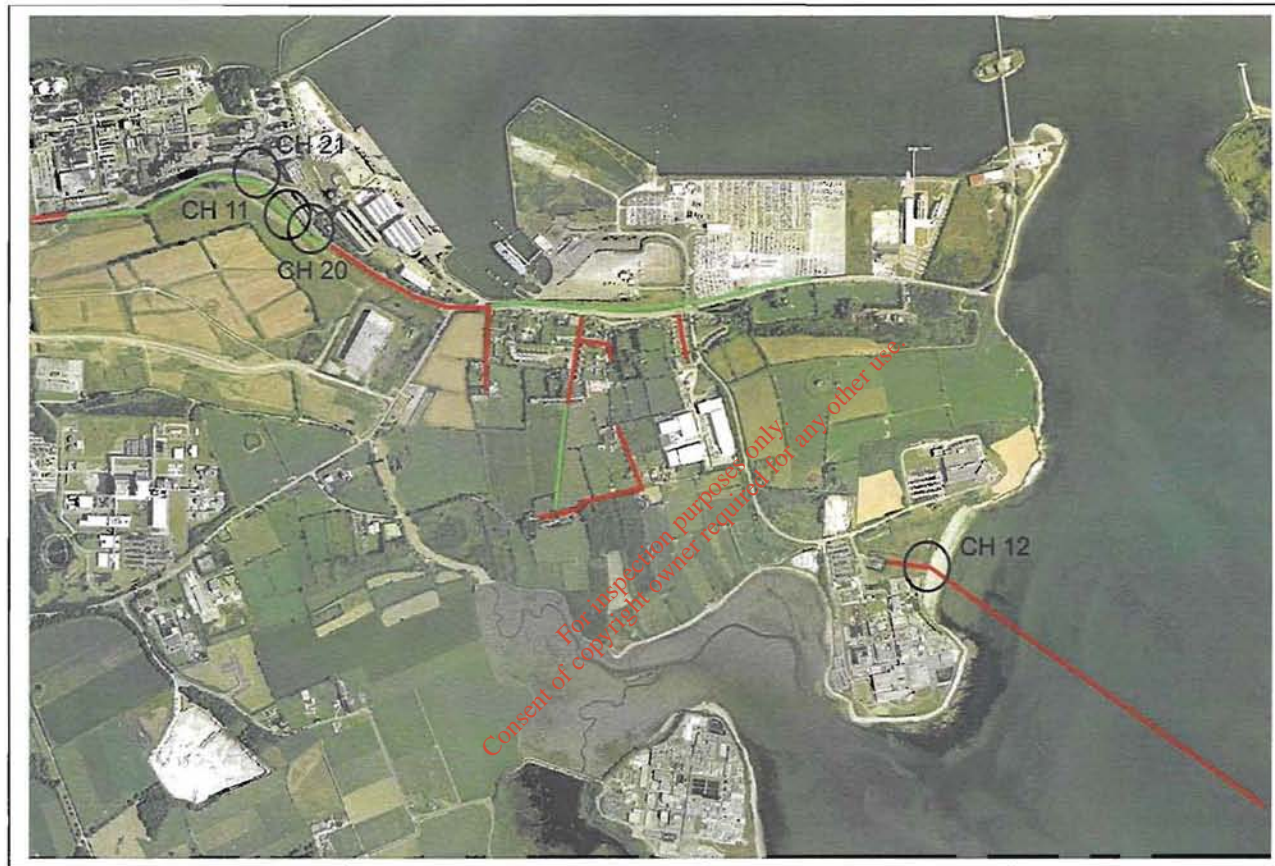
Figure 22. Aerial photo showing CH locations along pipeline routes in the Ringaskiddy area (north to top not to scale, for indication only)
