PROPOSED NEWPORT SEWERAGE SCHEME

ENVIRONMENTAL IMPACT ASSESSMENT

**FLORA AND FAUNA
(TERRESTRIAL)**

OCTOBER 2004

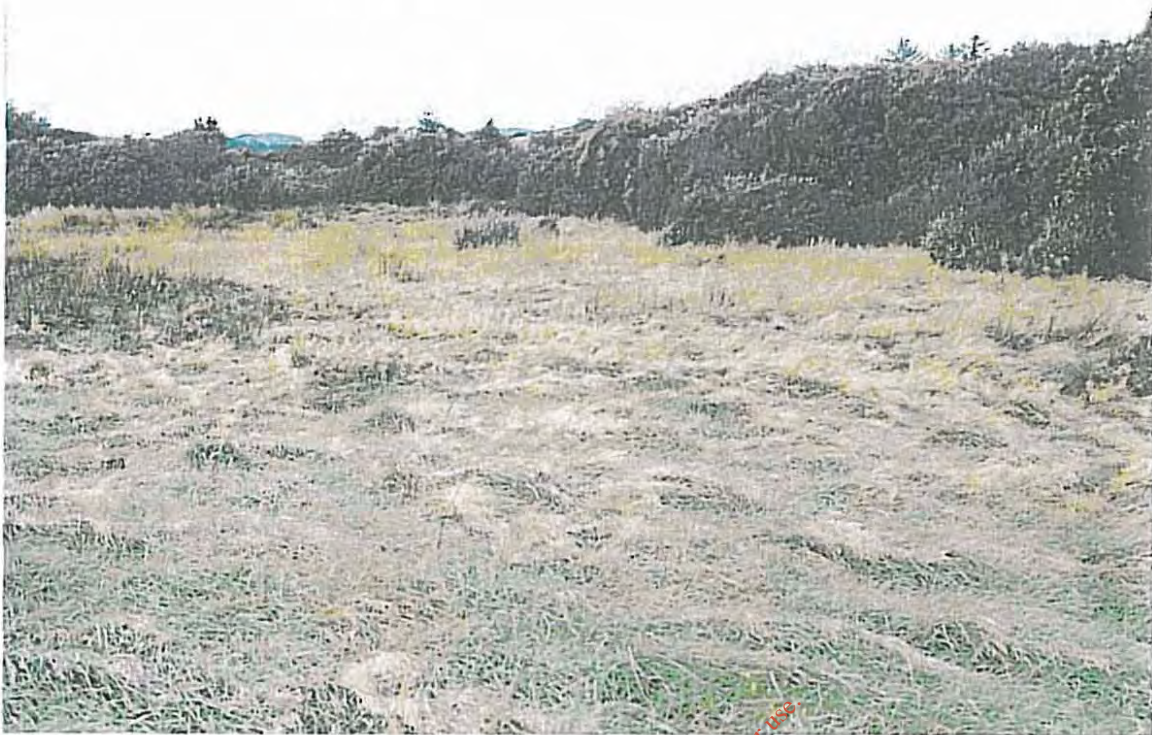
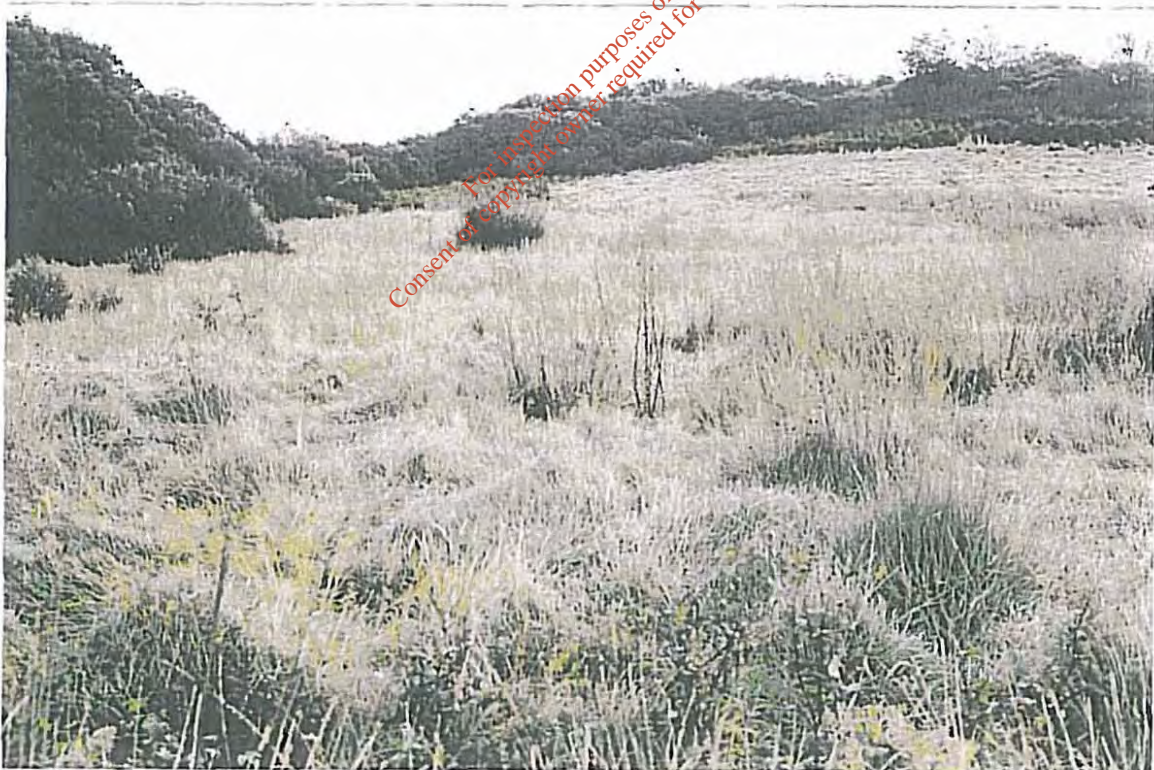
Plates 1 & 2. The field in which the water treatment plant is proposed to be located comprises unmanaged grassland. A strip of willow-dominated scrub occupies the northern part of the field. Top photograph is looking westwards, lower photograph is looking eastwards from the low-lying, damp area of the field.

The field in which the treatment plant will be located comprises unmanaged grassland that can be accommodated in the habitat category **Dry meadows and grassy verges GS2**. The sward is up to 1 m high over much of the field and, as already noted, merges with encroaching scrub and bracken *Pteridium aquilinum* at the margins (see Plates 1-3). Principal species include false-oat grass *Arrhenatherum elatius*, bent grass *Agrostis stolonifera*, Yorkshire fog *Holcus lanatus*, creeping buttercup *Ranunculus repens*, meadow vetchling *Lathyrus pratensis*, common knapweed *Centaurea nigra*, nettles *Urtica dioica* and common sorrel *Rumex acetosa*. The western end is more low-lying than the rest and has a damp character, with rushes *Juncus effusus*, meadowsweet *Filipendula ulmaria*, devil's-bit scabious, tormentil *Potentilla erecta*, marsh thistle *Cirsium palustre* and the occasional spotted orchid *Dactylorhiza maculata*.

The northern part of the field in which the treatment plant will be located is covered by **Scrub WS1** or low **Semi-natural woodland WN** (see Plates 1-3). This extends to the shoreline and is part of a larger stand that continues north-eastwards (see Plate 4). The scrub is dense with a continuous, closed canopy (see Plate 5). Willow (*Salix* spp., inc. *S. aurita* & *S. cinerea*) is the dominant species, with hazel *Corylus avellana* also present and occasional alder *Alnus glutinosa* and holly *Ilex aquifolium*. Ash *Fraxinus excelsior* occurs mainly at the margin of the wood above the shoreline. Brambles *Rubus fruticosus* are common in the understorey, with wild rose *Rosa* spp. and honeysuckle *Lonicera periclymenum* also present. Ivy *Hedera helix* is frequent throughout the wood, both on tree trunks and the ground. The diversity of herbaceous species in the ground layer is relatively low, reflecting the canopy cover. Species present include the following: wood avens *Geum urbanum*, bittersweet *Solanum dulcamara*, wild angelica *Angelica sylvestris*, wood sorrel *Oxalis acetosella*, meadowsweet *Filipendula ulmaria*, opposite-leaved saxifrage *Chrysosplenium oppositifolium* and lady fern *Athyrium filix-femina*.

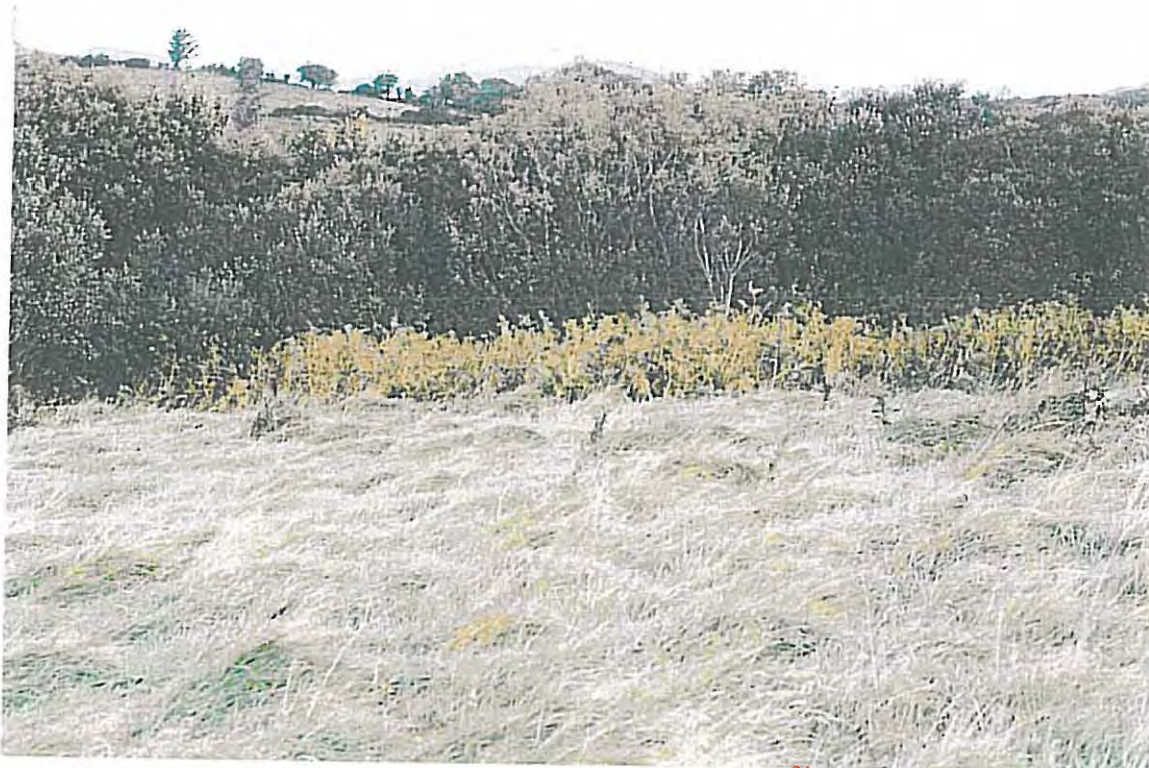
Plate 3. Scrub and bracken are encroaching into the grassland, in the field for the proposed treatment plant.

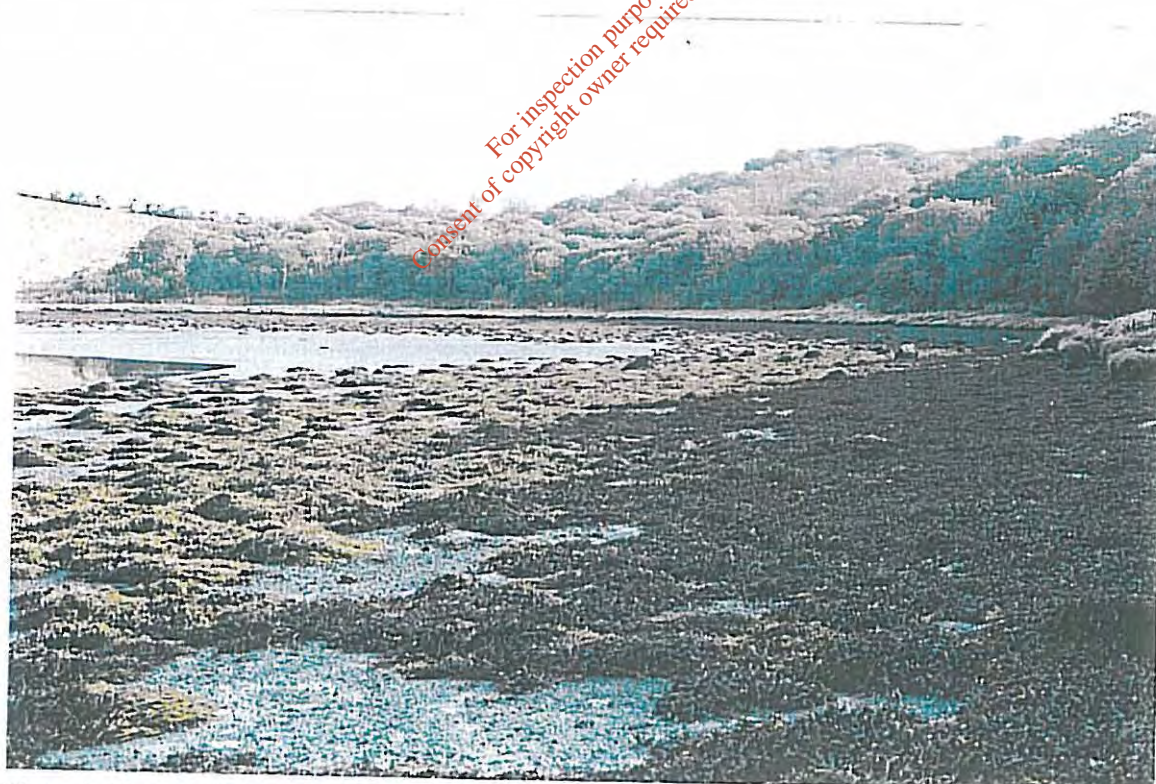
Plate 4. The scrub in the field is part of a larger stand of scrub/low woodland that continues north-eastwards on the Caulicaun peninsula. View is looking east-northeast from the shoreline.

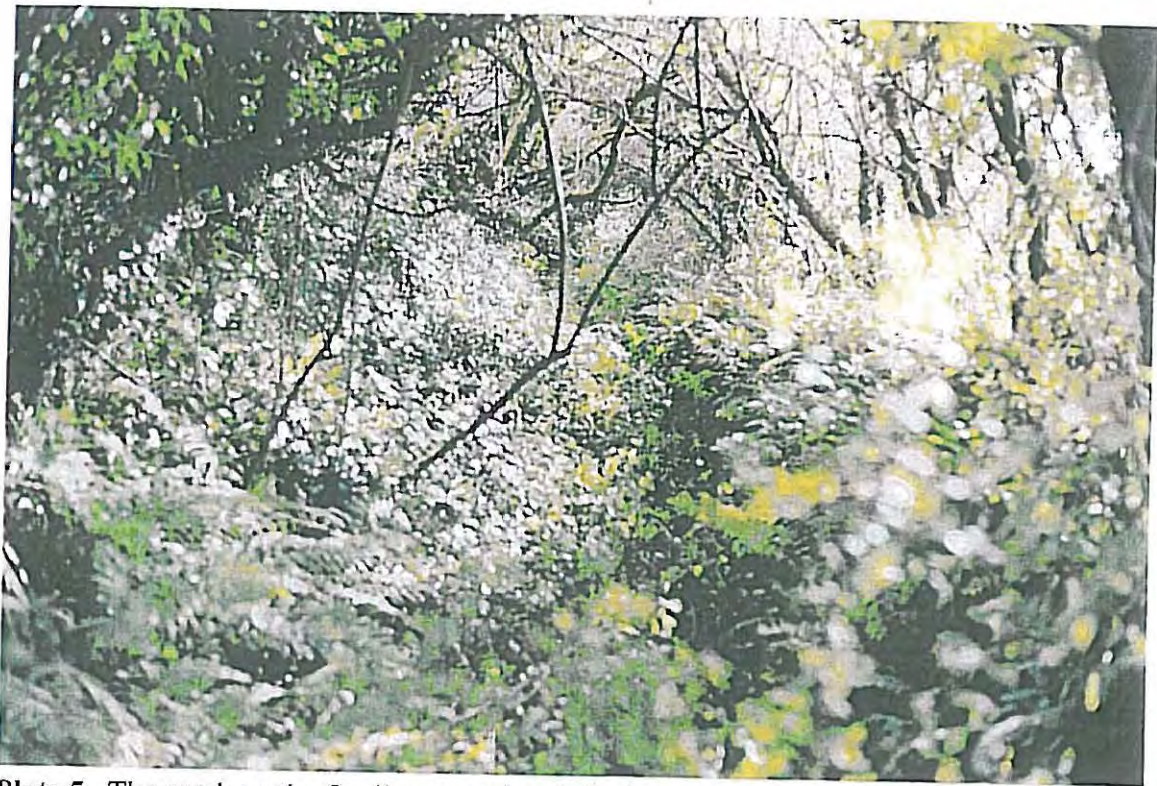
Plate 5. The scrub on the Caulicaun peninsula is dense with a continuous, closed canopy.

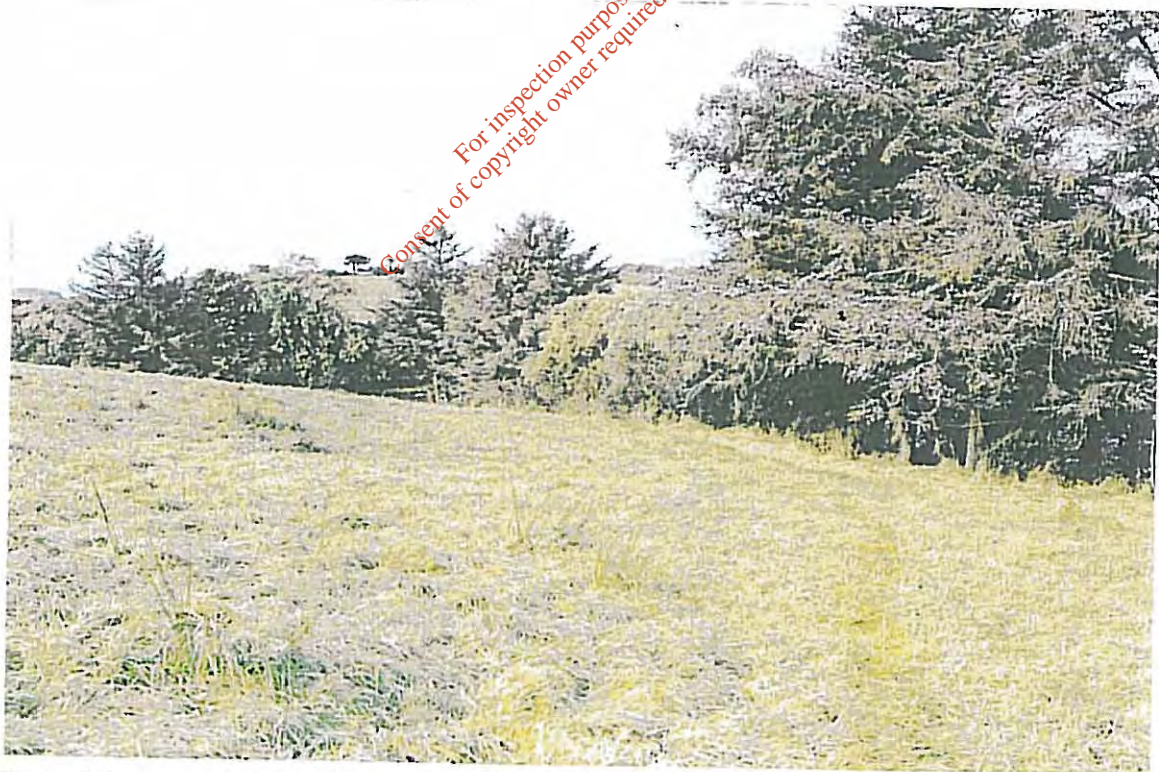
Plate 6. Improved grassland occurs in the fields to the west and south of the site for the proposed treatment plant. View is looking westwards towards the tip of the peninsula. Note the planted conifers in the hedge.

Improved grassland GA1 occurs in the fields to the west (see Plate 6) and south of the site for the proposed plant. It is a typical, grazed sward that is fertilised and has been reseeded in the past. The sward is dominated by perennial rye grass *Lolium perenne*, and has clovers *Trifolium* spp, dandelion *Taraxacum* spp., ribwort plantain *Plantago lanceolata*, creeping buttercup *Ranunculus repens* and thistles *Cirsium* spp.

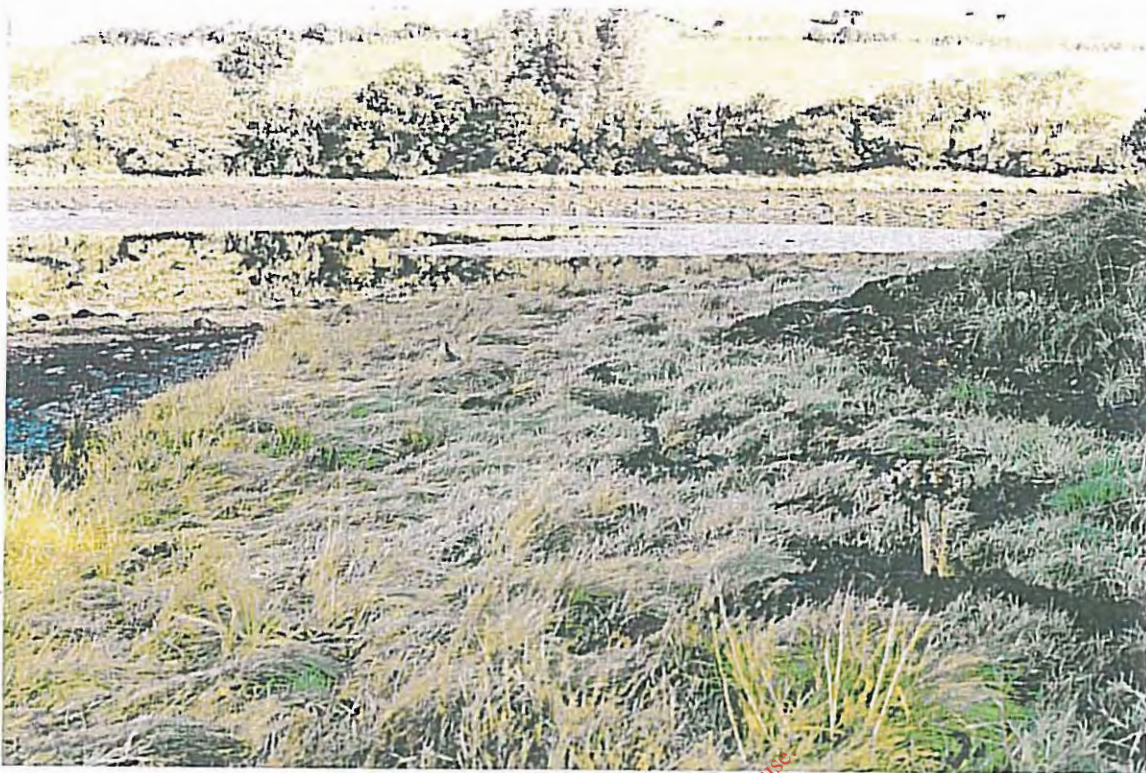
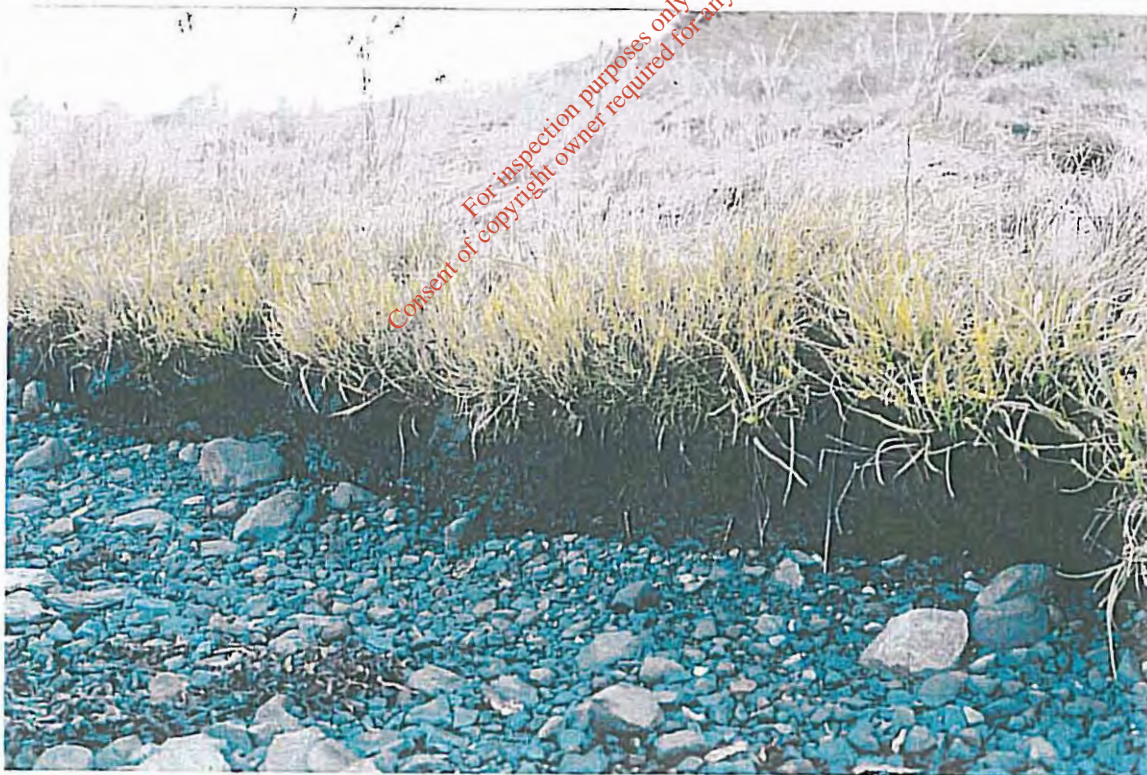
Plates 7 & 8. Salt marsh fringes much of the Caulicaun peninsula. The strip is narrow (top photograph), and the edge of the marsh is about 20 cm above the stony shore and is marked by a low cliff (bottom photograph). The upper part of the marsh is only inundated on the highest of tides. Views are from the western tip of the Caulicaun peninsula.

Salt marsh CM fringes much of the Caulicaun peninsula. The strip is narrow, varying from about 4 to 7 metres (see Plate 7). The edge of the marsh is about 20 cm above the stony shore and is edged by a low cliff (see Plate 8). The upper part of the marsh, which is only inundated on the highest of tides, is dominated by common bent *Agrostis stolonifera*. The middle and lower parts have more typical salt marsh plants, with sea rush *Juncus maritimus*, common saltmarsh grass *Puccinellia maritima*, sea plantain *Plantago maritima*, thrift *Armeria maritima*, sea arrowgrass *Triglochin maritima*, and sea aster *Aster tripolium*. Scurvy grass *Cochlearia officinalis* is occasional.

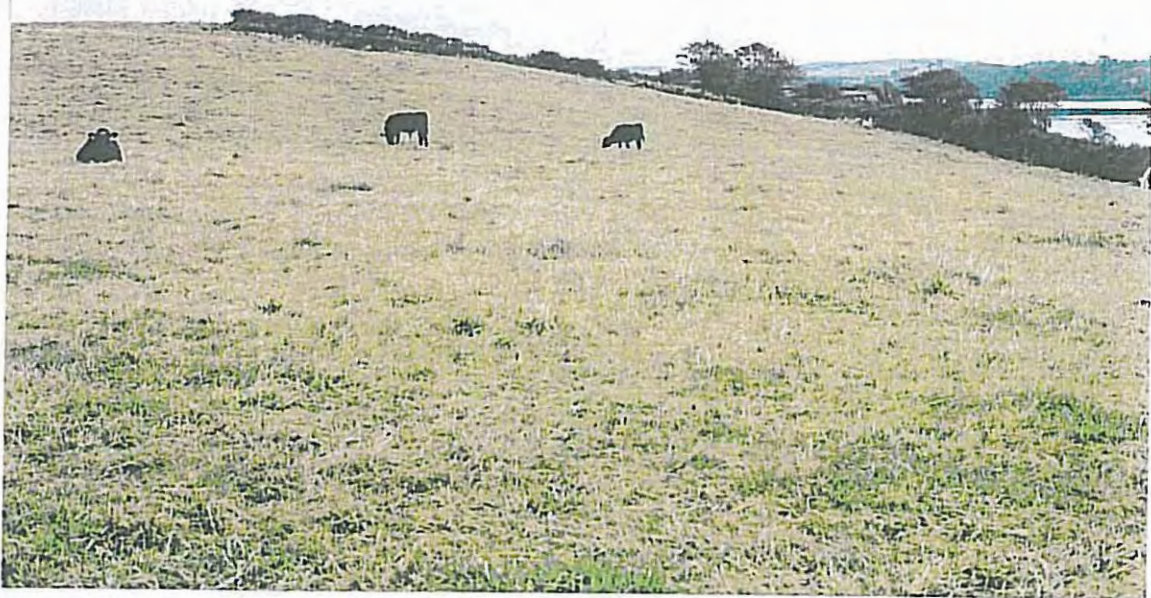
Plate 9. Improved grassland is the main habitat on the Rosmore peninsula. It is a well-managed, grazed sward that is fertilised and has been reseeded in the past.

The **improved grassland GA1** on the Rosmore peninsula is a well-managed, grazed sward that is fertilised and has been reseeded in the past (see Plate 9). In species composition it is similar to that as described for the Caulicaun peninsula, generally being dominated by perennial rye grass *Lolium perenne*. Some fields have wet patches with rushes *Juncus* spp.

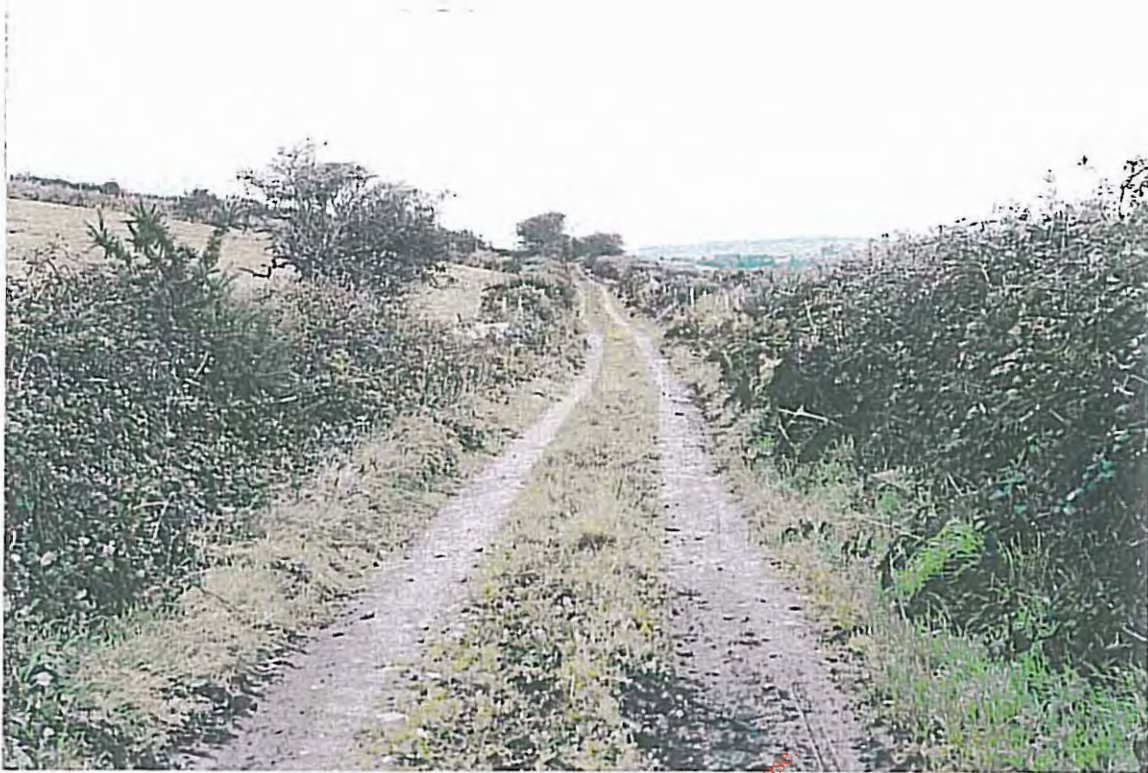
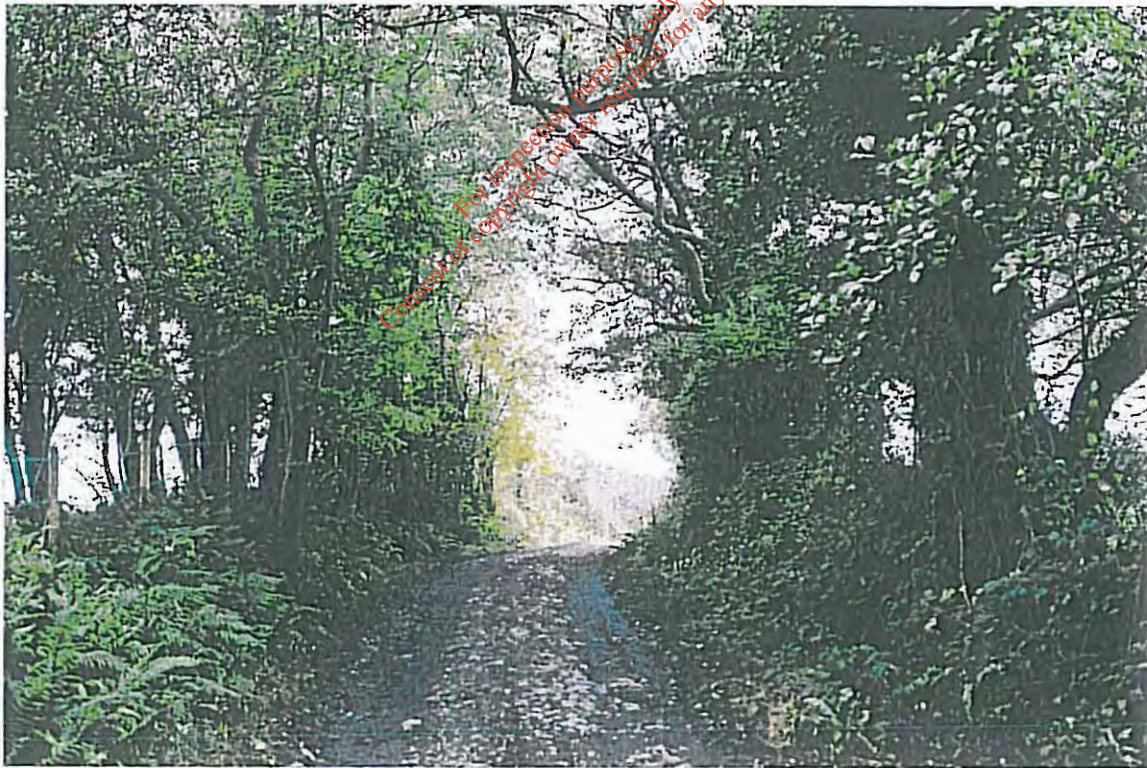
Plates 11 & 12. A track runs much of the length on the Rosmore peninsula. Hedgerows line both sides – these are mostly of low stature and low species diversity (top photograph). The first section of the track is lined by taller hedgerows which have not been cut (bottom photograph). Ash is frequent here.

The **hedgerows WL1** along the central track and in the fields are mostly of low stature (<4 m) and low species diversity (see Plate 11). Hawthorn is the dominant tree and shrub species, with gorse *Ulex europaeus*, blackthorn *Prunus spinosa*, willow *Salix* spp, and ash also occurring. Brambles and bracken are frequent in the hedgerows. The first section of the track is lined by taller hedgerows which have not been cut (see Plate 12). Ash is frequent here.

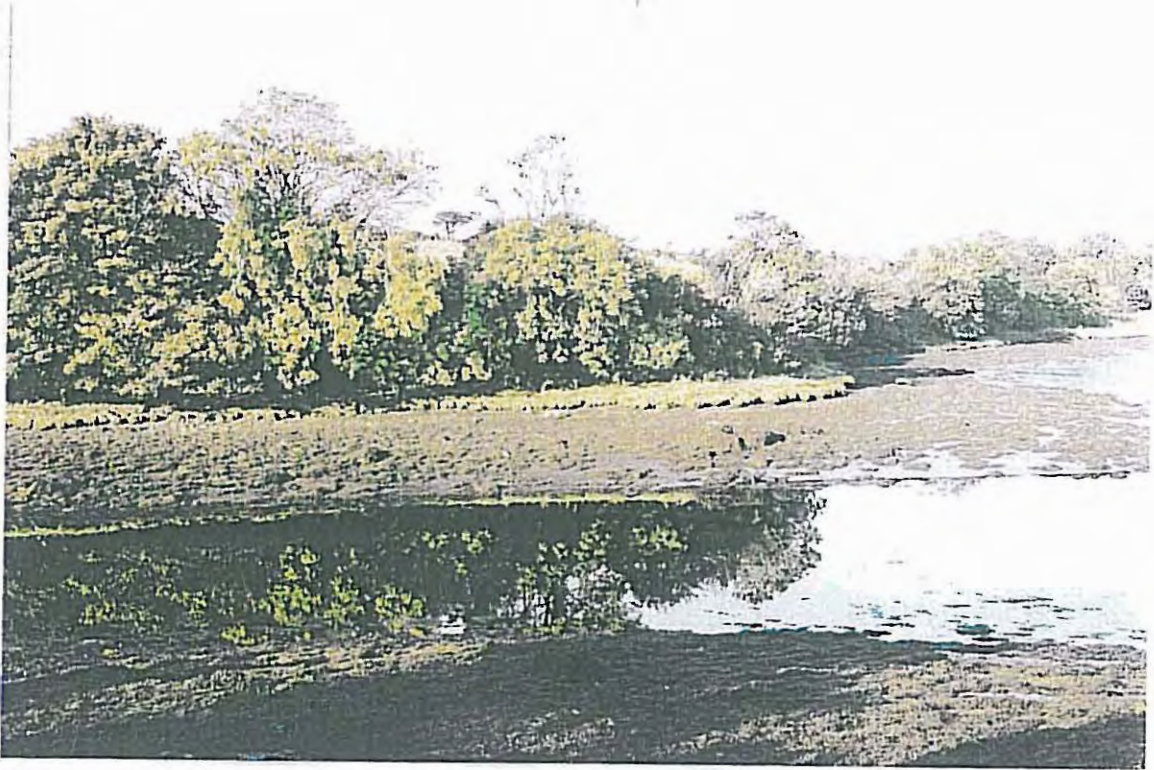
Plate 13. A patch of deciduous woodland at the eastern tip of the Rosmore peninsula is composed largely of ash and blackthorn. A salt marsh fringe occurs below the woodland.

The patch of **deciduous woodland WN** at the eastern tip of the peninsula is composed largely of ash and blackthorn (see Plate 13). Sycamore *Acer pseudoplatanus* is also present and brambles are frequent, especially at the margins.

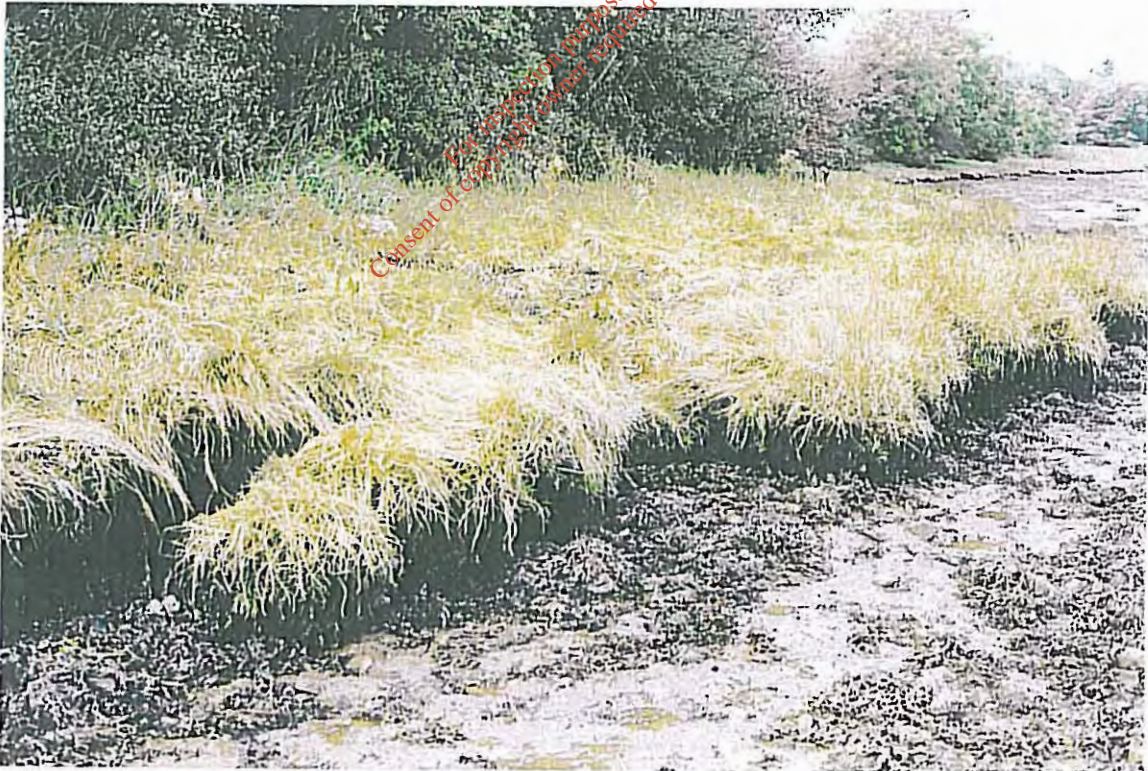
Plate 14. The salt marsh which fringes the eastern tip of the Rosmore peninsula is similar in character and species diversity as that on the Caulicaun peninsula.

The salt marsh CM which fringes the eastern tip of the Rosmore peninsula (see Plates 13 & 14) is similar in character and species diversity as that described for the Caulicaun peninsula. At most it is 5 m in width and at its outer edge is about 40 cm above the stony shore.

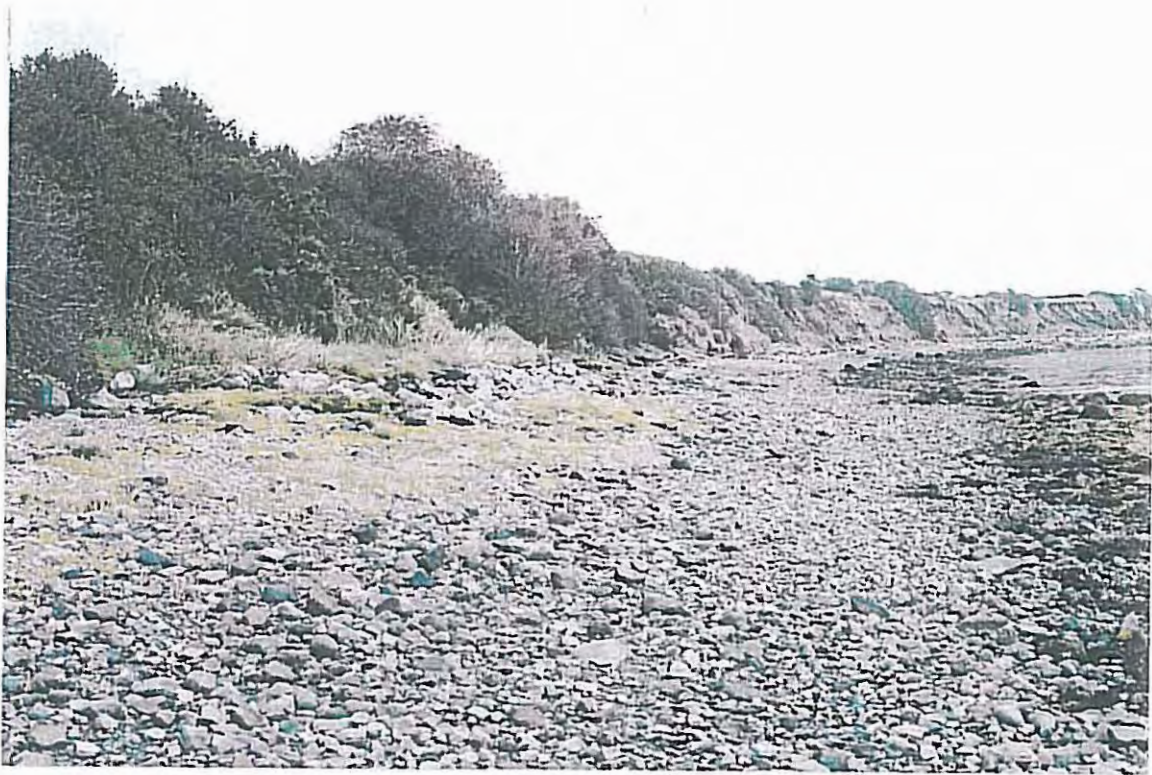
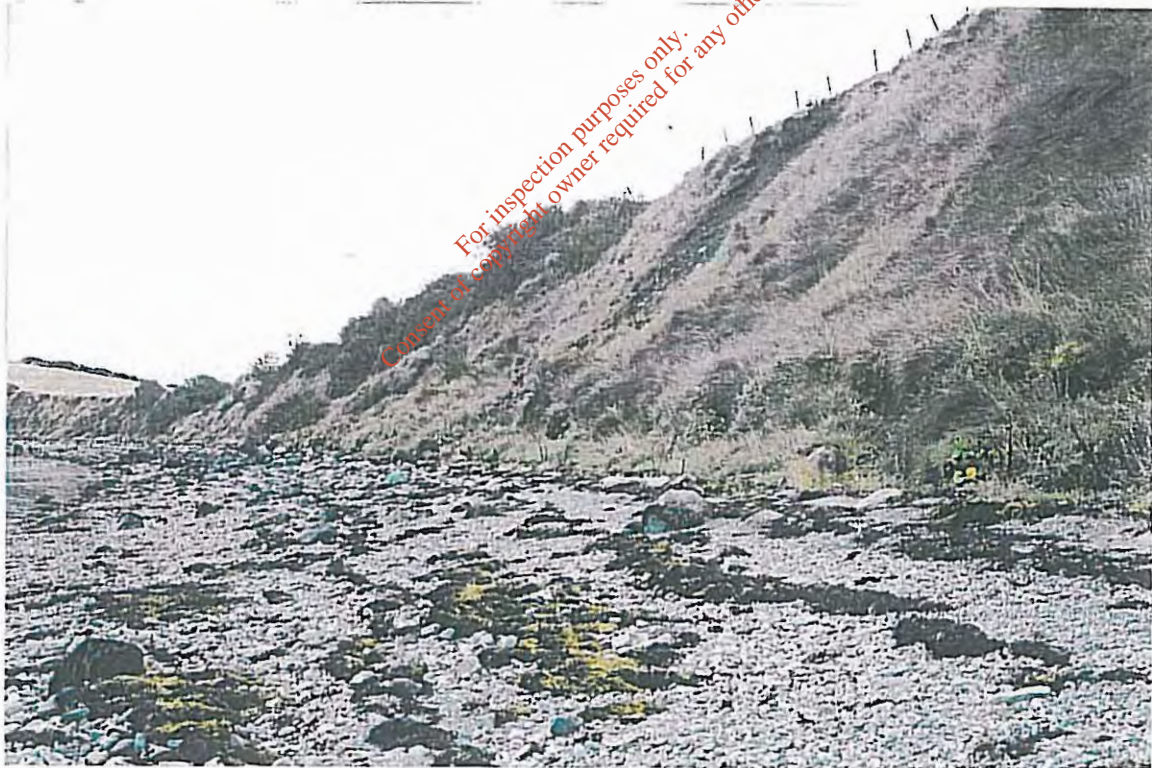
Plates 15 & 16. Clay cliffs, mostly well-vegetated, occur for much of the length of the northern shore of the Rosmore peninsula. These are substantial in height and occur immediately above the high tide mark. The vegetation of the cliffs is dominated by calcareous grassland and scrub. Top photograph is looking westwards, and bottom eastwards, from area of outfall for effluent pipe (option A).

Clay cliffs, mostly well-vegetated, occur for much of the length of the northern shore (see Plates 15 & 16). These are substantial in height and occur immediately above the high tide mark. Bare or partly vegetated soil occurs in places due to subsidence. Much of the vegetation of the cliffs can be ascribed to the habitat categories **Dry calcareous and neutral grassland GS1** and **Scrub WS1** of Fossitt (op. cit.). Species present in the grassland areas include red fescue *Festuca rubra*, sweet vernal grass *Anthoxanthum odoratum*, cock's-foot *Dactylis glomerata*, yarrow *Achillea millefolium*, knapweed *Centaurea nigra*, cat's-ear *Hypochoeris radicata*, bird's-foot trefoil *Lotus corniculatus* and, occasionally, wild thyme *Thymus praecox*. Seepage occurs in places and here black bog rush *Schoenus nigricans* occurs, along with such species as devil's-bit scabious *Succisa pratensis* and hard rush *Juncus inflexus*. In a few places, the calcareous glacial till has allowed an incipient tufa habitat to occur but where noted this was poorly developed (see Plate 17). Towards the top of the cliffs, patches of heather *Calluna vulgaris* are present, representing remnants of the former heath vegetation that probably occurred at the cliff tops and above. The main scrub species are willow *Salix* spp., hawthorn, gorse, bramble and bracken. Recently exposed areas as a result of subsidence have a more weedy vegetation, with species such as colts-foot *Tussilago farfara*, ribwort plantain *Plantago lanceolata* and scotch *Elymus repens* – here the vegetation can be ascribed to the **Recolonising bare ground ED3** category of Fossitt. On the stony shoreline at the base of the cliffs some salt-tolerant plants occur, including sea aster *Aster tripolium*, scurvy grass *Cochlearia officinalis*, spear-leaved orache *Atriplex prostrata*, silverweed *Potentilla anserina* and bucks-horn plantain *Plantago coronopus* – these species are typical of shingle and driftline vegetation.

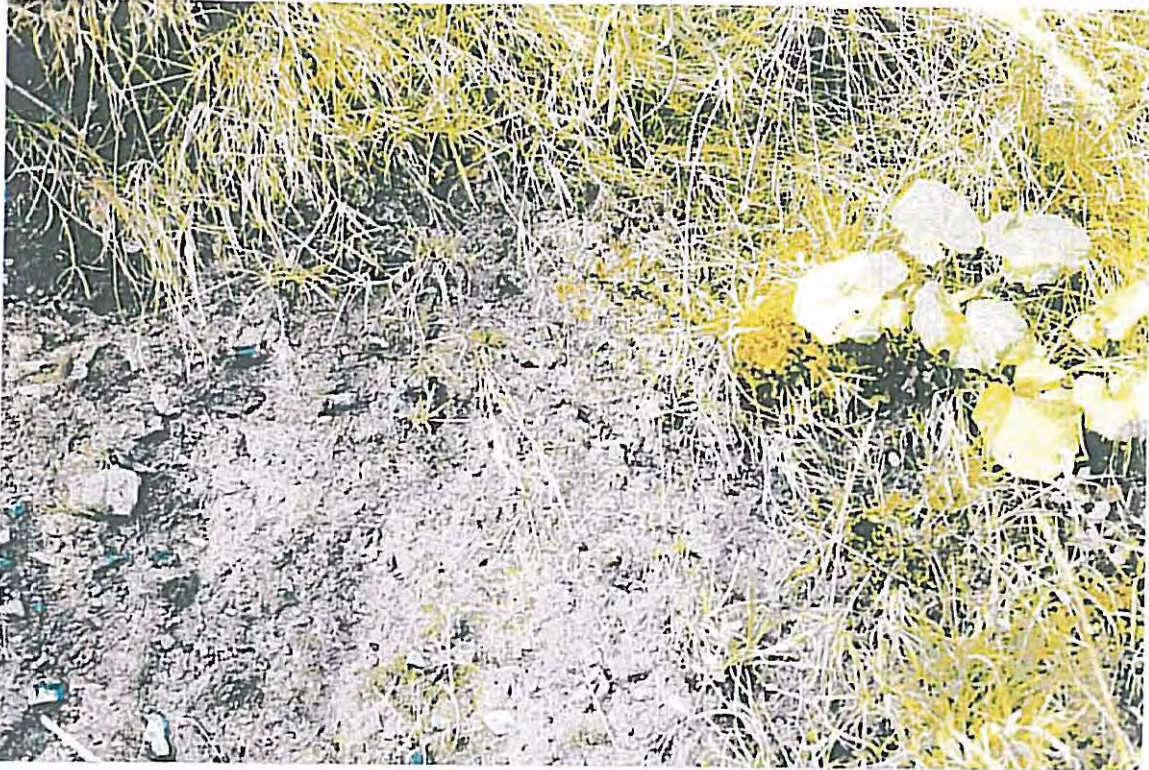
Plate 17. In a few places, the calcareous glacial till has allowed an incipient tufa habitat to occur but where noted this was poorly developed.

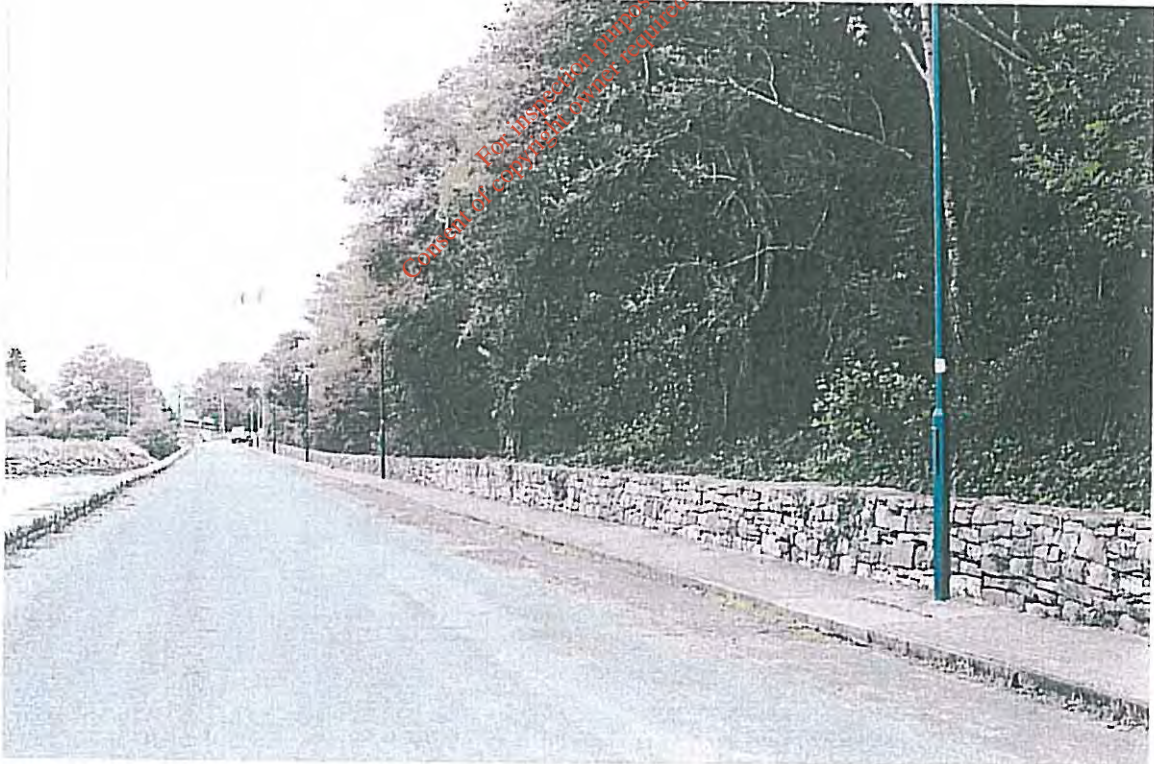
Plate 18. Part of Option F of the preferred wastewater collection system would run over a grassy/weedy strip of several metres width just inside a stone wall. This is along the margin of a stand of mixed woodland.

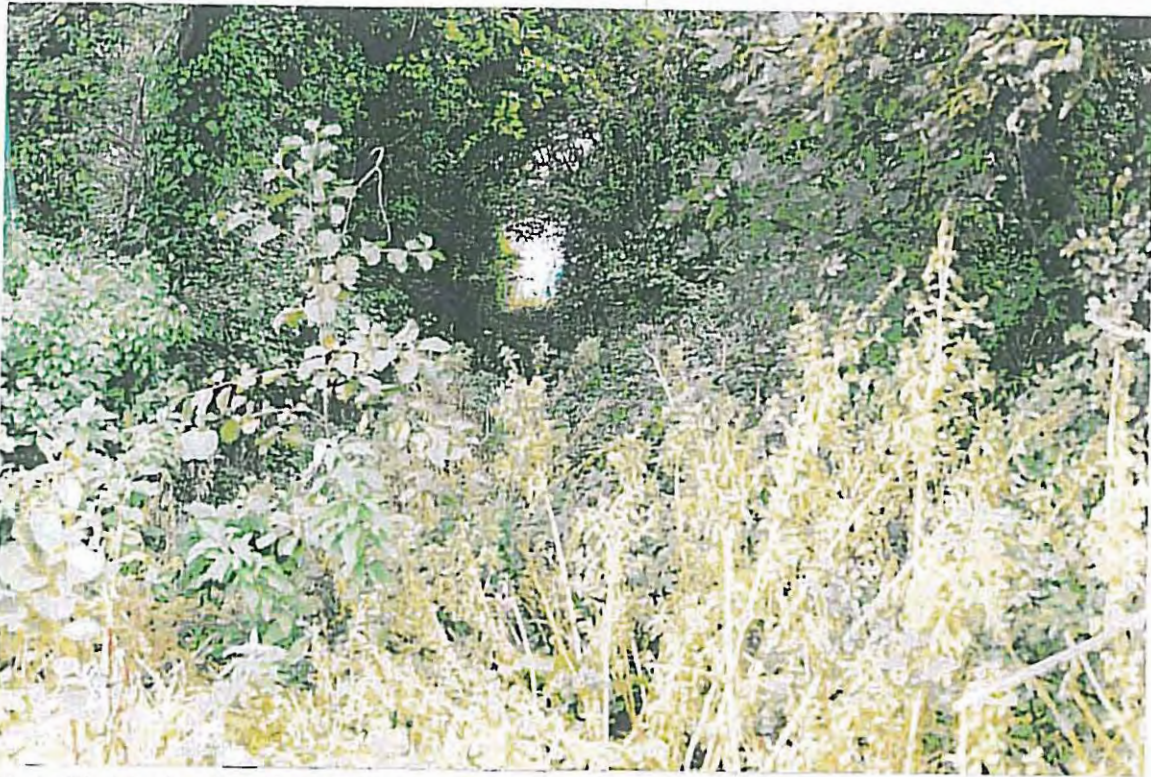
Plate 19. Much of Option D of the preferred wastewater collection system is along an overgrown track, with unmanaged hedgerows both sides.

Option D: section D1 to D2 is along an overgrown track, with unmanaged hedgerows both sides (see Plate 19). The track is covered mostly by brambles but there is a range of weed species as well as saplings of ash and sycamore. This track has negligible conservation interest. Section D4 to D5 is along an existing road.

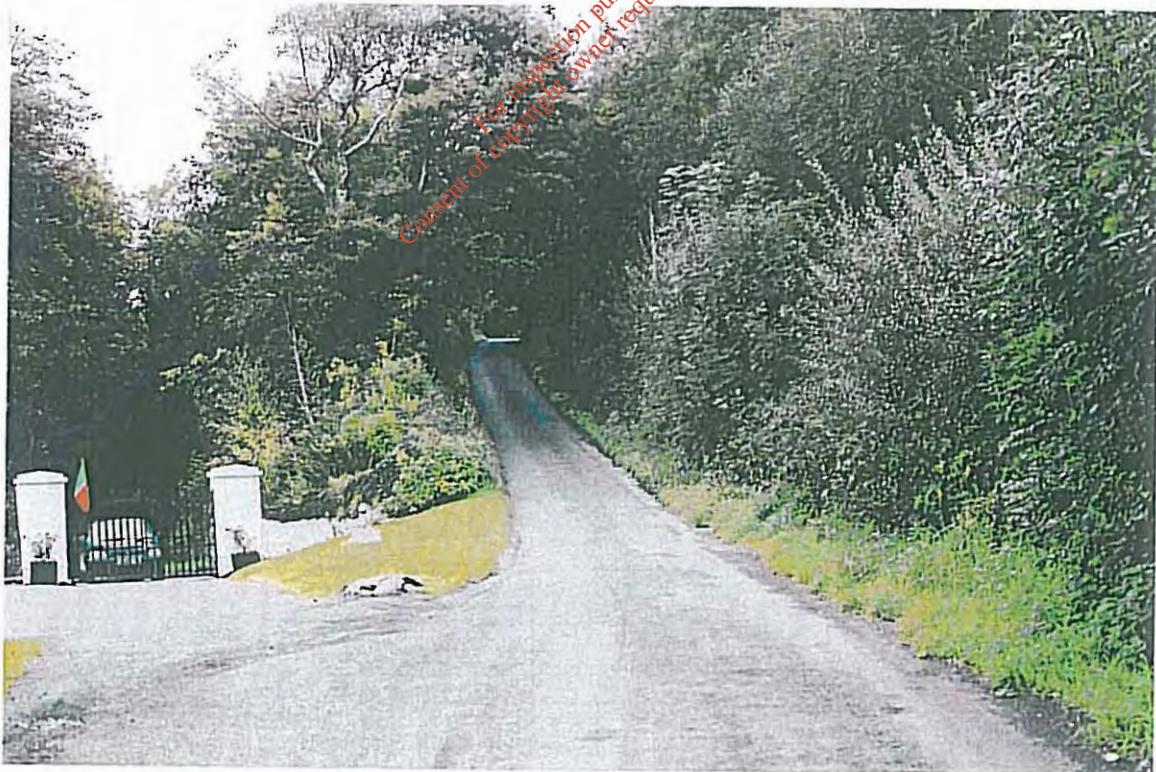
Plate 20. Much of Option A of the preferred wastewater collection system runs along an existing road that is lined by treeline and/or mixed woodland.

Option A: much of option A runs along an existing road that is lined by treelines and/or mixed woodland (see Plate 20). The road itself obviously has no conservation interest but the adjoining trees/woodland would have some local conservation value. .

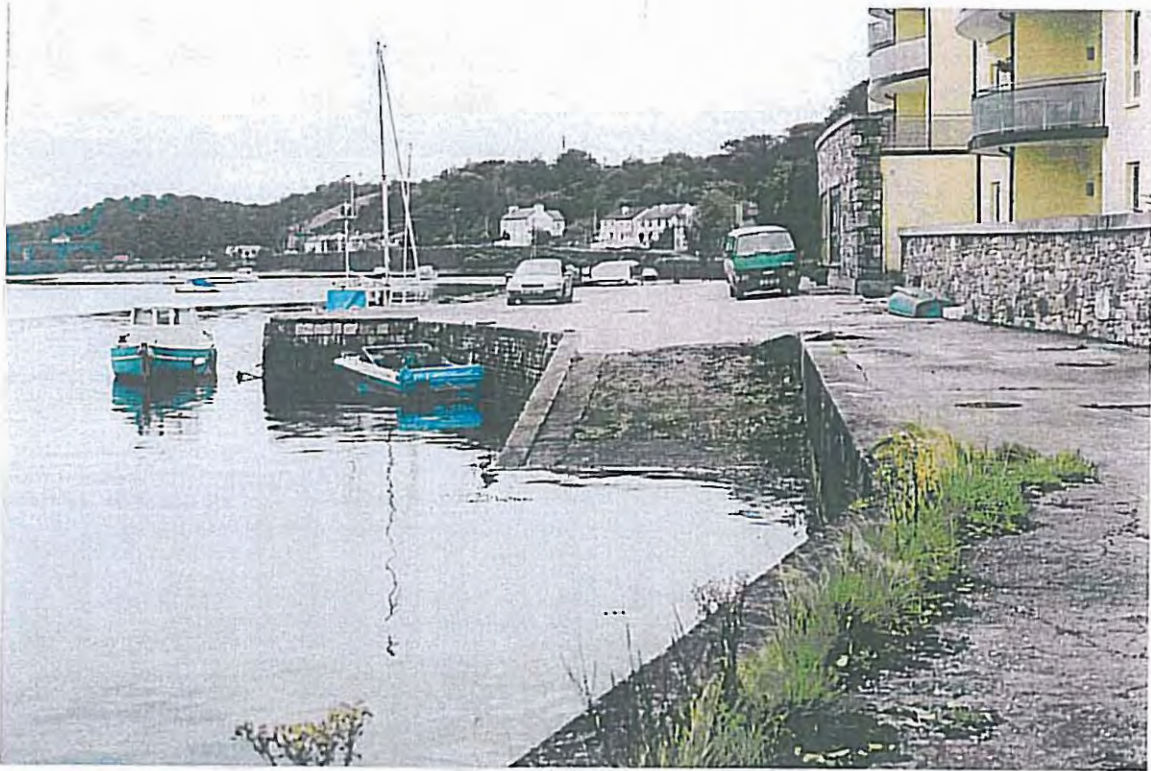
Plate 21. The pumping station linked to the rising main would be built on existing developed land associated with the harbour area and new apartment block.

Pumping station (rising main): the pumping station linked to the rising main would be built on existing developed land associated with the harbour area and new apartment block (see Plate 21).

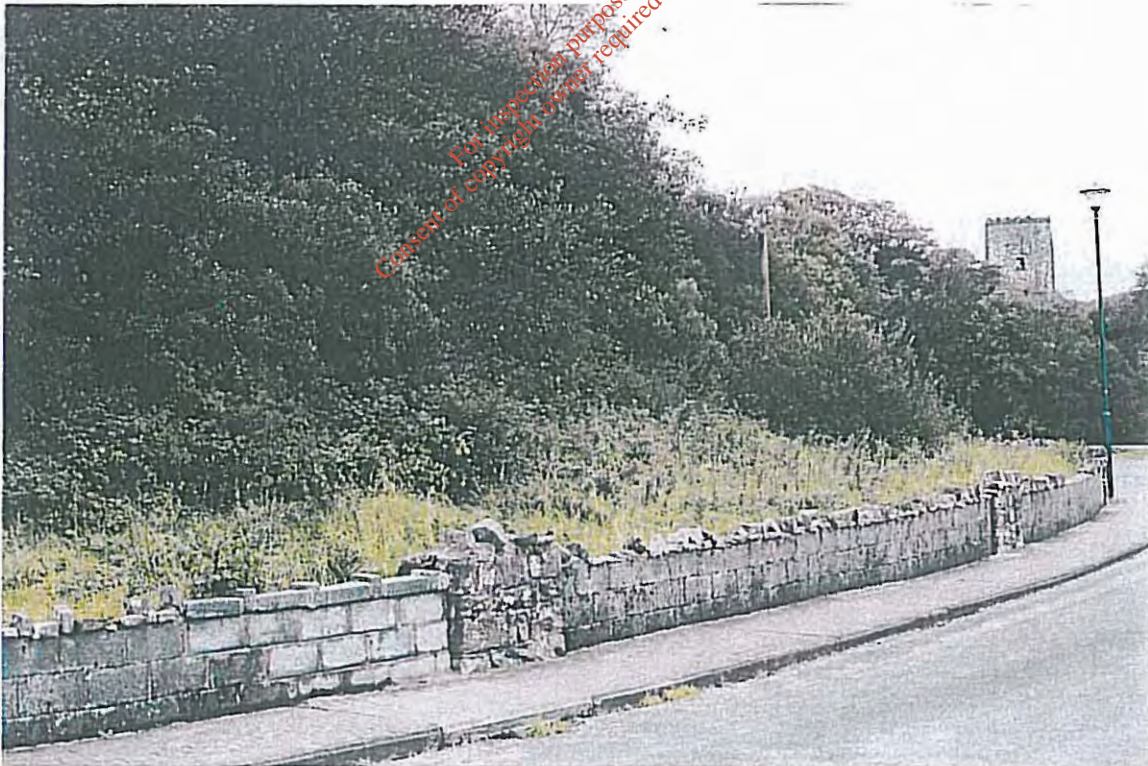
Plate 22. The site for the proposed pumping station on the Newport peninsula is at the tip of a mixed woodland stand. However, the station would be located mainly on a strip of rank grassland and weedy vegetation just inside the boundary wall.

Pumping station (Newport peninsula): the site for the proposed pumping station at Newport is at the tip of the woodland stand already referred to for pipe options F and G. Inside the boundary wall there is a strip of several metres of rank grassland and weedy vegetation, with brambles and nettles *Urtica dioica* (see Plate 22). This merges with scrub and low woodland of willows and alders and then taller trees. There are several existing manholes at the site location. Whilst the overall woodland stand is considered to have Low Local conservation value, this part is disturbed and not of conservation value.
