Inner and Outer Bantry Bay Waterbody Classification Report

Waterbody Report for Inner Bantry Bay Transitional Waterbody

Waterbody Report for Outer Bantry Bay Coastal Waterbody

Designated Shellfish Area – Bantry

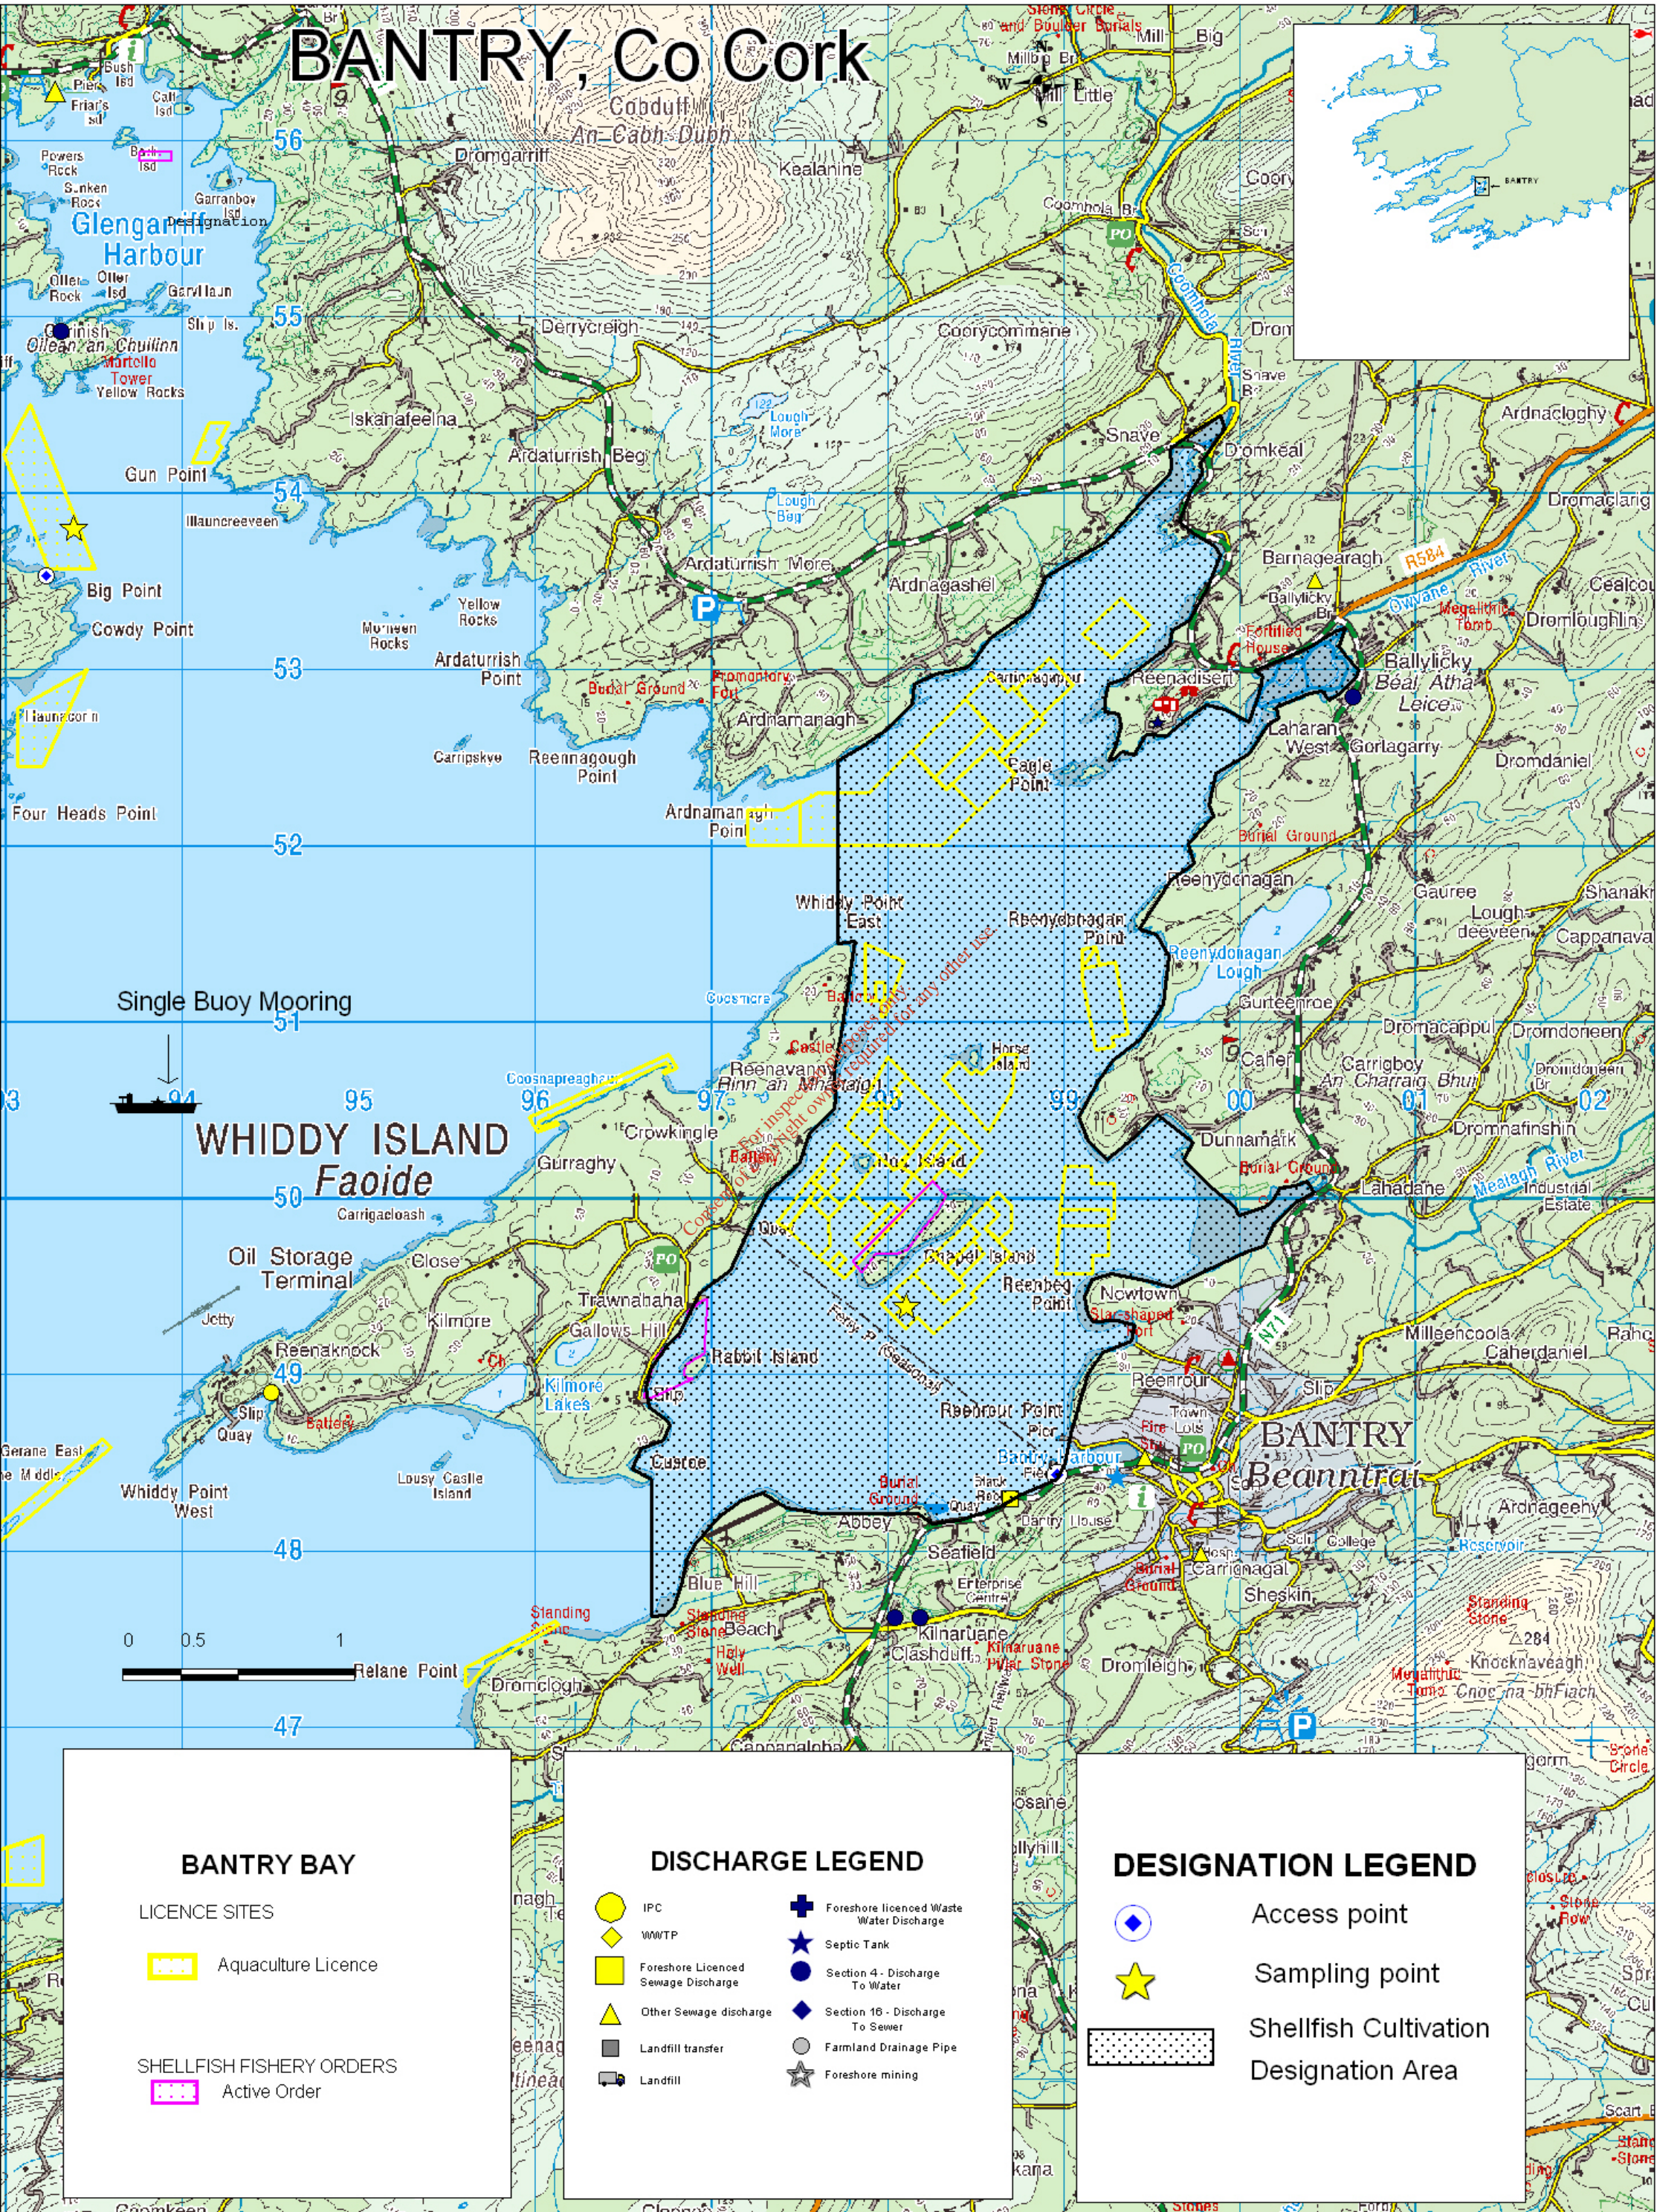
MAP II.1B SHELLFISH DESIGNATION (S.I. No 200 of 1994)
SECOND SCHEDULE

BANTRY, Co Cork

BANTRY BAY
