5. Constraints Inventory, Predicted Impacts & Suggested Mitigation

5.1 Archaeological Monuments Constraints Inventory (figs 19-23; Table 5)

ÆGIS ARCHAEOLOGY LIMITED
REF.: 62-37

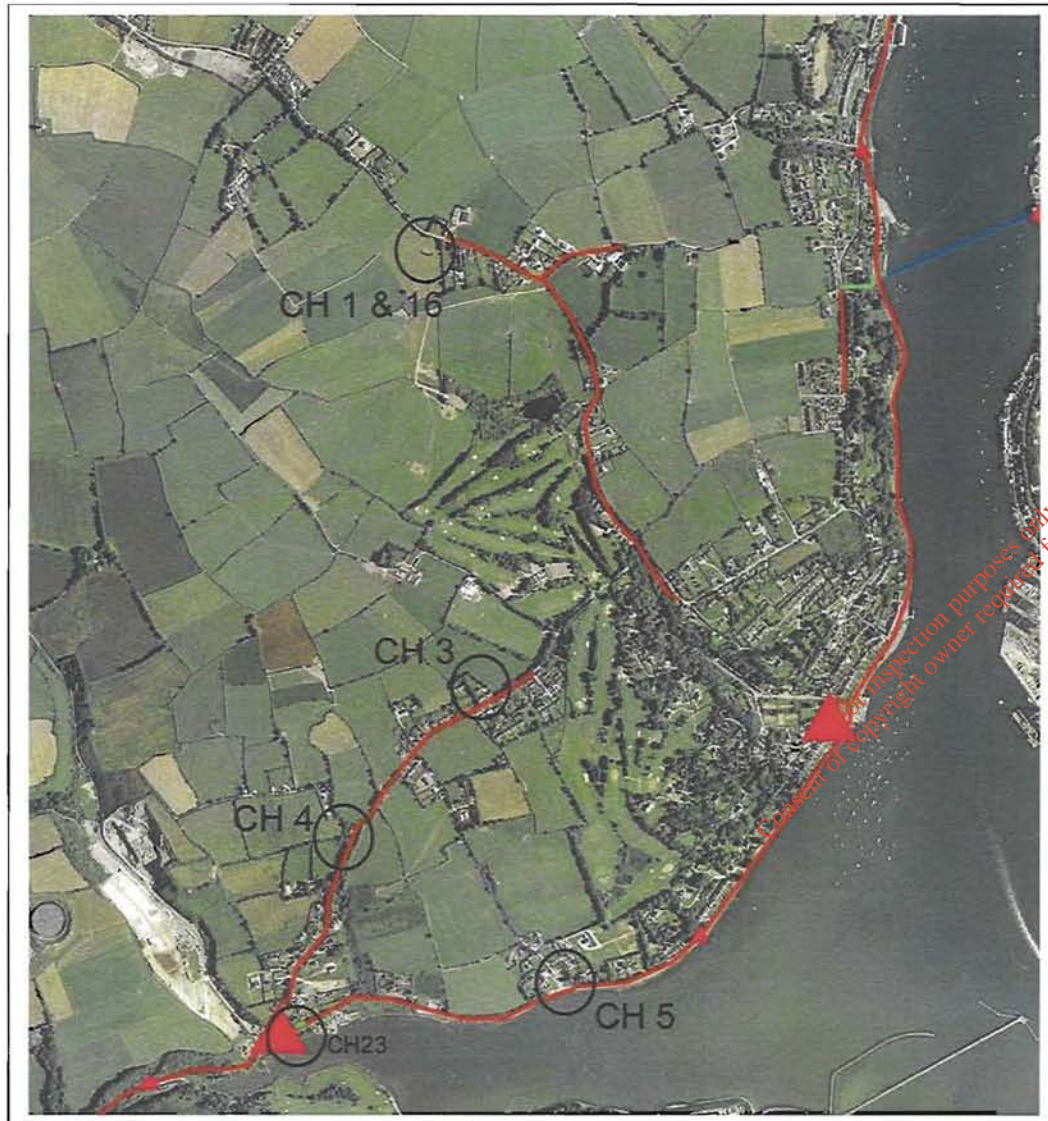
Figure 19. Aerial photo showing CH locations along pipeline routes in the Monkstown area (north to top not to scale, for indication only)

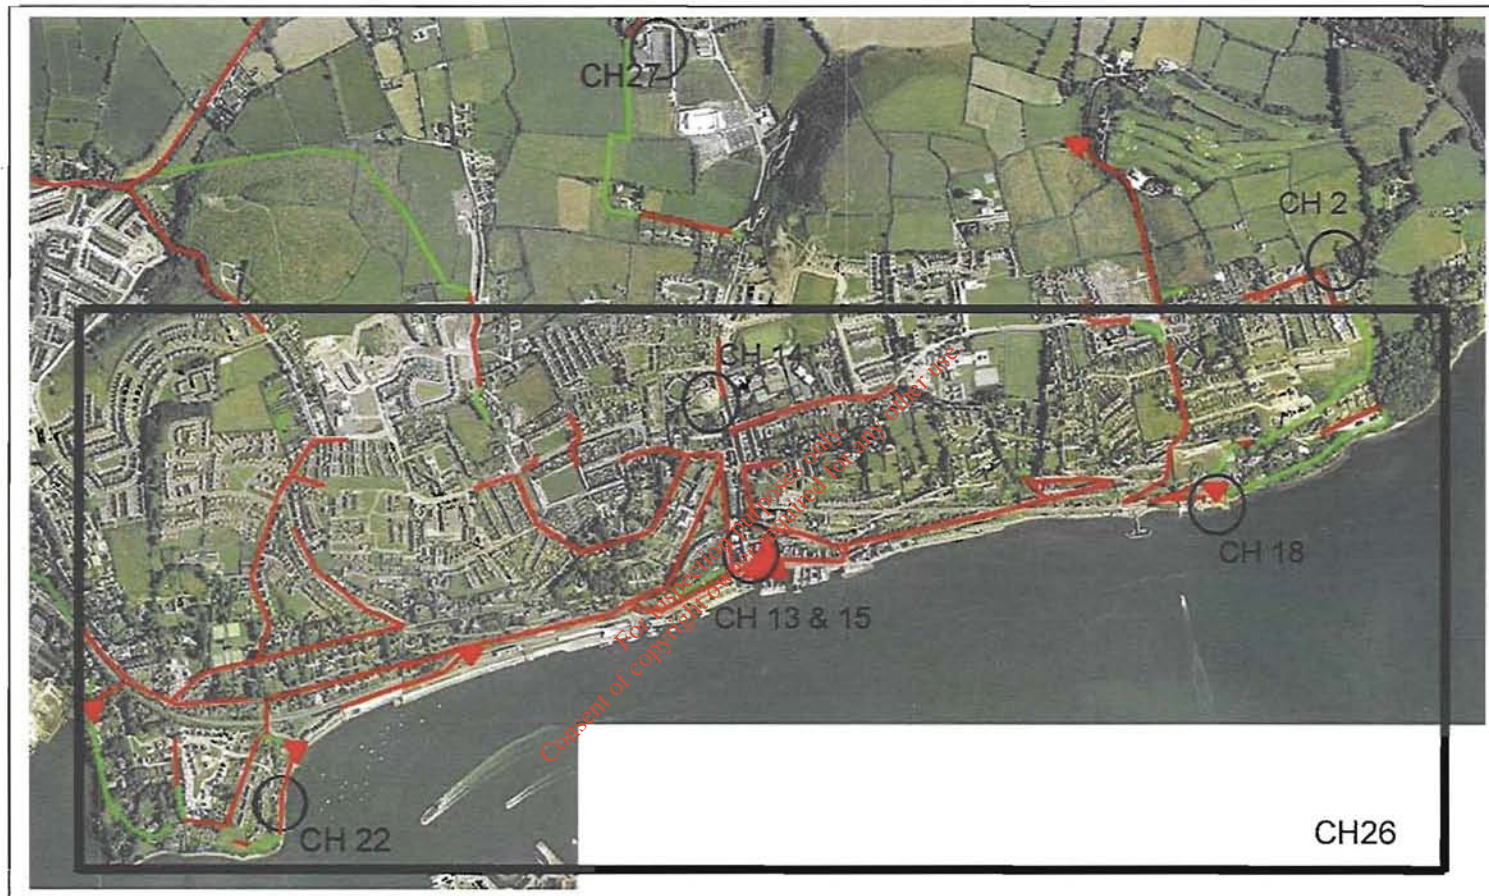
Figure 20. Aerial photo with CH locations in Cobh and environs (north to top not to scale, for indication only)

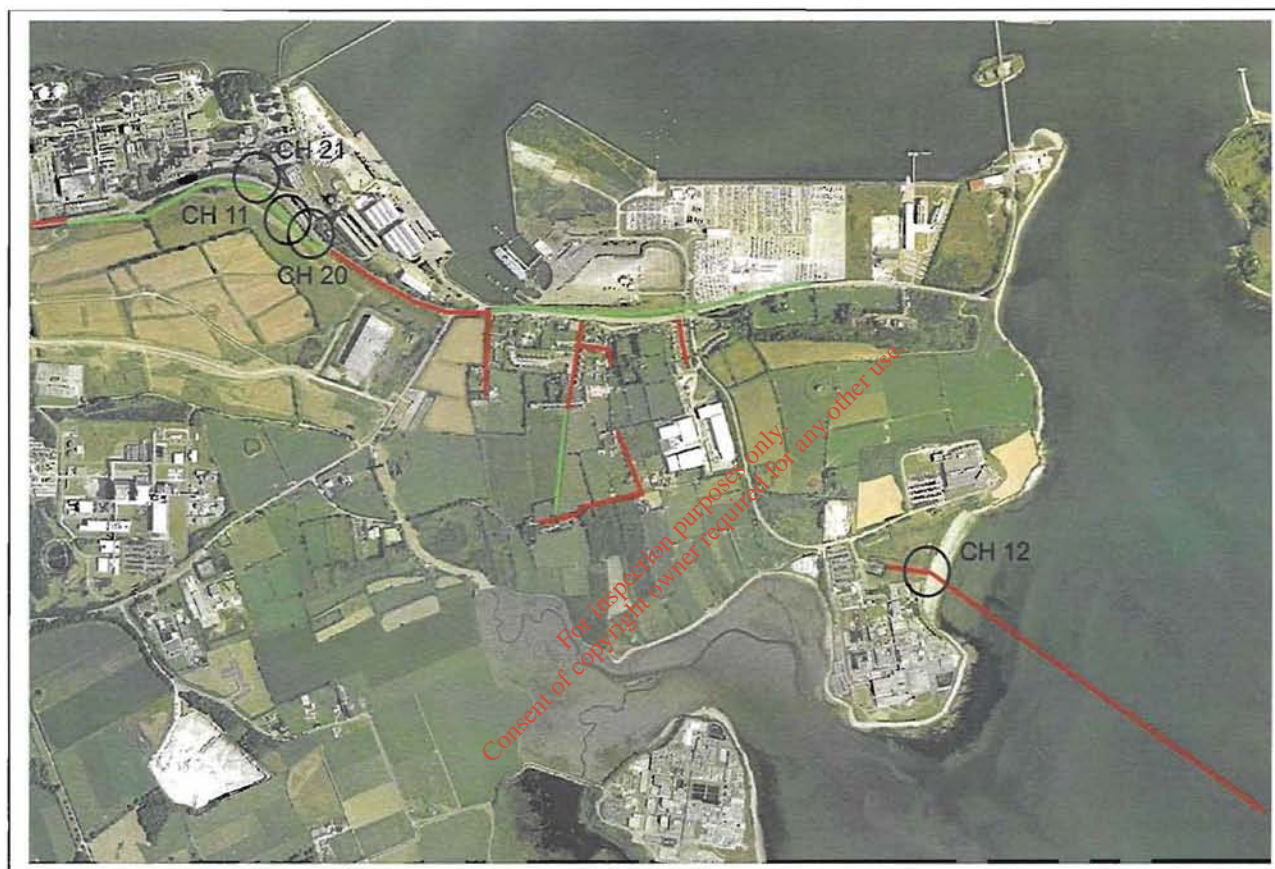
Figure 22. Aerial photo showing CH locations along pipeline routes in the Ringaskiddy area (north to top not to scale, for indication only)

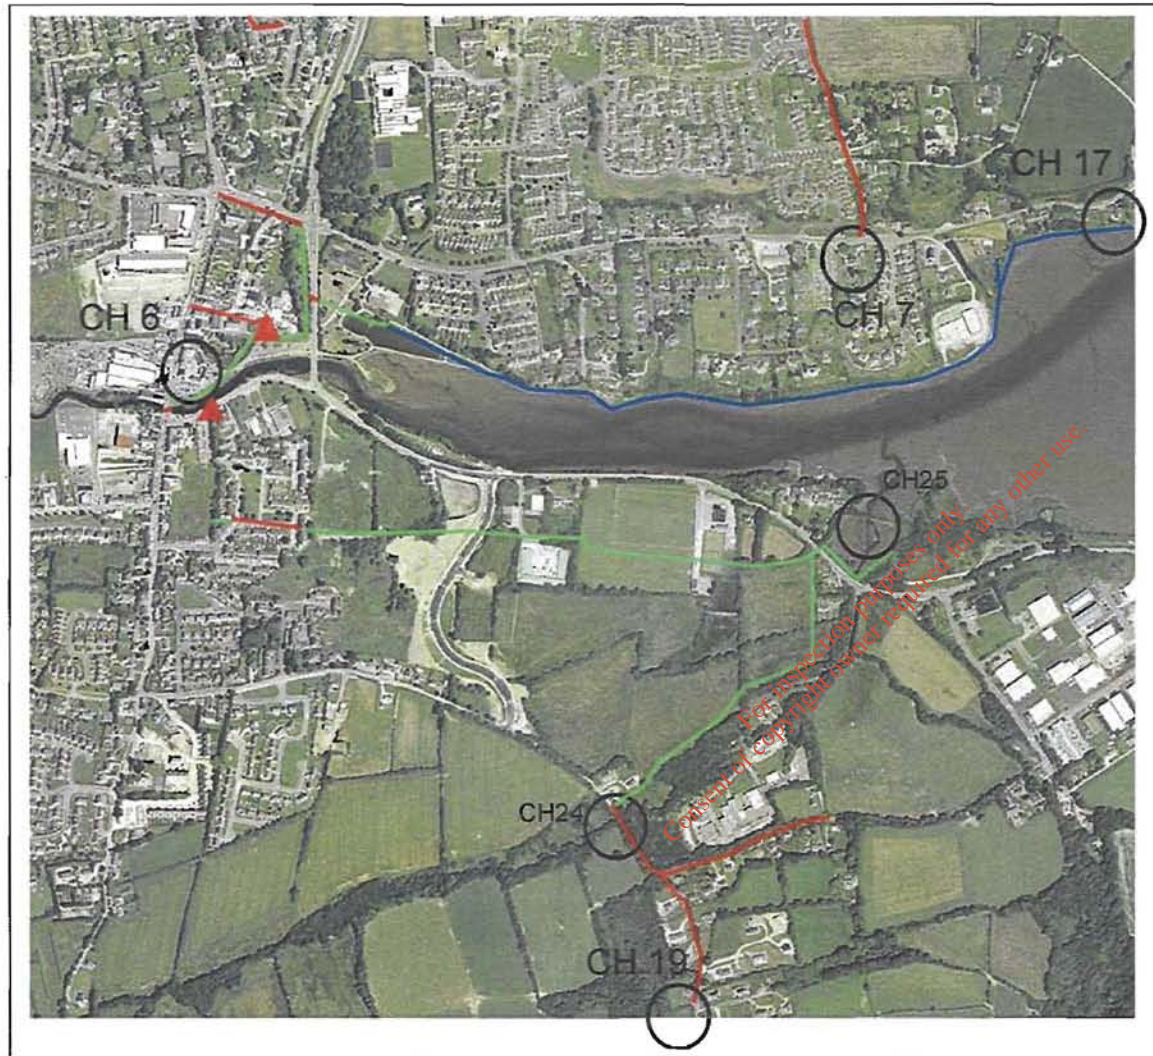
Figure 23. Aerial photo showing CH locations along pipeline routes in the Carrigaline area (north to top not to scale, for indication only)
