**ROADSTONE DUBLIN LIMITED**

**INERT WASTE RECOVERY FACILITY  
AT MILVERTON, SKERRIES, CO. DUBLIN**

**ENVIRONMENTAL IMPACT STATEMENT  
NON-TECHNICAL SUMMARY**

**AUGUST 2009**

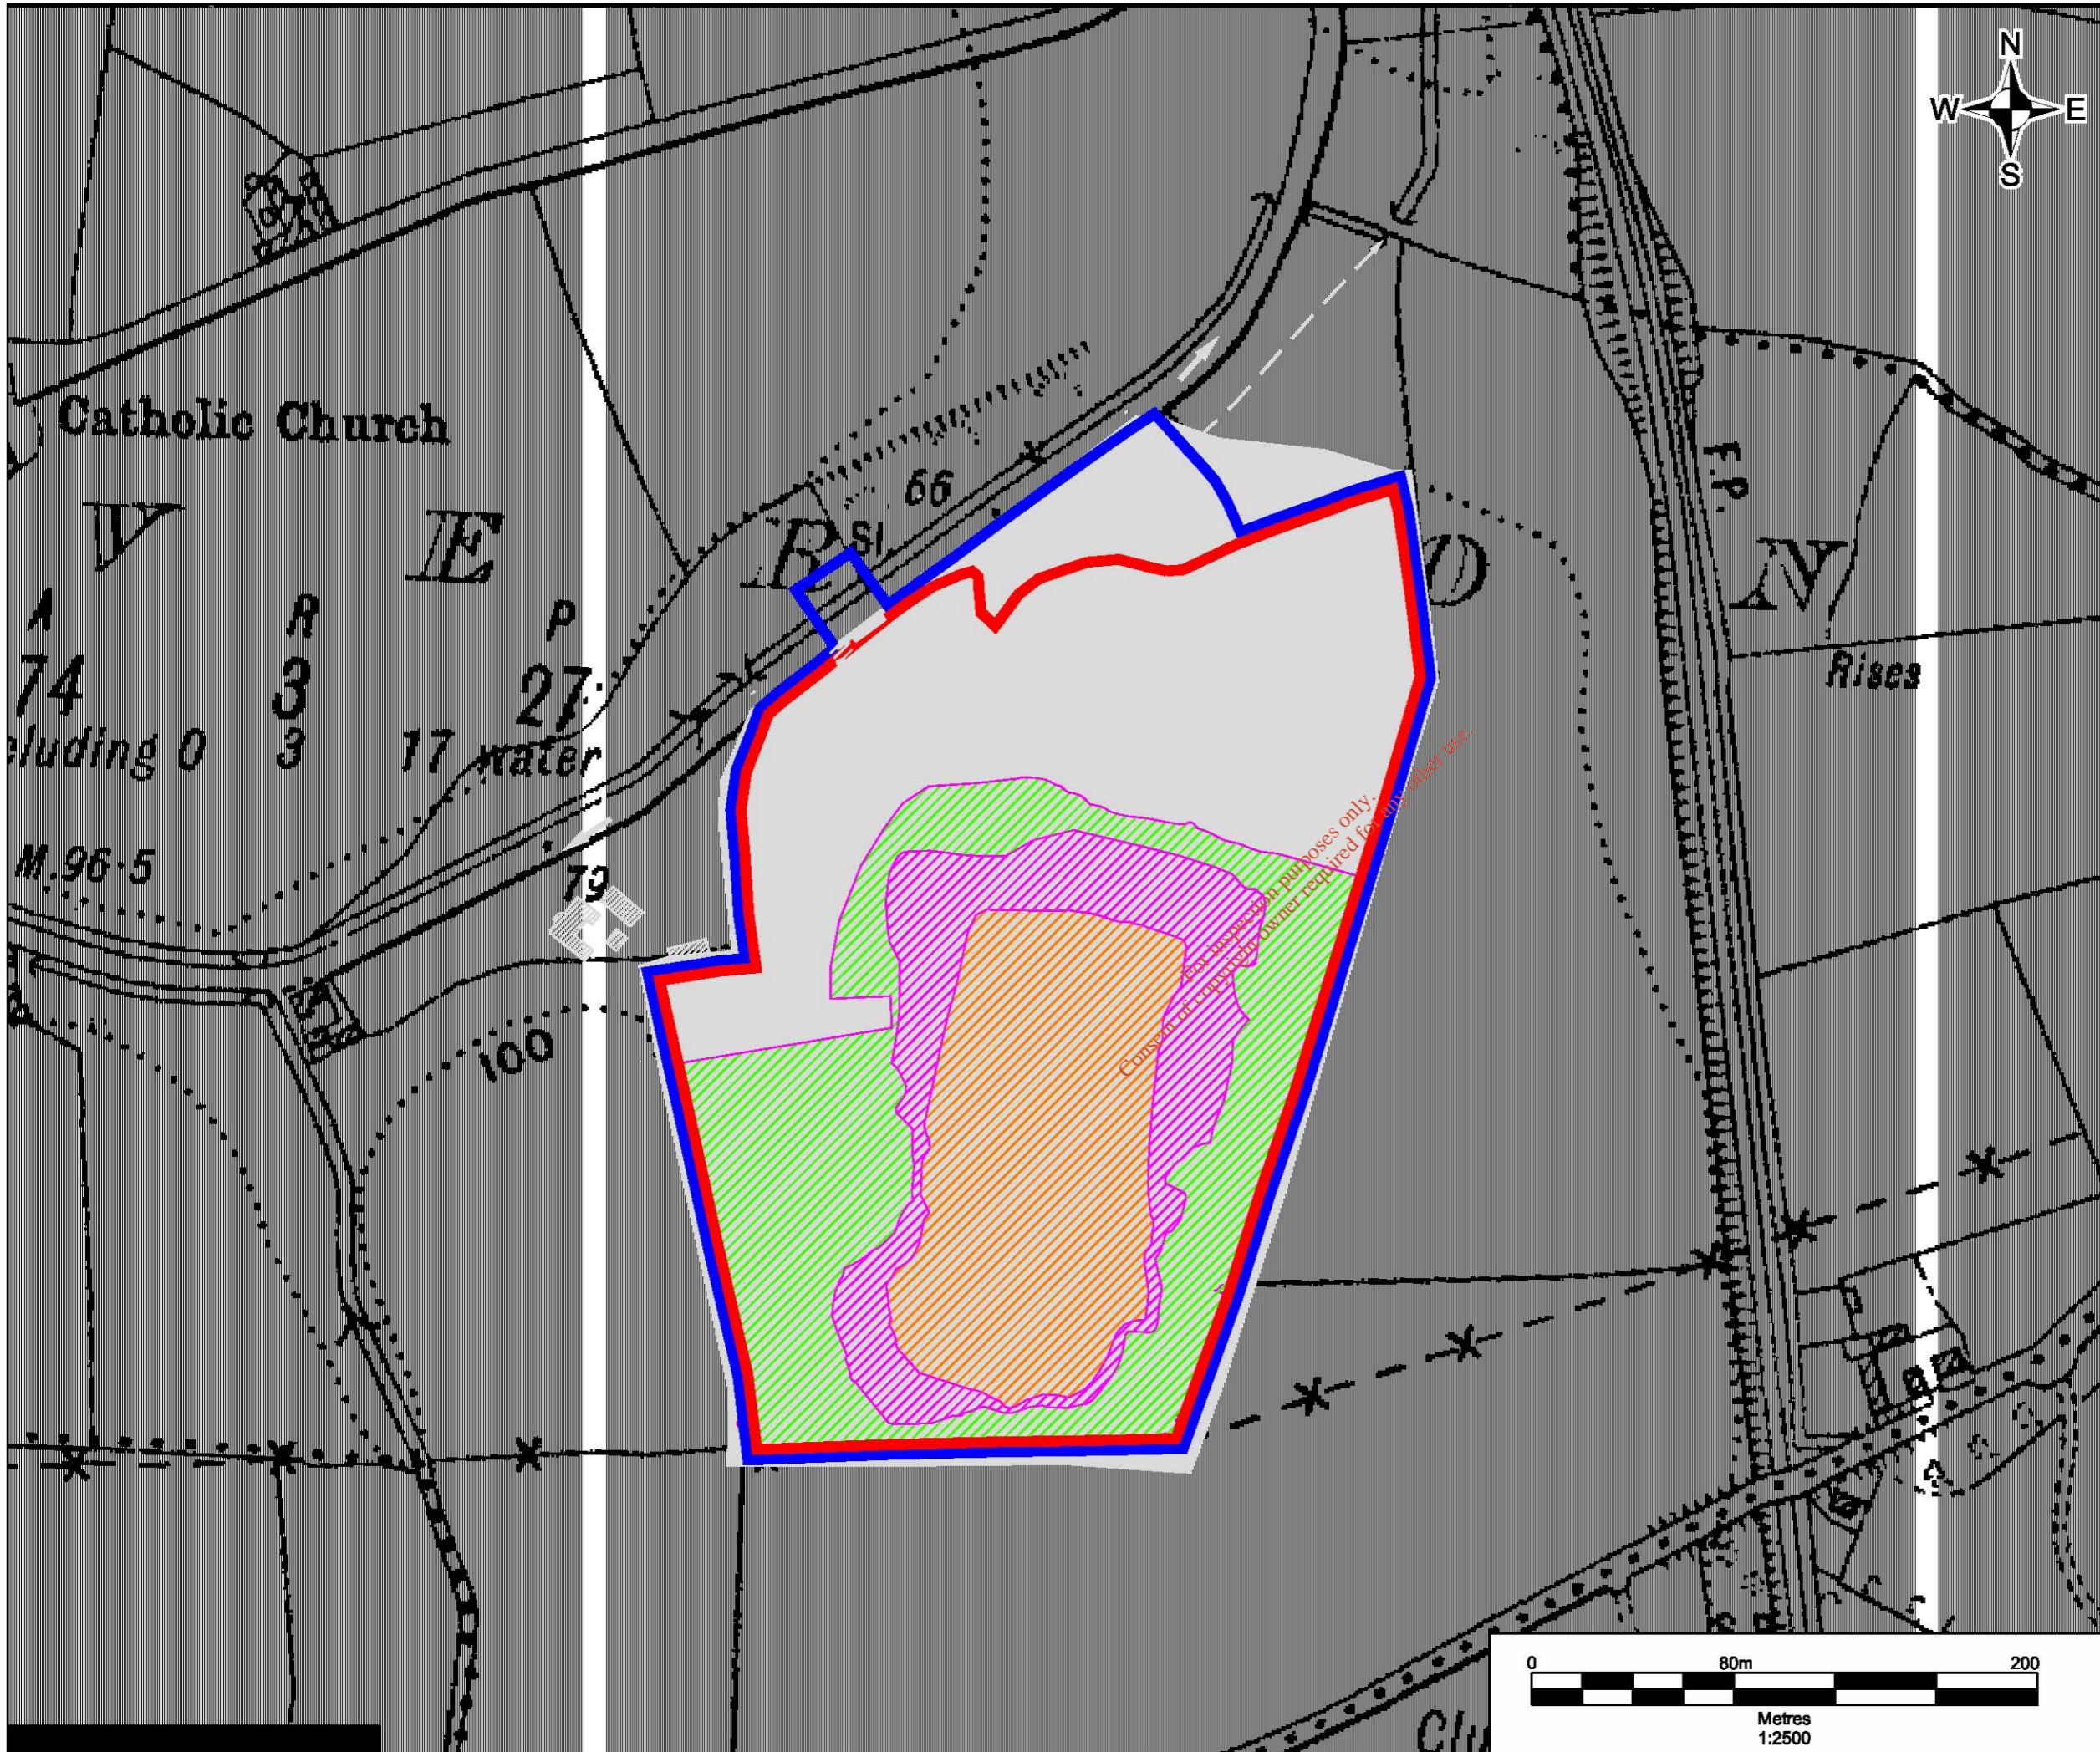
**FIGURE NTS 3**

Backfilling of the former quarry will proceed in several phases and on completion, the site will be restored to former agricultural use. A summary of the proposed phasing and final ground level contours are shown in Figure 3.

**ROADSTONE DUBLIN LTD.**  
**WASTE LICENCE APPLICATION**  
**WASTE RECOVERY FACILITY,**  
**MILVERTON, SKERRIES, CO. DUBLIN**  
**PHASING PLAN**

It is currently envisaged that backfilling of the existing void will be undertaken in a number of 'lifts' from the existing quarry floor. Each phase of backfilling will generally correspond to the depth and extent of existing worked-out quarry benches. Any temporary additional or replacement infrastructure required to facilitate the proposed works will be constructed and/or installed at the outset of the first phase of backfilling.

On completion of the final restoration phase, a cover layer of subsoil and topsoil will be placed and graded across the backfilled soil. This will then be planted with grass in order to promote stability and minimise soil erosion and dust generation.
