SECTION 6: WATER

SLR Consulting Limited (SLR) has been appointed by Roadstone Dublin Ltd. to undertake a hydrogeological and hydrological impact assessment for the backfilling and restoration of a limestone quarry at Milverton, County Dublin using imported inert soil.

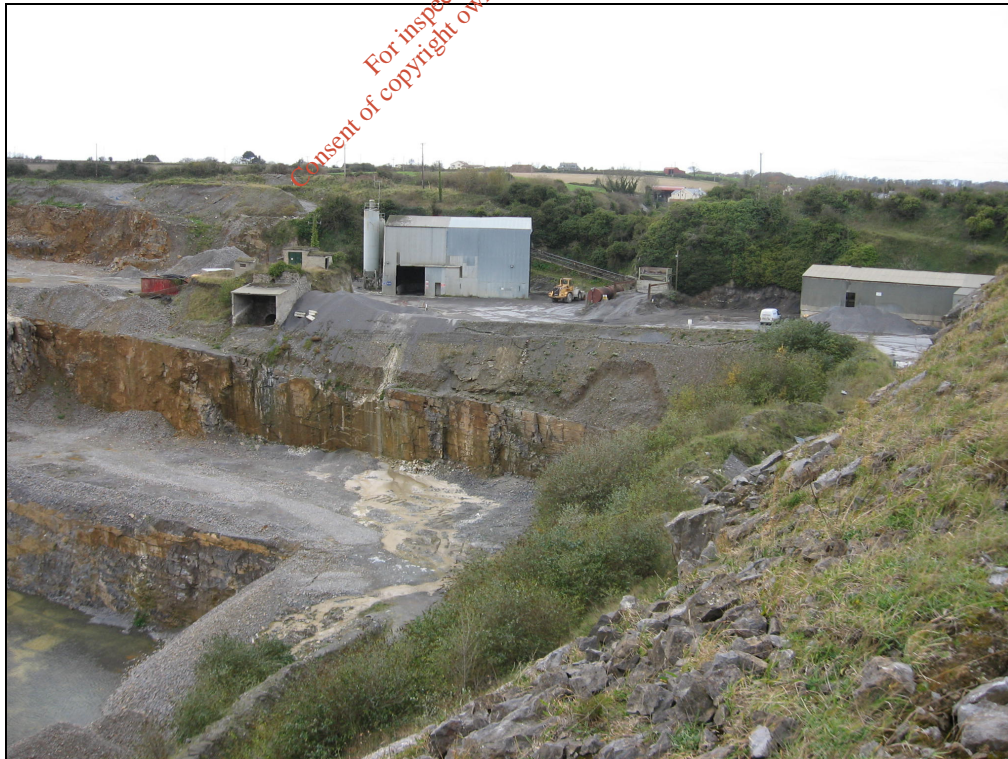
PLATE 6.2 Groundwater inflows at the northeastern quarry face

The excavation has intersected the groundwater table and had sequentially lowered it around the periphery of the excavation with each quarry bench. There are minor groundwater inflows to the quarry that drain to the floor, where they are contained. Water is pumped from the quarry floor as and when required in order to maintain dry conditions on the floor. When active, the pumps have an estimated discharge rate of 5l/s.

Site visits were undertaken by a senior SLR hydrogeologist between the 1st and 12th December 2008 (during the monitoring well installation works). In the course of these visits, some minor groundwater inflows into the quarry were observed from fractures. However, these only occurred at approximately 10mOD and only on the northern quarry face. Photographs of the features of note at the site are presented as plates at the end of this Chapter.
