SECTION 12: TRAFFIC

This chapter of the Environmental Impact Statement (EIS) has been prepared by WSP Ireland Ltd and reviews the impact of the proposed Inert Soil Recovery Facility at Milverton on the local road network and traffic flows thereon.

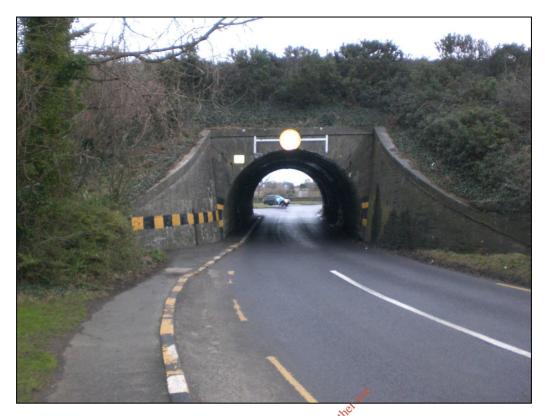
Plate 12.1 Low Rail Bridge along R127 on Approach to Skerries

The access to the former quarry site at Milverton is located directly off the R127 Regional Road. This road runs in a predominantly north-east / south-west alignment from its junction with the R132 Regional Road to the town of Skerries and bounds the application site to the north. The cross-sectional width of this road generally varies from 6.5m to 7.0m. There are a number of side road "T" junctions and staggered crossroads located along the length of the R127 between its junction with the R127 and Skerries. On the approach to Skerries, there is a low bridge with a maximum height of 3.44m. A photograph of this bridge is reproduced in Plate 12.1.

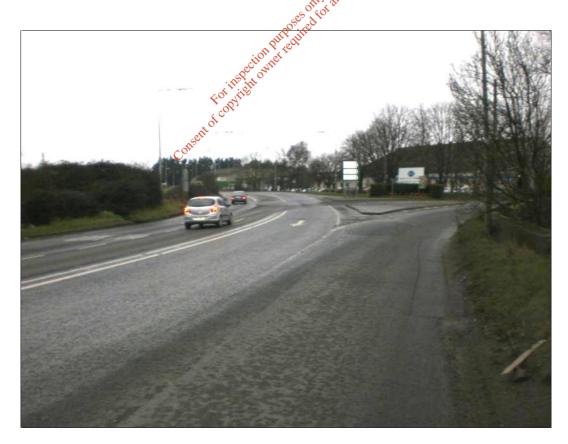
Plate 12.2 R132 / R127 Priority Junction

Travelling further south, the R127 then intersects with the R132, which was previously the old N1. This junction is 3km south of Lusk and is locally known as "Blakes Cross". This intersection is in the form of a priority junction, with priority in favour of the R132. On approach to this junction along the R127, there is a left turn slip lane provided for traffic heading south, enabling it to merge with the R132. Vehicles travelling northbound along the R132 wishing to turn on to the R127, are facilitated by a ghost island right turn lane. Vehicles travelling from a southbound approach to the

junction and making a left turn, are provided with a left turn slip lane. A photograph of this junction is provided in Plate 12.2.

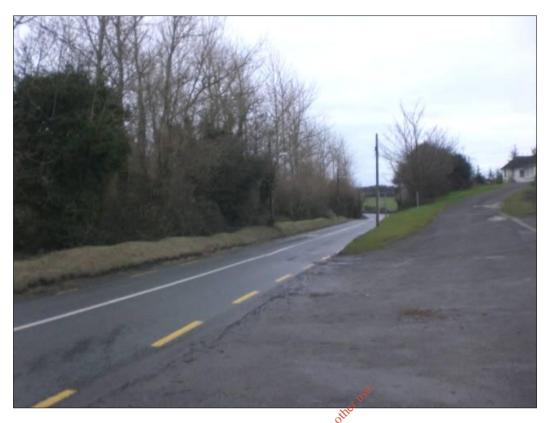
Figure 12.3 Visibility to the Right (East) of Site Entrance

The prevailing speed limit on the R127 Regional Road is 80kph. Therefore to provide for an 85km design speed, the existing access junction at the application site must have a sight visibility distance of 160m at a minimum 4.5m setback from the R127 road edge along the access road, as defined in NRA DMRB (TD 42/95). A photograph of the achievable visibility is depicted in Plates 12.3 and 12.4.

Visibility at the access junction onto the R127 is quite good to the right (east). To the left (west) visibility is slightly obstructed by signage and flag poles relating to the former retail centre. A number of mitigation measures are proposed to address this aspect in Section 12.4 (Proposed Mitigation Measures).

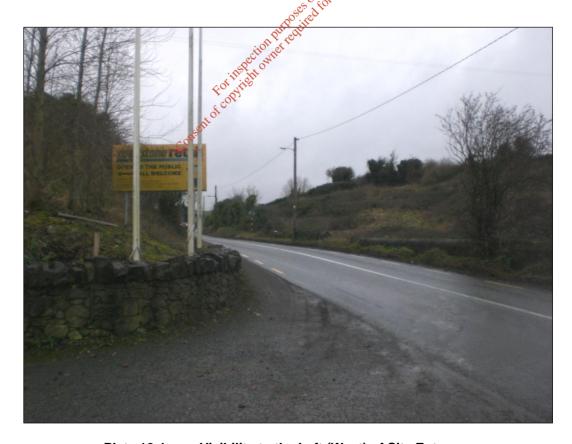
Plate 12.4 Visibility to the Left (West) of Site Entrance

To mitigate the impact of the obstruction due to signage and flag poles to the left (west) upon exit from the application site, it is recommended that the sign and the two outer flag poles be removed, particularly as the retail centre is no longer in operation. Maintenance (cutting back) of any vegetation which could also have potential impact on visibility should also be addressed.

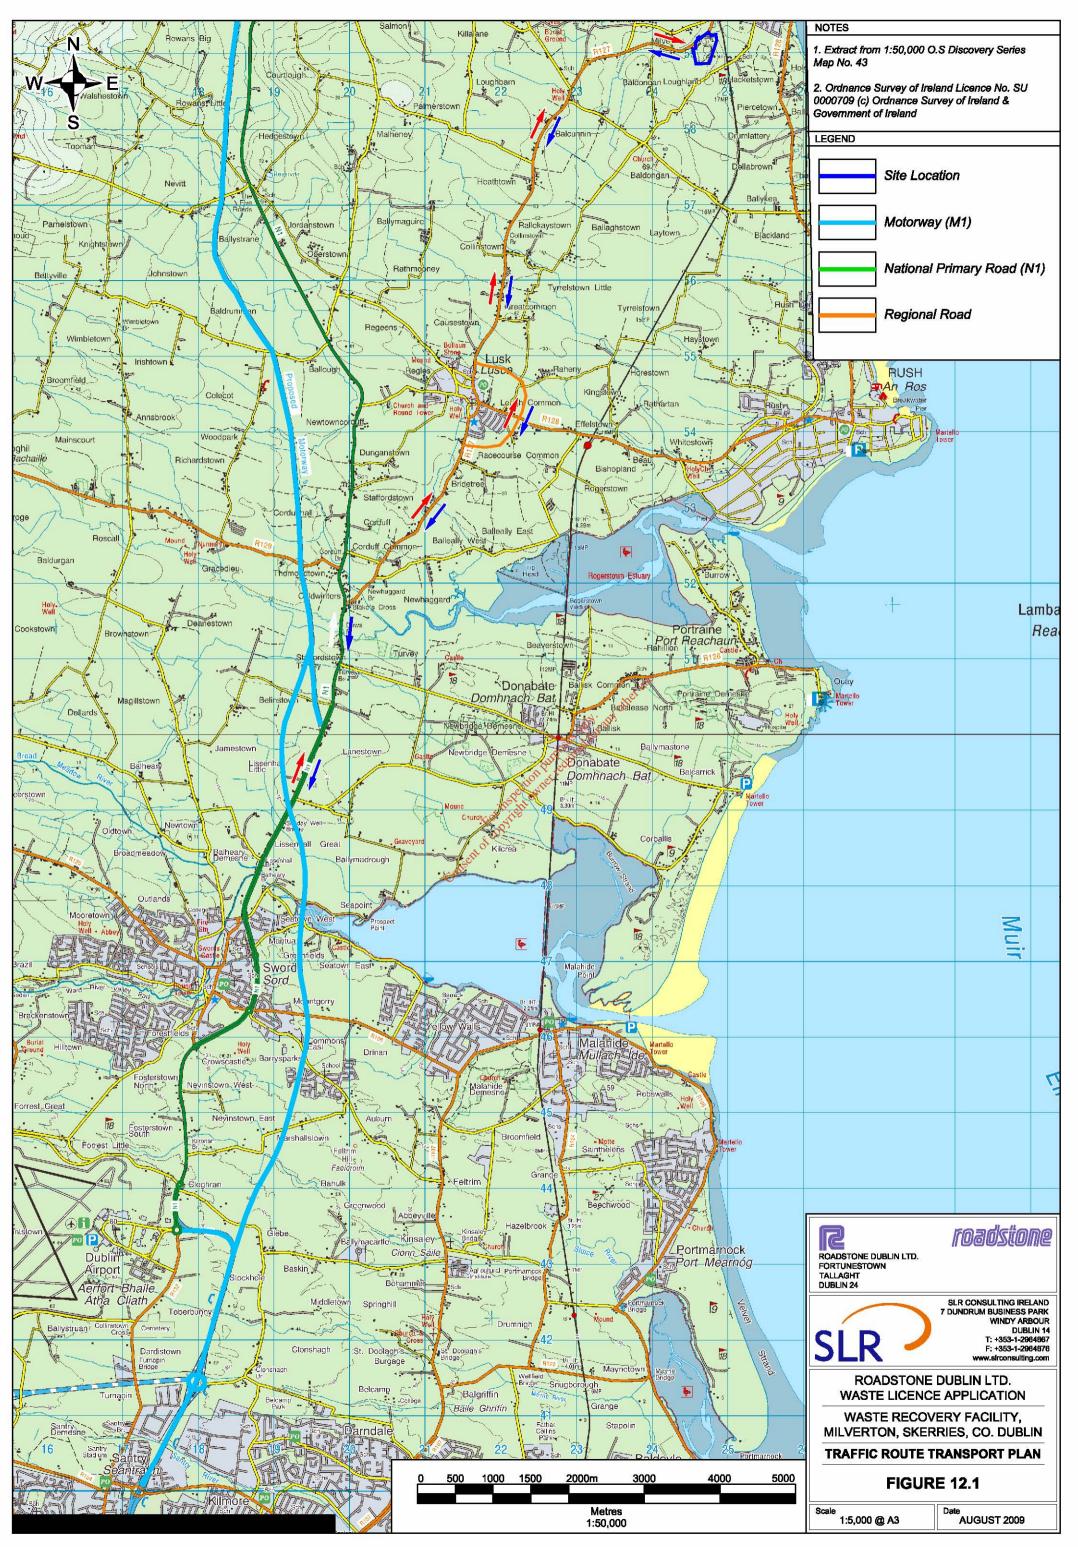
The route that will be travelled by HGV trucks to and from the proposed inert soil recovery facility is the same as that travelled by trucks going to and from the former quarry. This route is illustrated in Figure 12.1.

Upon leaving the site, all HGV traffic will turn left at the site exit and head south-west towards Lusk along the R127. When approaching Lusk, HGV traffic shall use the relief road by taking the first exit on the roundabout, and subsequently travel through the next two roundabouts. They will then proceed to take the first exit on the fourth and last roundabout. HGV traffic will then continue travelling south-west until it approaches the R127 / R132 intersection at Blake's Cross. At this junction, HGV traffic will turn south and move towards the Lissenhall Interchange on the M1 to their destination site in the Greater Dublin Area, or turn north and advance towards the Balbriggan Interchange on the M1 to the intended site in North Leinster.
