BALLYMURTAGH LANDFILL

Waste Licence W0011-01

ANNUAL ENVIRONMENTAL REPORT 2009

**Annual Environmental Report
2009**

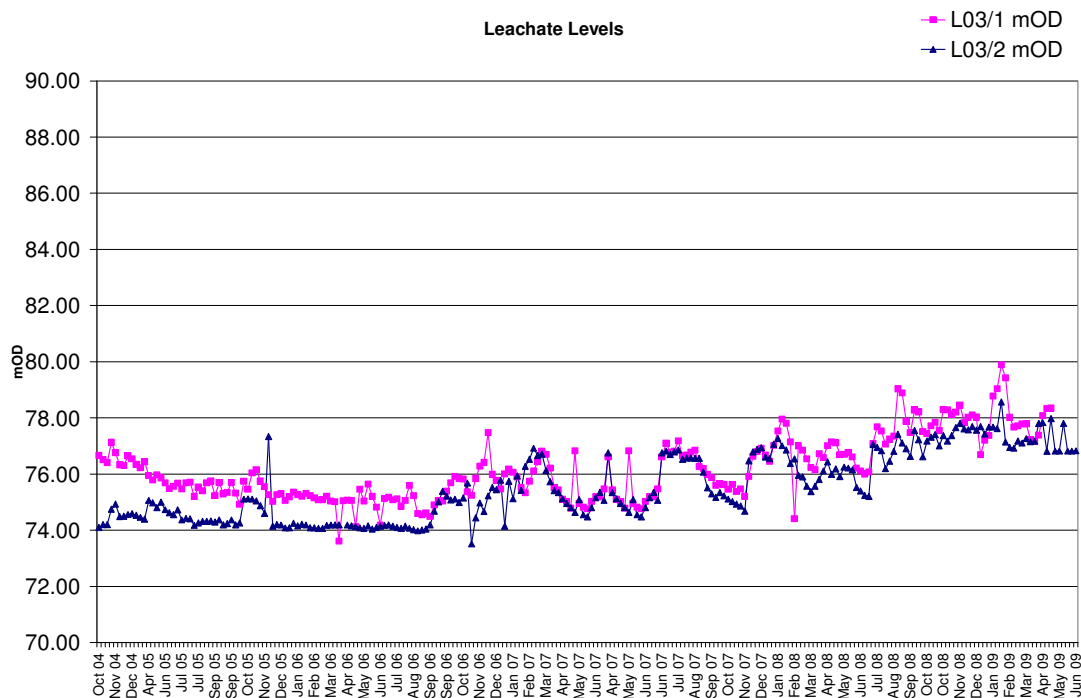
Figure 2.6: Leachate Levels at L03/1 and L03/2 – August 2004 to December 2009

Wicklow County Council record leachate levels at a number of monitoring locations in accordance with Condition 9.4 of the W0011-01. Historically L03/1, L03/2 and L03/4 were illustrated below. These boreholes were recorded as blocked and levels were not recorded in the 3rd & 4th quarters of 2009. Leachate levels fluctuate as shown in Figure 2.6.

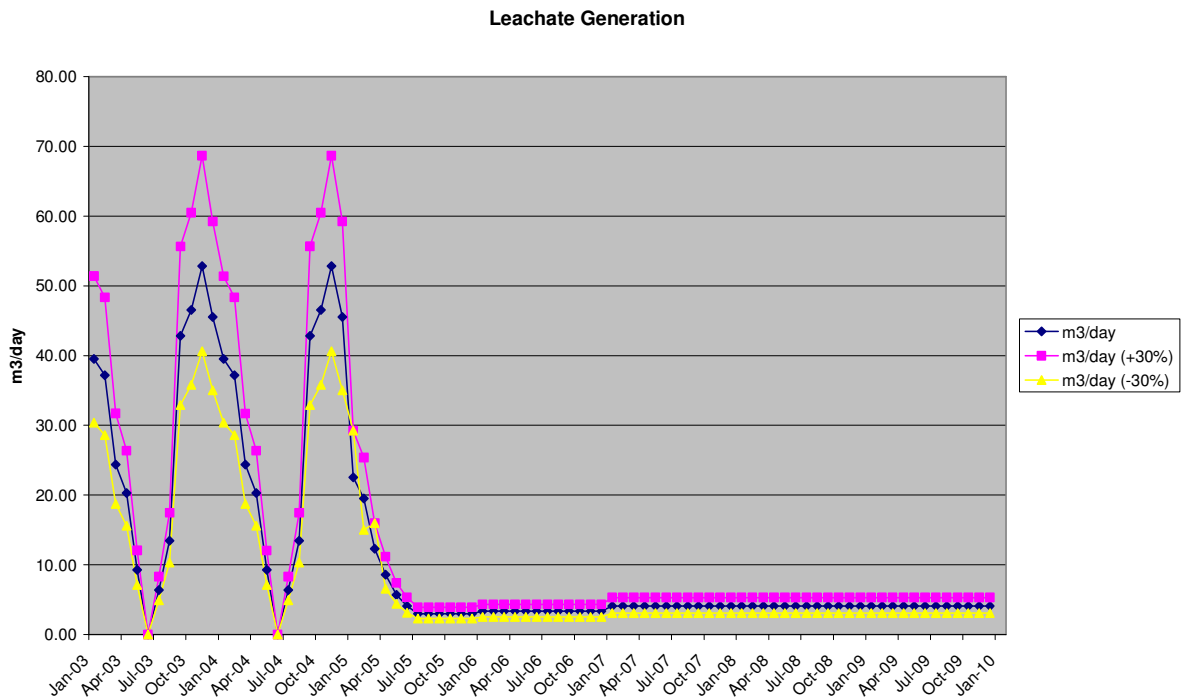
Figure 4.2: Estimated leachate generation at Ballymurtagh Landfill 2003-2009

It is estimated that up to 1,492.4 m³ of leachate were generated during the reporting period, 124.4m³/month. This amount is similar to the estimated figure of 91m³/month as calculated before capping.

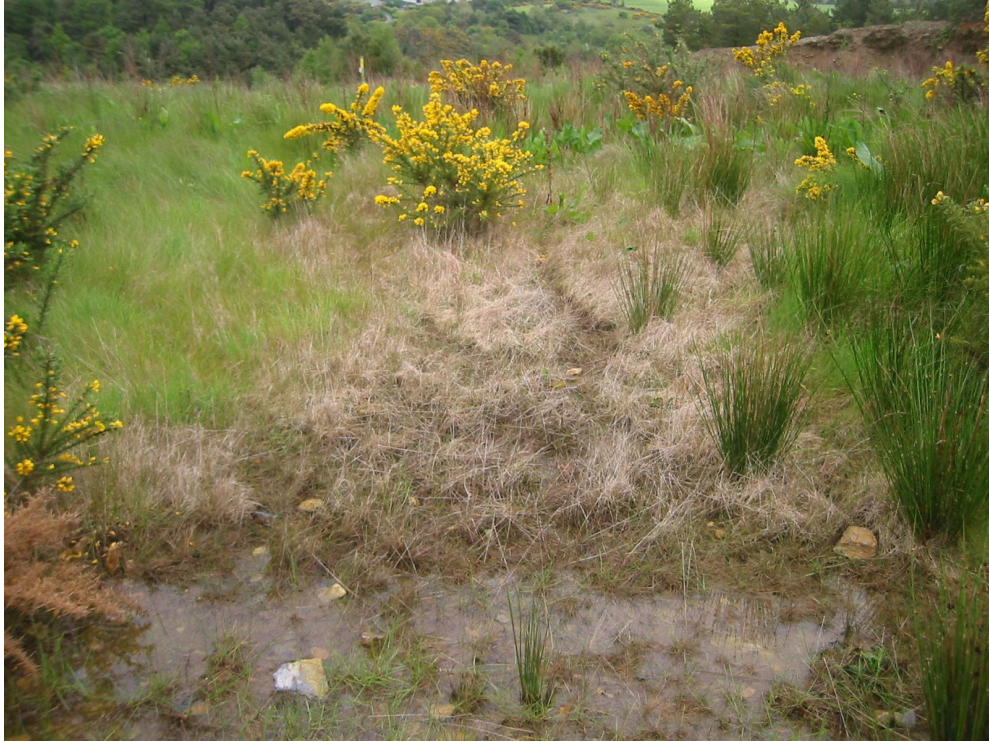
Photo 1. Vegetation effect at western end caused by run-off from surroundings

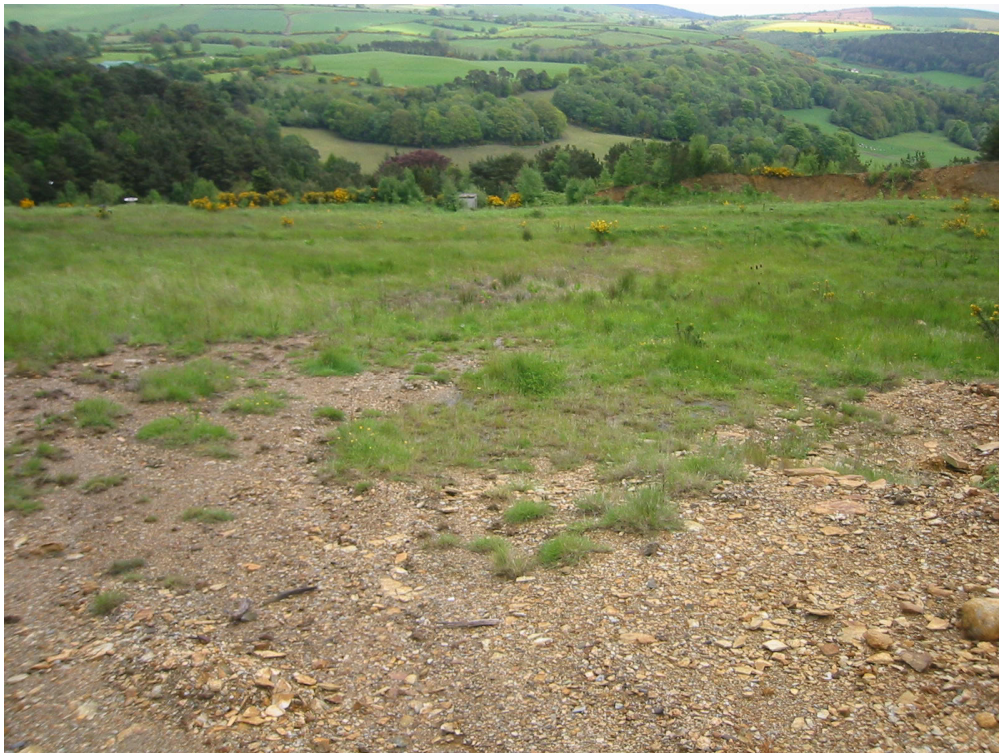
Photo 2. Gravel exposed at western end outside filled area

The amount of exposed gravel at the western margin of the site is noted and may require attention in time depending on the growth of vegetation in the next few years.

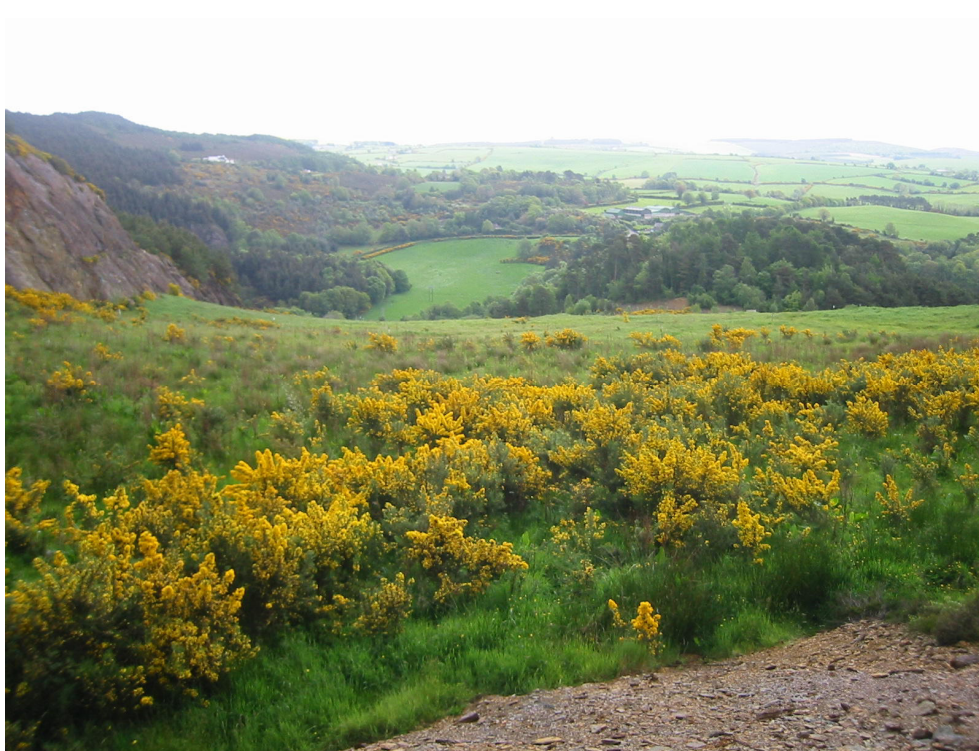
A possibly related pattern is also emerging in the gorse *Ulex europaeus* which is colonising the NW corner. Here a proportion of the outer bushes die off after a few years of growth with the result that they never reach above 50cm or so (Photo 3). Closer to the corner the growth is better, up to 1.5m. This again may have a hydrological or soil cause rather than any toxicity.

Photo 3. Gorse at NW corner of landfill. Note thin growth on outer fringe

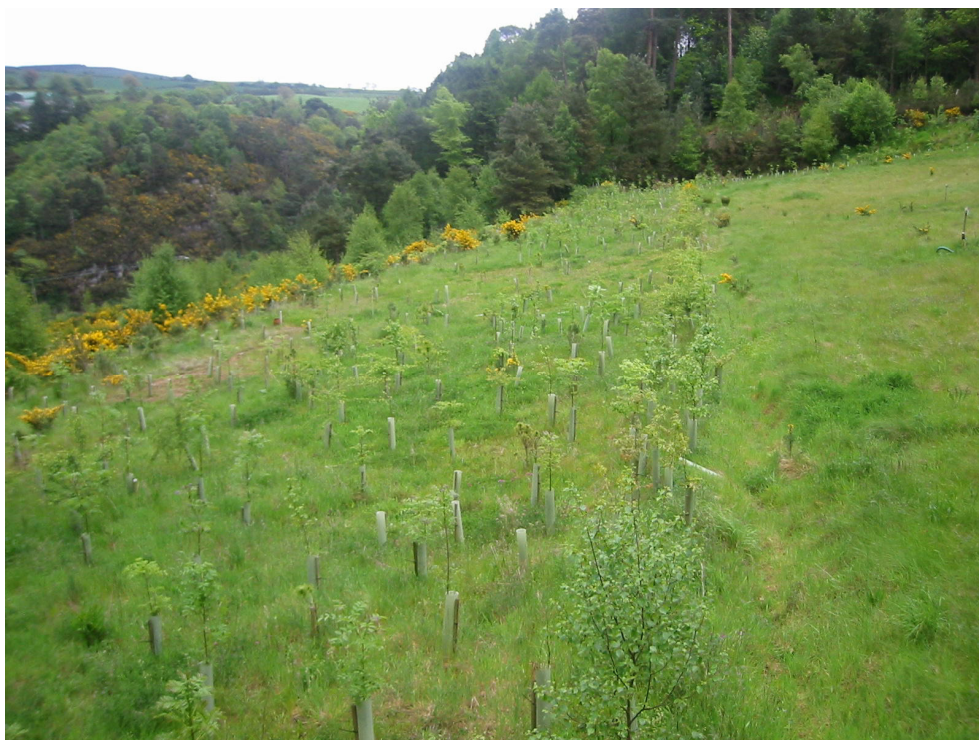
Photo 4. New planting above existing trees on eastern slope

The additional tree planting has caused minor soil disturbance and changes in surface water hydrology though these will be assimilated in due course. Hawthorn, ash and oak have been used in addition to the more widely successful birch and willow.

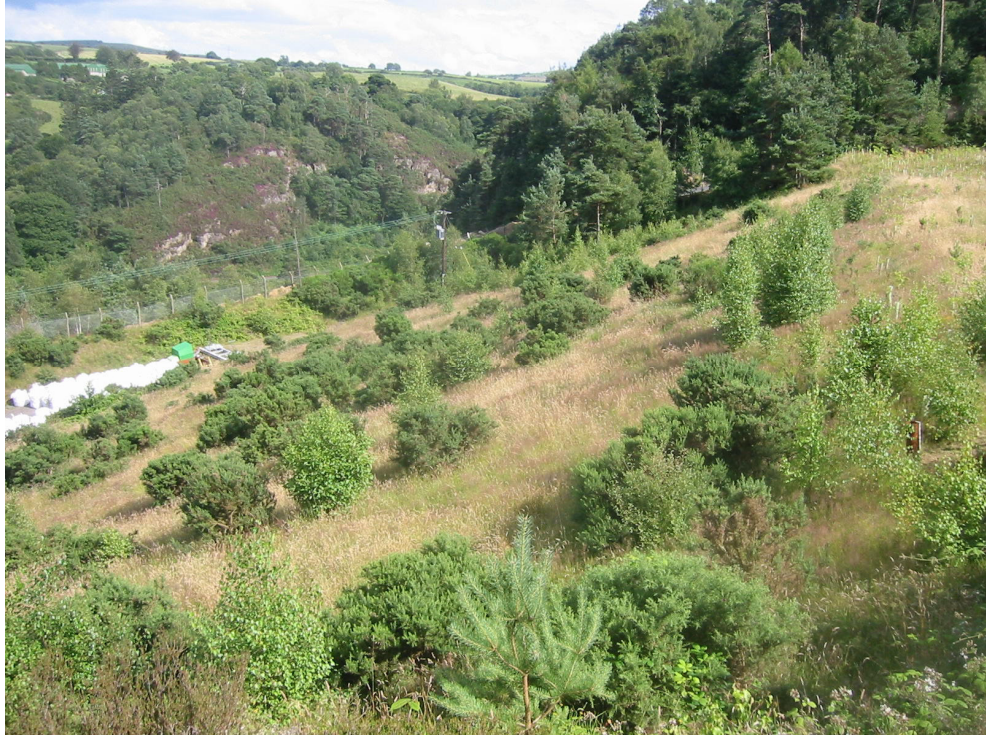
The established trees (Photos 5,6) on the slope are now 3-4m in height and include birches *Betula pubescens* and *B.pendula*, pines *Pinus contorta*, *P.sylvestris*, and willows *Salix cinerea* and a little *S.aurita*. The gorse is now 2m high and the shaded conditions suit

Photo 5. Eastern slope in 2007 (August)

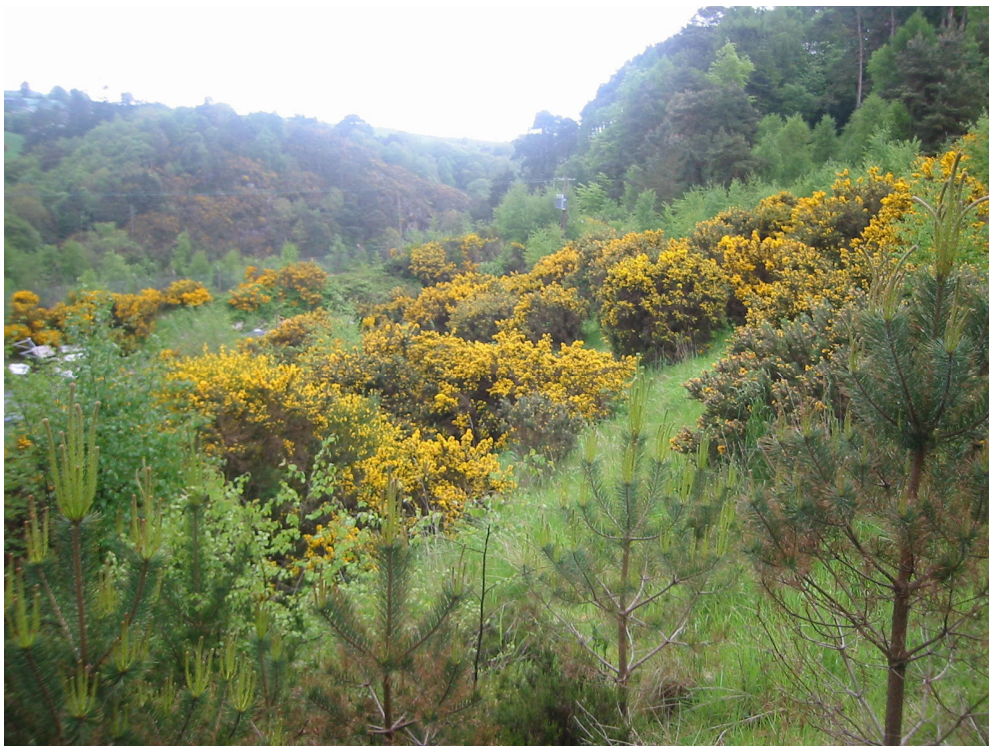
Photo 6. Eastern slope in 2009 (May)

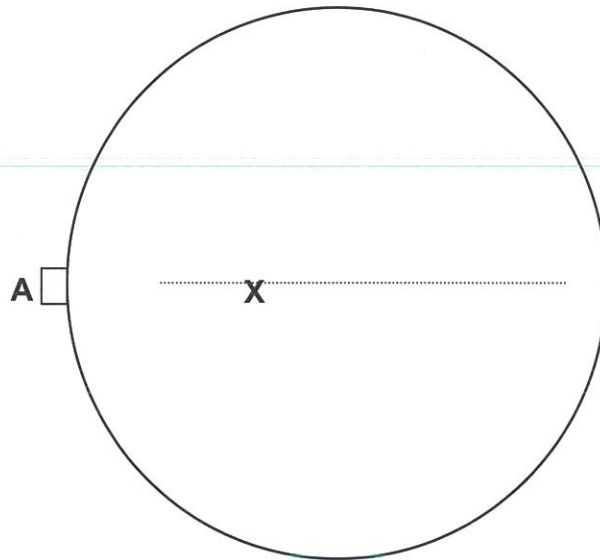
Diagram of Sampling Location (not to scale)

Particulates measurement was not carried out as port diameter was too small. Actual port diameter is 20mm for Particulates measurements minimum 100mm port is recommended.
