ROADSTONE WOOD LTD.
ENVIRONMENTAL IMPACT STATEMENT
WASTE RECOVERY FACILITY,
BROWNSWOOD, CO. WEXFORD
VIEWPOINTS A & B

FIGURE 10-2

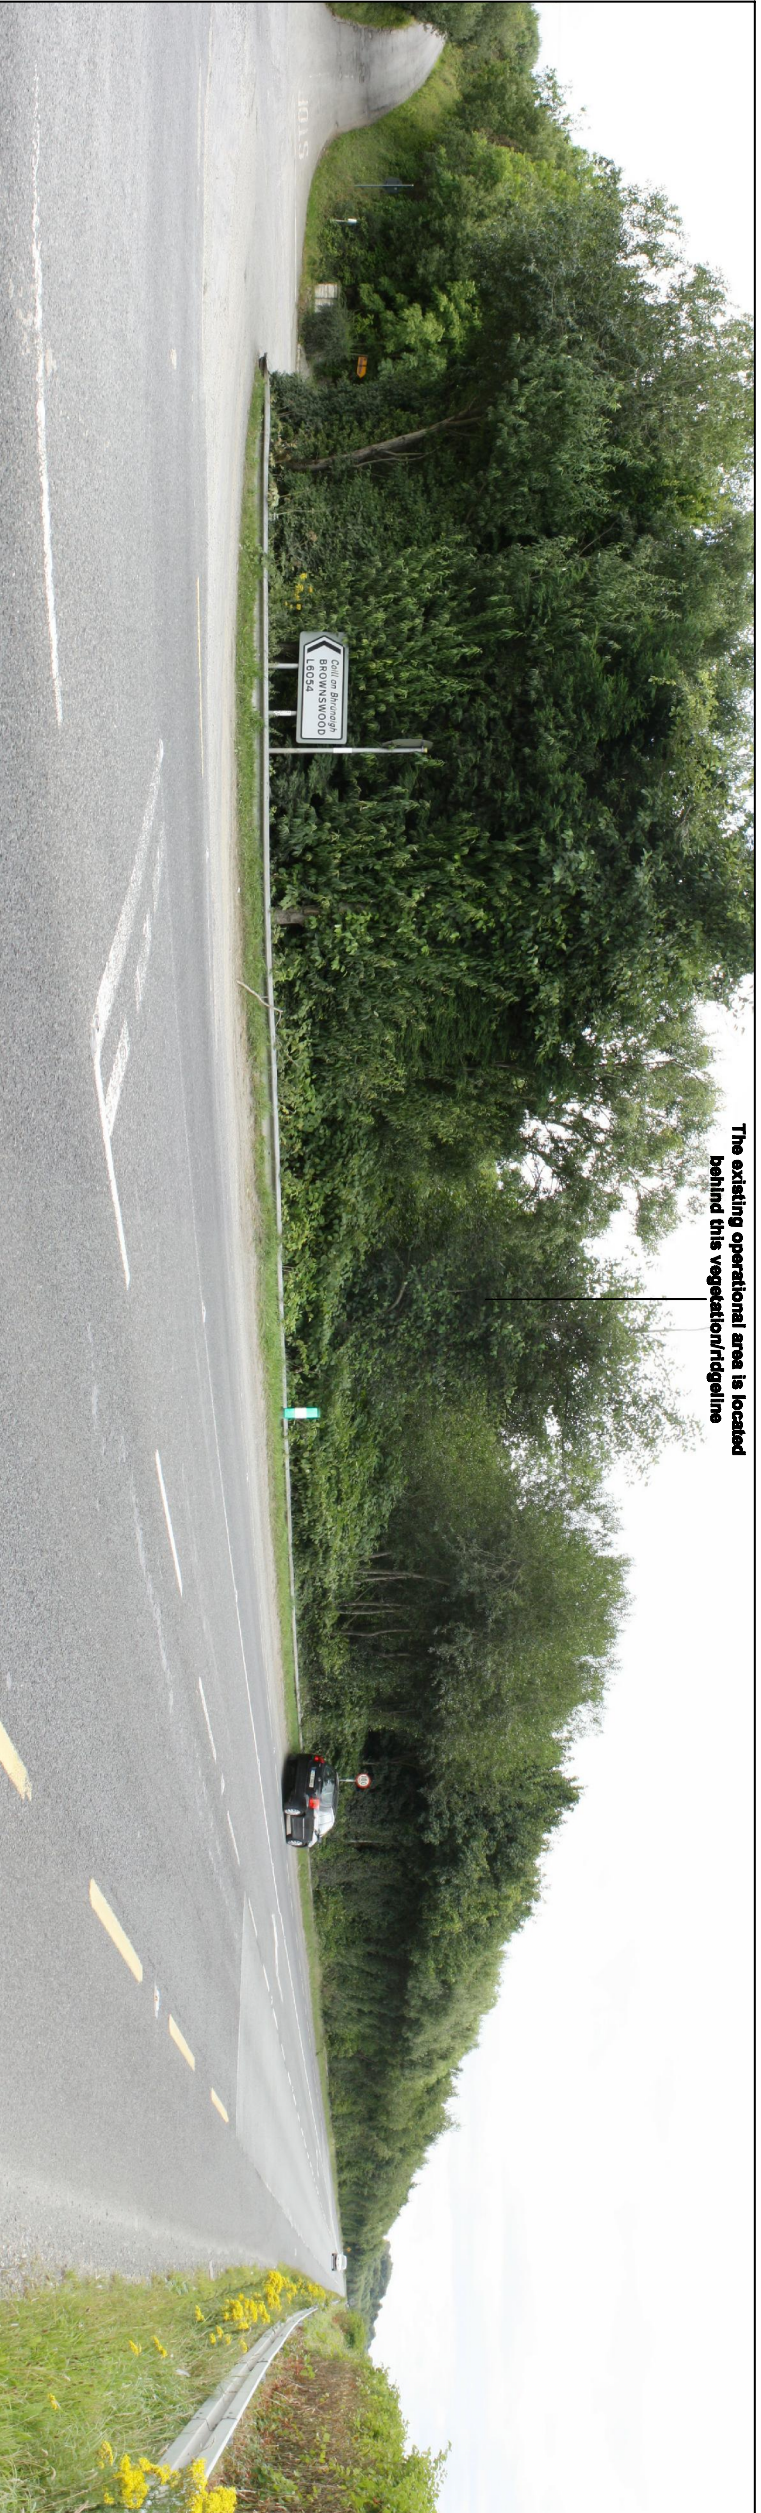
VIEWPOINT A: JUNCTION AND SITE BOUNDARY ALONG THE N11 NATIONAL ROAD & L6054 LOCAL ROAD TO THE ENTRANCE OF BROWNSWOOD QUARRY

The existing operational area is located behind this vegetation/ridge/line

Grid Reference: 297804E,137310N

Distance from site boundary: 89m

Approximate Elevation: 8m AOD

Direction of View: South East

DESCRIPTION: THE APPLICATION SITE IS NOT VISIBLE FROM THIS AREA, DUE TO INTERVENING TOPOGRAPHY AND MATURE VEGETATION.

SENSITIVITY OF VIEWPOINT: MEDIUM

MAGNITUDE OF CHANGE TO VIEW: NONE

RESIDUAL VISUAL IMPACT: NONE

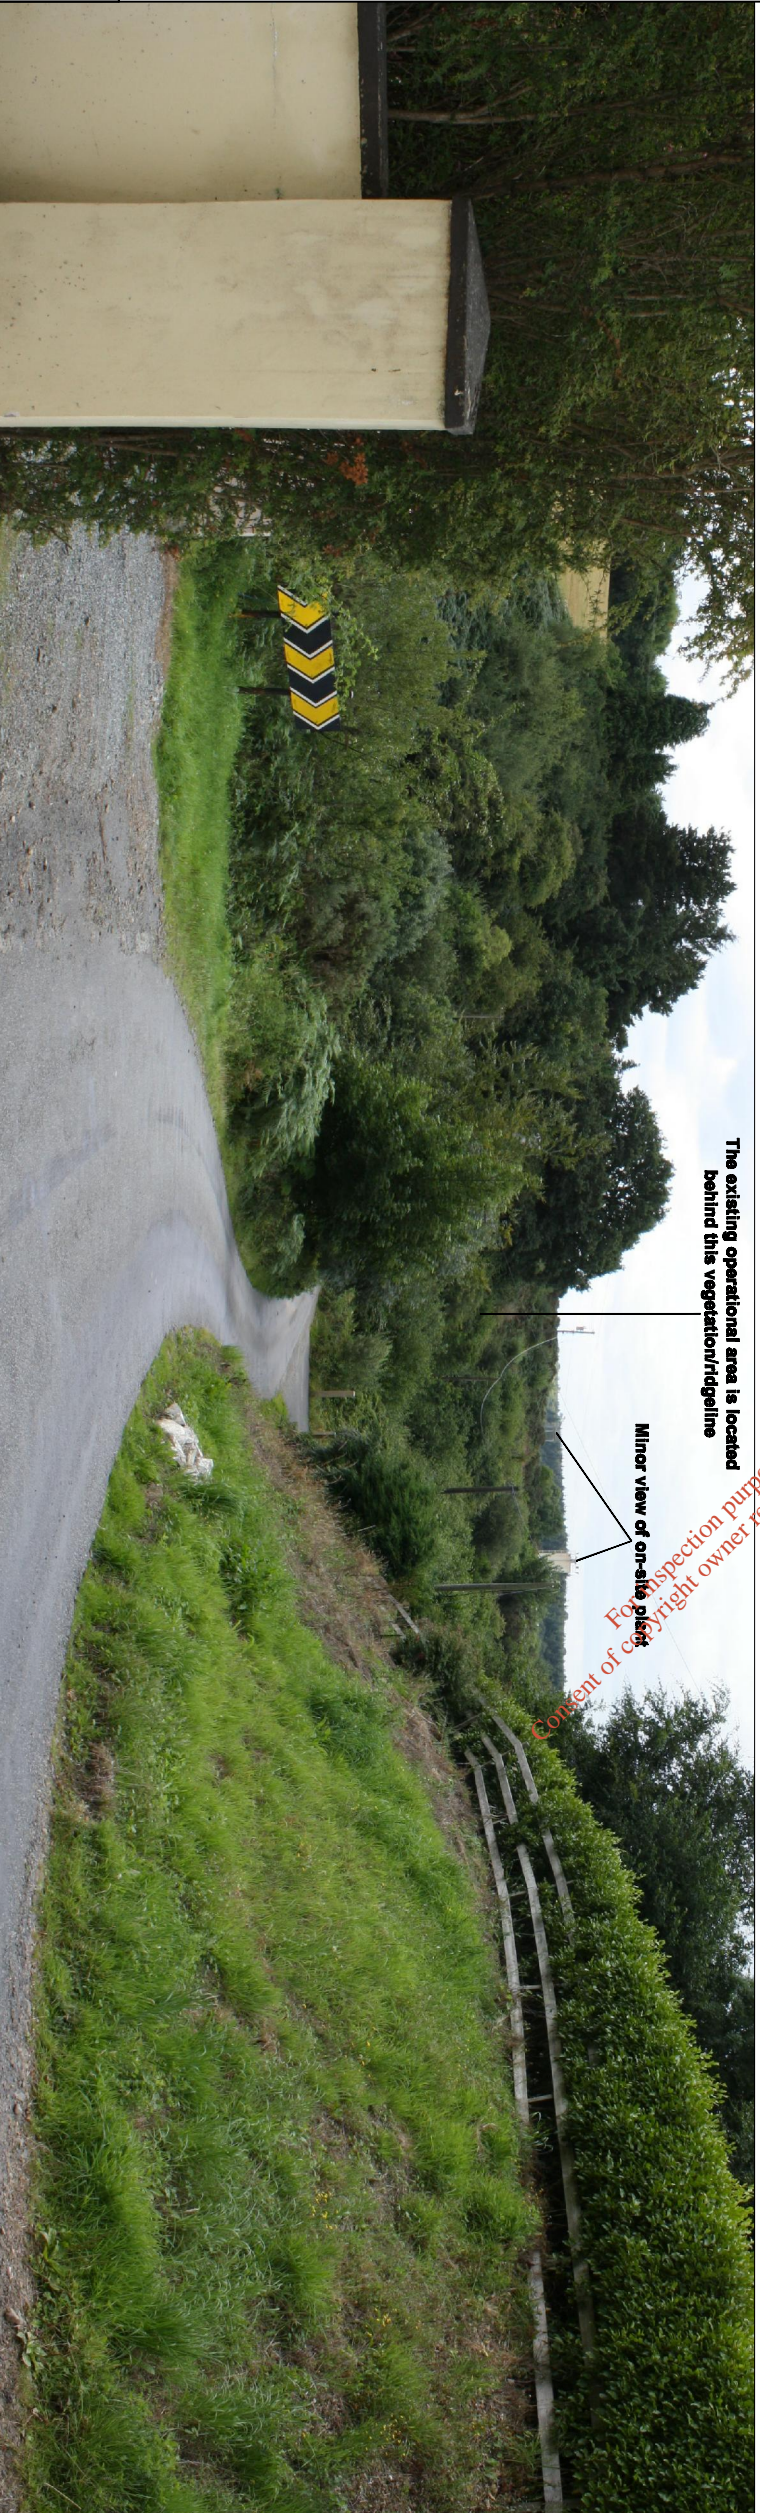
VIEWPOINT B: VIEW ALONG LOCAL ROAD NORTHEAST OF THE APPLICATION SITE

The existing operational area is located behind this vegetation/ridge/line

Minor view of on-site plant

Grid Reference: 297808E, 137570N

Distance from site boundary: 280m

Approximate Elevation: 30m AOD

Direction of View: South

DESCRIPTION: THERE ARE A NUMBER OF PROPERTIES IN THE VICINITY OF THIS VIEWPOINT WITH SIMILAR VIEWS. THE APPLICATION SITE IS NOT VISIBLE FROM THIS AREA, DUE TO INTERVENING TOPOGRAPHY AND MATURE VEGETATION.

Sensitivity of Viewpoint: MEDIUM

Magnitude of Change to View: MINOR

Residual Visual Impact: MINOR
