ROADSTONE WOOD LTD.
 ENVIRONMENTAL IMPACT STATEMENT
 WASTE RECOVERY FACILITY,
 BROWNSWOOD, CO. WEXFORD
 VIEWPOINTS G & H

FIGURE 10-5

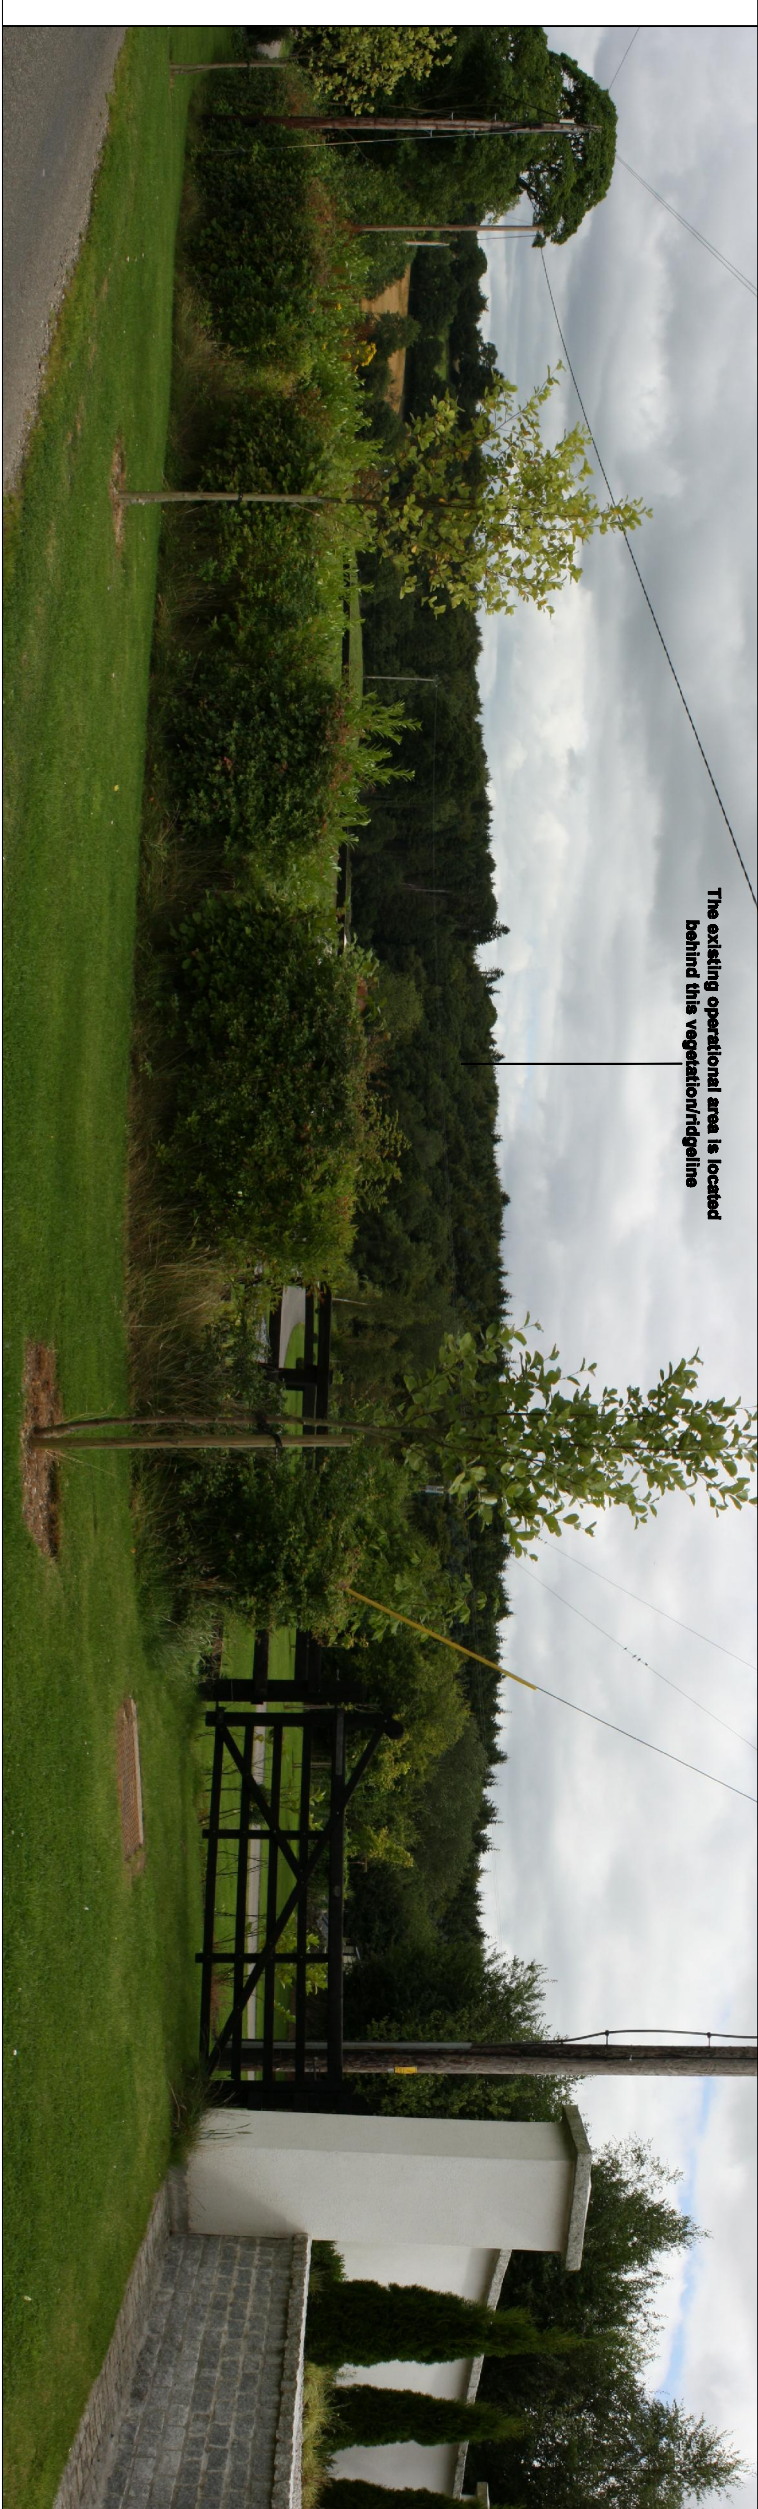
VIEWPOINT G: DISTANT VIEW ALONG LOCAL ROAD SOUTH WEST OF THE APPLICATION SITE

The existing operational area is located behind this vegetation/ridgeline

Grid Reference: 298008E,137297N

Distance from site boundary: 1.0km

Approximate Elevation: 10m AOD

Direction of View: North East

DESCRIPTION: THERE ARE A NUMBER OF PROPERTIES IN THE VICINITY OF THIS VIEWPOINT WITH SIMILAR VIEWS. THE APPLICATION SITE IS NOT VISIBLE FROM THIS AREA, DUE TO INTERVENING TOPOGRAPHY AND MATURE VEGETATION.

SENSITIVITY OF VIEWPOINT: NEGLIGIBLE

MAGNITUDE OF CHANGE TO VIEW: NONE

RESIDUAL VISUAL IMPACT: NONE

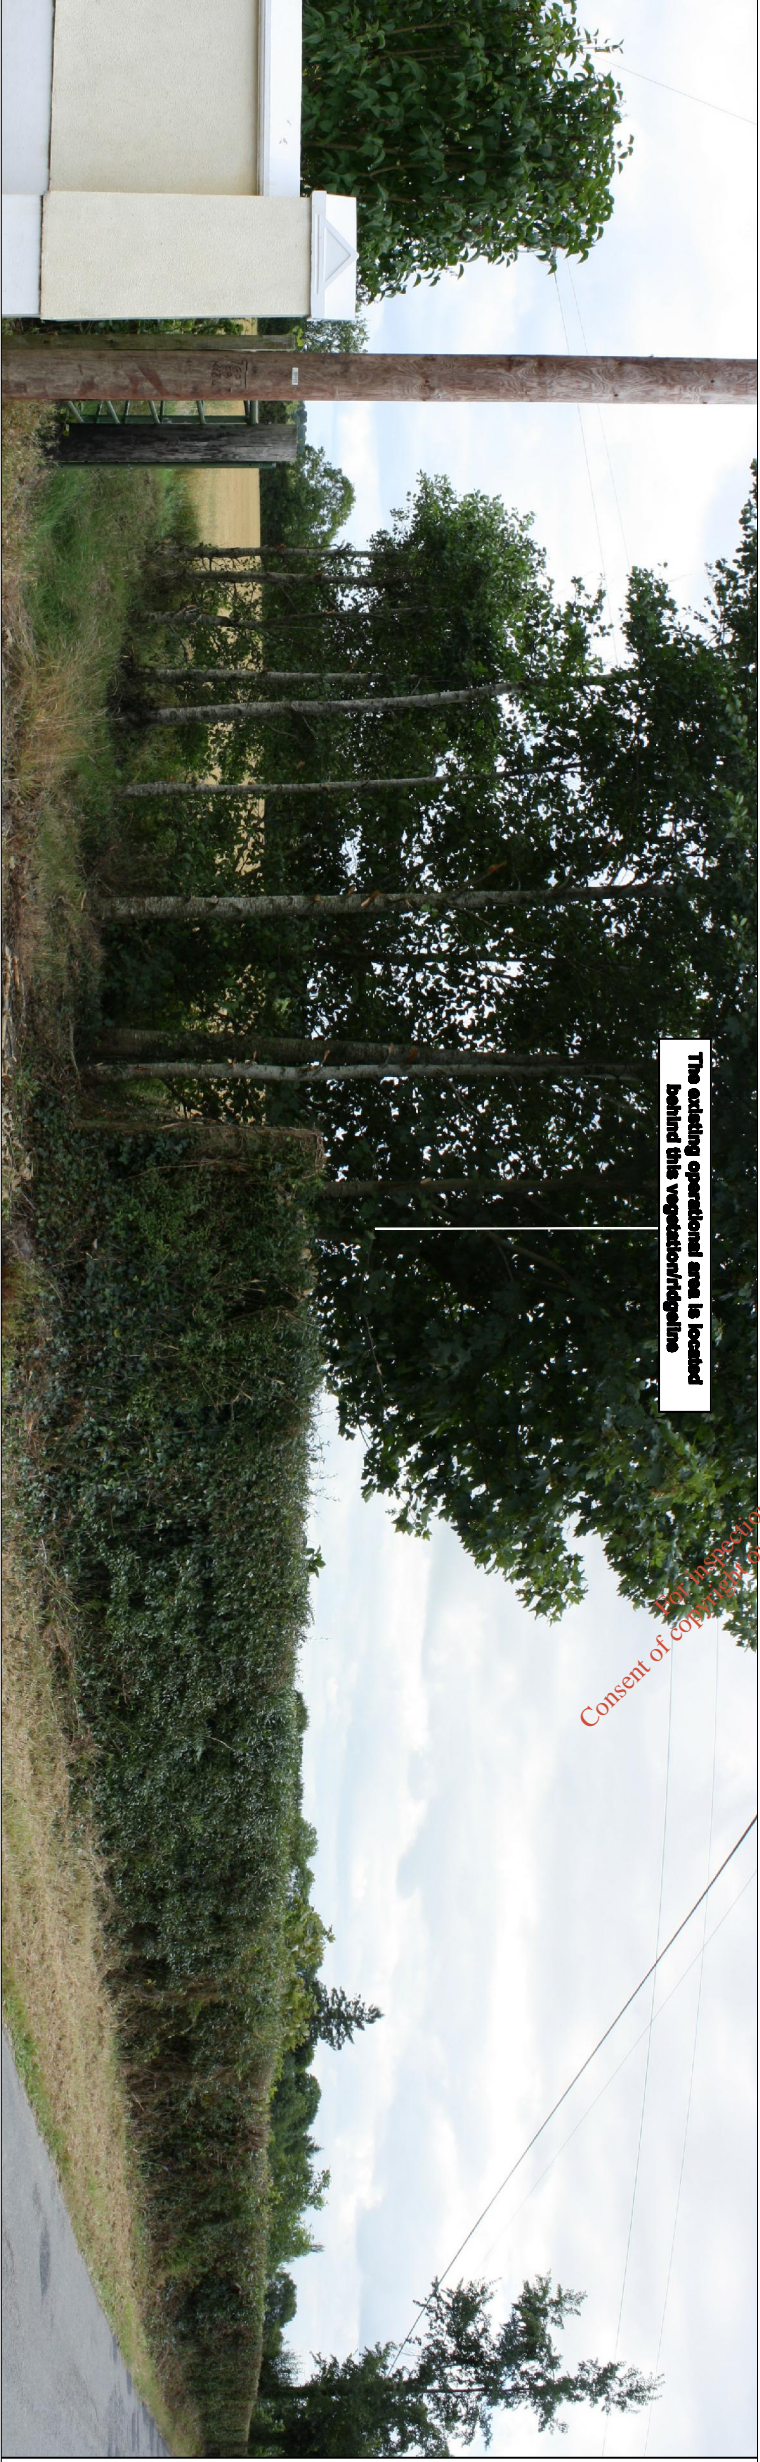
VIEWPOINT H: DISTANT VIEW ALONG LOCAL ROAD WEST OF THE APPLICATION SITE

The existing operational area is located behind this vegetation/ridgeline

Grid Reference: 298118E,136783N

Distance from site boundary: 600m

Approximate Elevation: 45m AOD

Direction of View: East

DESCRIPTION: THERE ARE A NUMBER OF PROPERTIES IN THE VICINITY OF THIS VIEWPOINT WITH SIMILAR VIEWS. THE APPLICATION SITE IS NOT VISIBLE FROM THIS AREA, DUE TO INTERVENING TOPOGRAPHY AND MATURE VEGETATION.

SENSITIVITY OF VIEWPOINT: NEGLIGIBLE

MAGNITUDE OF CHANGE TO VIEW: NONE

RESIDUAL VISUAL IMPACT: NONE
