Clare County Council

Waste Licence W0150-01

Annual Environmental Report for 2014

**Name & location of facility: Scarriff Recycling Centre & Transfer Station,
Fossa Beg, Feakle Road, Scarriff, Co. Clare.**

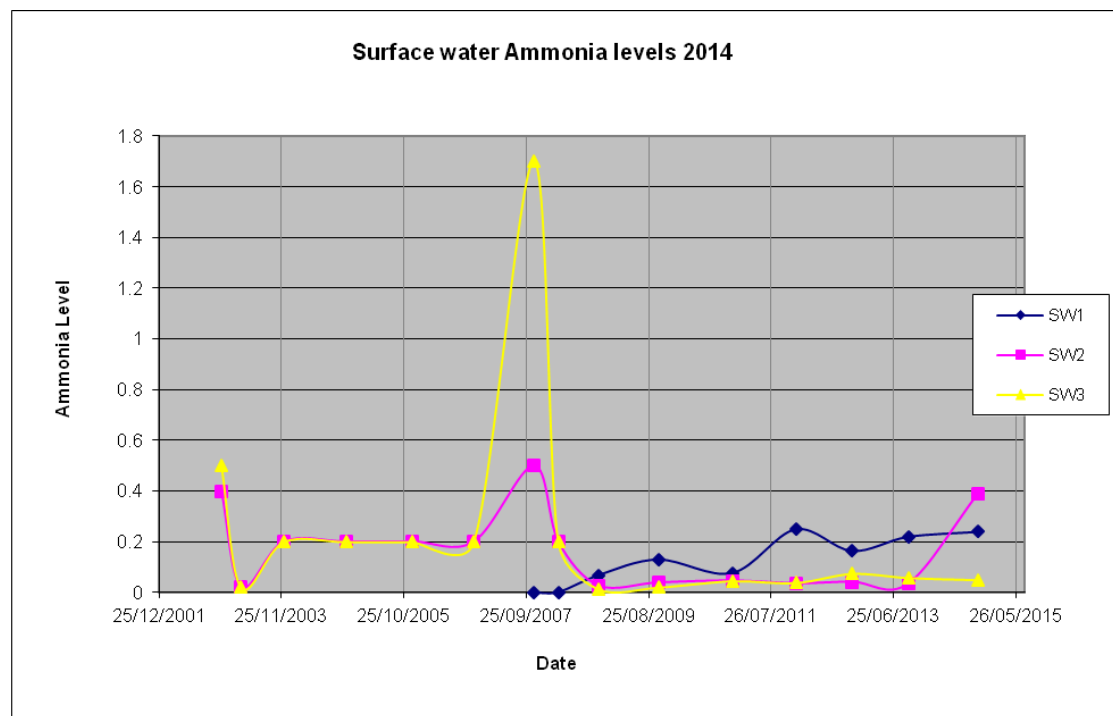
Figure 6.1

Ammonia levels remained low at all locations, with overall levels remained low, in line with historic values.

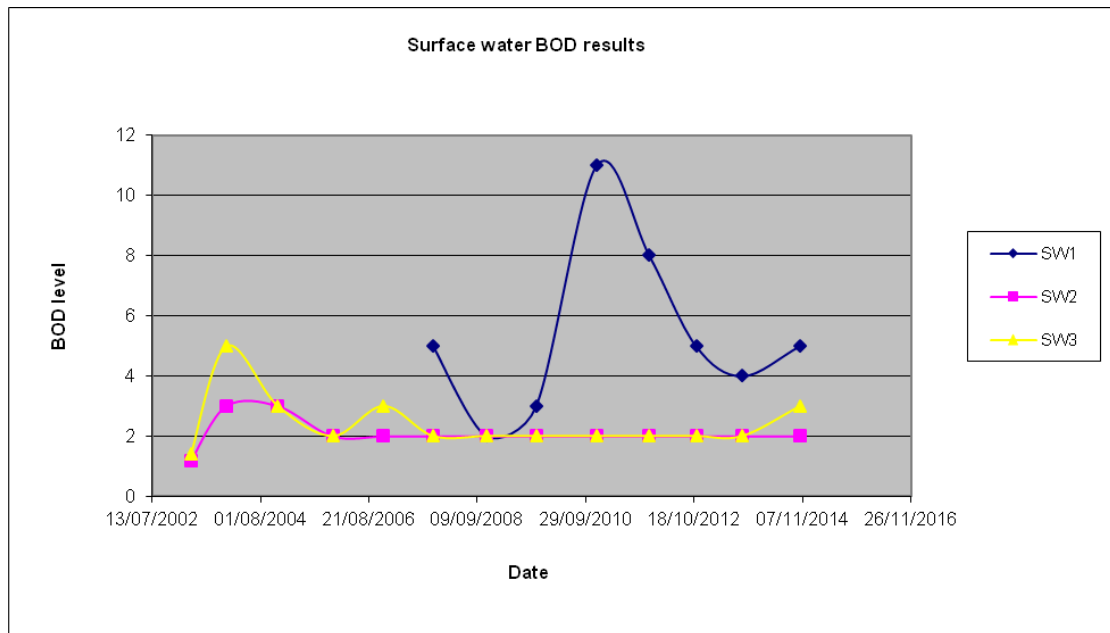
Figure 6.2

BOD results for surface water locations at this site continue to remain low, stable and are well below the proposed Environmental Quality Standard of 5ppm as displayed in Figure 6.2.
