Ballymount Solid Waste Recycling and Baling Centre and Civic Amenity

Waste Licence Reg. No.W0003-03

Annual Environmental Report 1st January 2014 – 31st December 2014

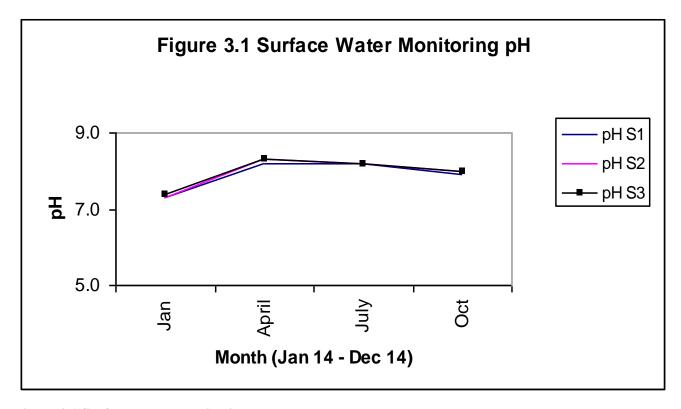
Figure 3.1 Surface Water Monitoring - pH

The surface water monitoring results for grab samples taken downstream of the facility at S2 and S3 during the reporting period 1st January to 31st December 2014 were fully compliant.

The background surface water monitoring results indicate that the levels of analyses detected downstream of the facility did not exceed the values detected upstream in 2014.

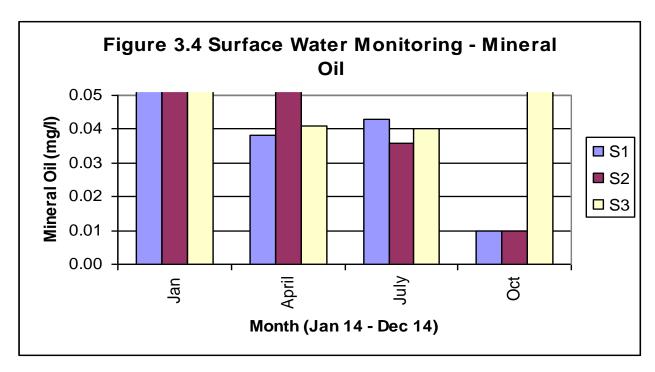
Figure 3.4 Surface Water Monitoring - Mineral Oil (ELV 10mg/l)

(Mineral Oil detectable limit: 0.04mg/l)

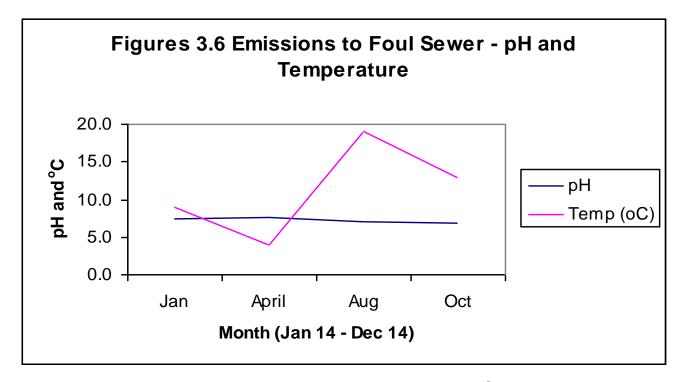
Figure 3.6 Emissions to Foul Sewer - pH and Temperature (ELV 5-10 & 42°C)

^{*}Average temperature taken for January and October

pH results were typically neutral to alkaline during the reporting period.

Temperature was recorded on a.. occasions during the reported period. The temperatures recorded were within the specified limits as set out in Schedule C.4 of the Waste Management Licence. The temperature recorded for this reporting period ranged between 10 and 21° C.

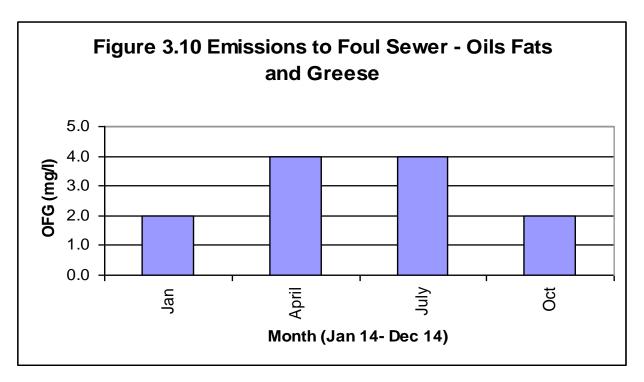
Figure 3.10 Emissions to Foul Sewer - Oils Fats and Grease (ELV 100mg/l)

(OFG detectable limit: <2mg/l)

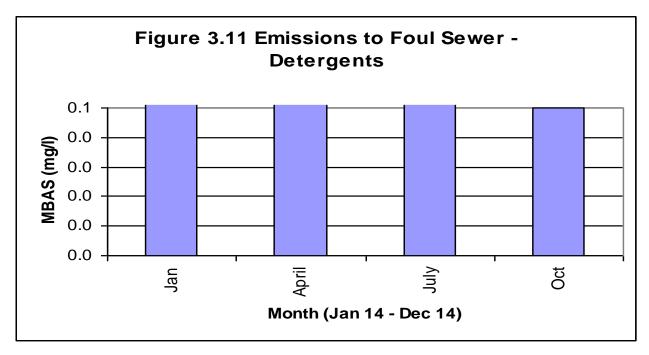
Figure 3.11 Emissions to Foul Sewer – Detergents (ELV 100mg/l)

(Detergents detectable limit: <0.05mg/l)

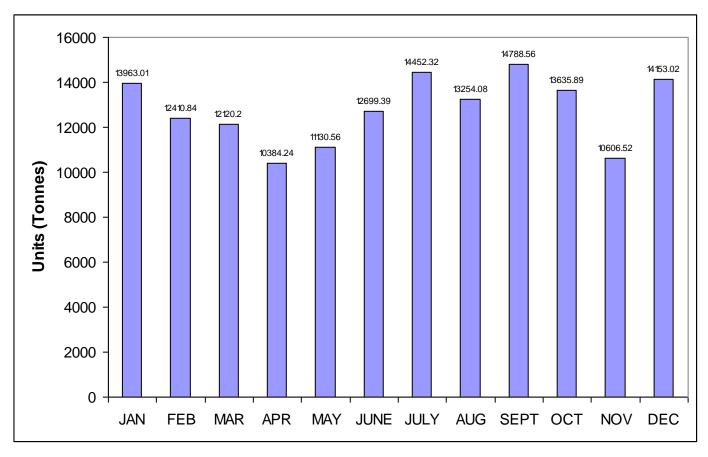
Figure 5.1 Monthly Waste Quantities to Incineration 2014

Monthly quantities of treated, baled and wrapped waste sent to incineration as EWC 191212 are shown in Figure 5.1.

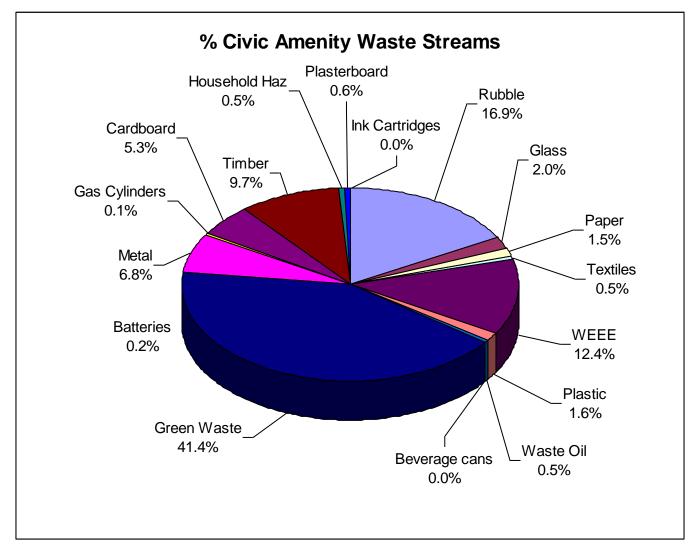
Figure 5.2 Recyclable Waste Types Received at the Civic Amenity Facility

The Civic Amenity Facility is a waste deposit facility for recyclable and non-recyclable waste delivered by members of the general public. Receptacles are provided for the deposit of glass, textiles, plasterboard, rubble, household hazardous, waste oil, paper, green waste, waste oil, batteries, beverage cans, plastics, scrap metal and white goods/ electrical items. Quantities of each of these wastes received are shown in Table 5.2 and Figure 5.2.

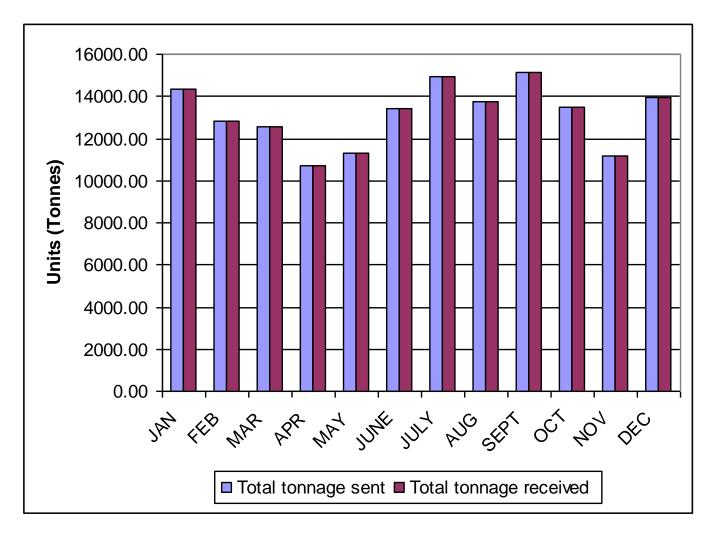
Figure 5.3 Tonnage Received and Sent in 2014 to the Baling Station and to Incineration or recovery

Waste received at the baling facility during the reporting period amounted to 157,685.70 tonnes, which is 166,794.30 tonnes below the Licence limit of 324,480 tonnes per annum

The following figure is a summary of the waste movements to and from the facility. Small differences in quantities entering and leaving the site are due to the 4% allowed tolerance error on the weighbridge (Class III accuracy: Source EN45501: 1992).
