## ATTACHMENT L1 – STATUTORY REQUIREMENTS

### COMPLIANCE WITH SECTION 40(4) WASTE MANAGEMENT ACTS 1996-2008

**Huntstown Inert Waste Recovery Facility  
North Quarry, Huntstown  
Finglas, Dublin 11**

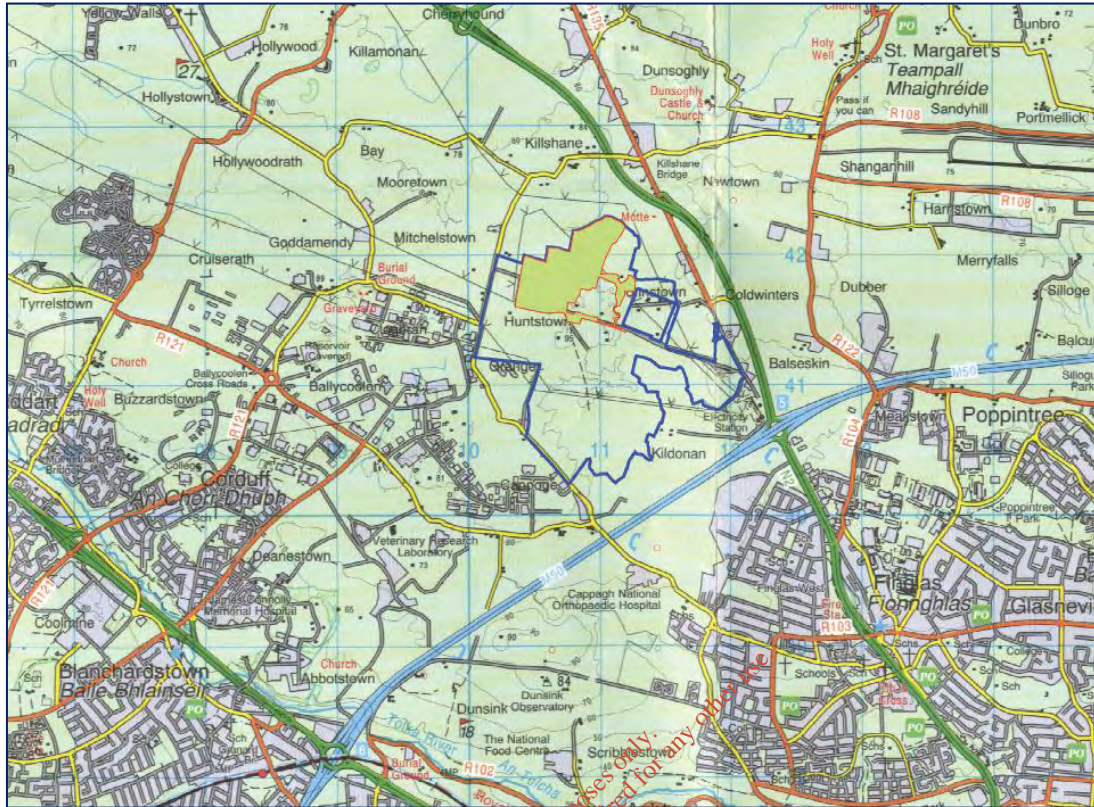
**Figure 1**  
**Site Location**

The waste licence facility is located entirely within a large active quarry complex and adjoins concrete and asphalt production facilities operated by Roadstone Ltd. The waste facility covers an area of approximately 36.1 hectares (87.0 acres) and comprises a largely worked-out limestone quarry with perimeter screening / overburden mounds, together with established site infrastructure required to operate the inert waste / soil recovery facility. The existing site layout, together with additional infrastructure required to support waste recovery activities, is shown in Figure 2.

Ground levels across the licensed facility have been significantly disturbed by previous quarrying activities. The original ground levels around the worked-out quarry vary between approximately 62mOD and 66mOD (Malin) along the eastern face and between 80mOD and 85mOD along the western face. Existing ground levels immediately behind the quarry faces are locally 5m to 10m higher than surrounding ground due to the presence of perimeter screening mounds.

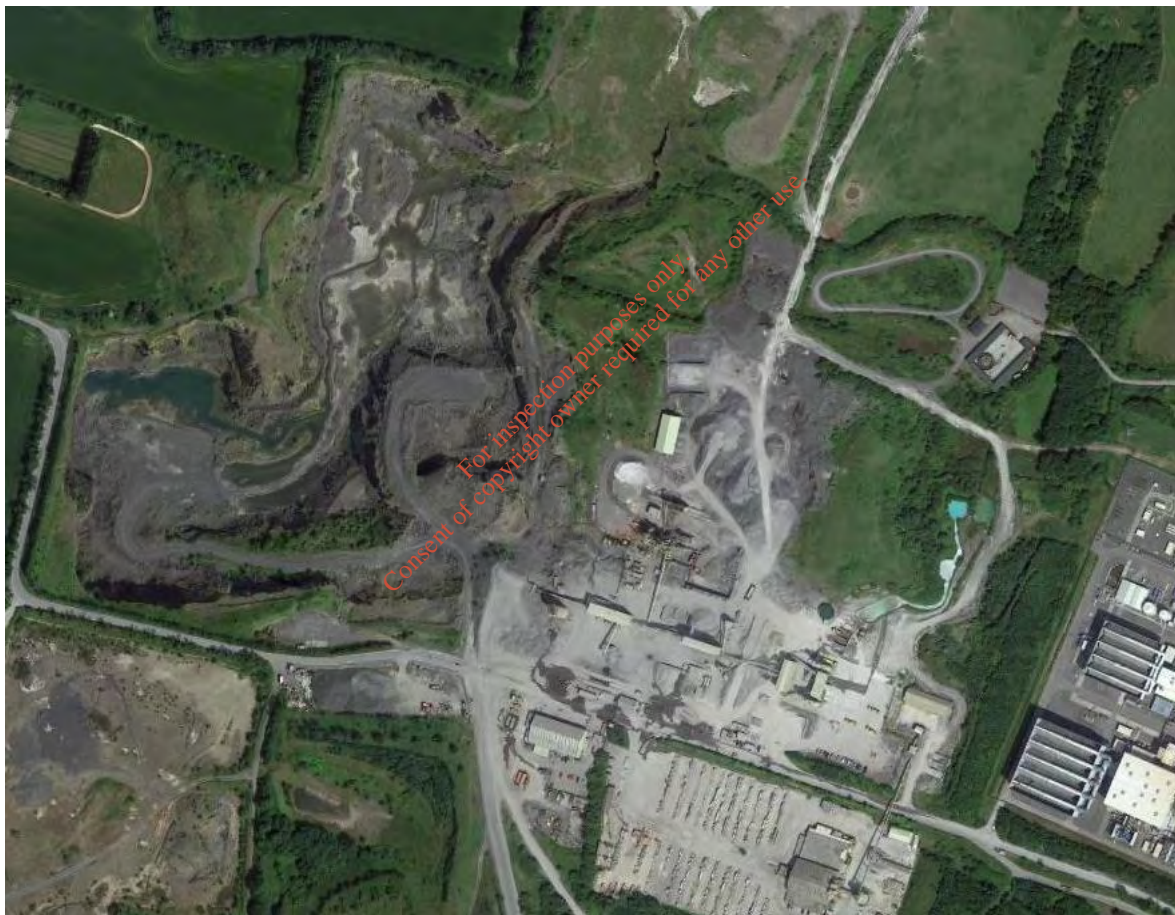
**Plate 1**  
**Aerial View of Site from Google Earth (July 2013)**

The existing quarry void covers an area of approximately 11.2 hectares (27.0 acres) within the licensed site area and is shown on Plate 1 below, in an aerial view from Google Earth dated July 2013.

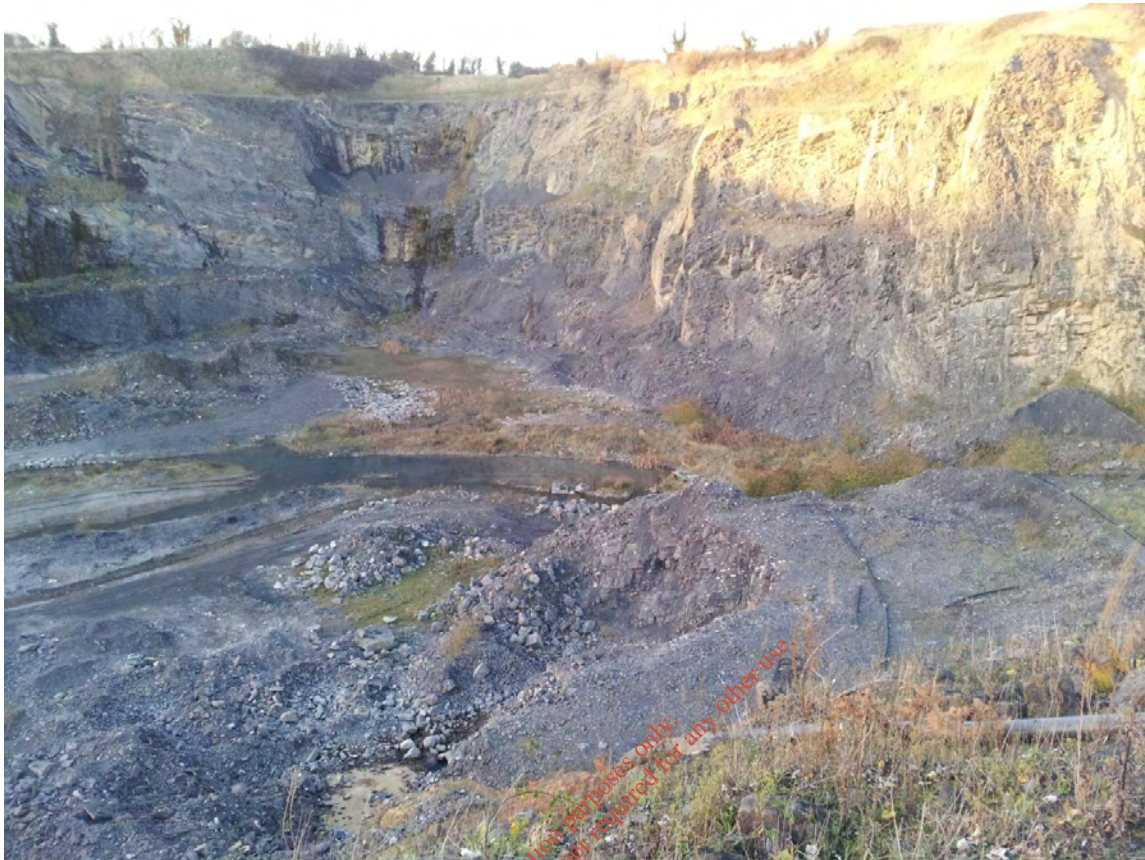
**Plate 2**  
**View of North Quarry Void in December 2013**

The proposed recovery of inert soils at the North Quarry will provide for complete backfilling of a large open void above the groundwater table, facilitate the restoration of the lands to agricultural use and improve protection to the underlying groundwater resource, which is currently classified as 'extremely vulnerable' due to the absence of any protective soil cover. Plate 2 overleaf shows the quarry void in December 2013.
