Clare County Council

Waste Licence W0170-01

Annual Environmental Report for 2016

**Name & location of facility: Lisdeen Recycling Centre &
Transfer Station, Cemetery Road,
Lisdeen, Kilkee, Co. Clare**

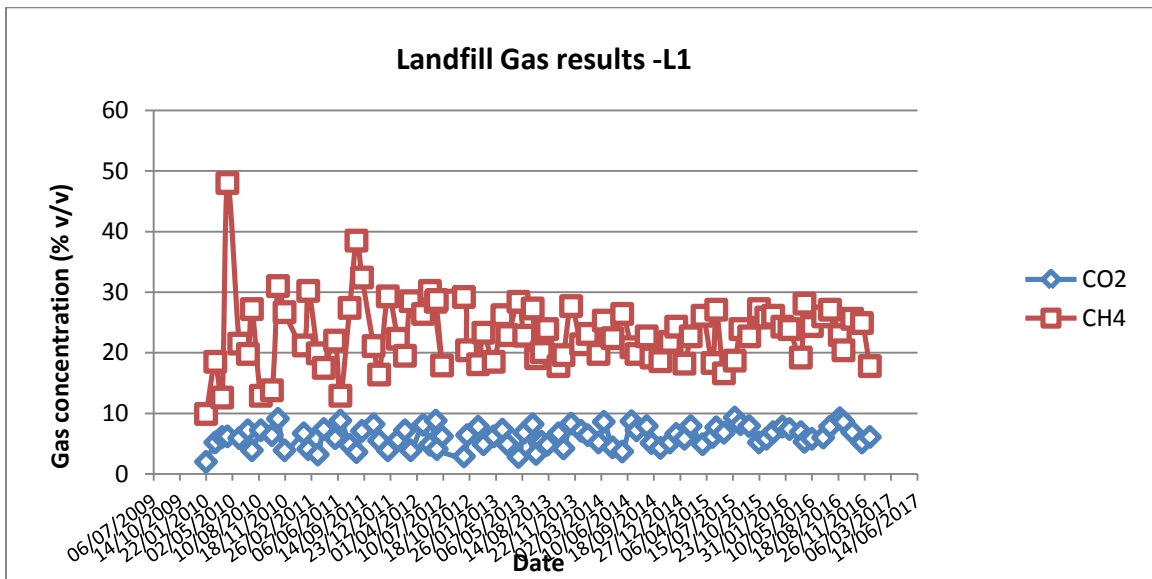
Figure 7.1:

Both gas wells are located in waste; L2 is located in the centre of the waste body and L1 is close to the northwest site boundary

The methane concentration at L1 is significantly higher than at L2. The trend during 2016 was in line with historic monitoring within the site. Carbon dioxide levels for the the year were similar at both locations with levels <10% v/v.
