ENVIRONMENTAL LIABILITIES RISK ASSESSMENT (ELRA) FOR NENAGH WASTE TRANSFER STATION, SPRINGFORT CROSS, NENAGH, CO. TIPPERARY

W0240-01

OCTOBER 2016

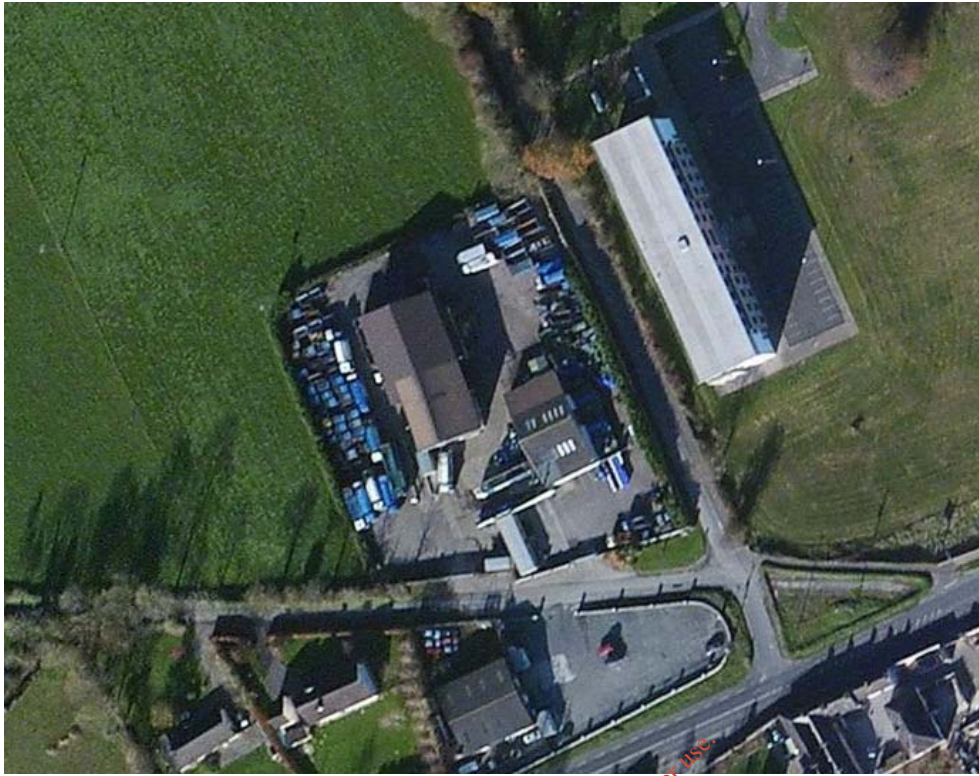
Figure 2-2: Site Layout (centre of image)

Waste vehicles access the facility through a c. 8 m gated entrance. Access is off the local Kilcolman Road junction on the R445 road. After entering through the access gate, vehicles travel directly onto a weighbridge for weighing at the portacabin offices, prior to travelling along the western flank and northern side of the processing building to access the processing building on the eastern flank. A second entrance, located on the southern boundary of the site, facilitates visitors and customers arriving the facility.

Carparking is provided to the southwest of the site adjacent to portacabin offices. Truck parking is facilitated east of the waste vehicle entrance

A bunded diesel tank is located along the northern side of the processing building to facilitate vehicle refuelling.

There are two access points to the processing building on the eastern flank; one that allows for the filling of high sided trailers at a lower level and one that allows for the emptying of loads within the main body of the building.

A ramp on the external eastern flank of the building allows for the loading of skips and hooklifts for glass, timber etc.

A vehicle maintenance shed is located to the south east of the processing building where vehicle upkeep is undertaken.

A washing area directly south of the processing building is used for the washing of bins, containers and vehicles.

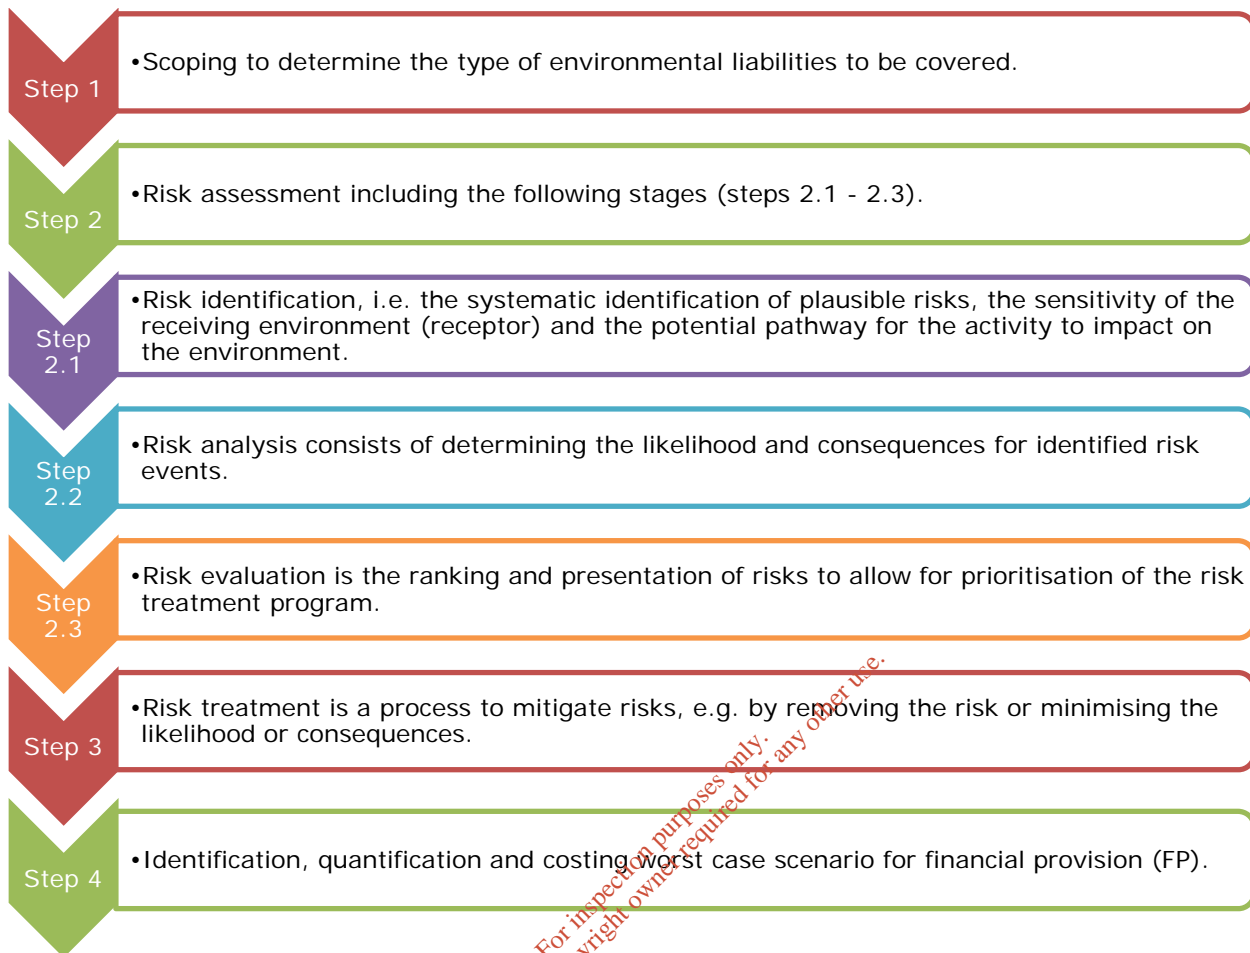
Figure 3-2: Environmental Liability Risk Assessment Process

The ELRA procedure is set out in Figure 3-2.

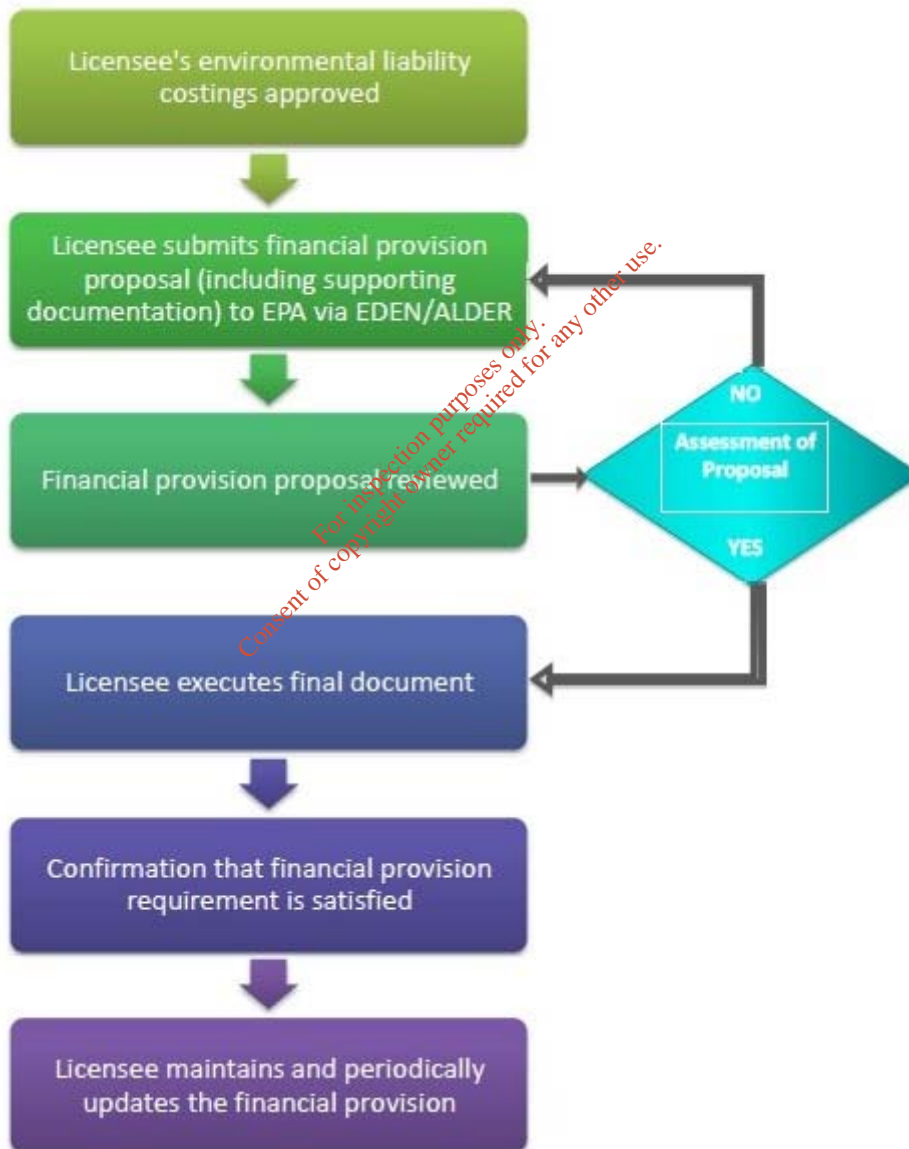
Figure 4-1: Steps in Financial Provision assessment process

The EPA prepared draft guidance on the matter of financial provision in 2014, entitled “*Draft Guidance on Financial Provision*”. The steps in the agreement of the financial provision assessment process are shown in Figure 4-1.
