Subject: FW: Kingscourt Landfill
Attachments: CCC-08-01-03-GAS-Rev 0.pdf; CCC-08-01-03-GAS-Rev 0 (002).pdf; Gas Monitoring.xlsx

GAS MONITORING REPORT KINGSCOURT LANDFILL 2017

Project Name: Kingscourt Landfill
Dunaree,
Co. Cavan

GAS MONITORING REPORT KINGSCOURT LANDFILL 2018

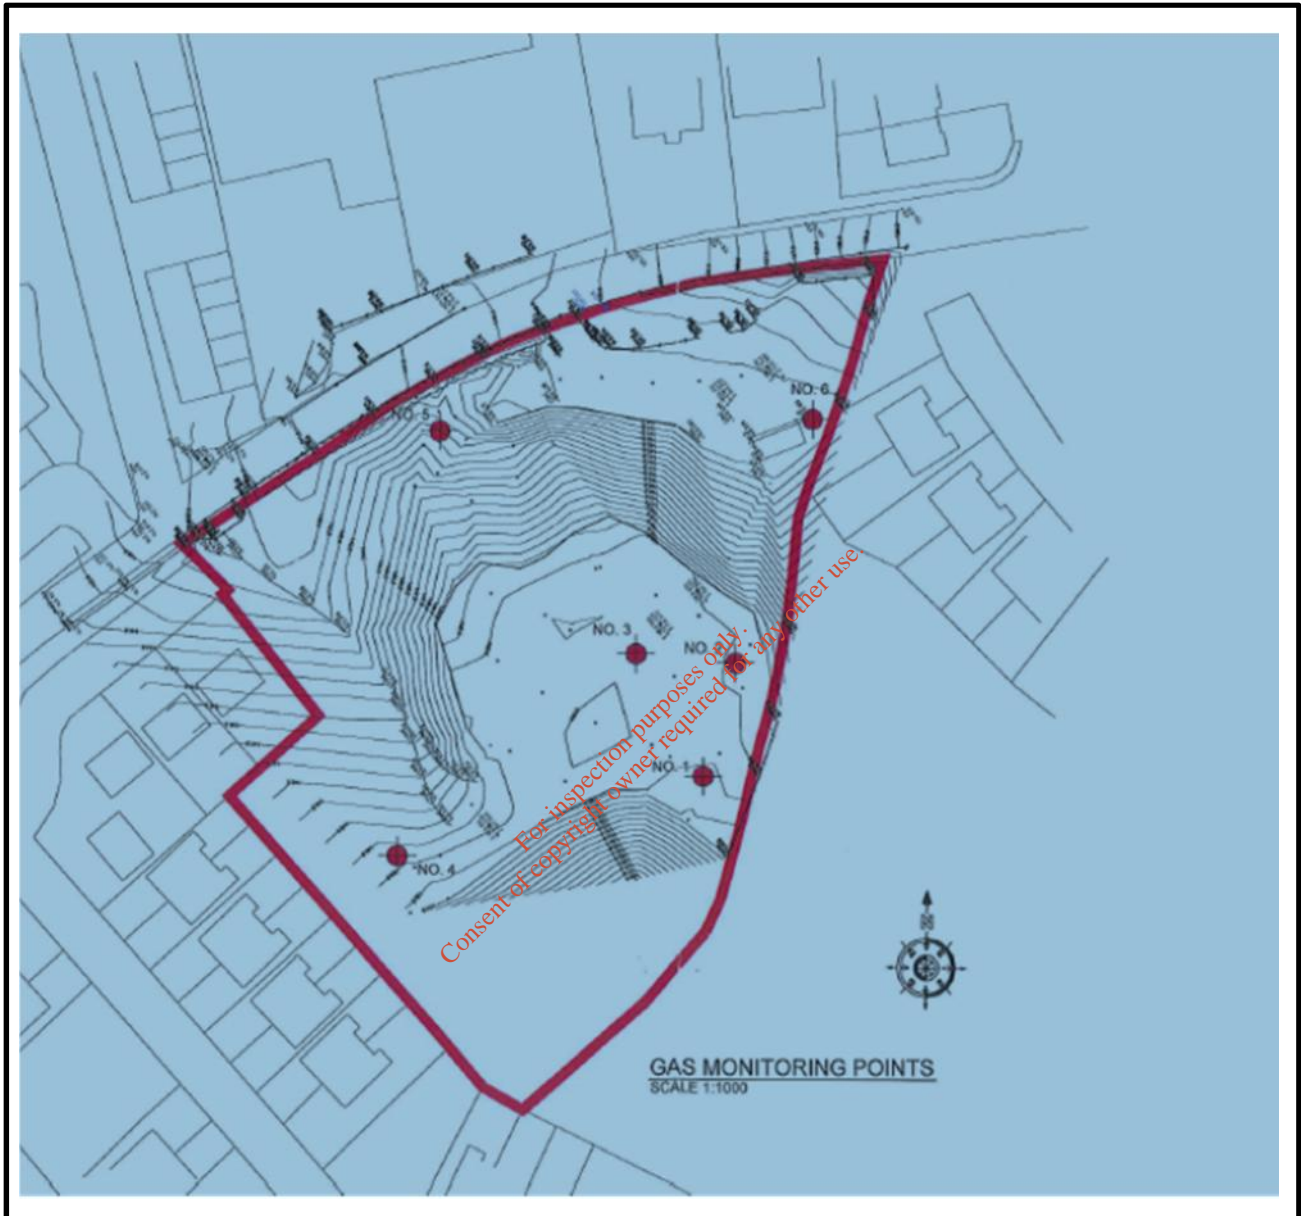
Figure 1 – Gas monitoring locations

The gas monitoring locations for December 14th 2017 are presented in the Figure 1 below.

It should be noted that the monitoring plan presented in Figure 1 outlines that MW4 may be located inside the waste mass. Monitoring at this location returned a concentration of 7.3 % v/v, however, a review of historic OSI maps indicate that this area is located within the quarry site and therefore infilling may have occurred here also.

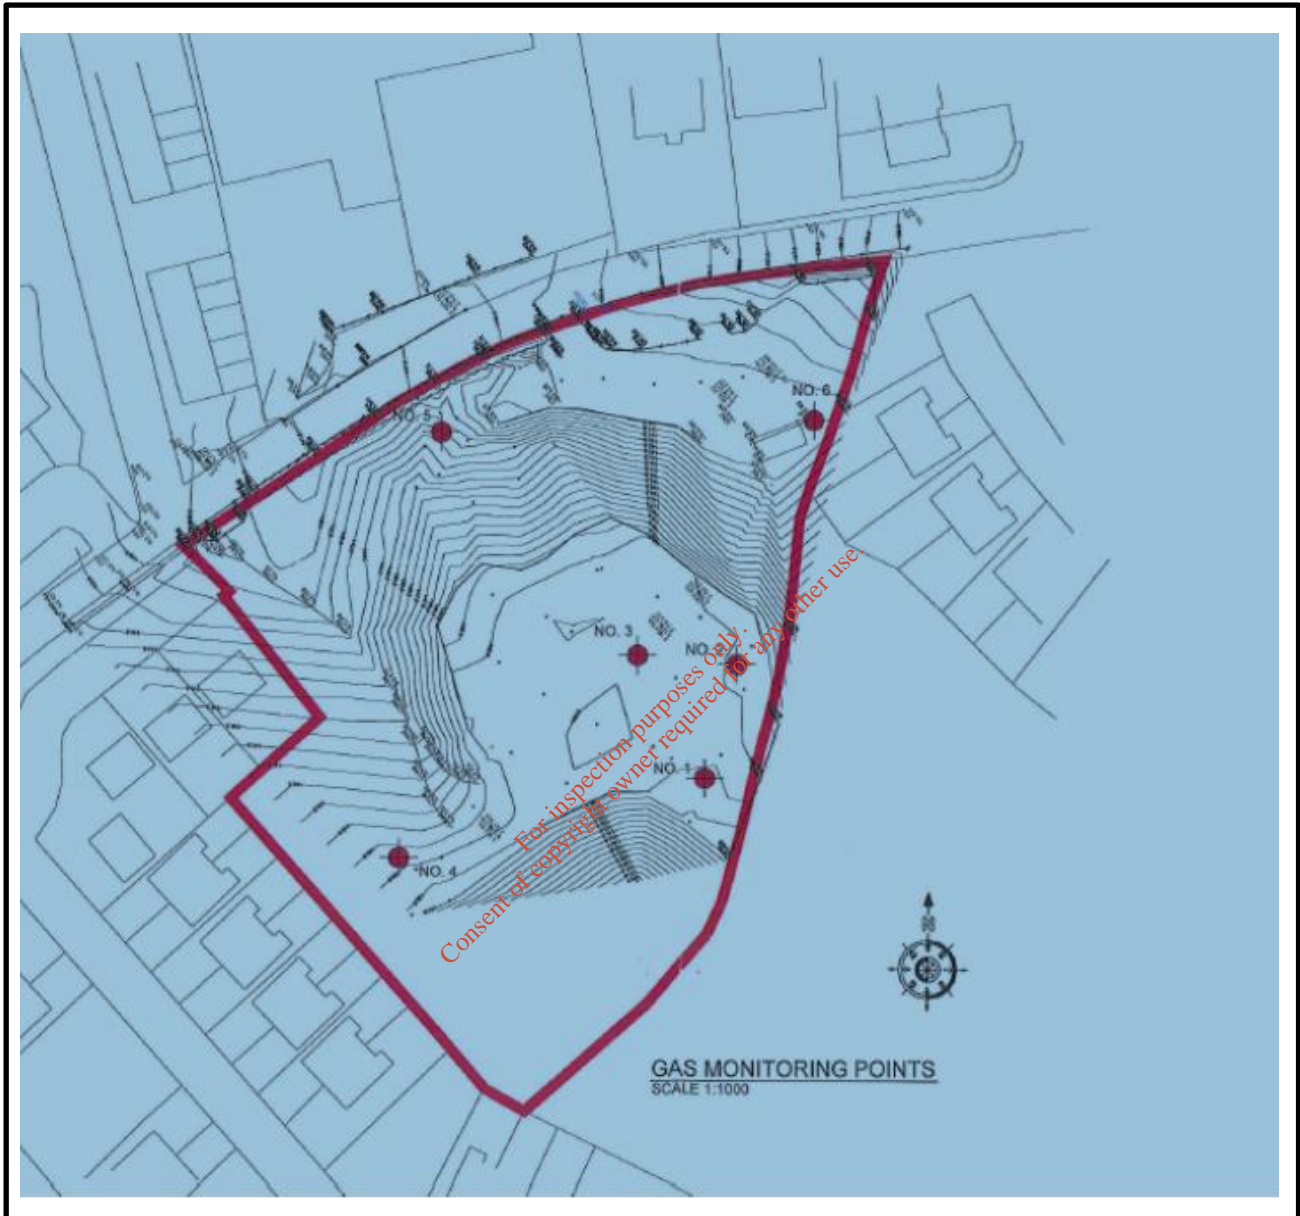
Figure 1 – Gas monitoring locations

The gas monitoring locations for October 11th 2018 are presented in Figure 1 as shown below.

It should be noted that the monitoring plan presented in Figure 1 outlines that MW4 may be located inside the waste mass. MW4 could not be located during the monitoring event. A review of historic OSI maps indicate that this area is located within the quarry site and therefore infilling may have occurred here.
