Article 6(3) Appropriate Assessment Screening Report

Kellysgrove Bog, Co Galway
Decommissioning and
Rehabilitation 2021

**KELLYSGROVE BOG CUTAWAY BOG
DECOMMISSIONING AND
REHABILITATION PLAN 2021**

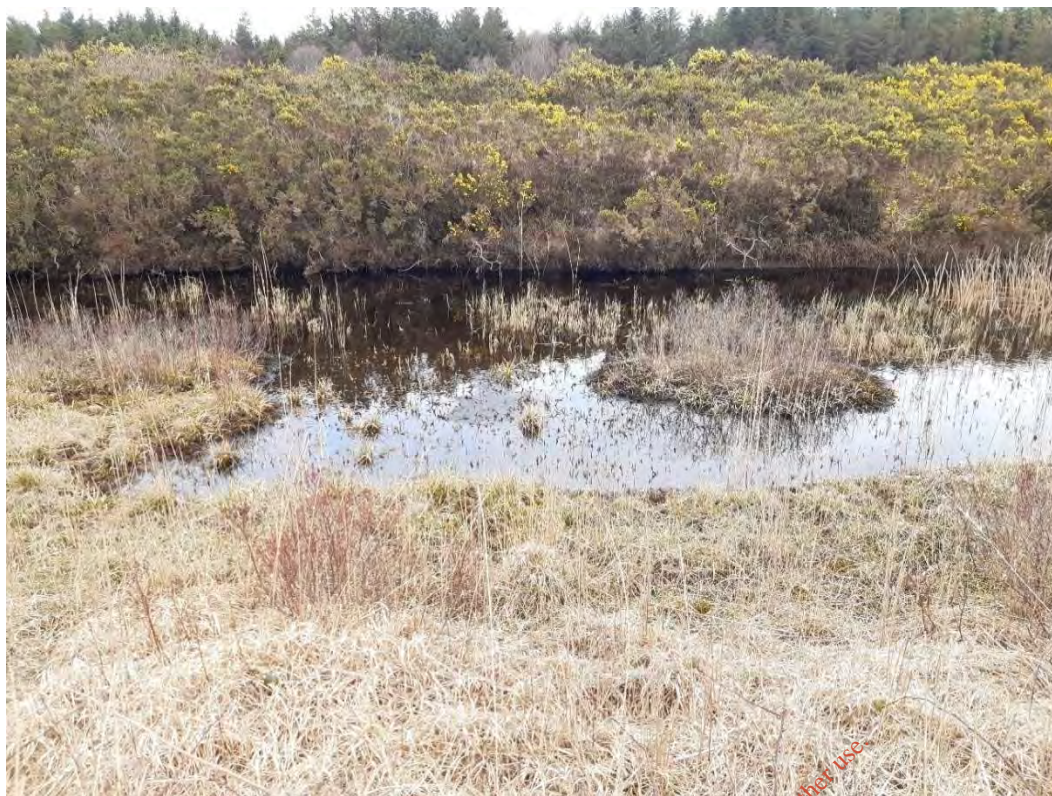
Figure 3.7 View of the old Ballinasloe Canal showing emergent vegetation (Apr 2020)

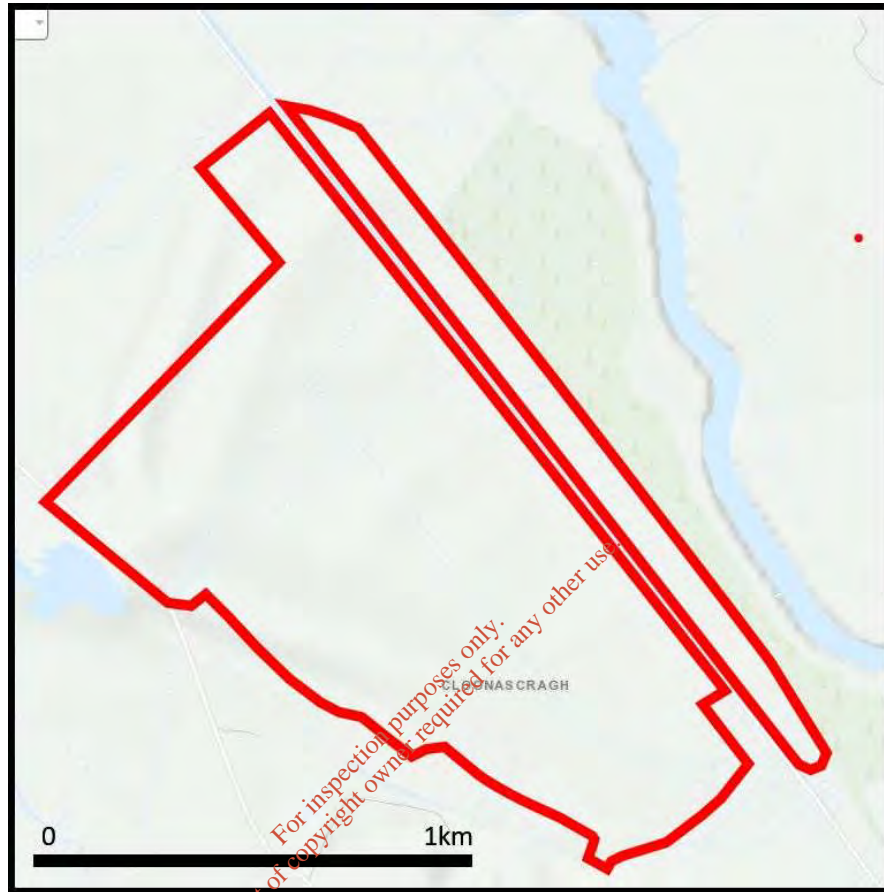
Fig. 2. Kellysgrove Bog, Co. Galway, detail of the Sites and Monuments Record. The proposed rehabilitation area is outlined with the redline. There are no SMRs in the area.

publication of the RMP. This review established that there are no monuments entered in the SMR in the proposed rehabilitation area (See Fig. 2).

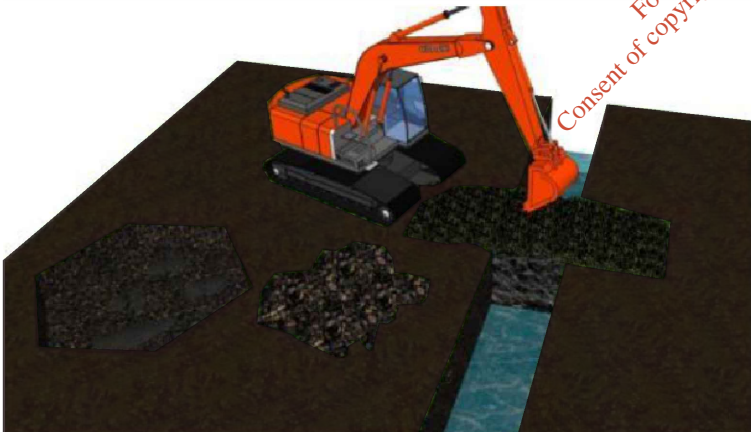
5. Build the drain block up at least 300mm-500mm above the ground level of the bog to allow for subsequent shrinkage of the peat as it dries.
(Take any vegetation removed in step 1 and step 3 and place on the top of the dam, to help bind and stabilise the drain block.)
