Geotechnical Report

Historical Landfills in Mid Kerry - Castleisland

Report No.: 18-1102b

Date: September 2019

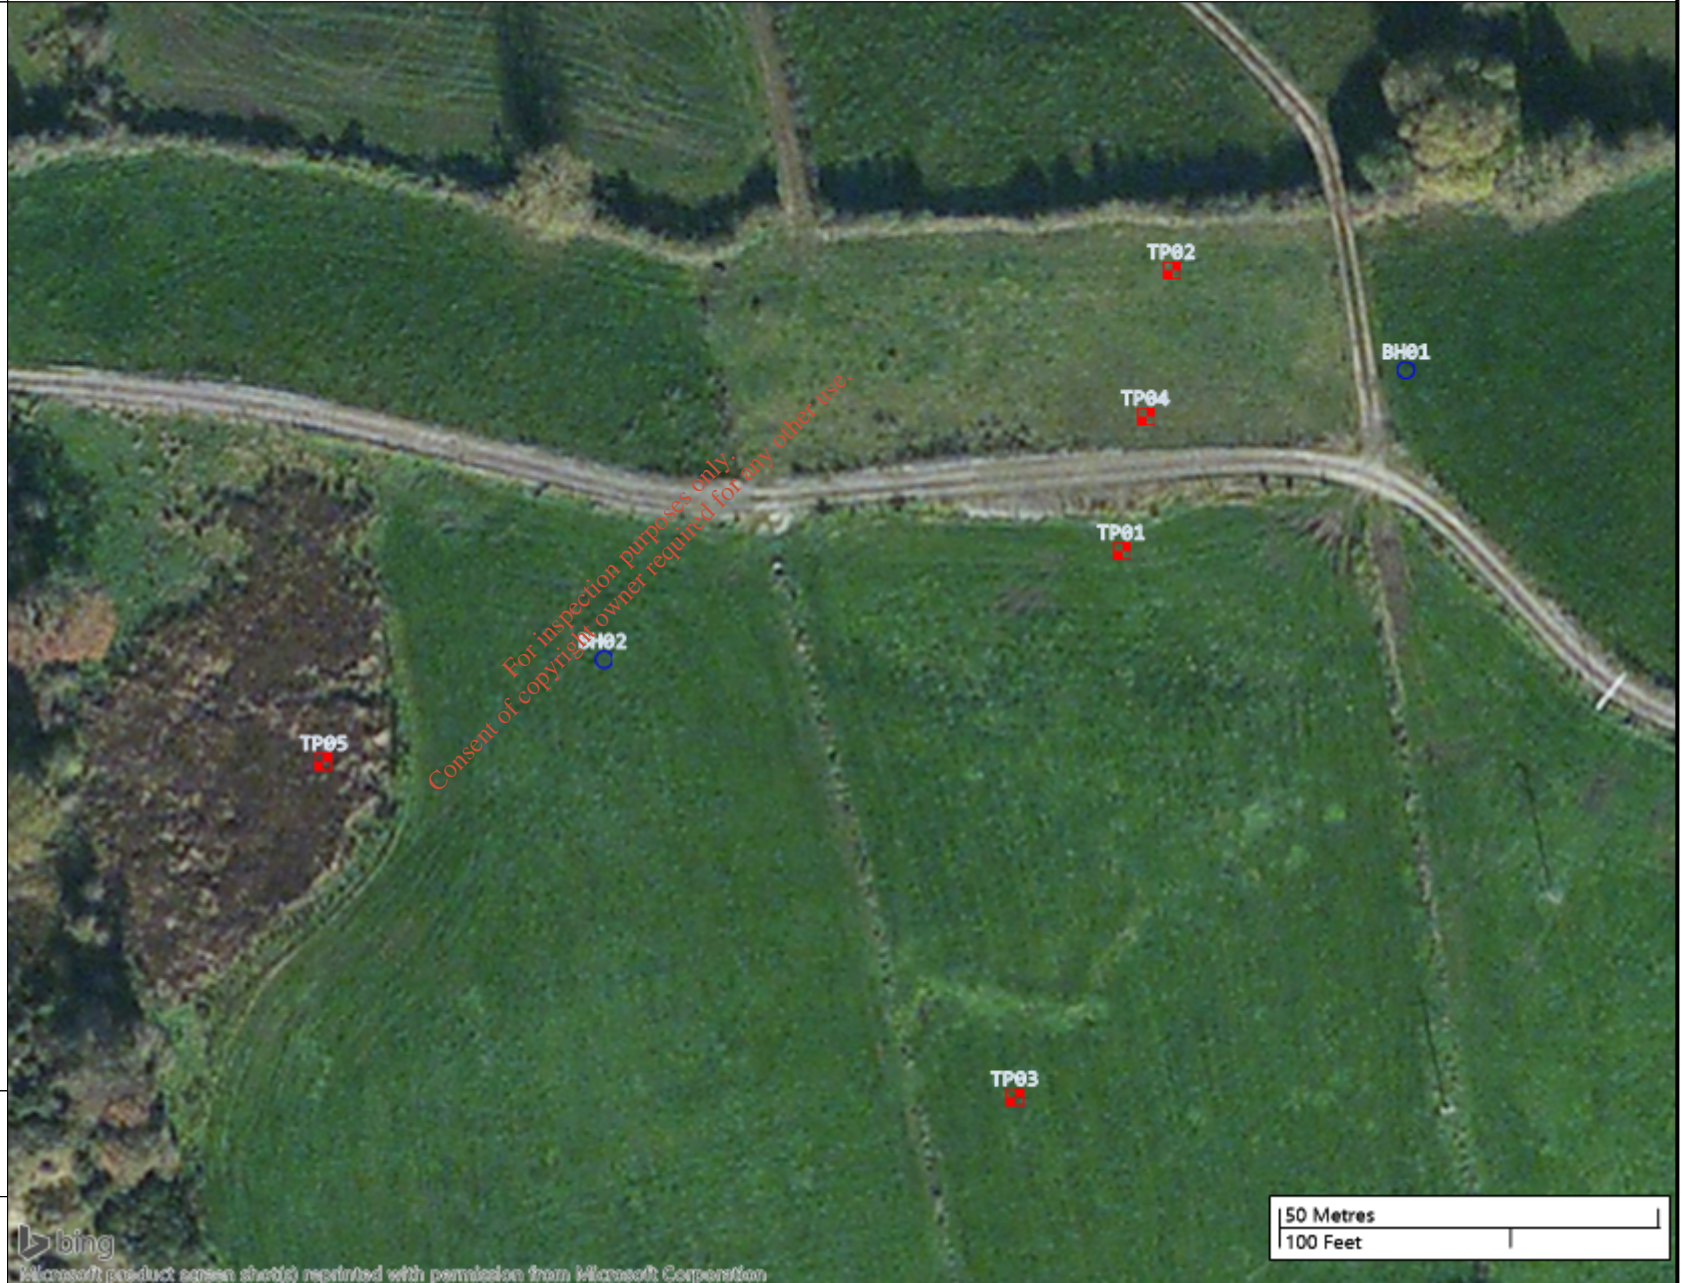
Title:
Exploratory Hole Location Plan

- Locations By Type - RO
- Locations By Type - TP

The exploratory holes and in-situ tests were located as instructed by the Client's Representative, as shown on the exploratory hole location plan in Appendix A.

The plan coordinates (Irish National Grid) and ground elevation (mOD Malin) at each location are recorded on the individual exploratory hole logs. The exploratory hole plan presented in Appendix A shows these as-built positions.
