3. TIER 2 SITE INVESTIGATION

TITLE:	
Site Investigation Location Plan	
PROJECT:	
Gort Historic Landfill ERA	
FIGURE NO:	3.1
CLIENT:	Galway County Council
SCALE: 1:2,000	REVISION: 0
DATE: 15/10/2020	PAGE SIZE: A3

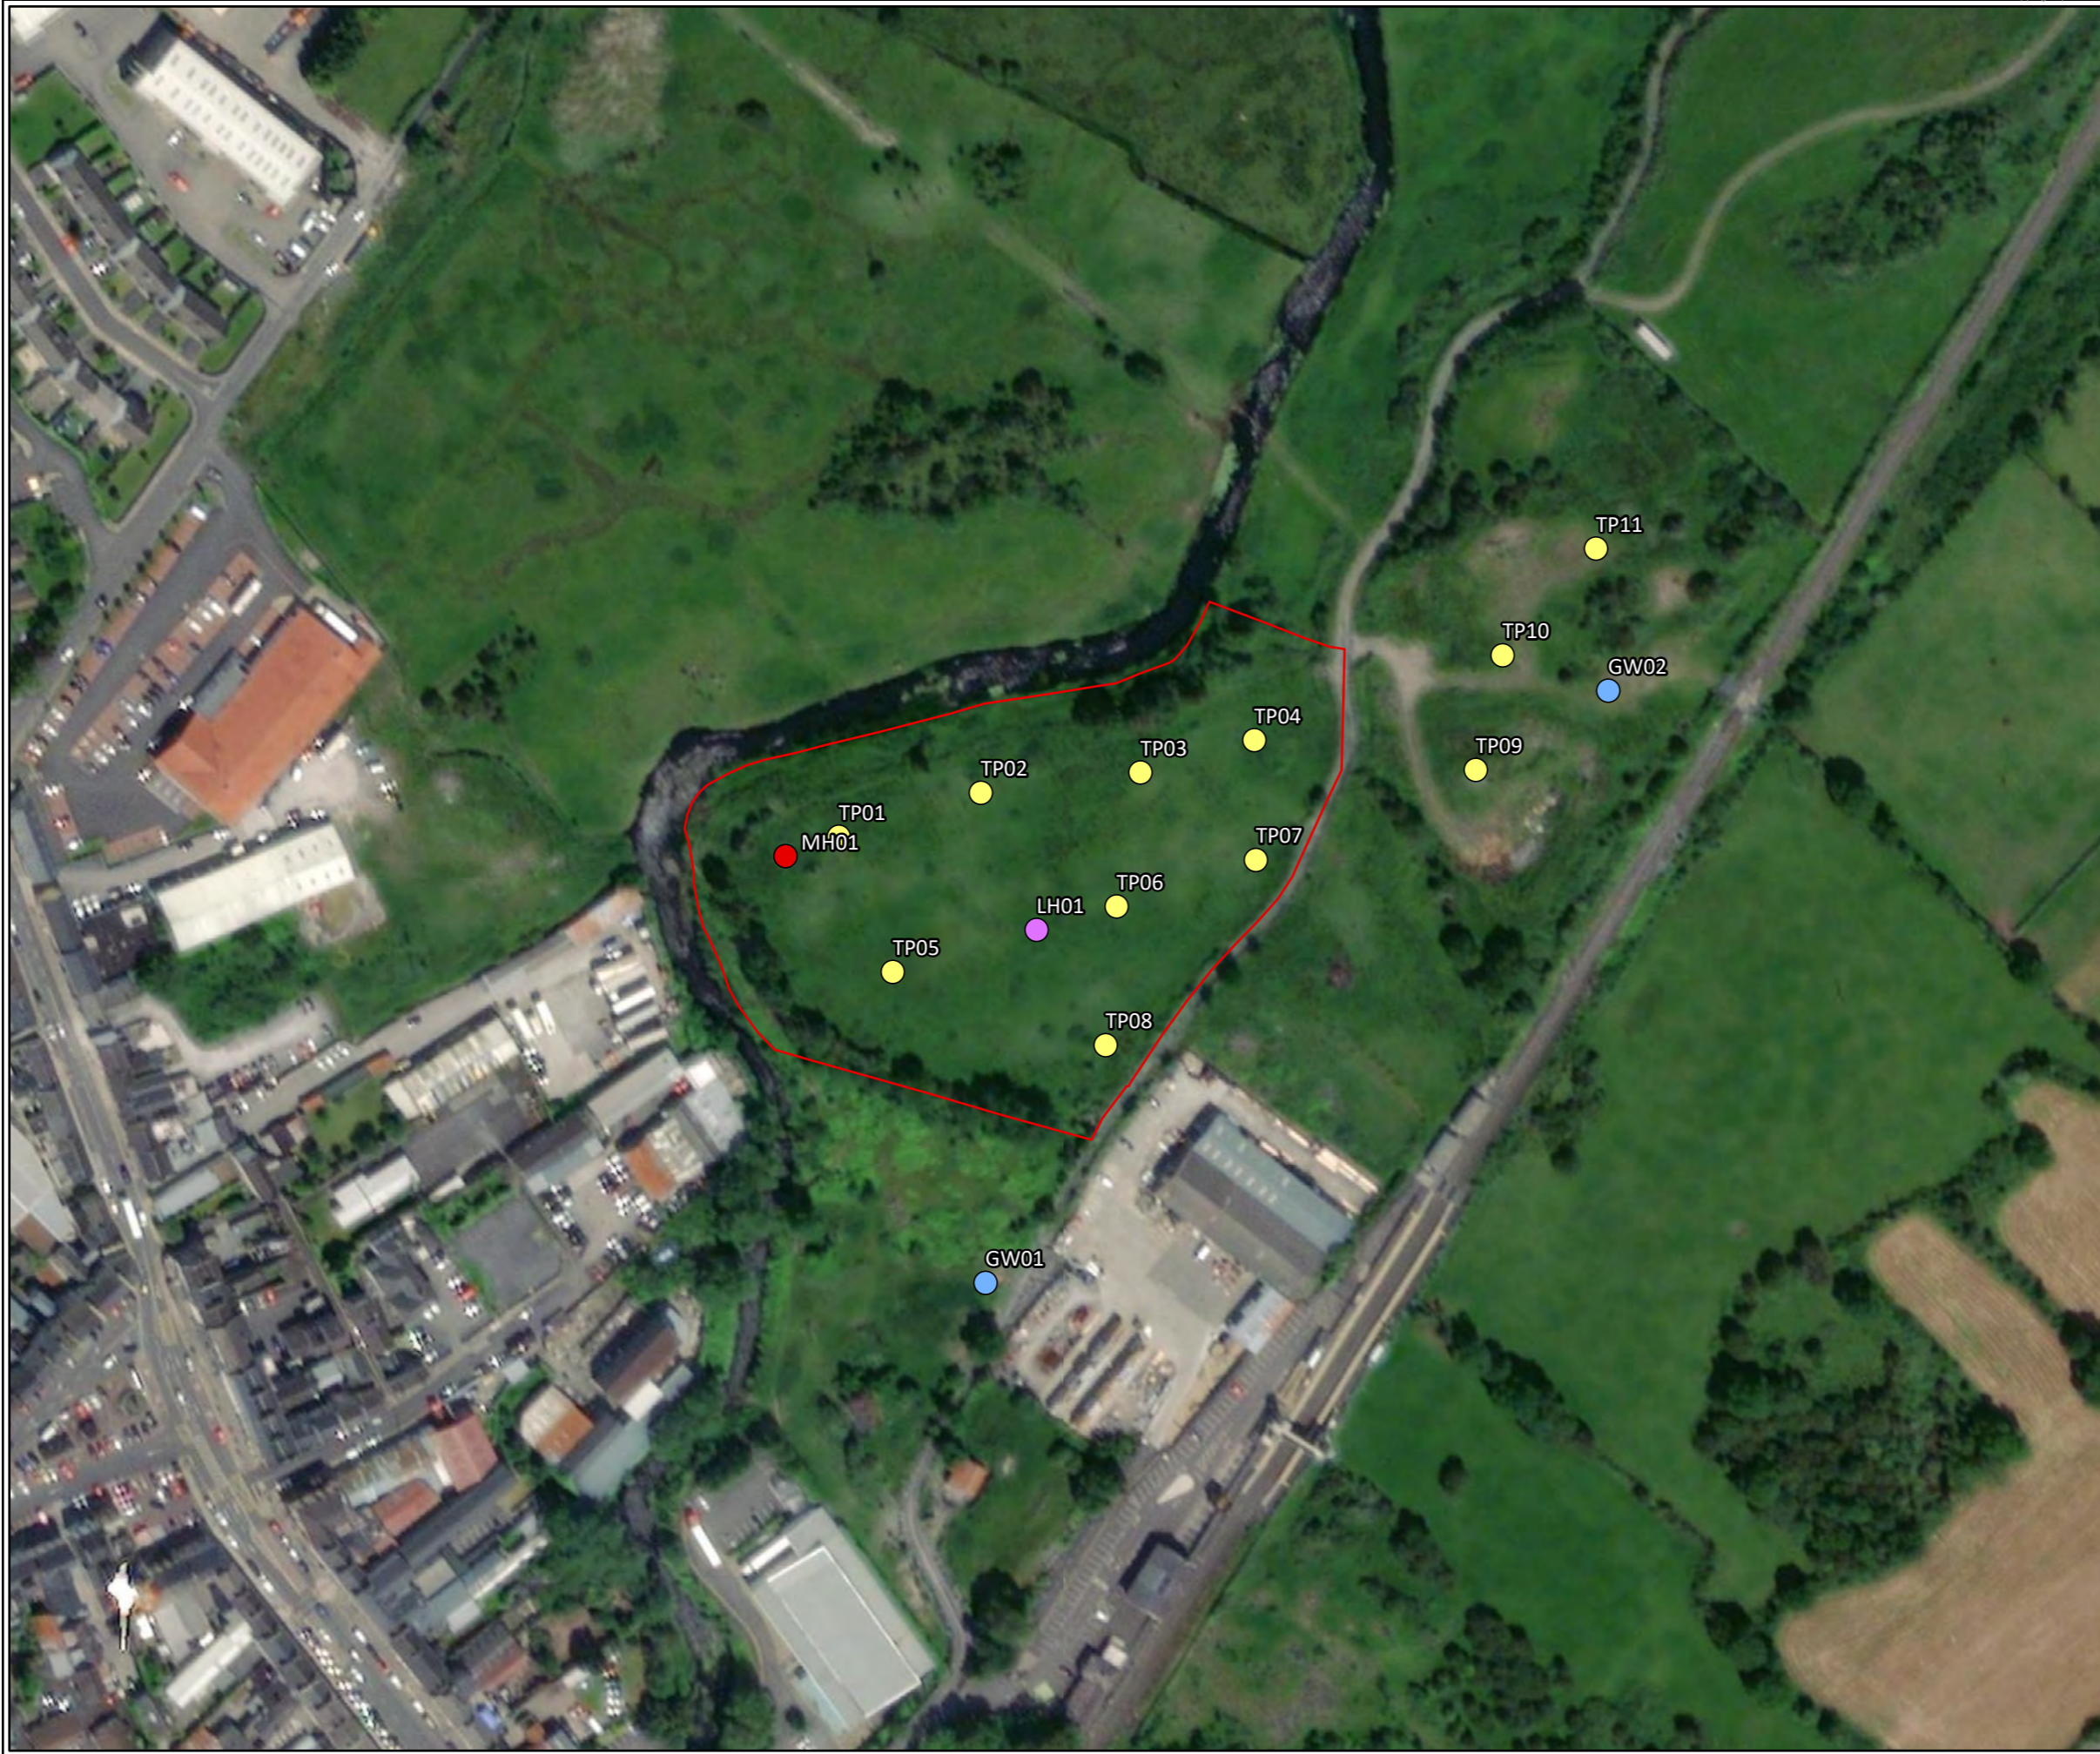
The locations of the intrusive works conducted at the site are presented in Figure 3-1.

- Site Boundary
- Groundwater Well
- Trial Pit
- Leachate Borehole
- Existing Leachate Collection Manhole

A Causeway Geotech (CGL) Engineering Geologist supervised the advancement of 11 No. trial pit, shown in Figure 3-1, on the 26th June 2020.

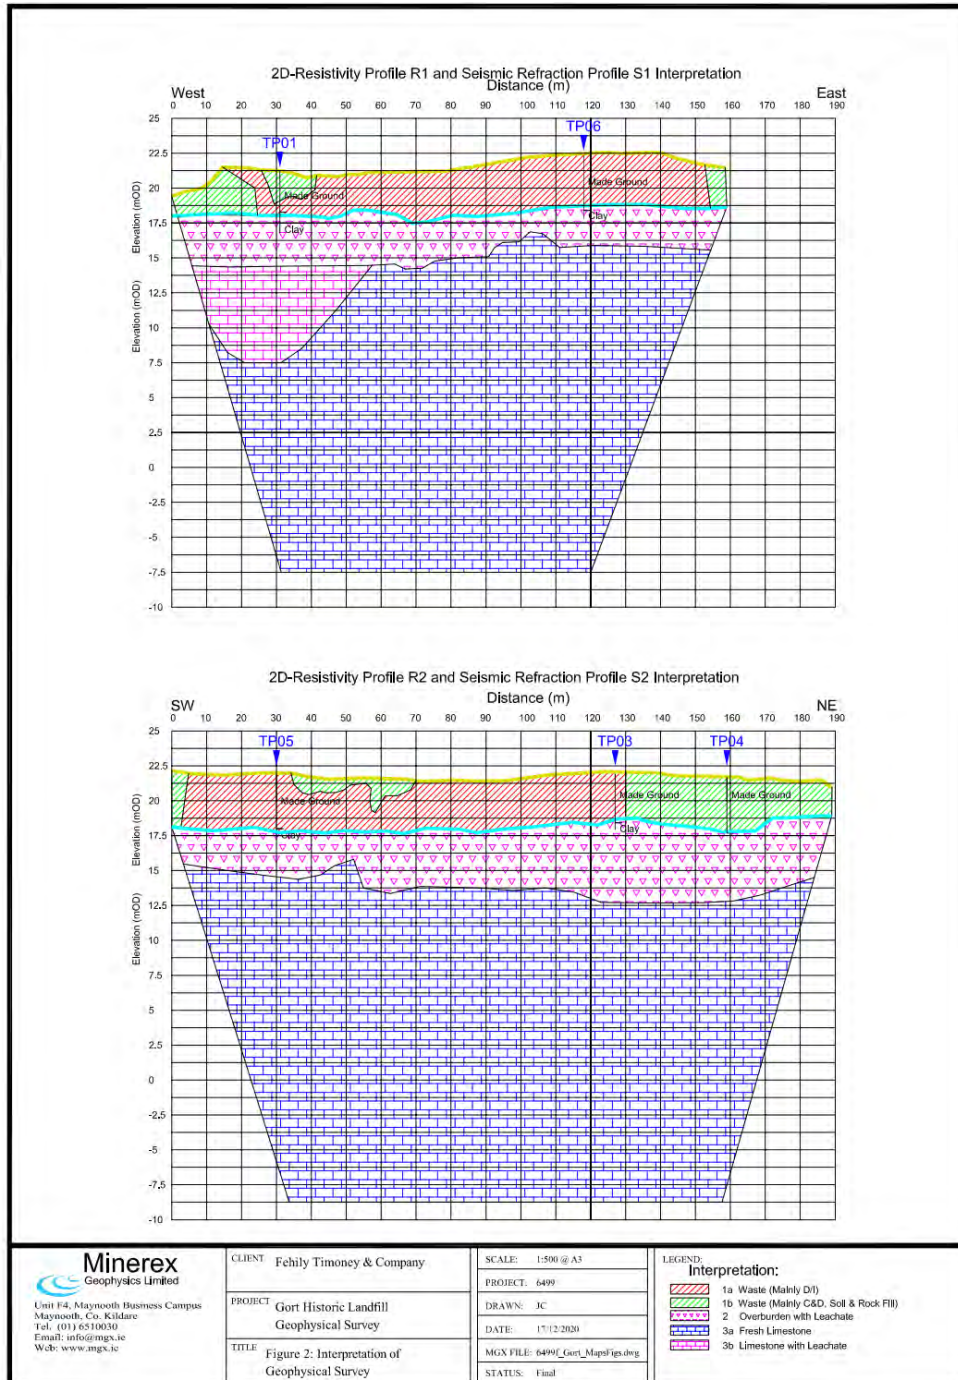
Figure 3-3: Integration of Geophysical Survey

A layered ground model was created from the modelled seismic data (See Figure 3-3):

Layers 1a and 1b have a seismic velocity range of 200 m/s and found in most of the survey area. This velocity would represent domestic and industrial waste and C&D or soil and rock fill, materials that have a lower velocity than the surrounding natural ground.

Layer 2 has a seismic velocity range of 1600 and 2000 m/s. This layer is interpreted as overburden material with leachate, and it is found in most of the survey area below layers 1a and 1b.

Layer 3a is interpreted as fresh Limestone and is found in most of the survey area, under layers 2 and 3b. This layer has N/A seismic velocity.

Layer 3b is interpreted as Limestone with Leachate and is found to the West of the survey area, under layer 2. This layer has N/A seismic velocity.

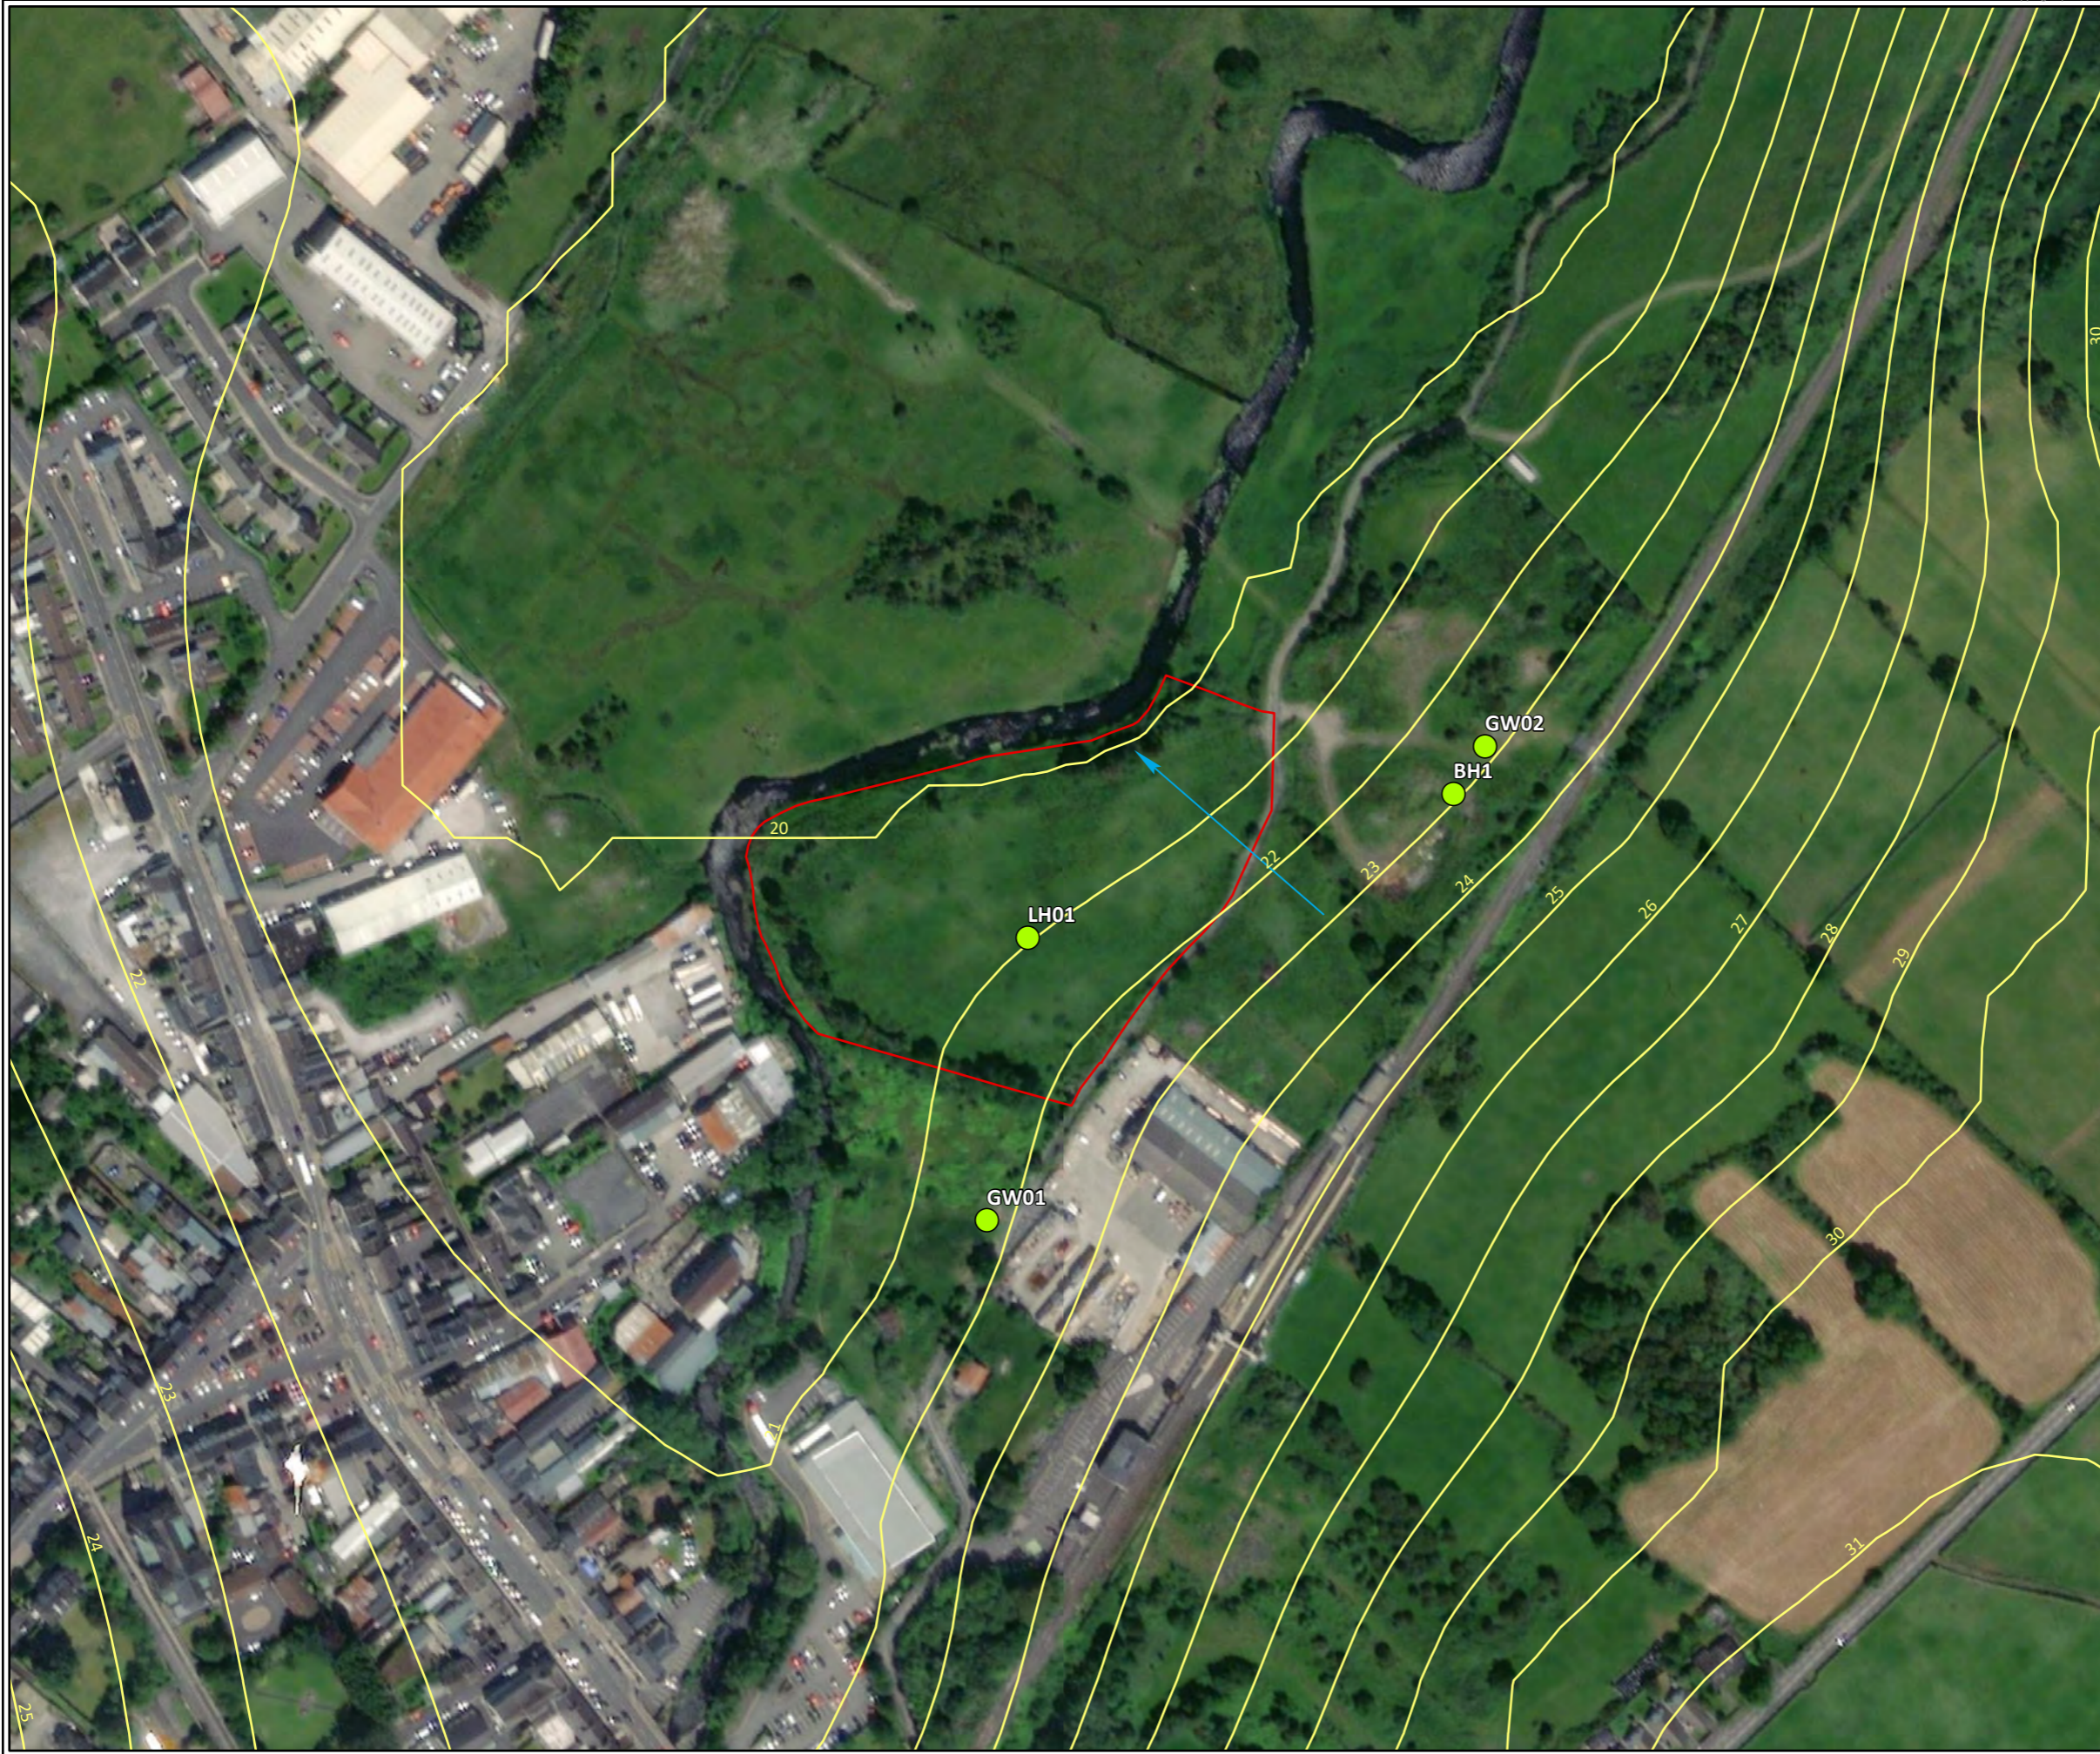
TITLE:	Groundwater Flow Direction		
PROJECT:	Gort Historic Landfill ERA		
FIGURE NO:	4.1		
CLIENT:	Galway County Council		
SCALE:	1:2,500	REVISION:	0
DATE:	15/10/2020	PAGE SIZE:	A3
		Cork Dublin Carlow www.fehilytimoney.ie

Based on the above field survey measurements, the groundwater flow direction is estimated to be south-east to north-west towards the River Gort and following the local topography. A potentiometric map illustrating the hydraulic gradient and the direction of groundwater flow is presented in Figure 4-1.

- Site Boundary
- Borehole Locations
- 1m Ground Elevation Contours
- ➔ Indicative Groundwater Flow Direction

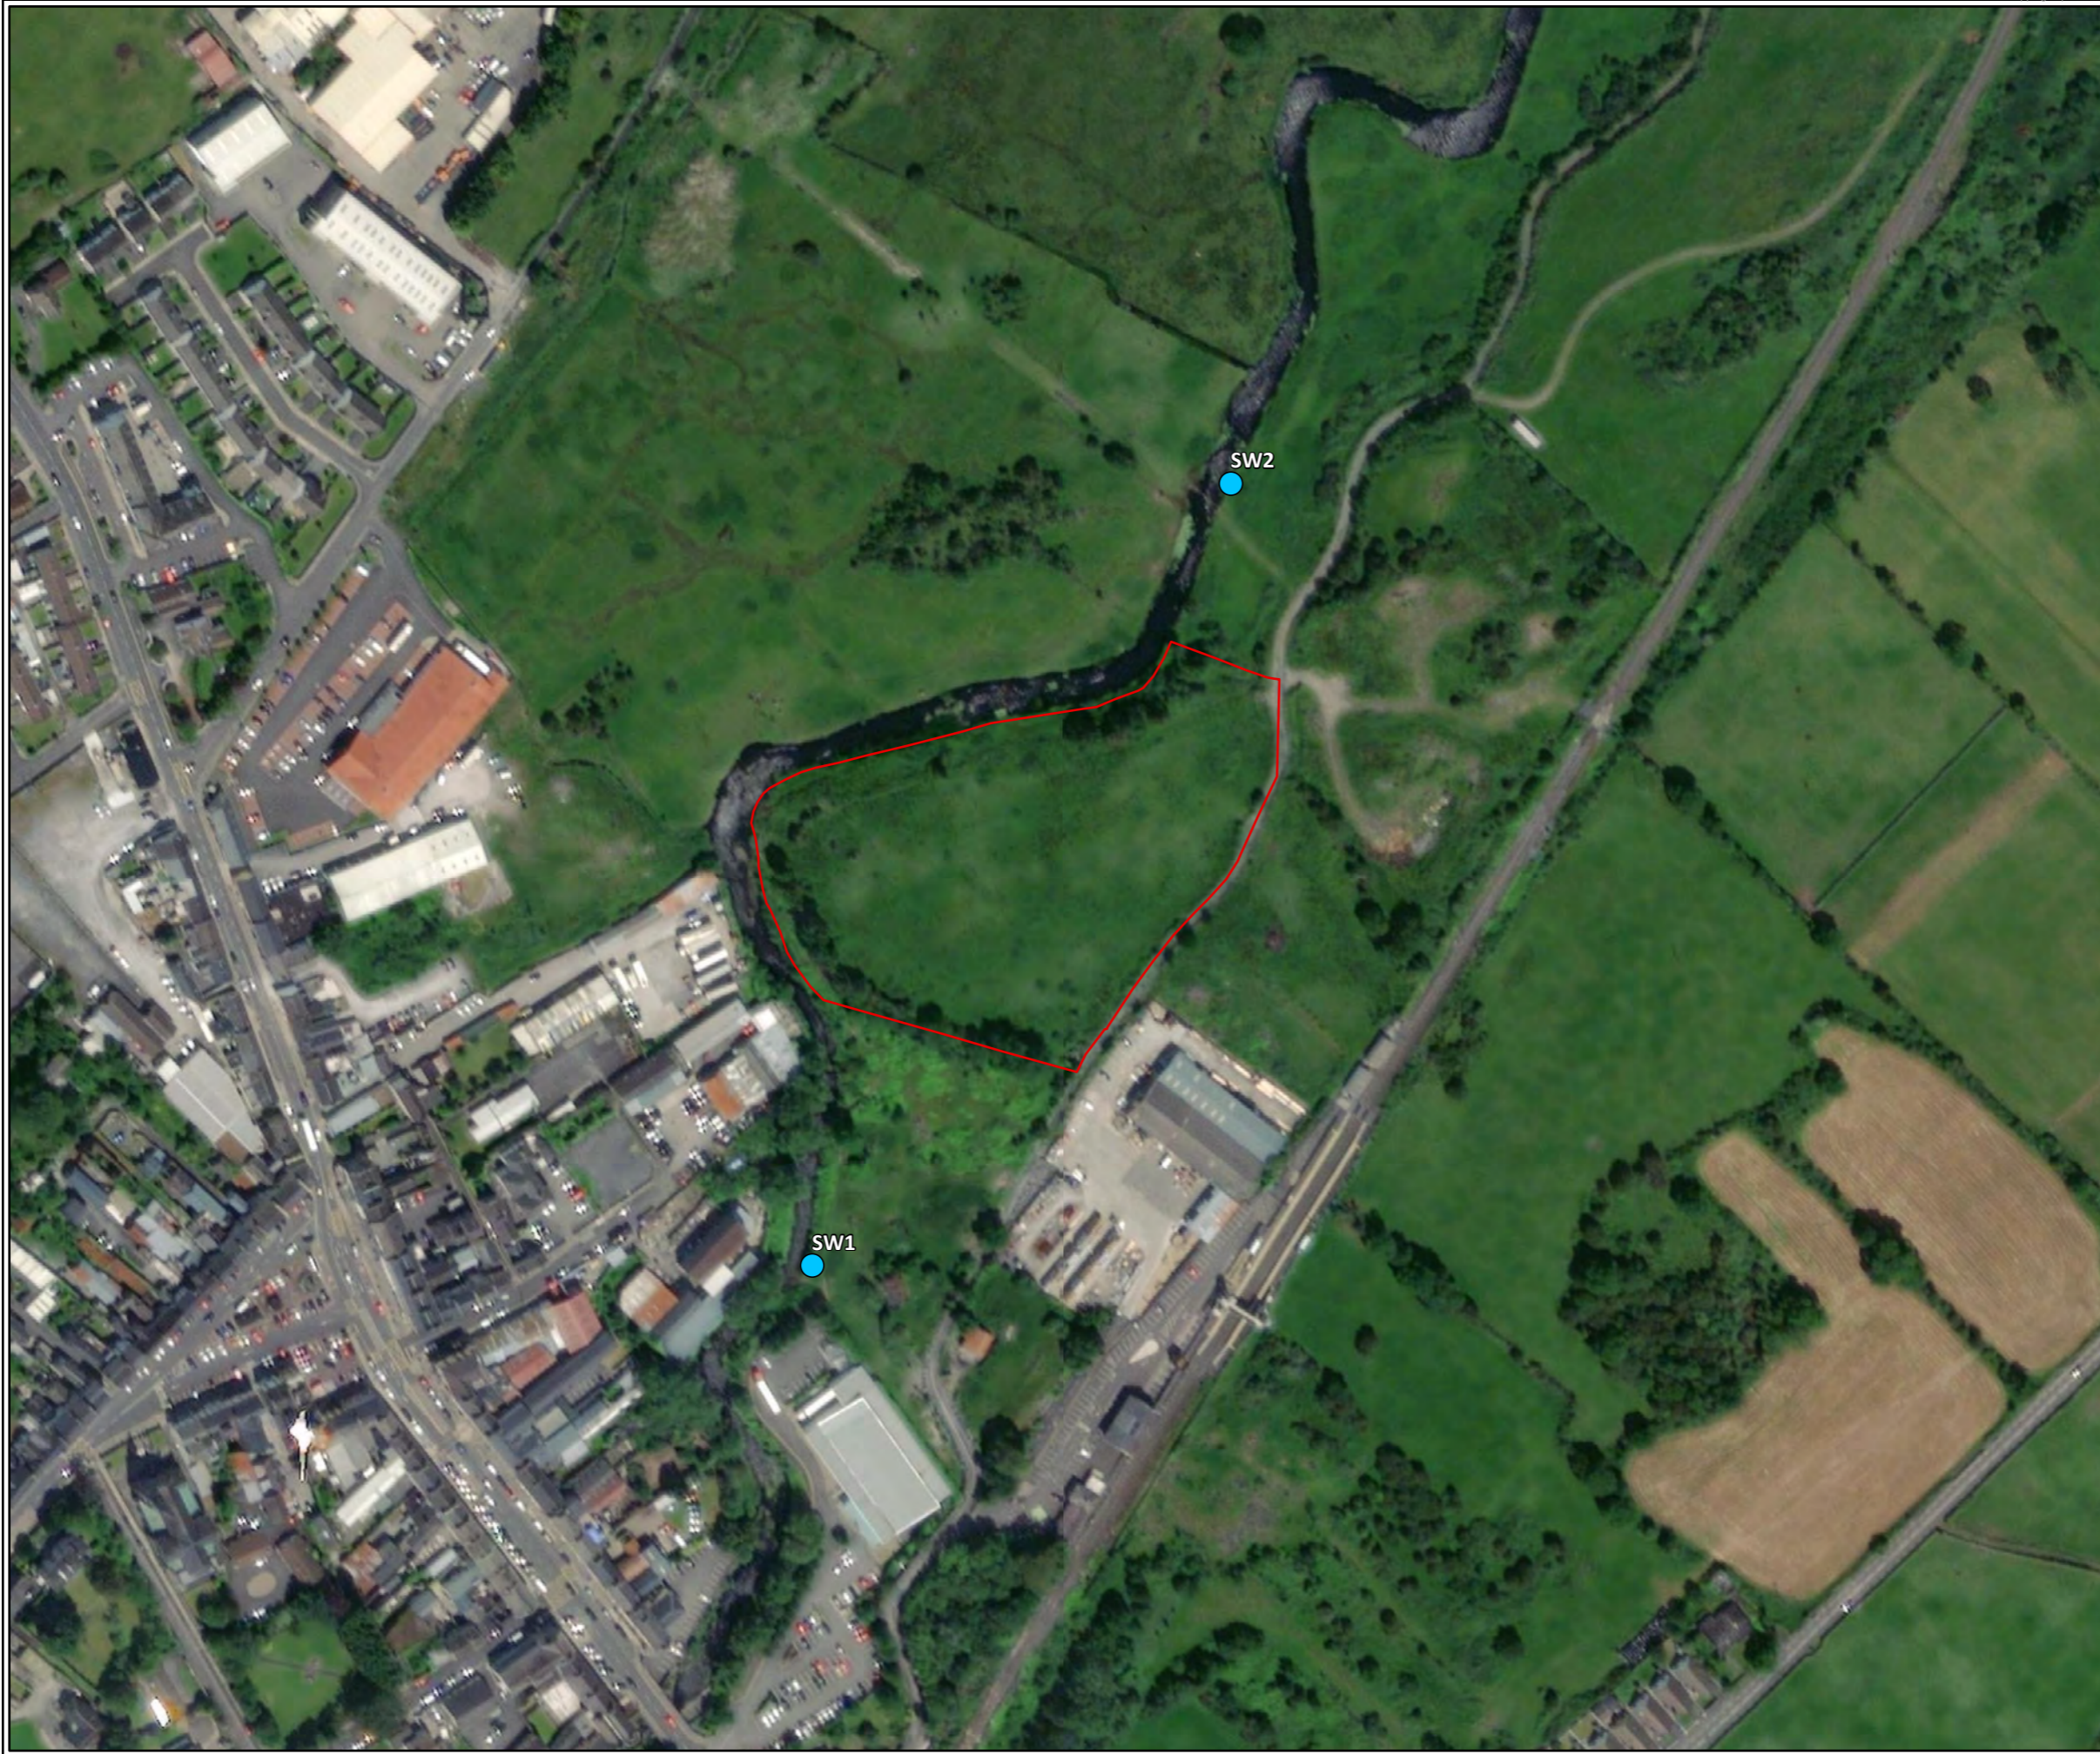
TITLE:	
Surface Water Sampling Locations	
PROJECT:	
Gort Historic Landfill ERA	
FIGURE NO: 4.2	
CLIENT: Galway County Council	
SCALE: 1:2,500	REVISION: 0
DATE: 15/10/2020	PAGE SIZE: A3

- Site Boundary
- Surface Water Monitoring Locations
