Priority Geotechnical Reports

**LONGFORD LANDFILLS
CARTRON BIG
GROUND INVESTIGATION
REPORT No. P18159_CB_Rp_D01**

Client						
Engineer Representative	Fehily Timoney					
Project Name	Longford Landfills- Ground Investigation					
Document Name	Longford Landfills- Cartron Big Ground Investigation- Draft Report					
Project Number	P18159_CB					
This Report Comprises of	TOC	Text	No. of Volume	No. of Appendices	Drawings	Electronic data
	1	14	1	2	6	*.dwg, *.pdf

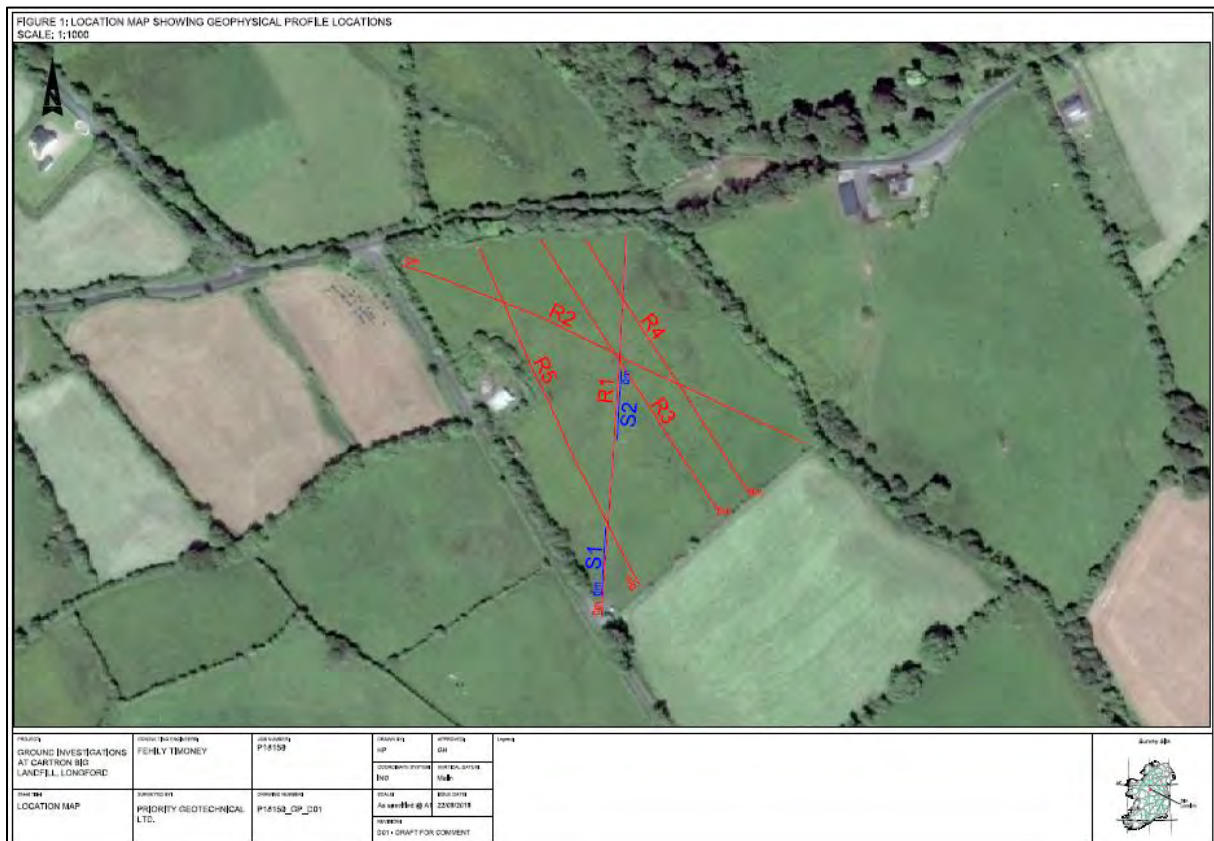
The direct intrusive works consisted of boreholes, trial pit excavations and in-situ permeability determination of ground conditions. The geophysical survey consisted of seismic refraction and electrical resistivity surveying in accordance with BS5930 and BS7022 and the Geological Society Engineering Group Working Party Report on Engineering Geophysics. The site and geophysical survey locations are shown in Figure A.1 below.

Figure A.1 Background map showing survey location.

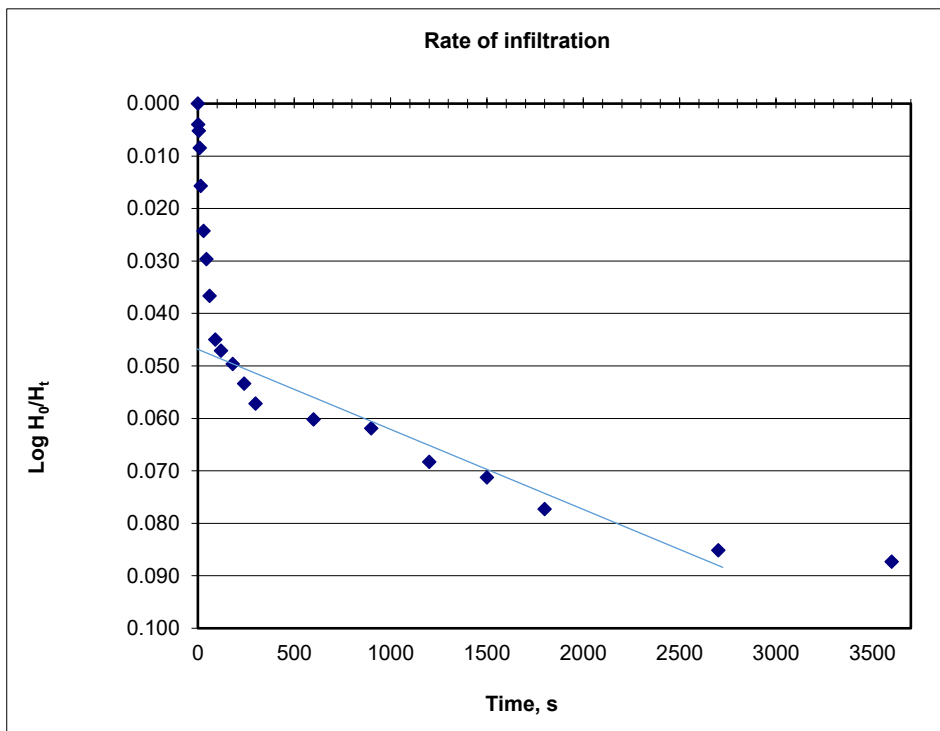
Min	Sec	depth, m bgl	vol, cu.m	H_t	$\log H_0/H_t$
0	0	0.000	0.00000	25.00	0.000
0.02	1	0.100	0.00075	24.90	0.004
0.08	5	0.130	0.00098	24.87	0.005
0.17	10	0.210	0.00158	24.79	0.008
0.25	15	0.390	0.00294	24.61	0.016
0.50	30	0.600	0.00452	24.40	0.024
0.75	45	0.730	0.00550	24.27	0.030
1	60	0.900	0.00679	24.10	0.037
1.5	90	1.100	0.00829	23.90	0.045
2	120	1.150	0.00867	23.85	0.047
3	180	1.210	0.00912	23.79	0.050
4	240	1.300	0.00980	23.70	0.053
5	300	1.390	0.01048	23.61	0.057
10	600	1.460	0.01101	23.54	0.060
15	900	1.500	0.01131	23.50	0.062
20	1200	1.650	0.01244	23.35	0.068
25	1500	1.720	0.01297	23.28	0.071
30	1800	1.860	0.01402	23.14	0.077
45	2700	2.040	0.01538	22.96	0.085
60	3600	2.090	0.01576	22.91	0.087

$k_{mean} = 9.33E-08 \text{ ms}^{-1}$
 $k_H = k_V$

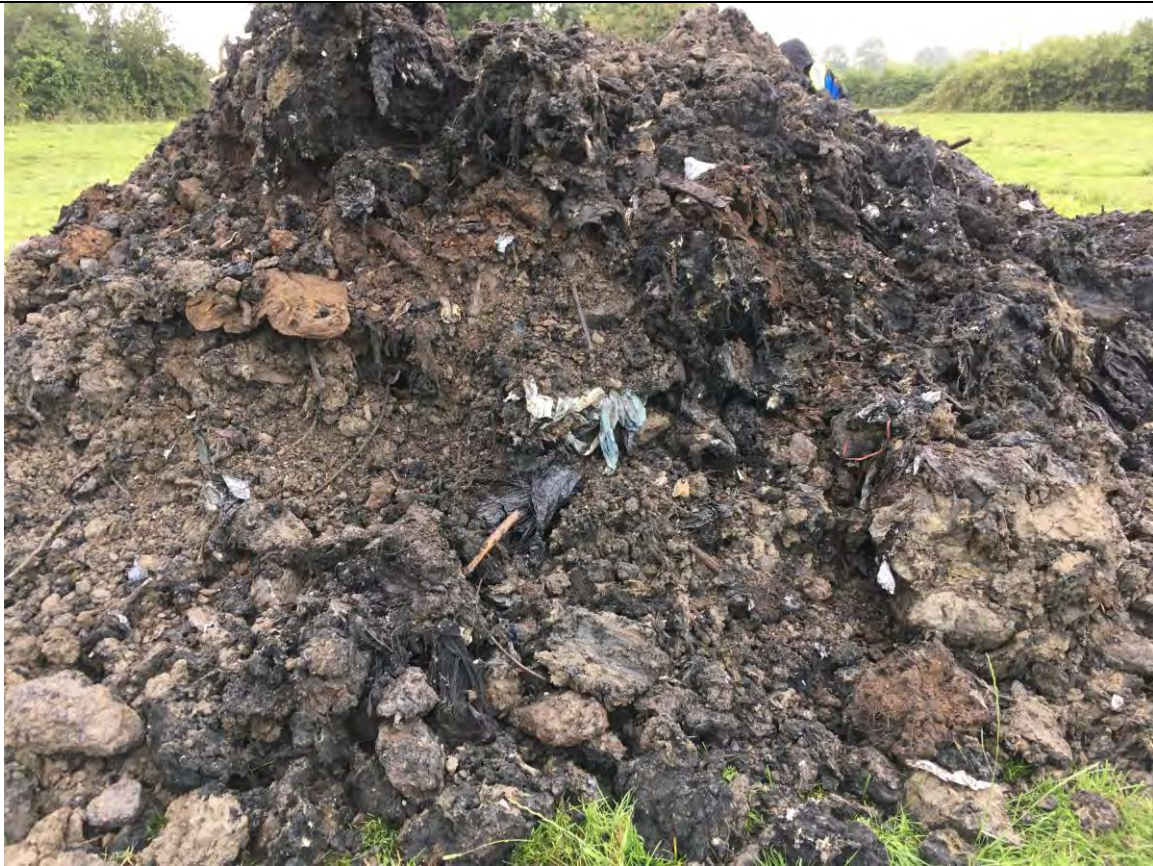
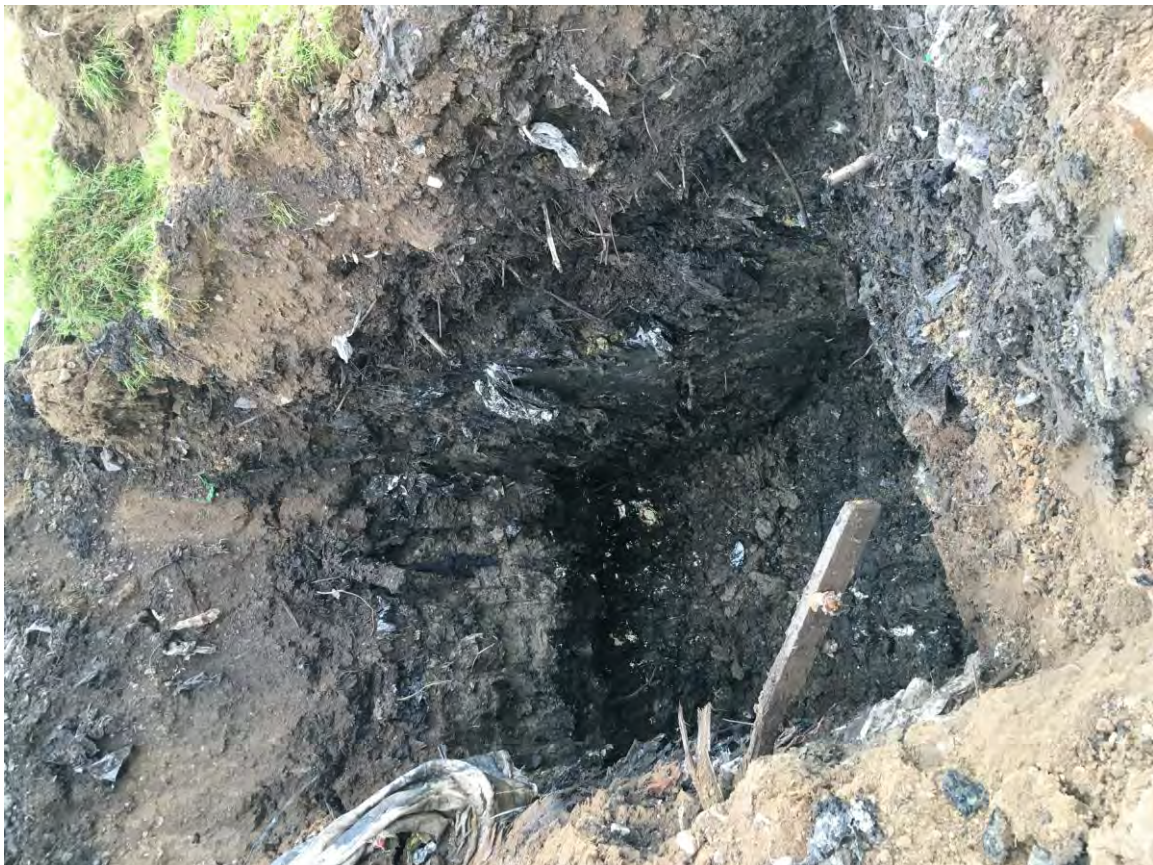
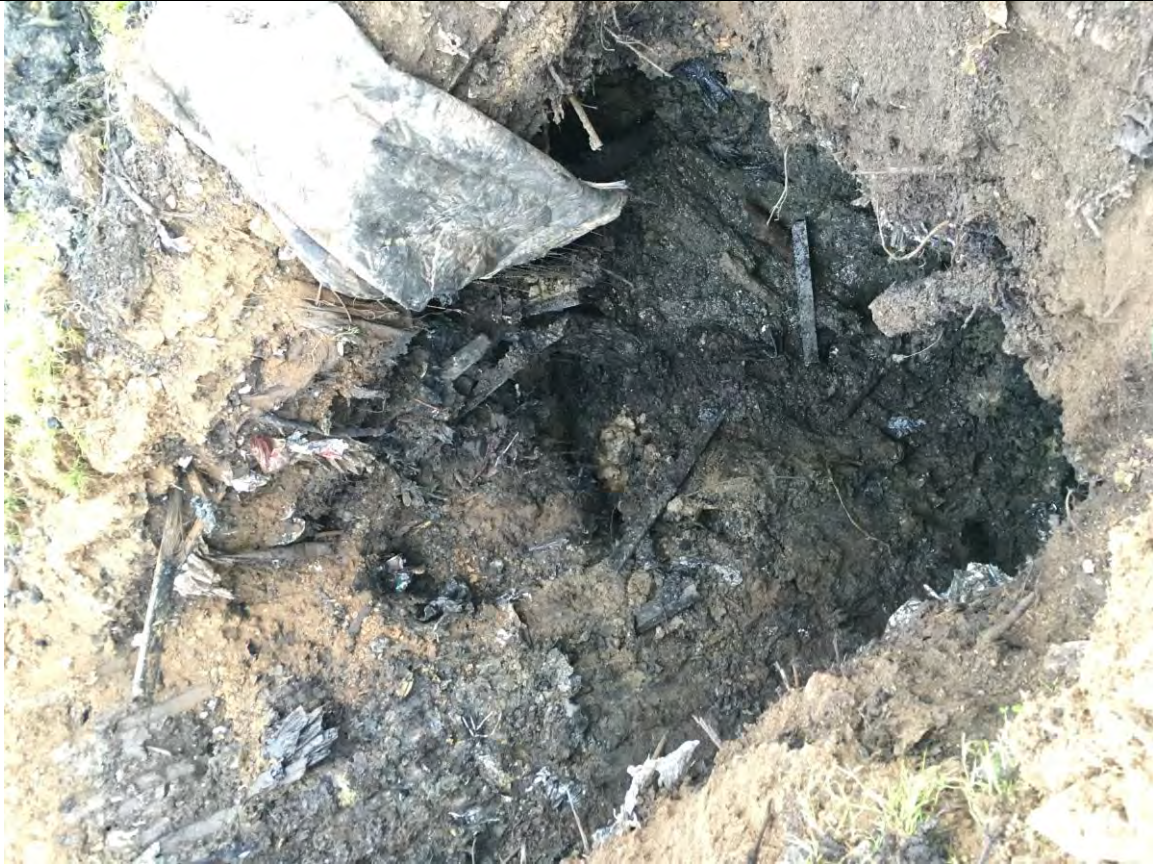
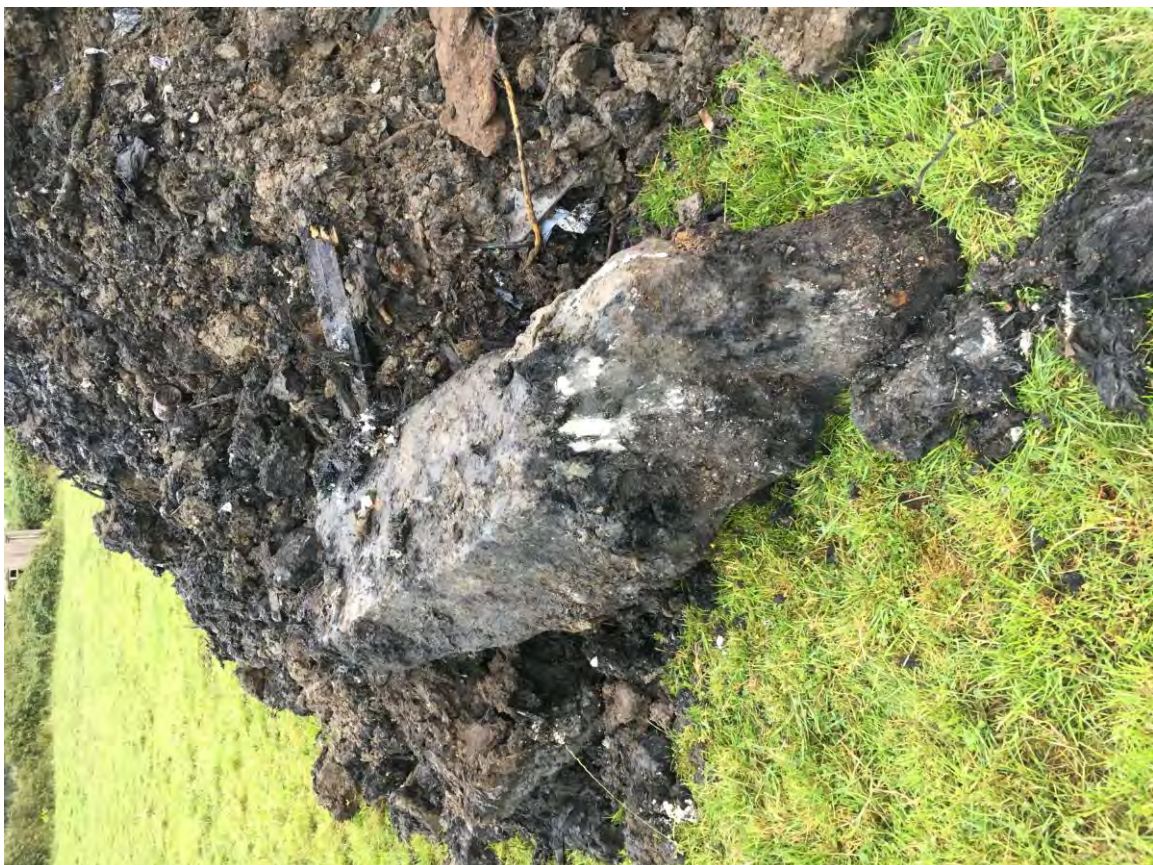
CB – TP01

Stability: Moderate.	Groundwater: Slow rate of flow.
Plant: 13t tracked excavator.	
Backfill: Arisings.

Remarks: Trial pit terminated at 4.50m at the required depth.

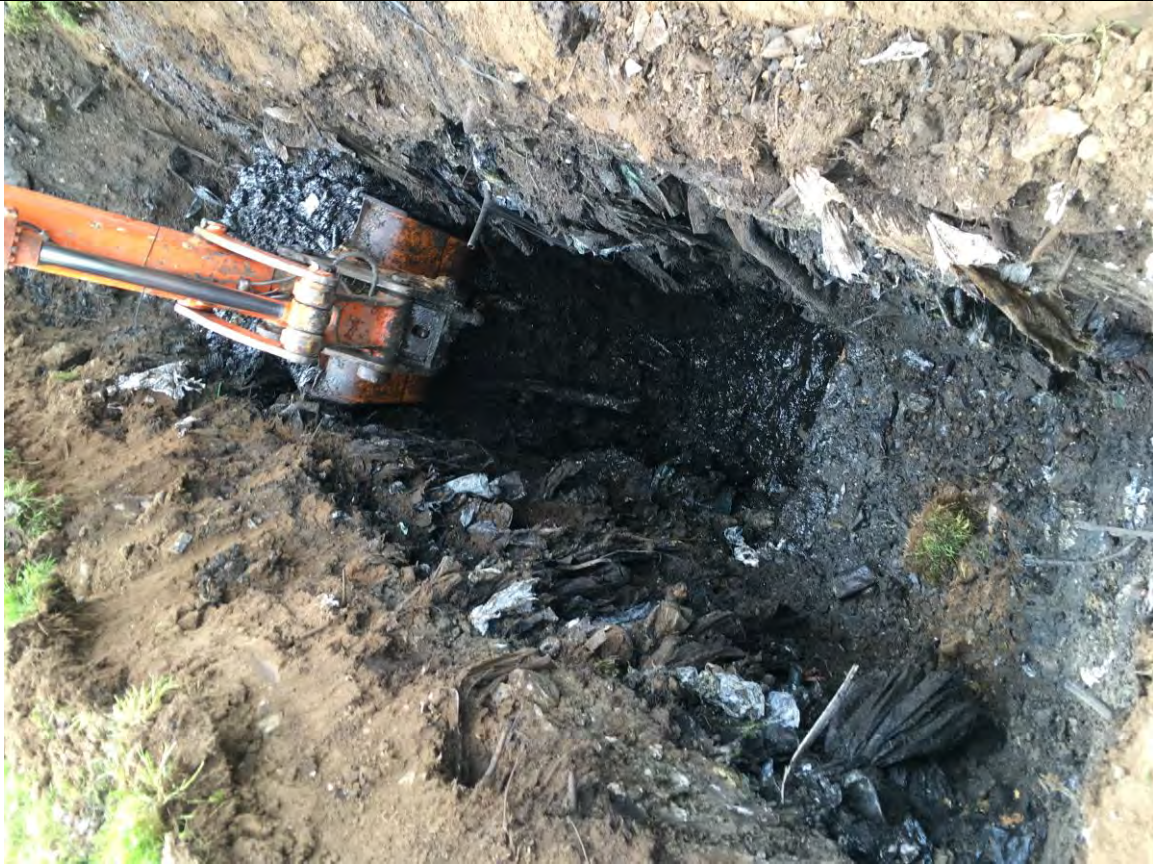
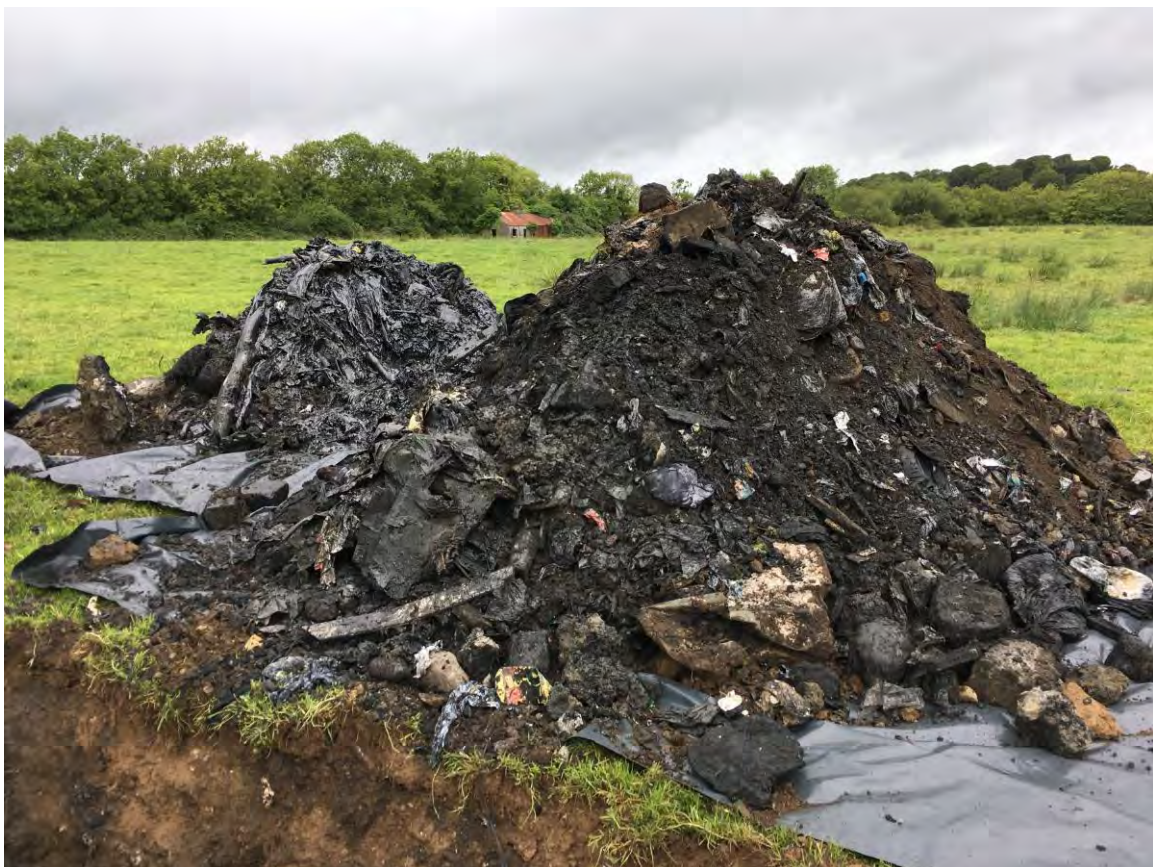
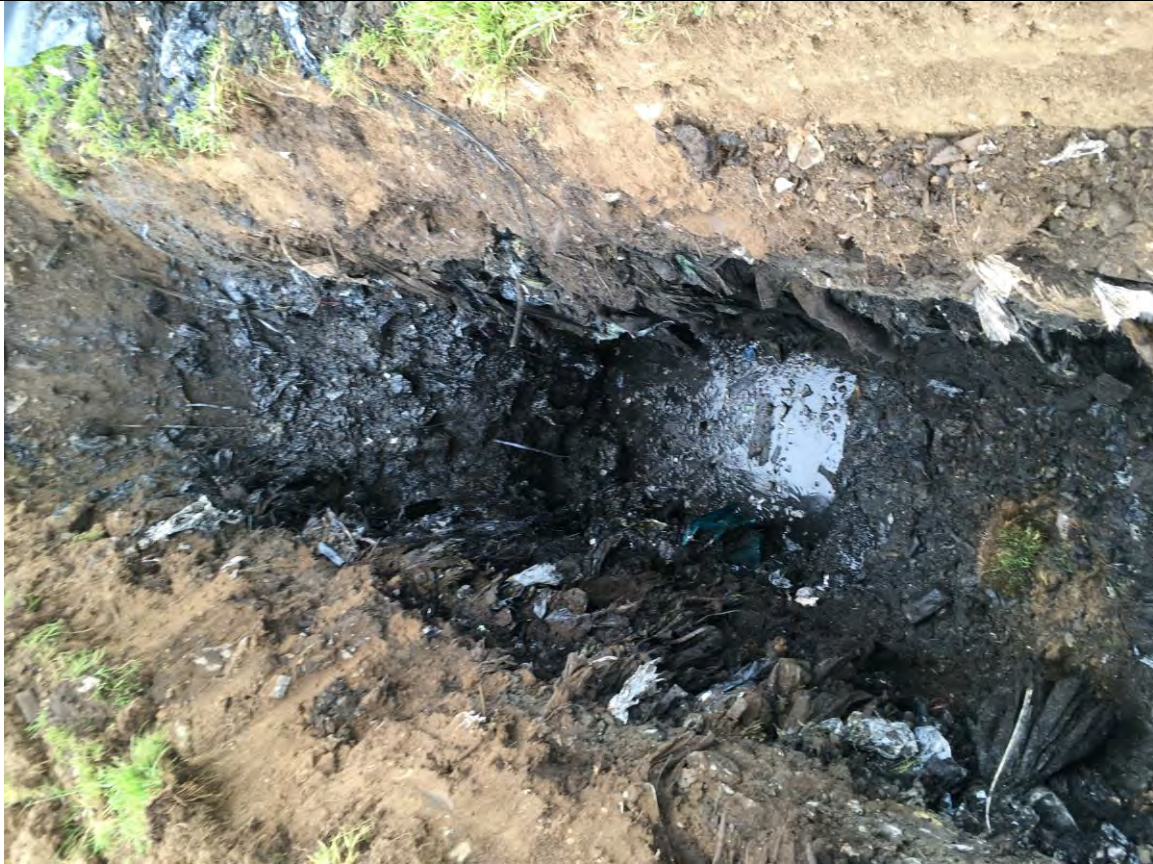
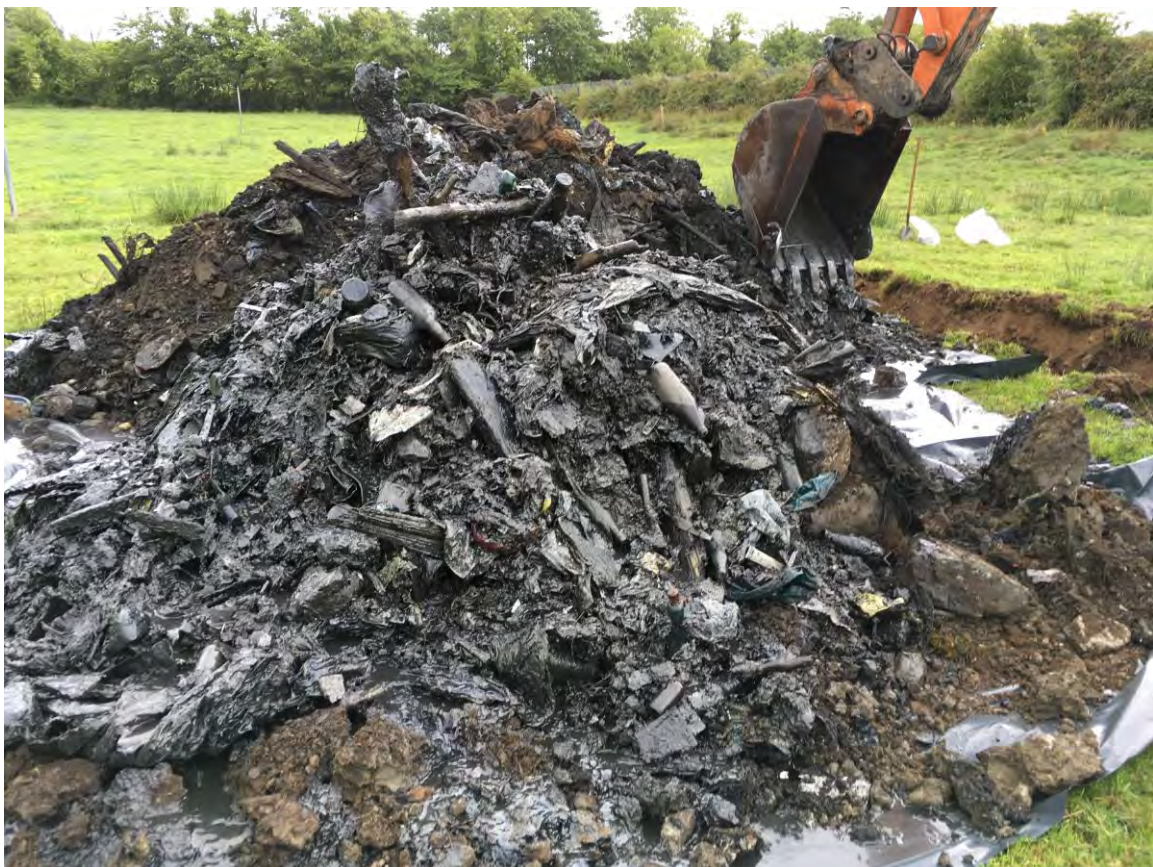
CB – TP02

Stability: Moderate	Groundwater: 2.85m: Steady rate of flow.
Plant: 13T Track machine	
Backfill: Arisings.

Remarks: Trial pit terminated at 3.50m bgl at the required depth.

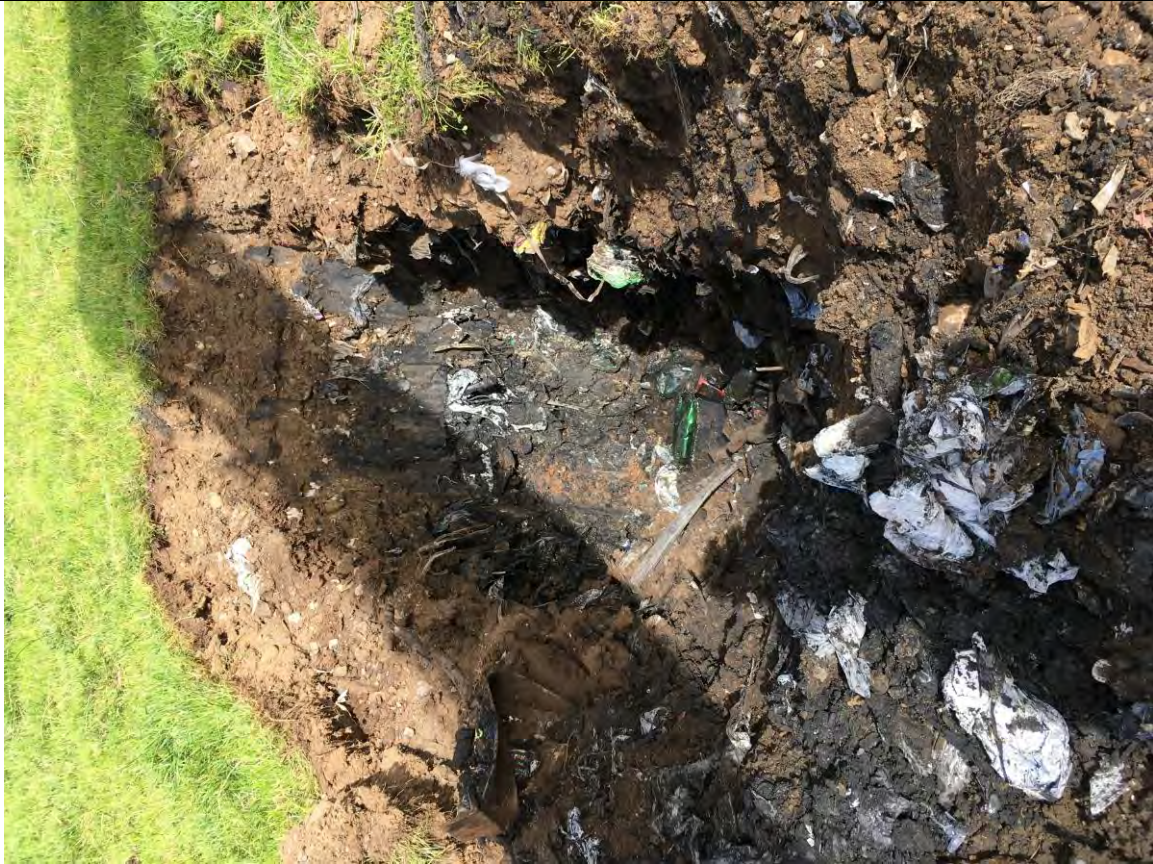
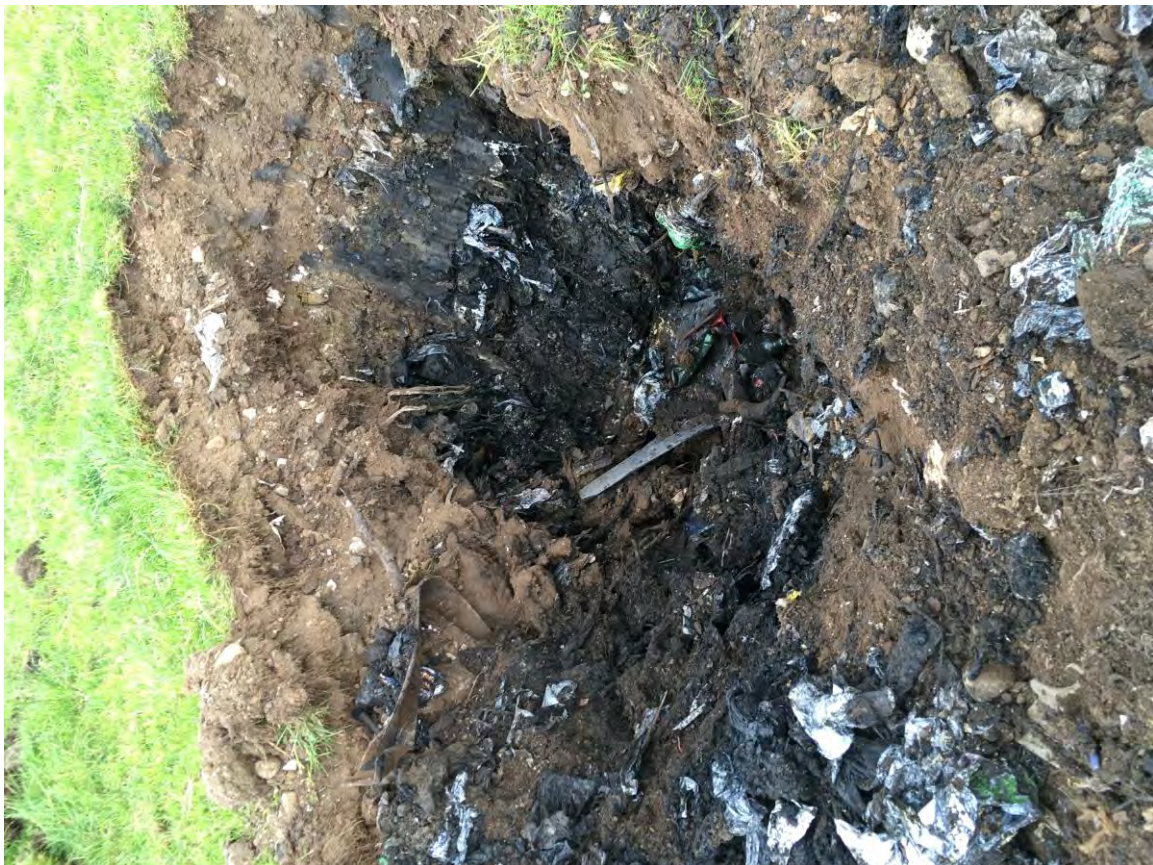
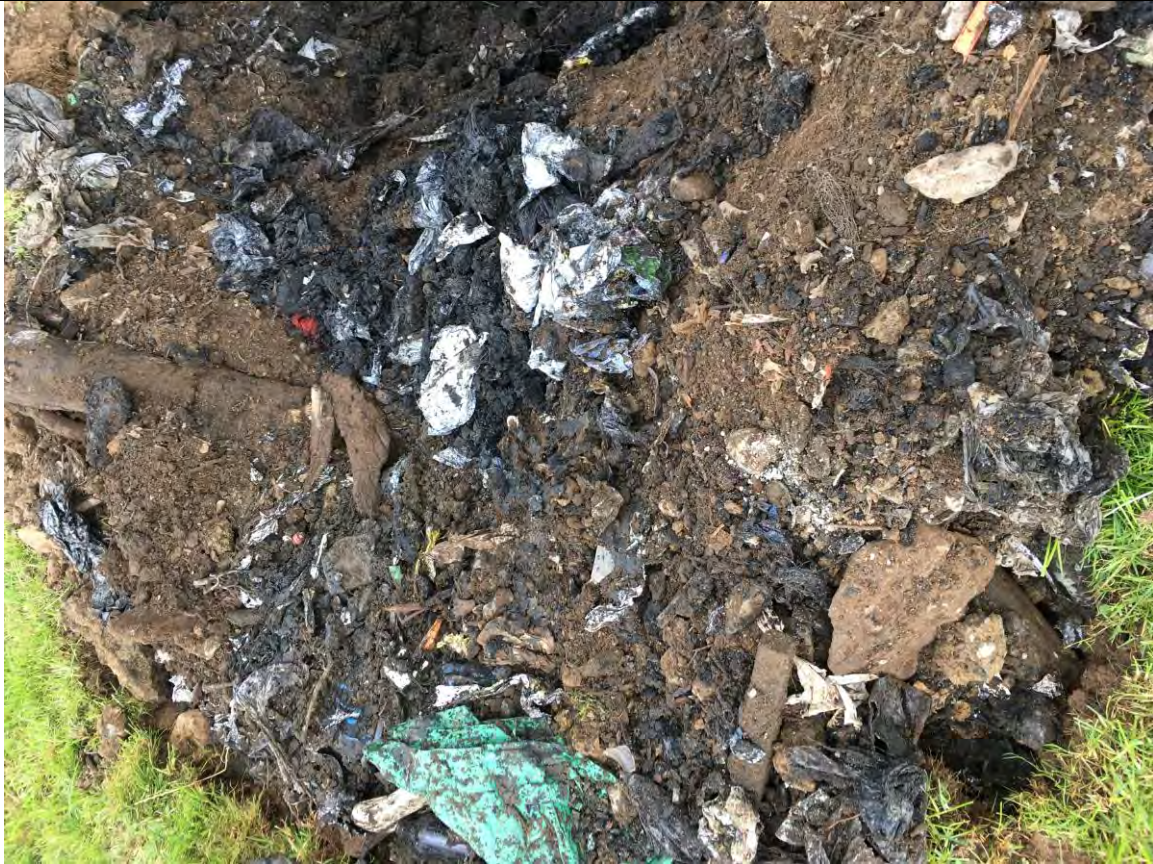
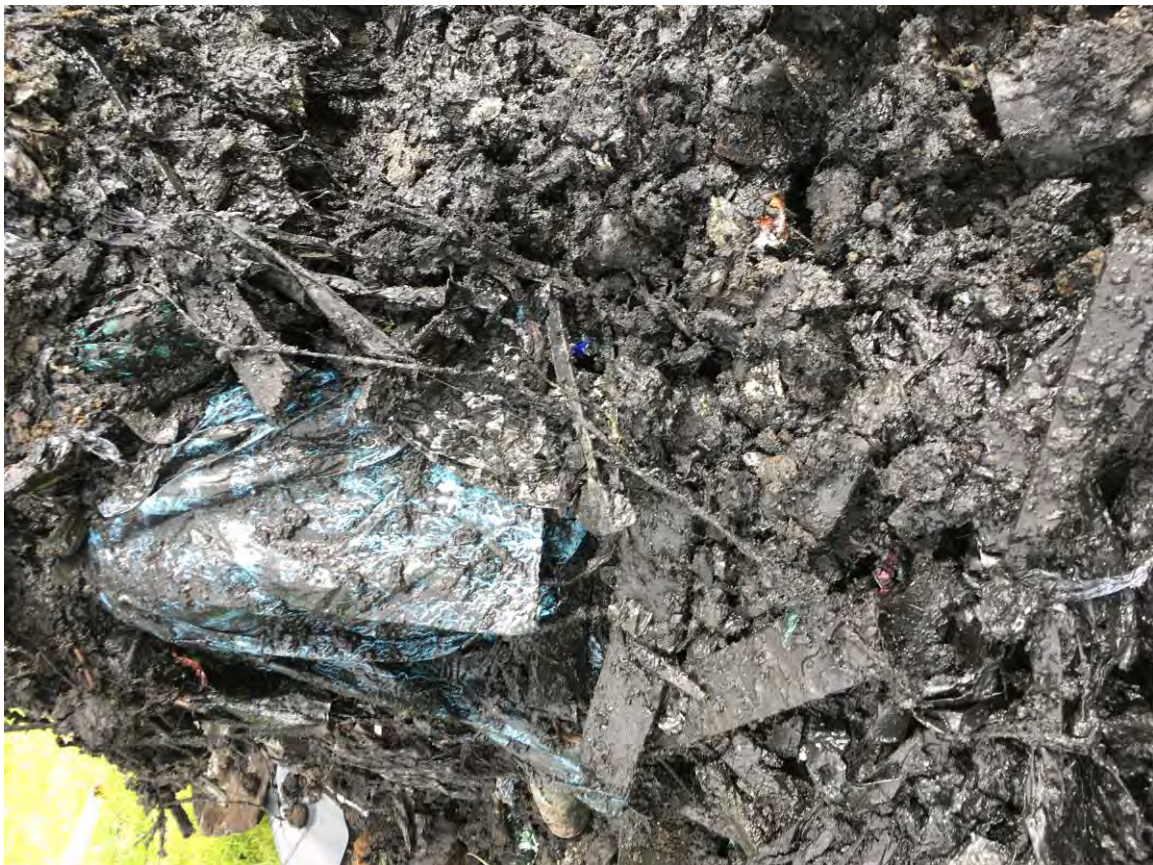
CB – TP03

Stability: Good	Groundwater: 1.80m: Slow rate of flow.
Plant: 13T Track machine.	
Backfill: Arisings.

Remarks: Trial pit terminated at 1.80m bgl at the required depth.

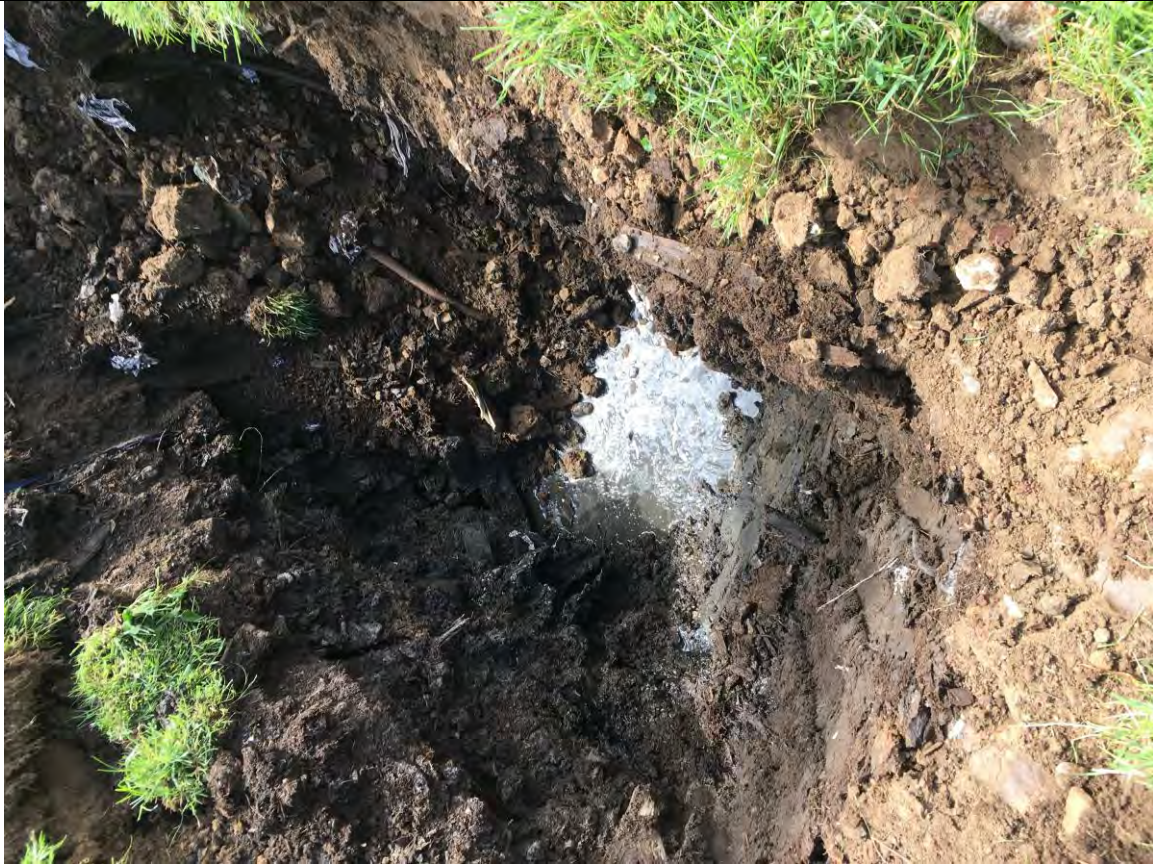
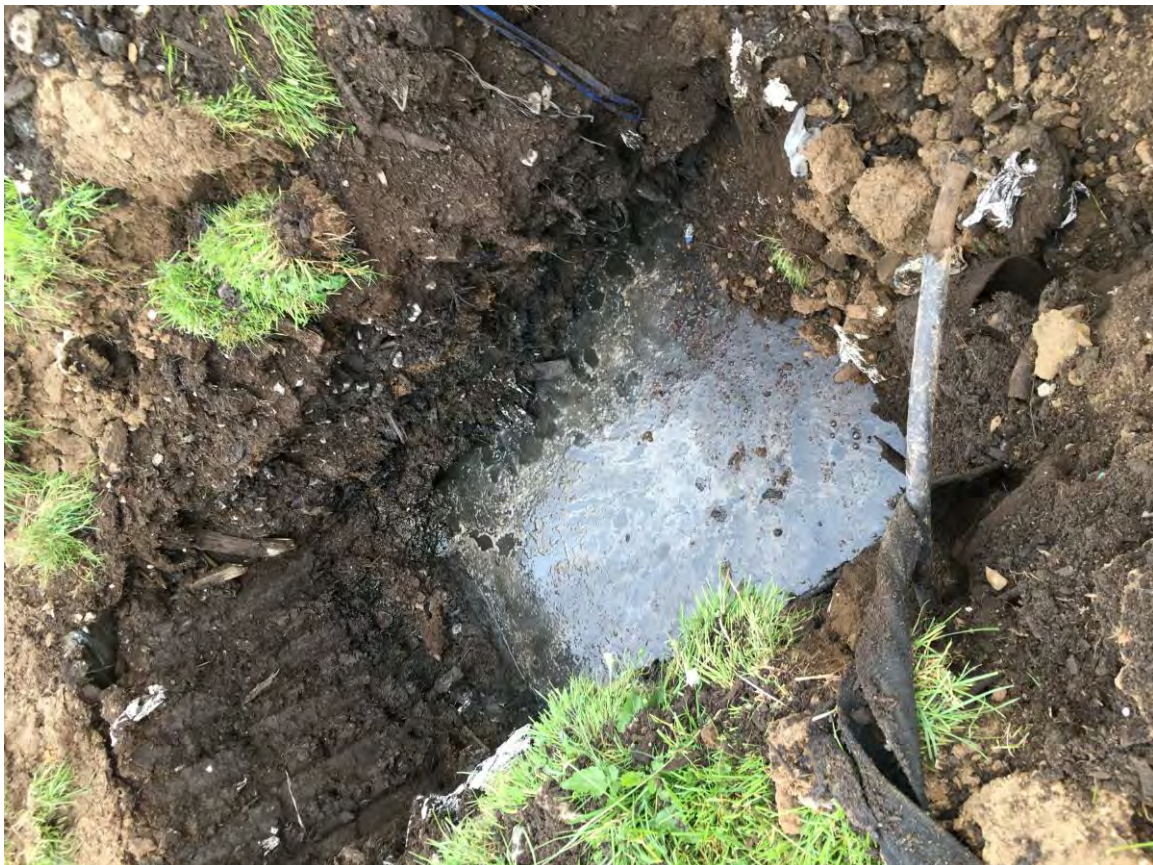
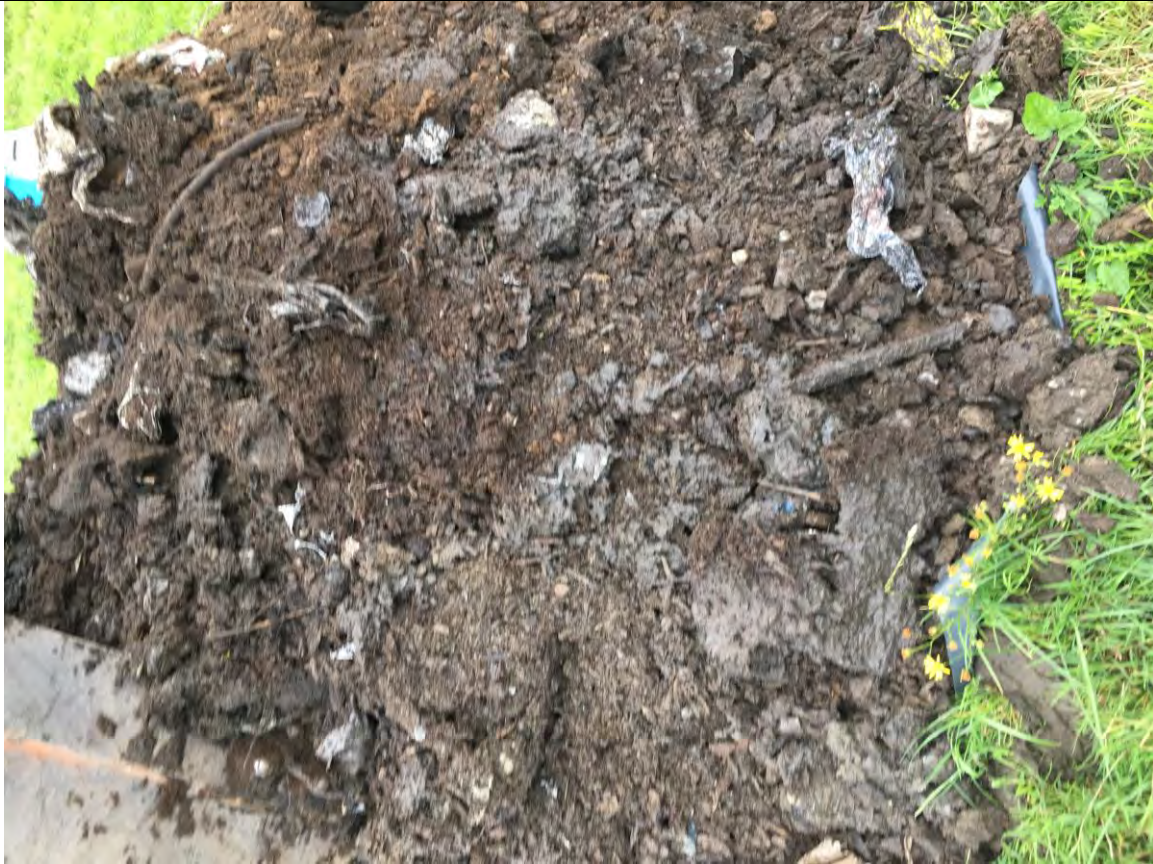
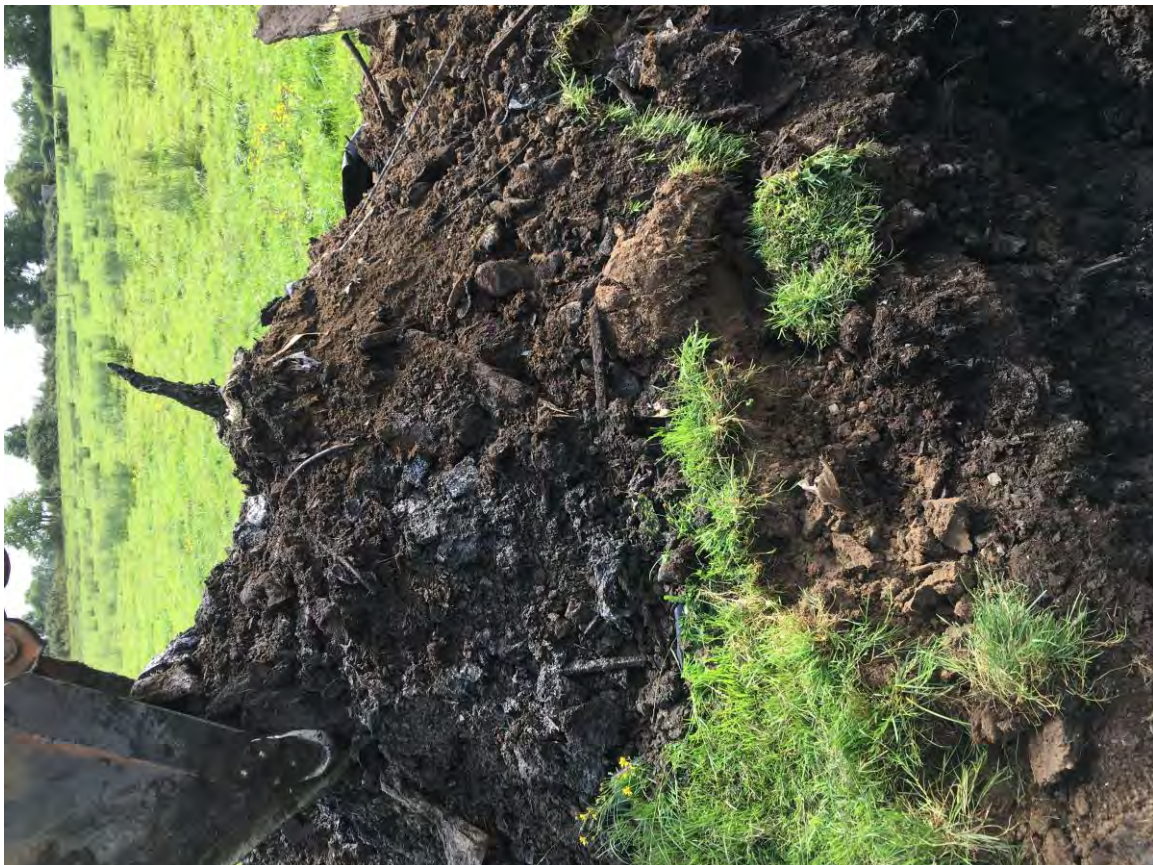
CB – TP04

Stability: Moderate.	Groundwater: 1.00m Slow rate of flow. 1.70m: Fast rate of flow.
Plant: 13T Track machine	
Backfill: Arisings.

Remarks: Trial pit terminated at 1.80m bgl at the required depth.

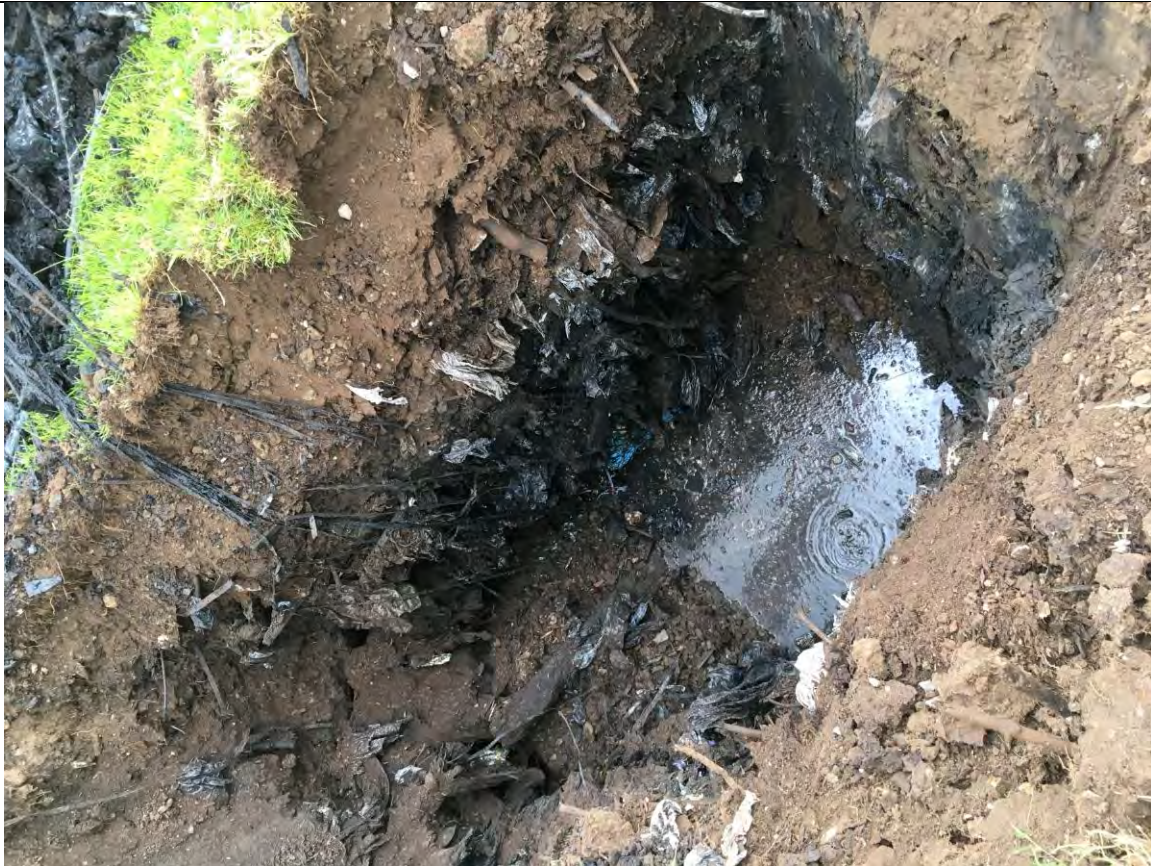
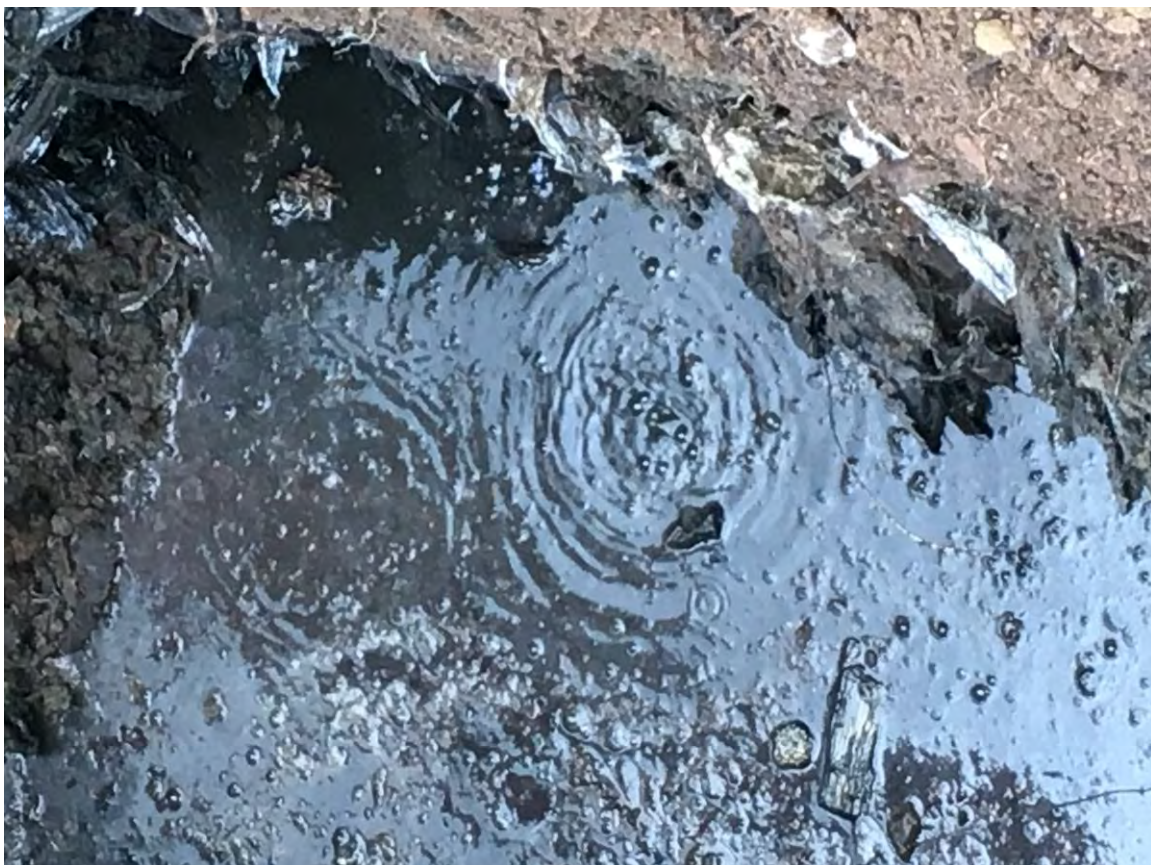
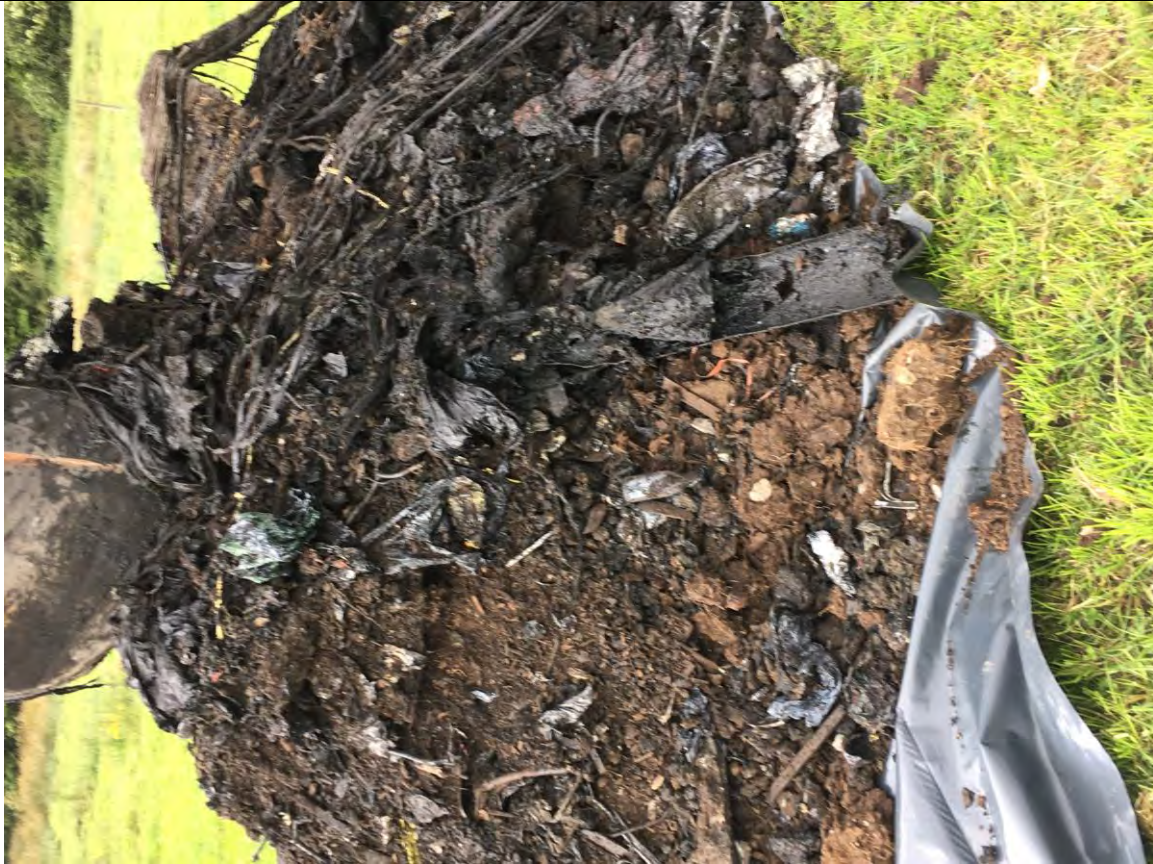
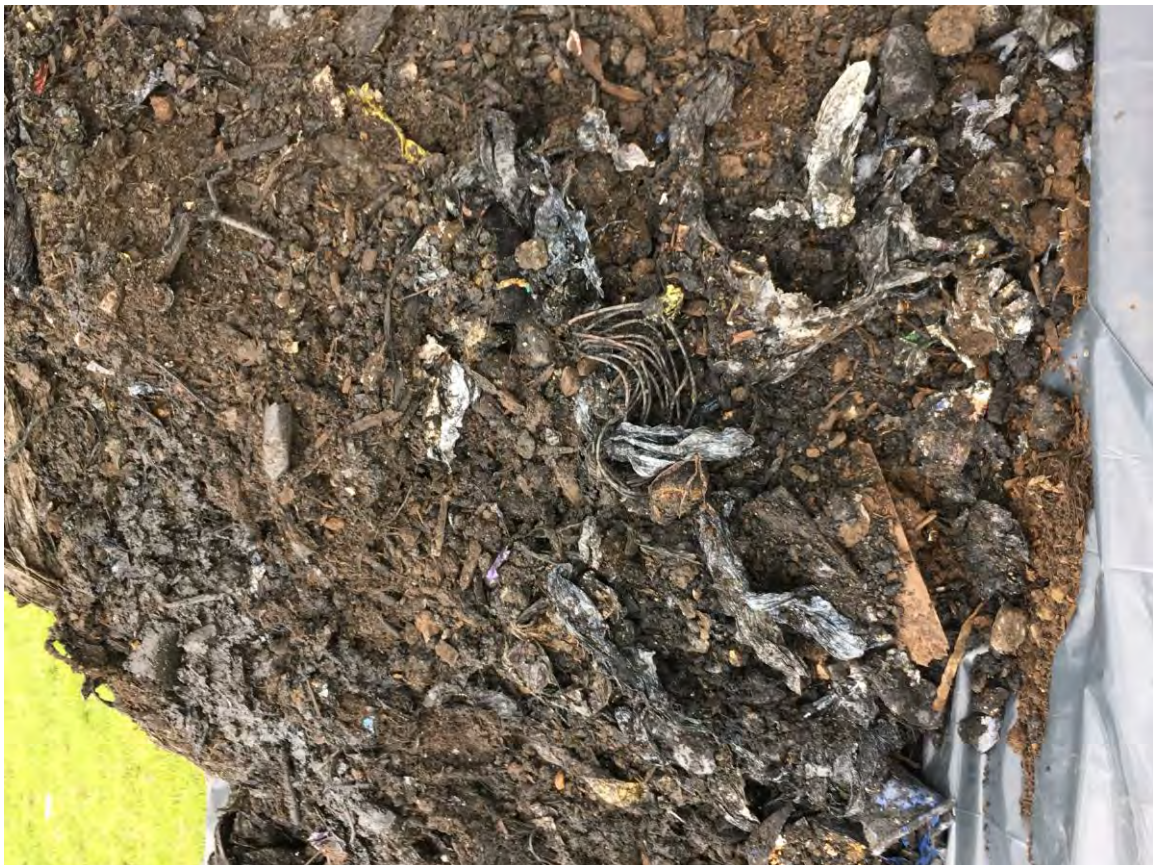
CB – TP05

Stability: Good	Groundwater: 2.00m: Fast rate of flow.
Plant: 13T Track machine	
Backfill: Arisings.

Remarks: Trial pit terminated at 2.10m bgl at the required depth.
