Priority Geotechnical Reports

**LONGFORD LANDFILLS
CARTRON BIG
GROUND INVESTIGATION
REPORT No. P18159_CB_Rp_D01**

Client						
Engineer Representative	Fehily Timoney					
Project Name	Longford Landfills- Ground Investigation					
Document Name	Longford Landfills- Cartron Big Ground Investigation- Draft Report					
Project Number	P18159_CB					
This Report Comprises of	TOC	Text	No. of Volume	No. of Appendices	Drawings	Electronic data
	1	14	1	2	6	*.dwg, *.pdf

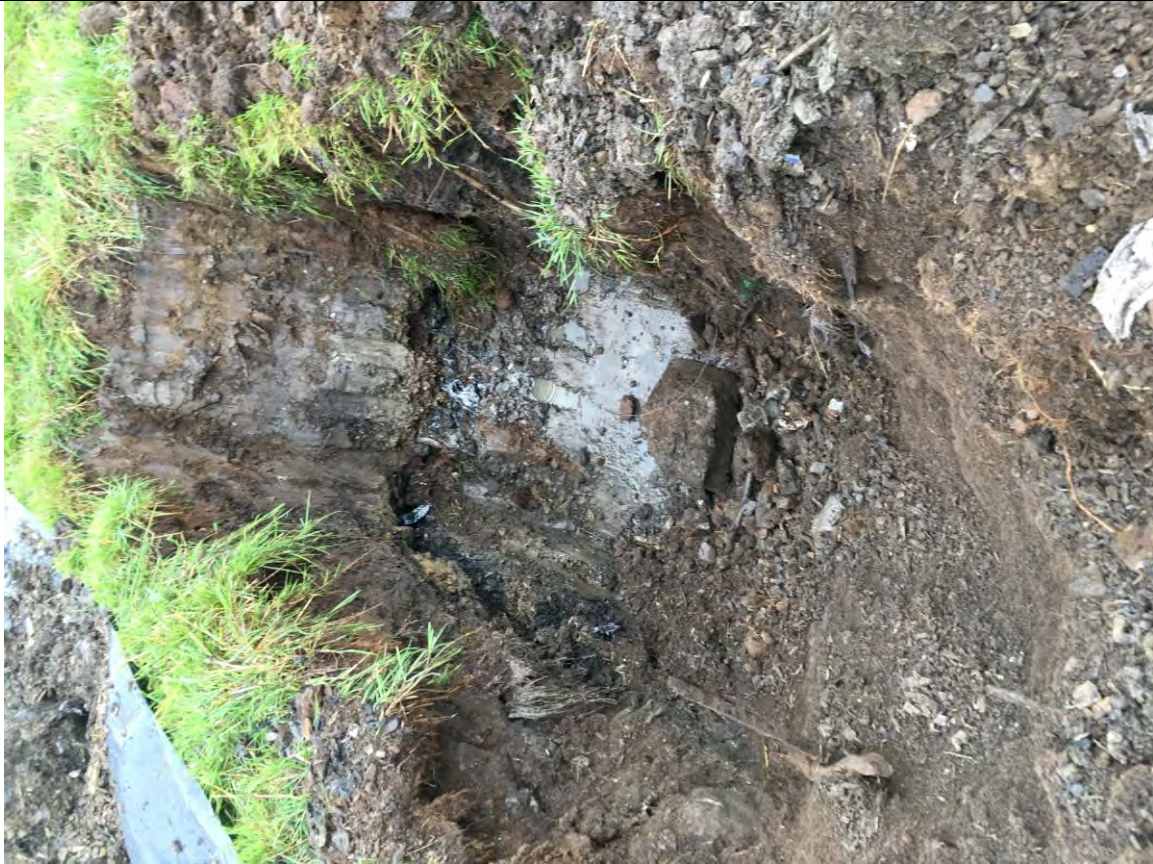
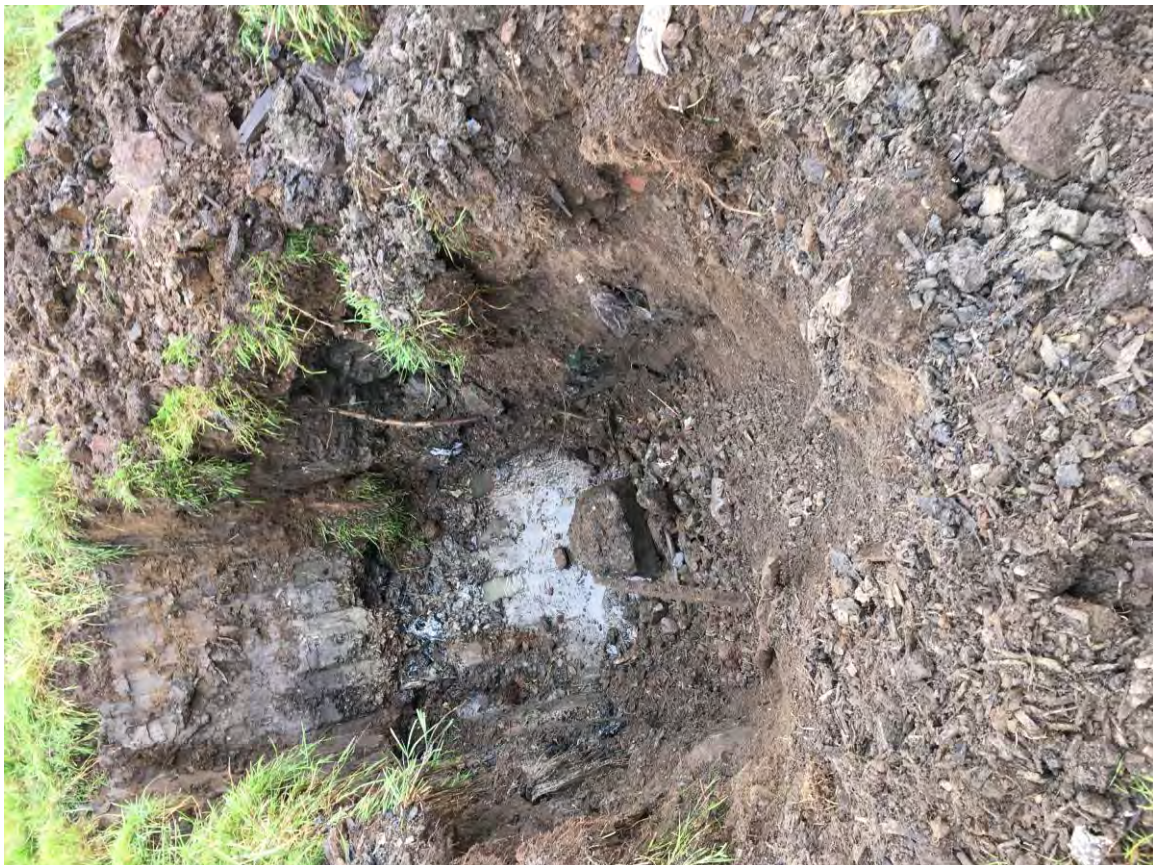
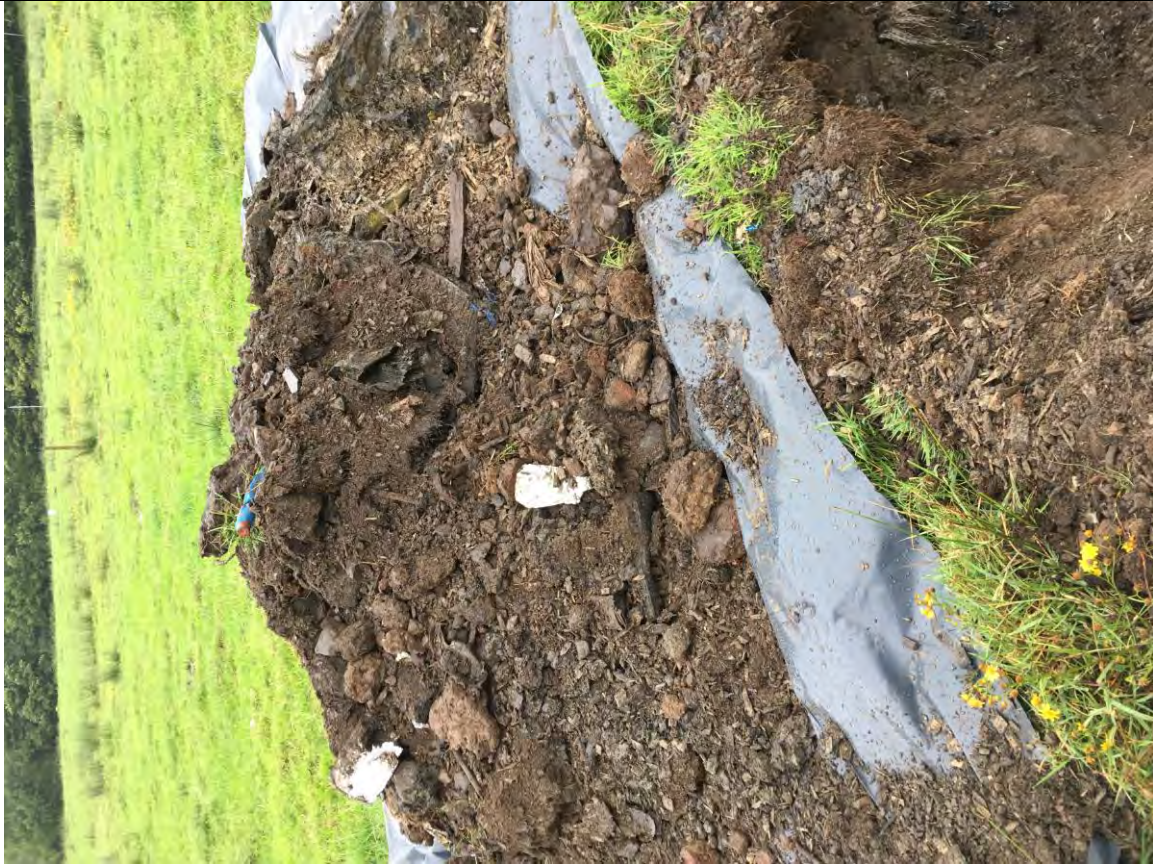
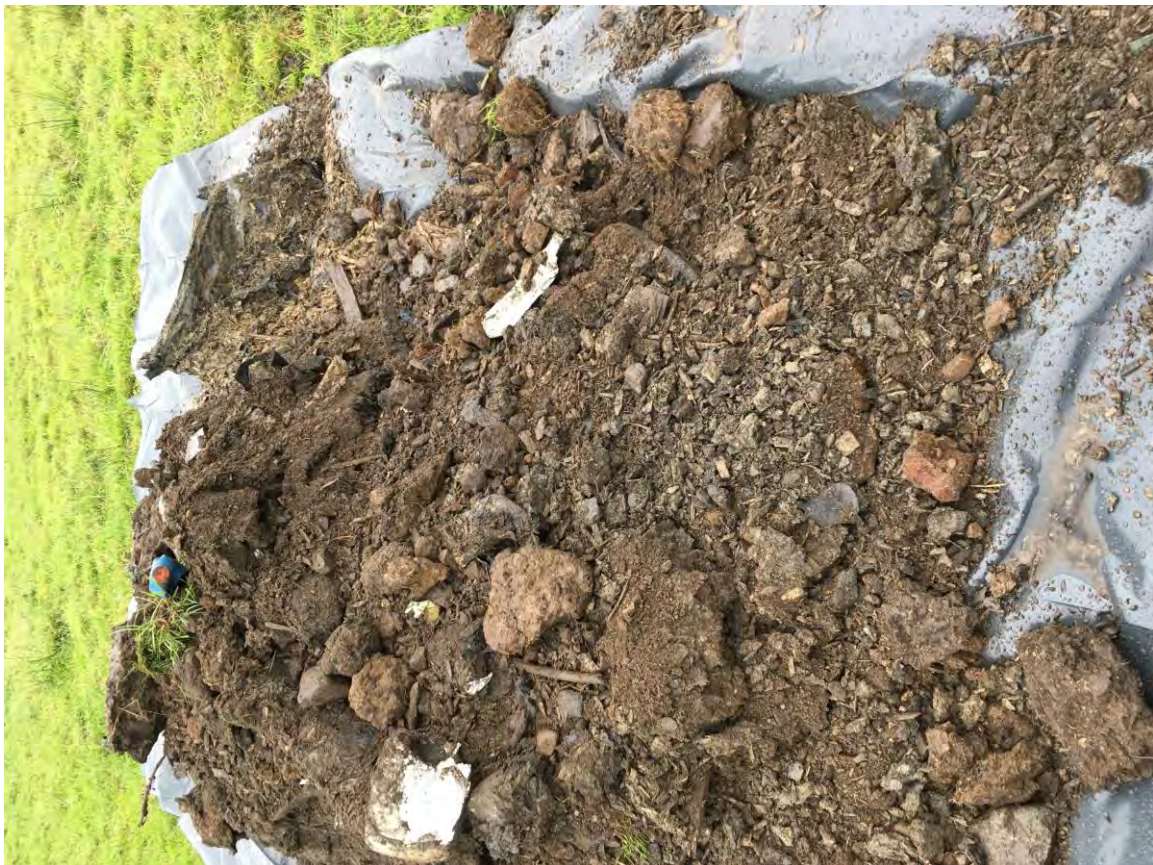
CB – TP06

Stability: Good.
Plant: 13t tracked excavator.
Backfill: Arisings.
Groundwater: 1.10m: Slow flow rate.

Remarks: Trail pit terminated at 1.3m bgl at the required depth.

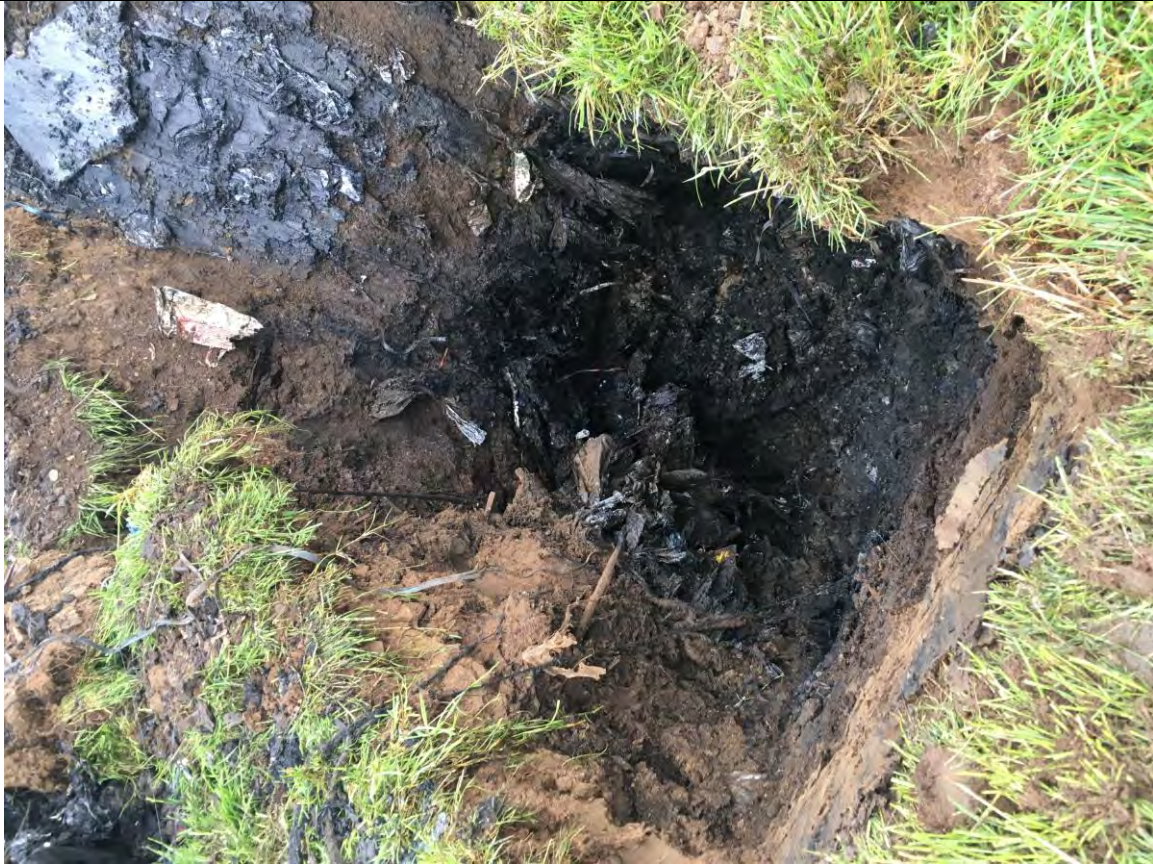
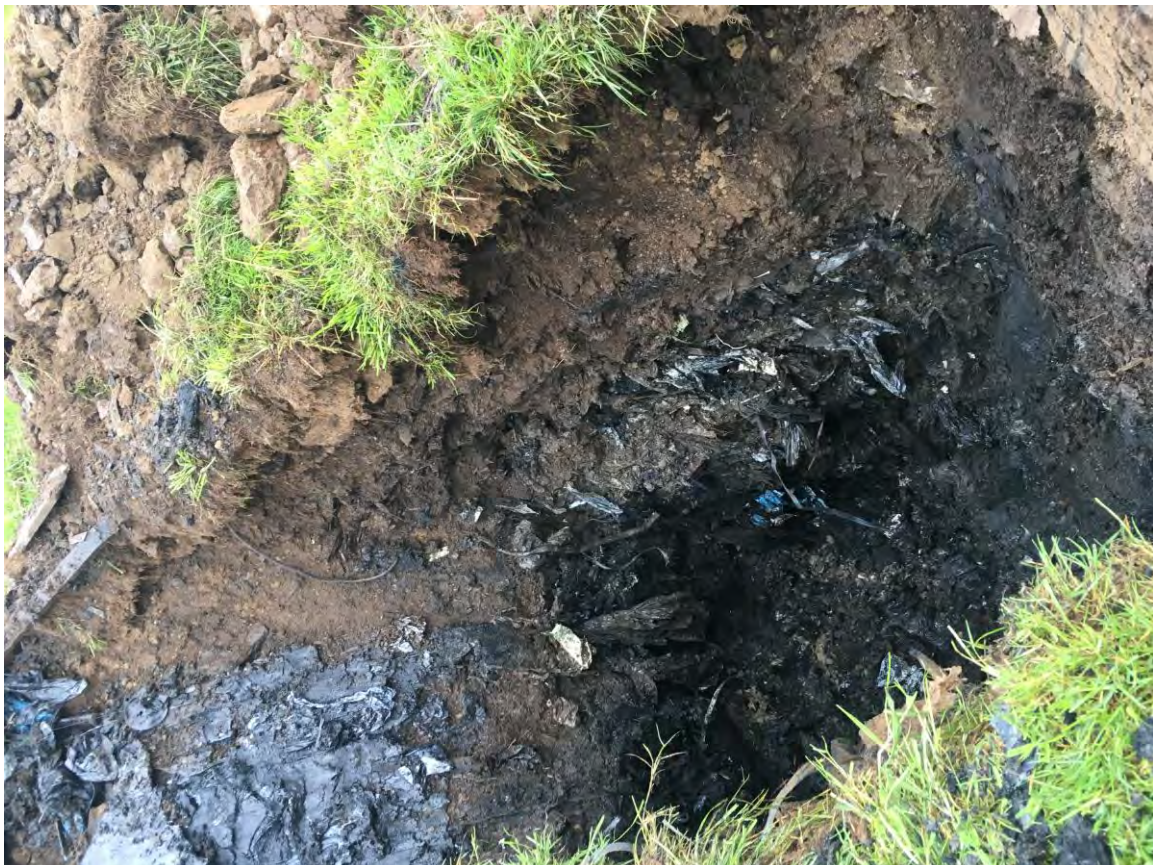
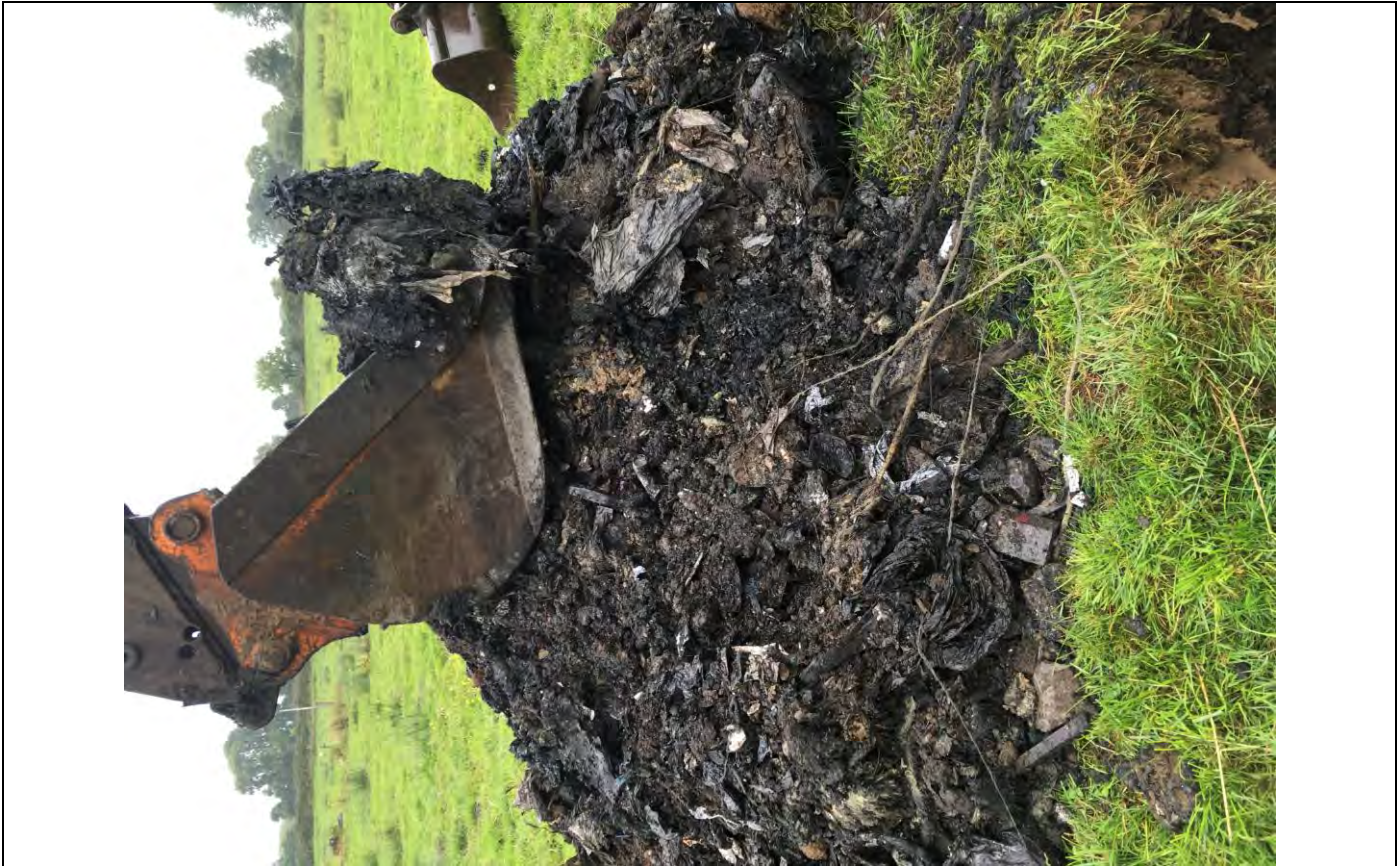
CB – TP07

Stability: Good.	Groundwater: 2.90m: Slow flow rate.
Plant: 13t tracked excavator.	
Backfill: Arisings.

Remarks: Trial pit terminated at 3.00m bgl at the required depth

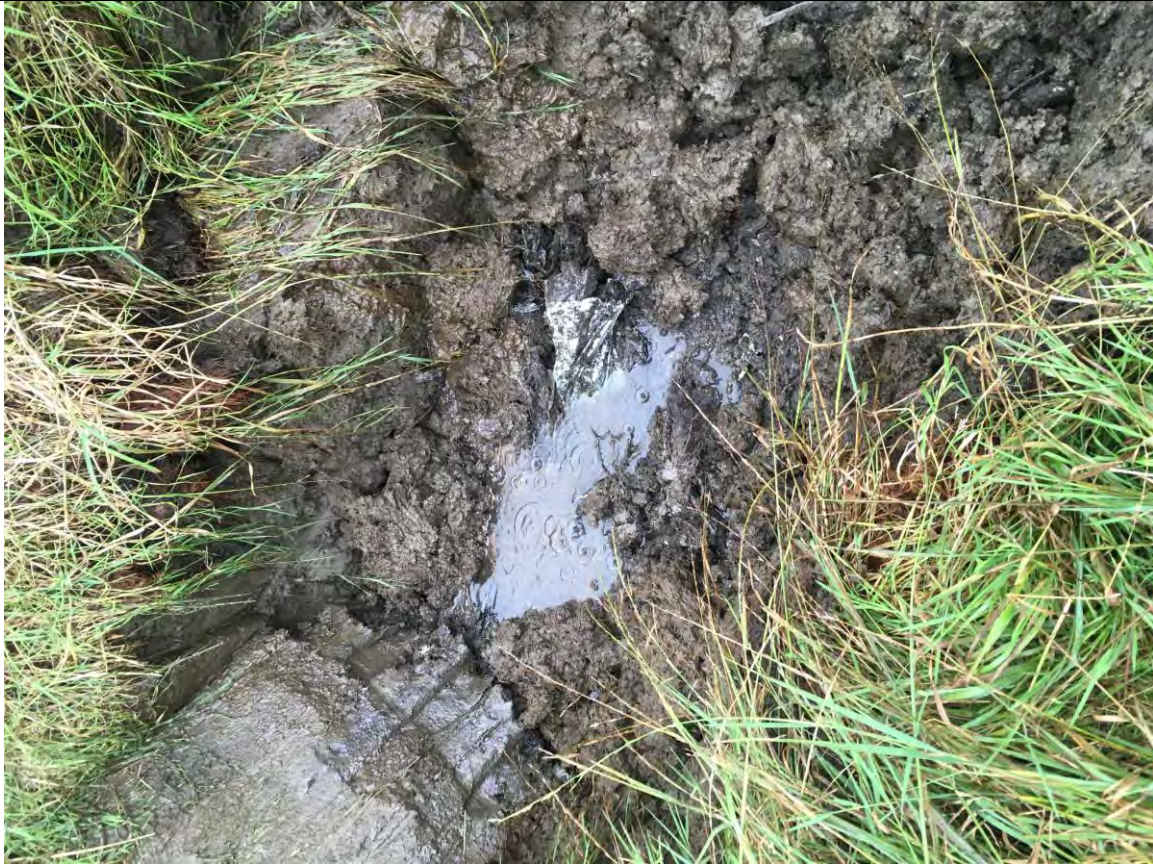
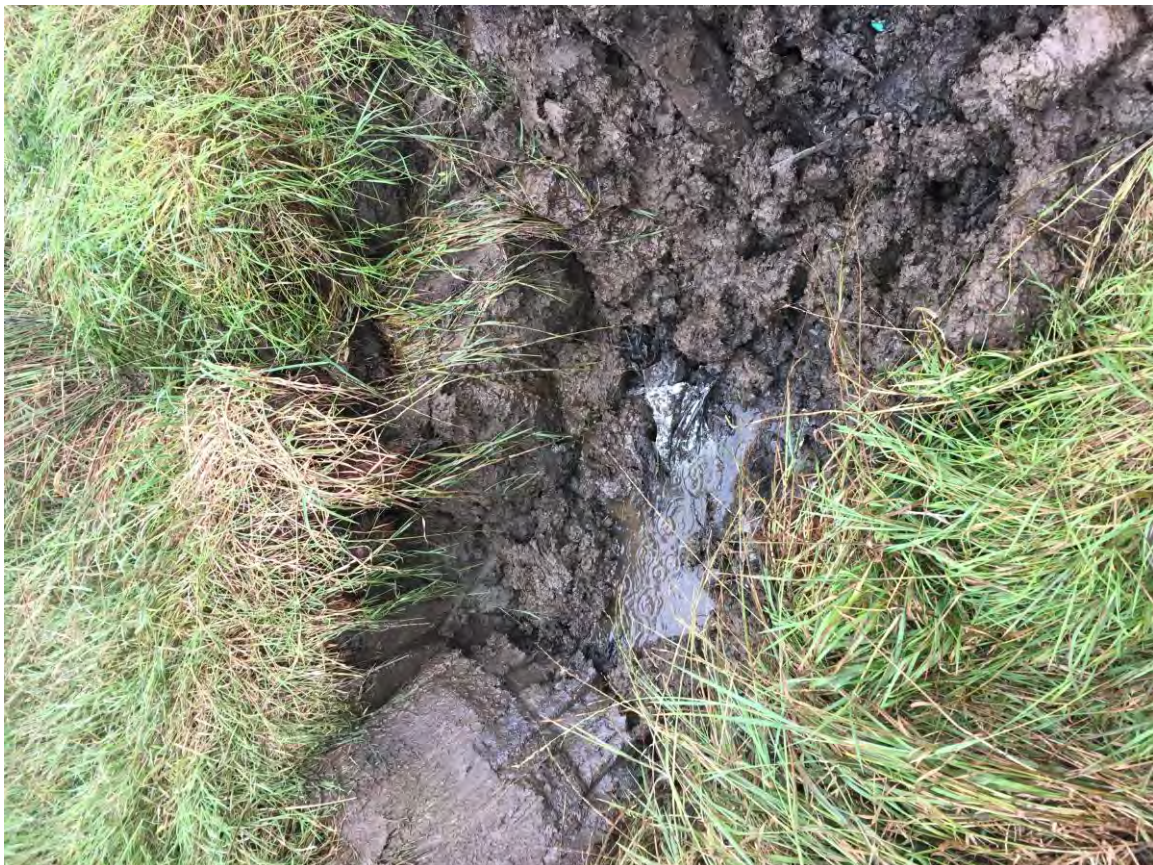
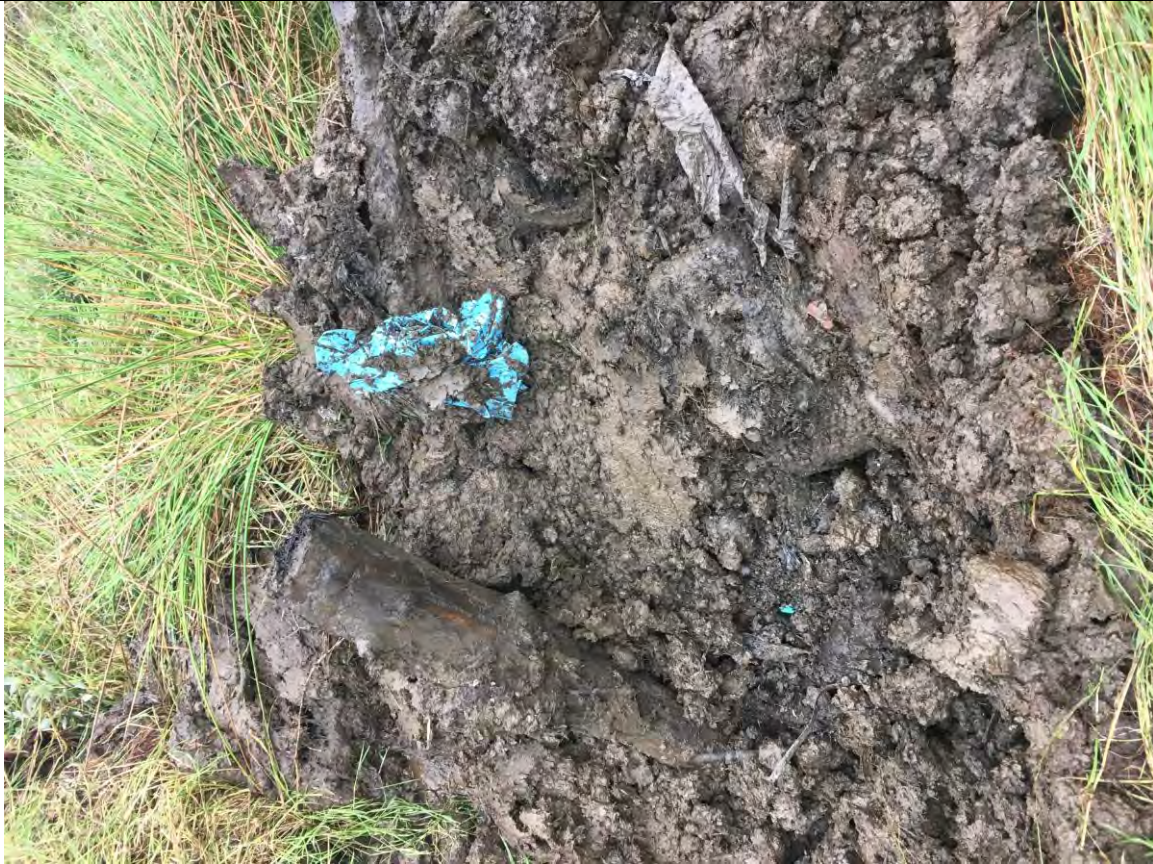
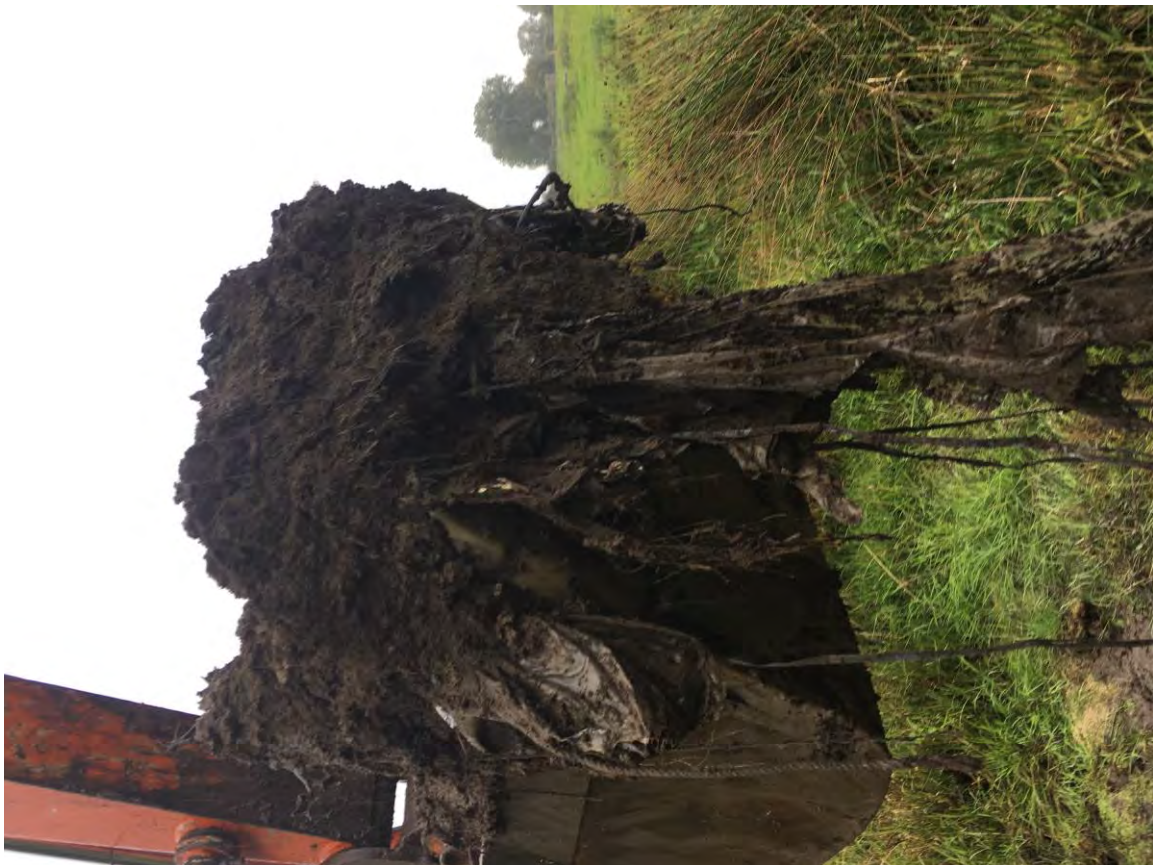
CB – TP08

Stability: Moderate.
Plant: 13t tracked excavator.
Backfill: Arisings.
Groundwater: 0.65m: Fast flow rate.

Remarks: Trial pit terminated at 0.90m bgl, groundwater encountered.
