The Tecpro Building,
Clonshaugh Business & Technology Park,
Dublin 17, Ireland.

ATTACHMENT-4-8-3 COMPLETE BASELINE REPORT

Technical Report Prepared For
Amazon Data Services Ireland Limited

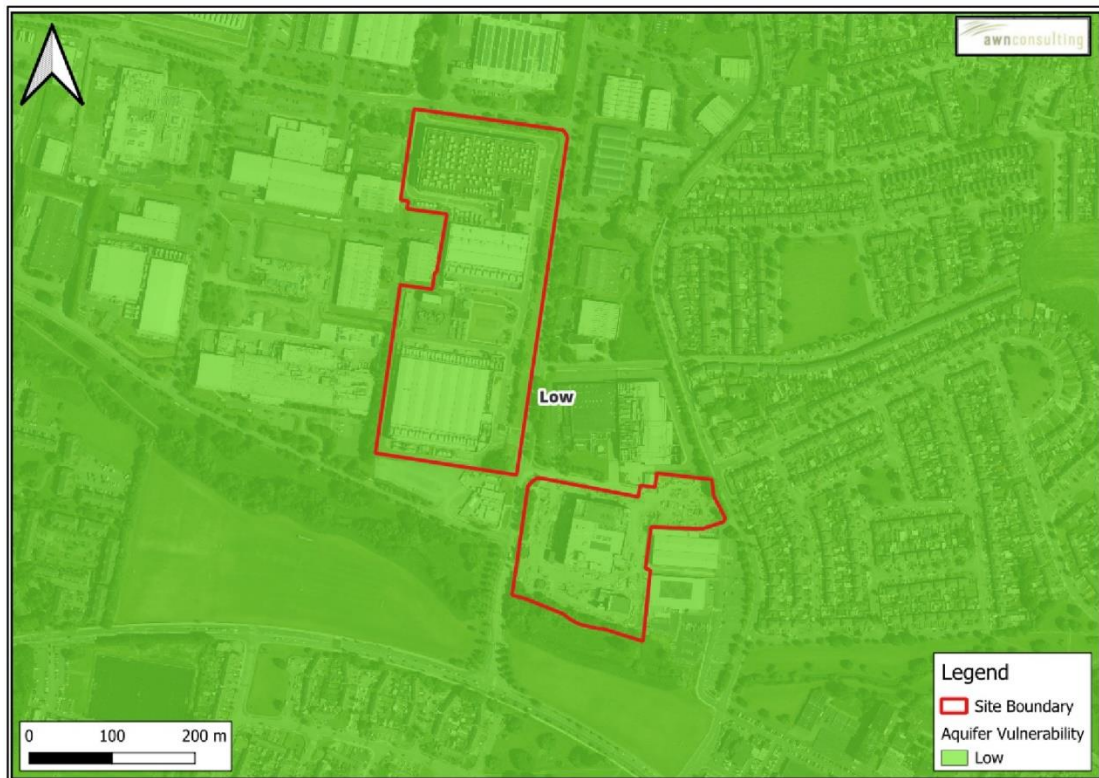
Insert 7.3 Aquifer vulnerability (Source: www.gsi.ie) showing indicative red line boundary

The GSI currently classifies the bedrock aquifer in the region of the existing Installation and extended Installation site as having (L) - Low Vulnerability status across the site and the immediate area of the site (indicating >10 m of low permeability soil).

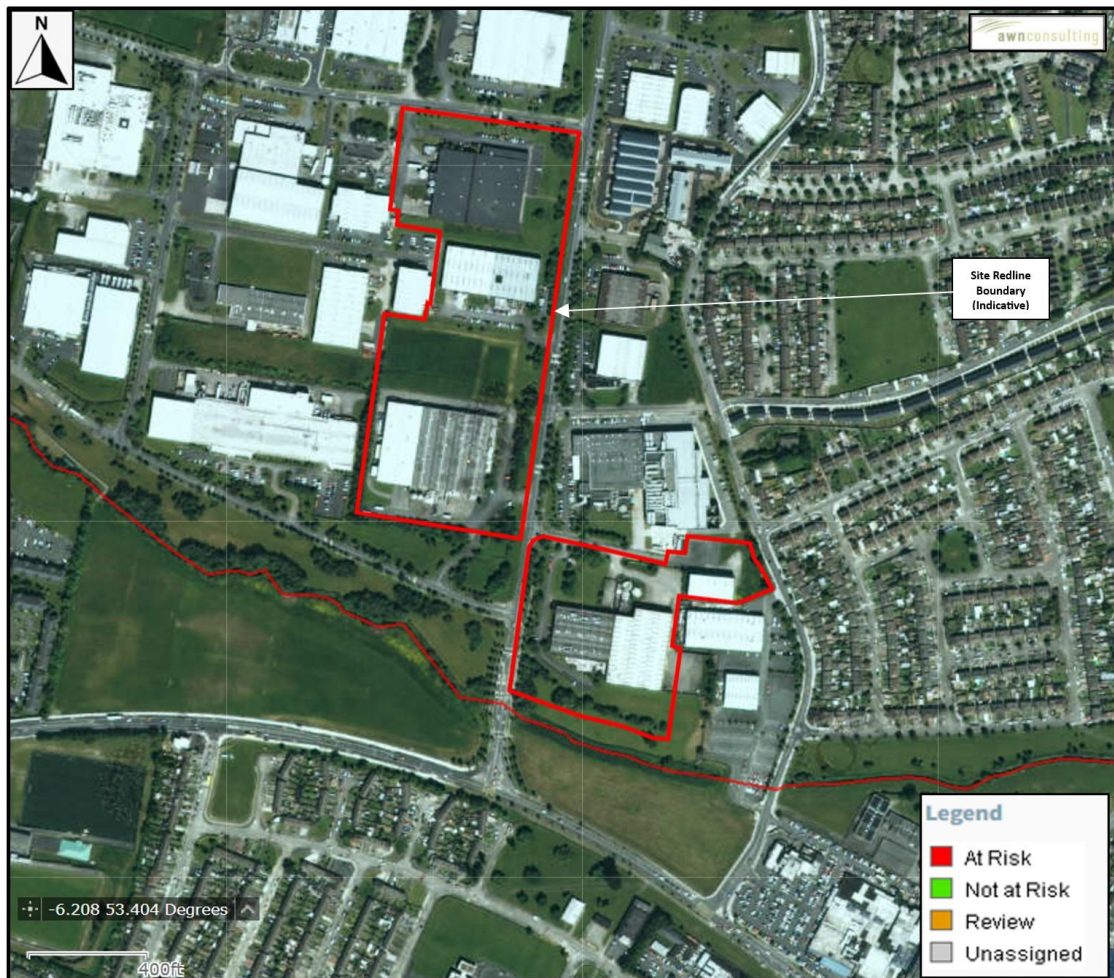
Insert 7.9 River Waterbody Risk - 'At risk of not achieving good status, WFD Ecological Status: Poor. and showing indicative site red line boundary

3' according to its 2022 records, which means a 'Moderately Polluted' status in the river. This is consistent with historical ecological conditions recorded in the Santry River during previous years. Insert 7.9 presents the river waterbody risk EPA map.

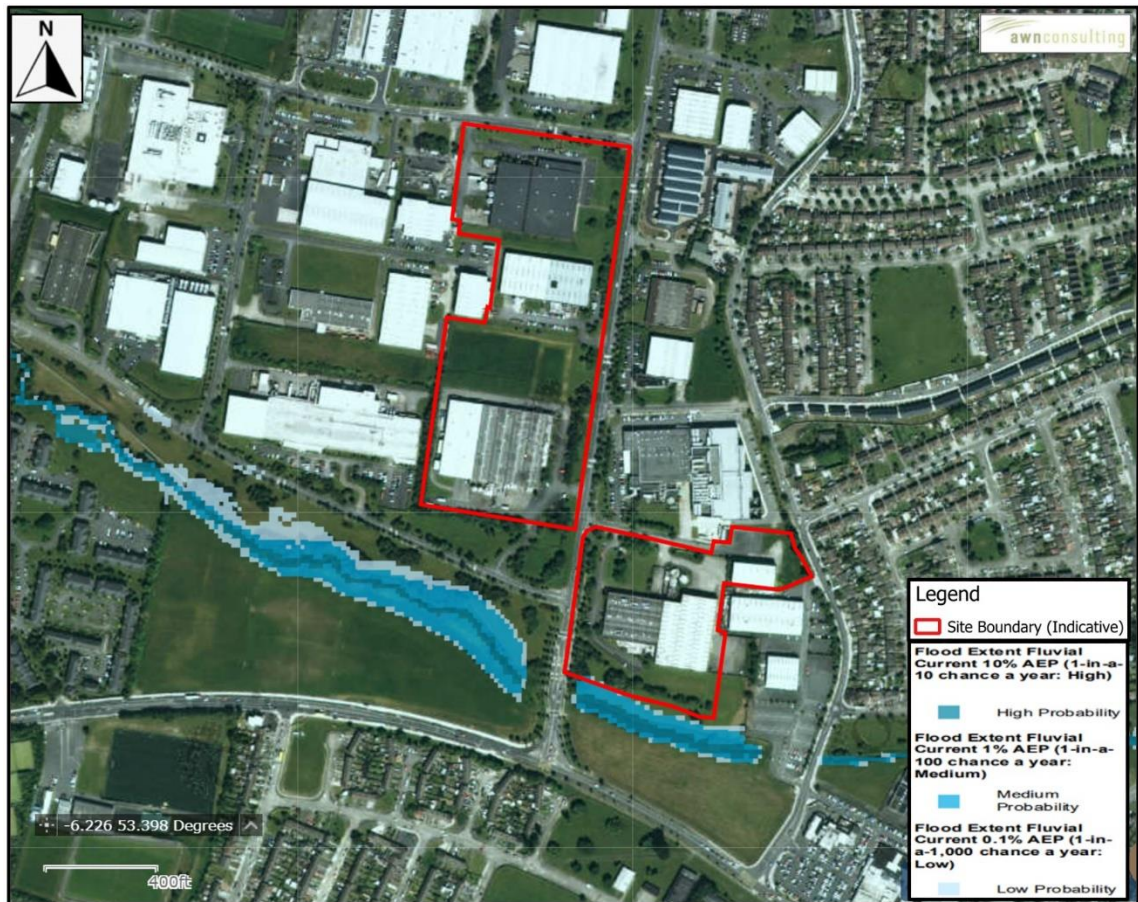
Insert 7.10 Floodinfo.ie extract: The Site Location is Highlighted in Red (indicative red line boundary)

There are no historical flood events in the immediate vicinity of the site.
