# ATTACHMENT-4-8-3 COMPLETE BASELINE REPORT

Technical Report Prepared For

Amazon Data Services Ireland Limited

HB/237501.0453WR0

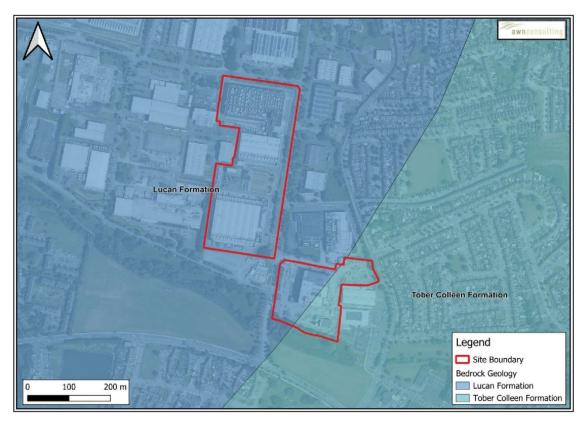
No bedrock outcrop was identified on the sites. In terms of the structural relationship of the area, the GSI database (refer also to Insert 7.1) does not show any faults on the site or within the immediate vicinity of the sites. A synclinal axis line feature does run from south west to north east beneath the Clonshaugh Roundabout to the northwest of the site.

Insert 7.1 Bedrock Geology Map (Source www.gsi.ie) showing indicative red line boundary

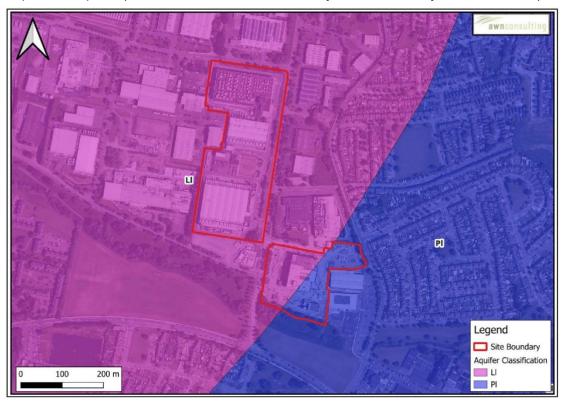
The bedrock aquifer underlying the existing Installation site according to the GSI (<a href="www.gsi.ie/mapping">www.gsi.ie/mapping</a>) National Draft Bedrock Aquifer Map is classified as a Locally Important Aquifer (LI) which is described as Bedrock which is Moderately Productive only in Local Zones. Insert 7.2 presents the current bedrock aquifer map for the area surrounding the site. According to the GSI, the aquifer is not considered to have any primary porosity and flow will be primarily fracture controlled.

According to the GSI National Draft Bedrock Aquifer Map, the bedrock aquifer underlying south-eastern part of the extended Installation, is classified as a 'Poor Aquifer' (PI) which is described as Bedrock which is Generally Unproductive except for Local Zones. The north-western part of the site is, however, classified as a Locally Important Aquifer (LI, Bedrock which is Moderately Productive only in Local Zones).

Insert 7.2 Aquifer Classification map (Source: <a href="www.gsi.ie">www.gsi.ie</a>) showing indicative red line boundary

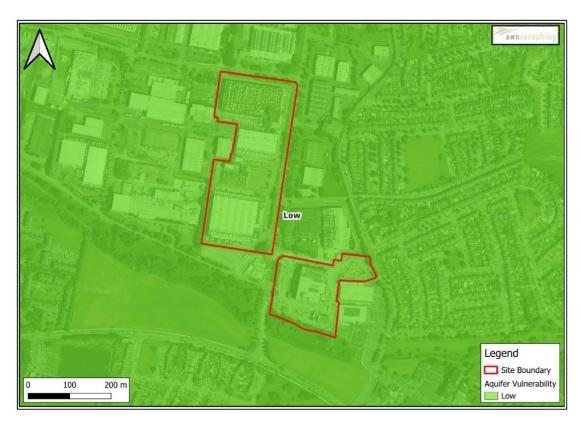
The GSI currently classifies the bedrock aquifer in the region of the existing Installation and extended Installation site as having (L) - Low Vulnerability status across the site and the immediate area of the site (indicating >10 m of low permeability soil).

Insert 7.3 Aquifer vulnerability (Source: <a href="www.gsi.ie">www.gsi.ie</a>) showing indicative red line boundary

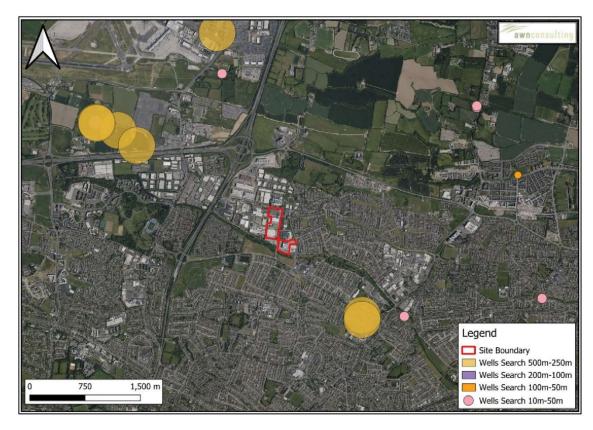
Insert 7.4 below presents the GSI well search for the area surrounding the site (Note this source does not include all wells) and Table 7.1 below summarises the details of some of the wells present within this search area.

Insert 7.4 GSI Well Search (GSI, 2024) showing indicative red line boundary

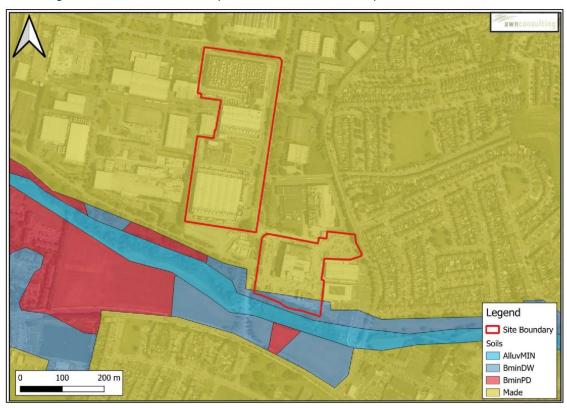
The subsoil has been classified as limestone till (Carboniferous). This is the dominant subsoil type in the region and is a glacial deposit which is known as Dublin Boulder Clay. There is alluvial deposits immediately south of the extended Installation site at the River Santry. The soils and subsoils map for the site is illustrated in Insert 7.5 and 7.6.

Insert 7.5 Soils map (Source: <a href="www.gsi.ie">www.gsi.ie</a>) showing indicative red line boundary

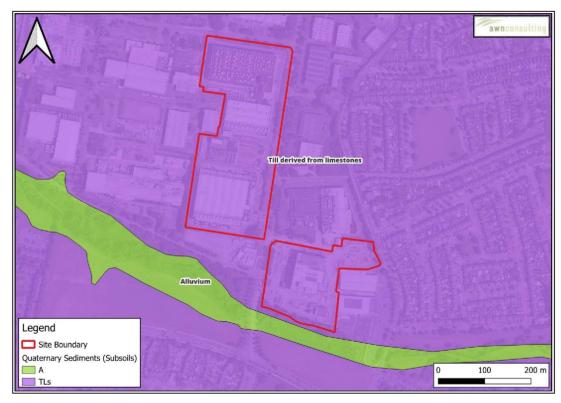
The boulder clays generally exhibit very low permeability in the order of 1x10<sup>-7</sup> to 1x10<sup>9</sup> m/s or lower. The glacial boulder clay will tend to act as an aquitard or aquiclude (a confining layer with low permeability) between the other more permeable formations including the limestone bedrock (fracture dominated flow).

Insert 7.6 Sub-Soils map (Source: <a href="www.gsi.ie">www.gsi.ie</a>) showing indicative red line boundary

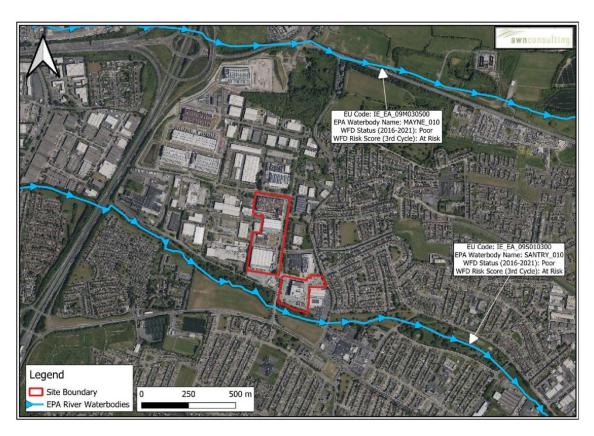
The Santry River flows in a south-easterly direction from the existing and extended Installation site for c. 5.15 km before it outfalls into North Bull Island SPA & North Dublin Bay SAC.

Insert 7.7 Hydrological Environment, illustrating the River Mayne and the Santry River flowing in an easterly direction and showing indicative red line boundary

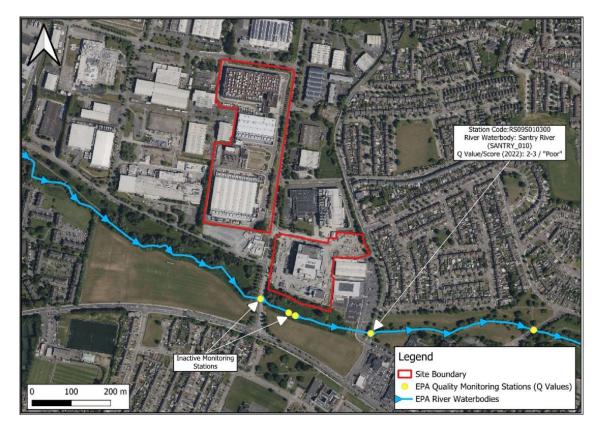
Insert 7.8 Surface Water Quality Monitoring Point (source: www.epa.envision) (Site location indicated with star with monitoring point locations shown with orange circles)

With reference to the site setting, the nearest downstream EPA monitoring station is situated along the Santry River to the south of the site.

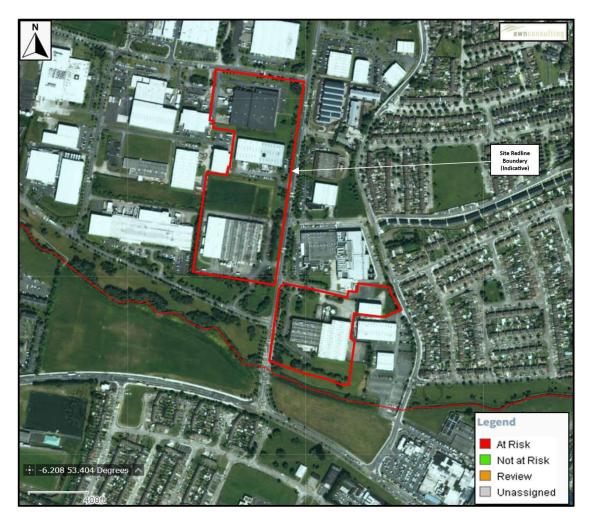
3' according to its 2022 records, which means a 'Moderately Polluted' status in the river. This is consistent with historical ecological conditions recorded in the Santry River during previous years. Insert 7.9 presents the river waterbody risk EPA map.

Insert 7.9 River Waterbody Risk - 'At risk of not achieving good status, WFD Ecological Status: Poor. and showing indicative site red line boundary

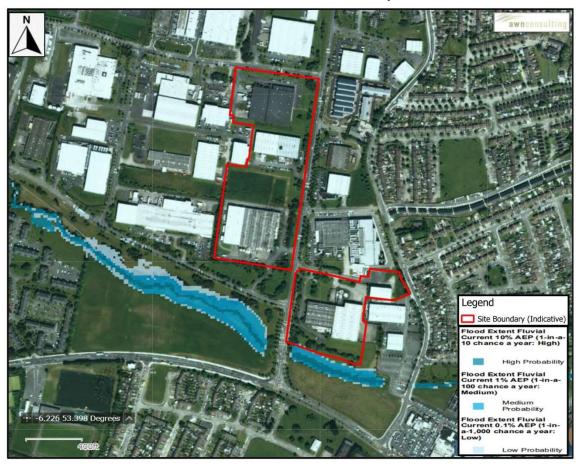
There are no historical flood events in the immediate vicinity of the site.

Insert 7.10 Floodinfo.ie extract: The Site Location is Highlighted in Red (indicative red line boundary)

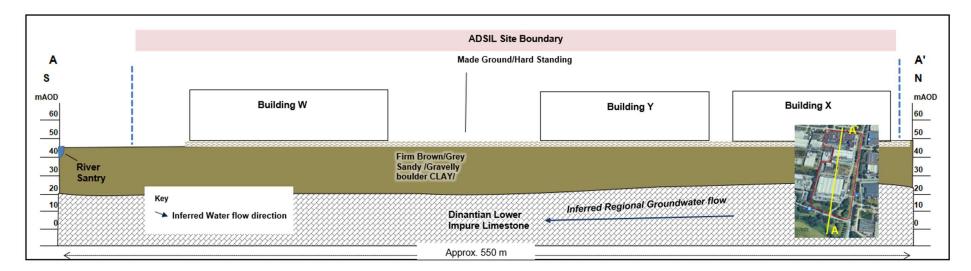
Insert 8.1 A-A' Schematic local cross section showing the ADSIL Existing Installation site

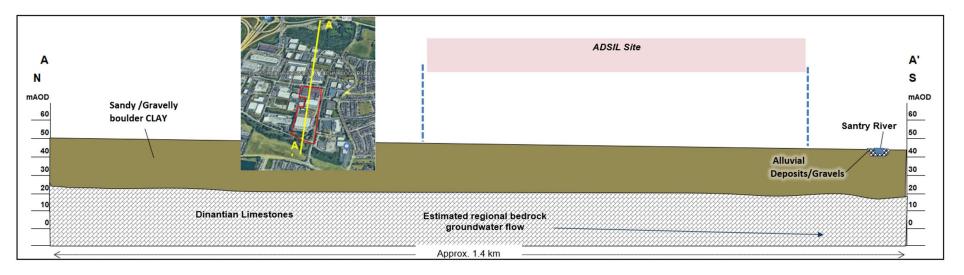
Insert 8.2 A-A' Schematic regional cross section showing the ADSIL Existing Installation site

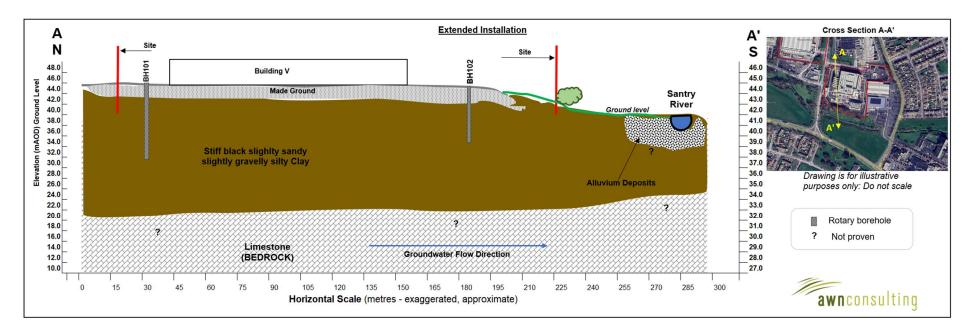
Insert 8.2 A-A' Schematic cross section showing the ADSIL Extended Installation site
