R&A Bailey
IPPC Licence No. P0807-01

Annual Environmental Report
2011

2011 Boiler Combustion Testing Report	29
ATTACHMENT 2	30
2011 Noise Report	30
ATTACHMENT 3	31
Bund Integrity Assessment Report 2011	31

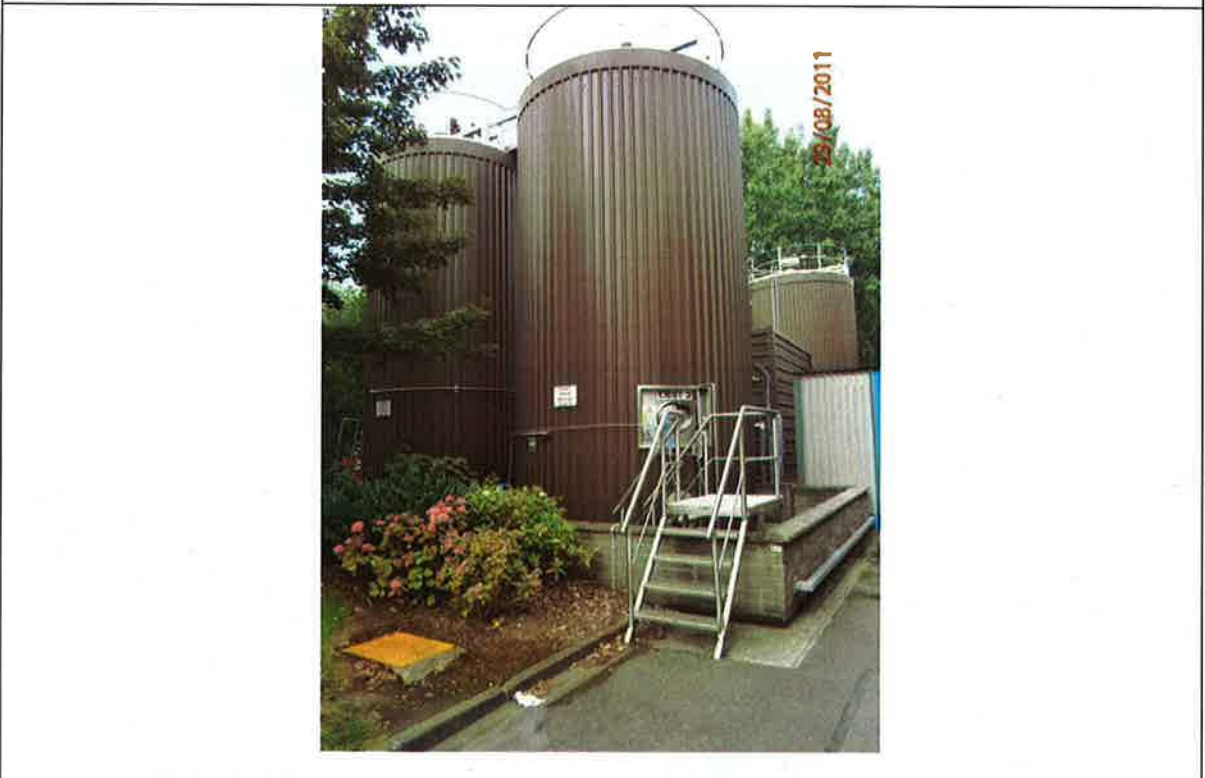
Figure 2.1: Bund 02

Company: Diageo Baileys Global Supply		Bund Location:		
Site: DBGS, Nangor Road		Southwest end of site		
PM Bund Ref. No.: Bund 02 For Cream Blend Storage Tanks 3&4		Photo: Figs. 2.1-2.5		
Bund Dimensions: 10m x 6.4m x 0.75m H		Vessel(s) – Materials of Construction: Steel, jacketed with glycol		
Bund Materials of Construction: Breeze block walls with concrete base		Vessel(s) – Total Storage Volume: 117m ³		
Bund Lining Material: N/A		Vessel(s) – 110% of Volume of Largest Vessel: 60.5m ³		
Bund Retention Volume: 45.6m ³ (measured)		Vessel(s) – 25% of Total Storage Volume: 29.3m ³		
Tank Contents: Cream Blend (2 x 55m ³) Glycol (estimate 1 x 3m ³ , 1 x 4m ³)	WKG Class	Risk Phrases	BOD Load	Haz Category

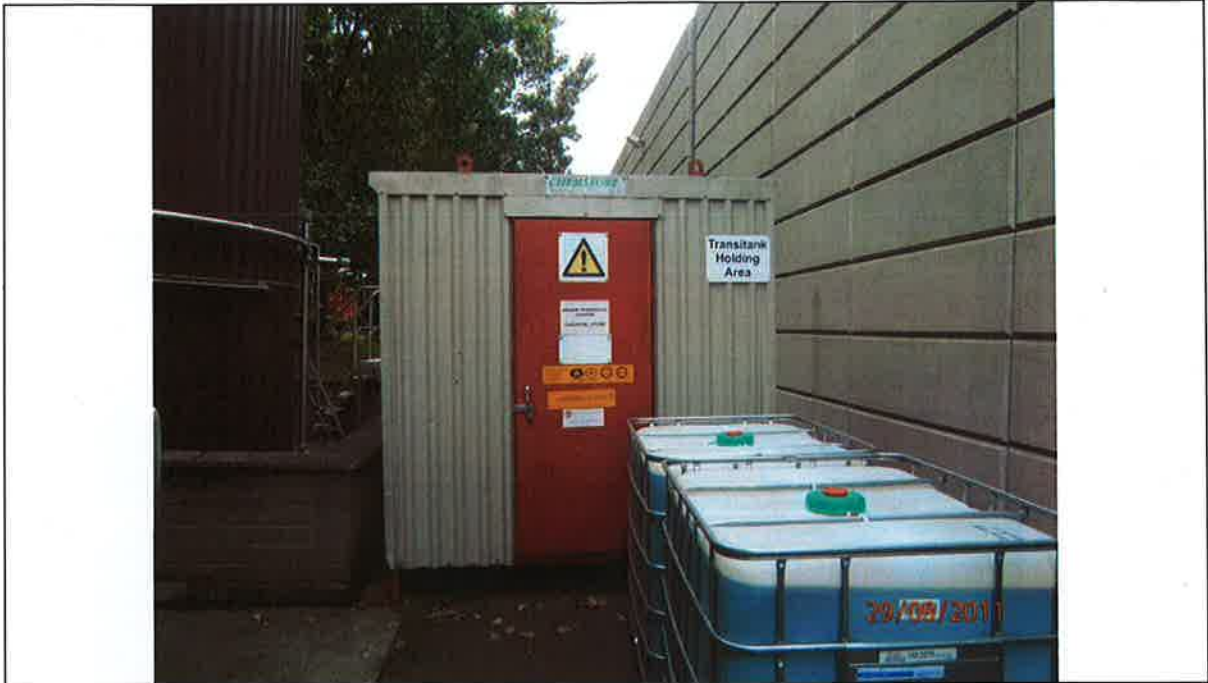
Figure 5.1: Bund 05

Company: Diageo Baileys Global Supply		Bund Location:	
Site: DBGS, Nangor Road		In front of Bund 01, at southwest end of site	
PM Bund Ref. No.: Bund 05 Brand Technical Centre Hazardous Waste Store (Chemstore)		Photo: Figs. 5.1 - 5.4	
Bund Dimensions: 1.3m x 1.3m x 0.12mH		Vessel(s) – Materials of Construction: Mixture of Plastic and Glass containers	
Bund Materials of Construction: Galvanised Steel		Vessel(s) – Total Storage Volume: up to 912L	
Bund Lining Material: N/A		Vessel(s) – 110% of Volume of Largest Vessel: 55L	
Bund Retention Volume: 200l		Vessel(s) – 25% of Total Storage Volume: up to 228L approx.	
Tank Contents: Approx. 40 x 50ml Various Flavours Approx. 40 x 1l Various Flavours Approx. 45 x 5l Various Flavours Approx. 70 x 50ml-3l Various Lab Chemicals 3 x 2.5l Acetonitrile & Sodium Methoxide 3 x 2.5l Dichloromethane 1 x 50l Urea (lab waste for disposal) 1 x 25l Cleaner (peroxyacetic acid) 4 x 25l drums of solvent 7 x 25l drums of Flavouring 2 x 25l Spartan P220 (degreaser) 1 x 5l Waste Cream 3 x 5l drums of unknown substance (unlabelled) + Miscellaneous	WGK Class	Risk Phrases	Haz Category

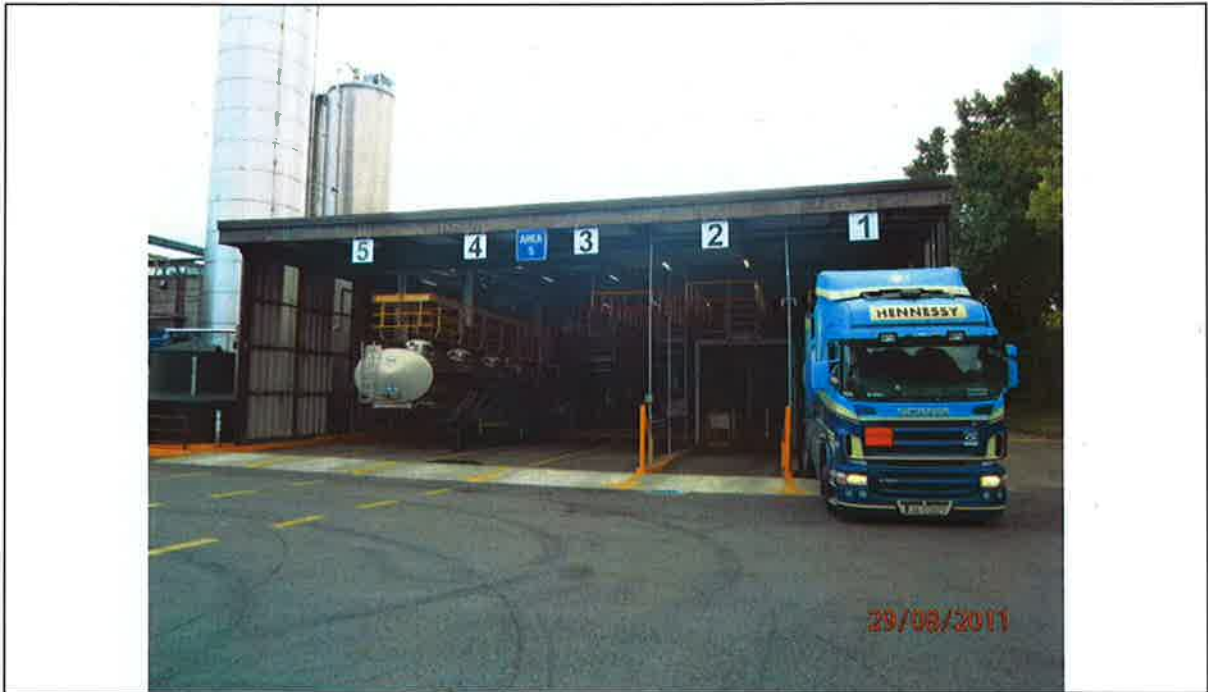
Fig. 6.1: Bund 06

Company: Diageo Baileys Global Supply		Bund Location:			
Site: DBGS, Nangor Road		To west of site opposite the Boiler House			
PM Bund Ref. No.: Bund 06 Cream & Alcohol Bulk Intake Area (2 separate sections)		Photo: Fig. 6.1-6.2			
Bund Dimensions: See sketch Fig. 6.6 in Appendix 2		Vessel(s) – Materials of Construction: Steel			
Bund Materials of Construction: Concrete		Vessel(s) – Total Storage Volume: 7m ³ (volume of one tanker compartment)			
Bund Lining Material: N/A		Vessel(s) – 110% of Volume of Largest Vessel: 7.7m ³			
Bund Retention Volume: Uncertain, vol of alcohol section estimated by DBGS at 9m ³		Vessel(s) – 25% of Total Storage Volume: N/A			
Tank Contents:		WGK Class	Risk Phrases	BOD Load	Haz Category
Cream (50% fat)		-	-	3,500kg (based on 100% of 1 compartment vol)	A
Alcohol (96%)		1	R11	-	A
Compatibility of Chemicals in Bund: No compatibility issue					
Results of Visual Inspection		Date of Visual Inspection: 29/08/2011

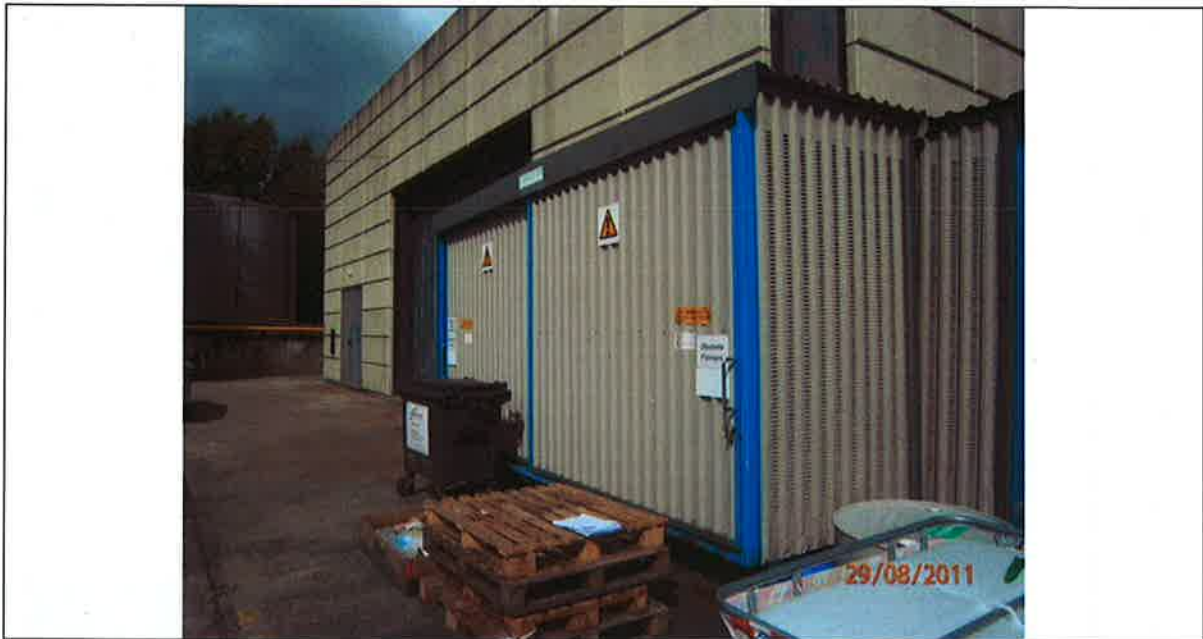
Figure 10.2: Bund 10 – Containment gaps in SW corner

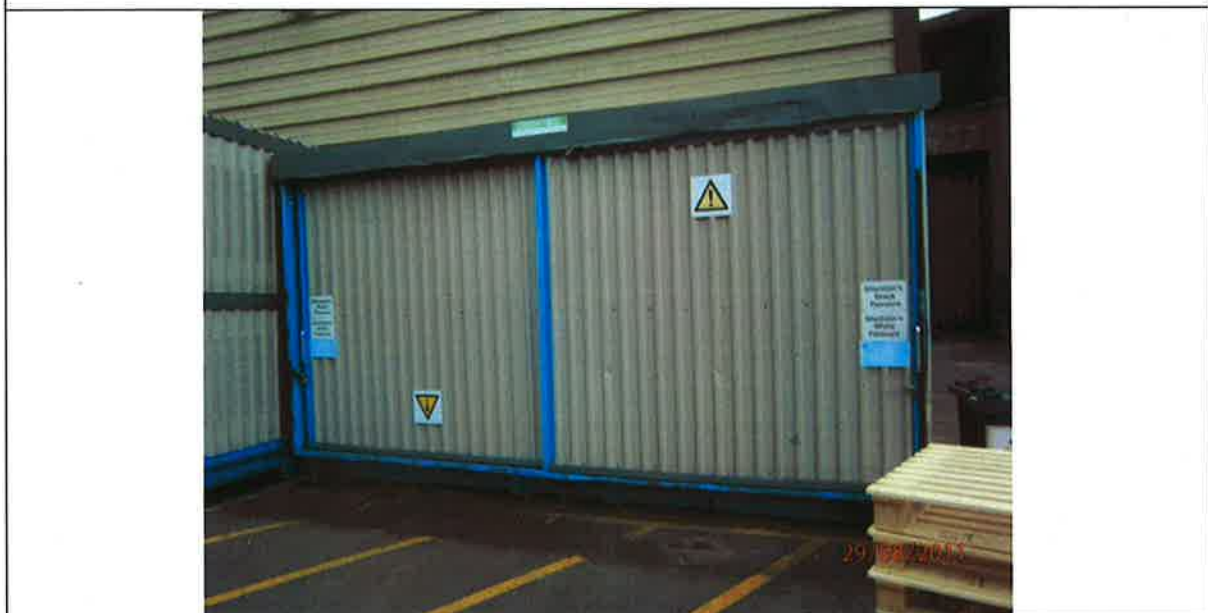
Fig. 14.2: Rusting at base of Bund 14

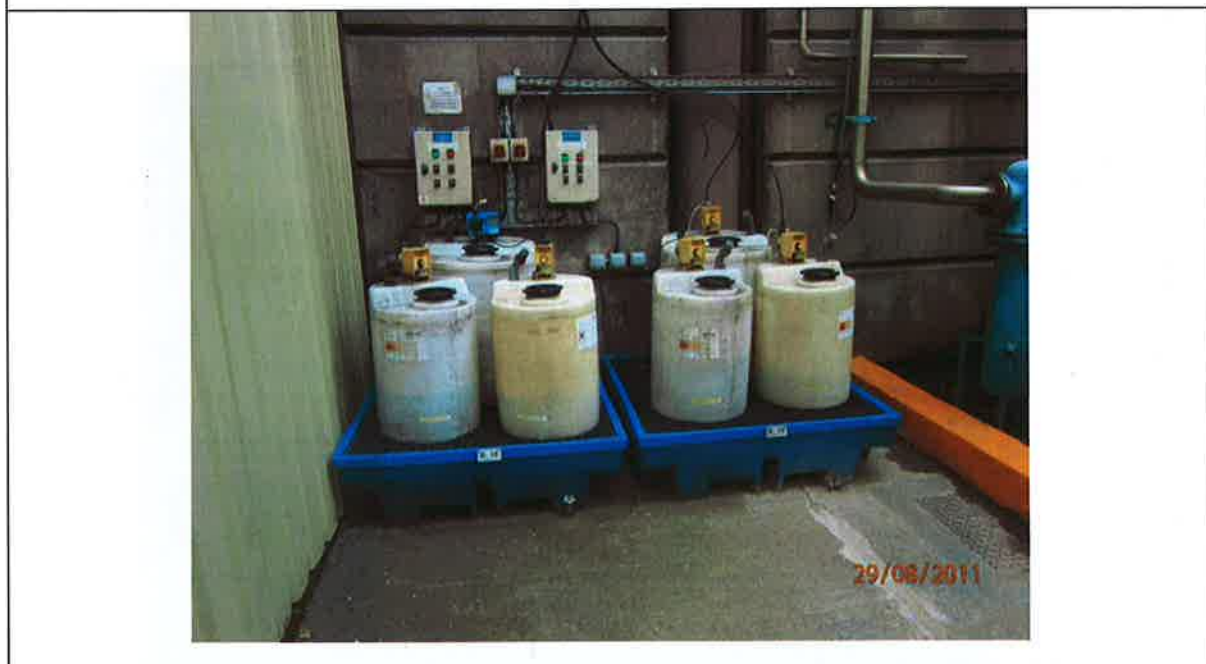
Fig. 17.2: Spill around detergent tank

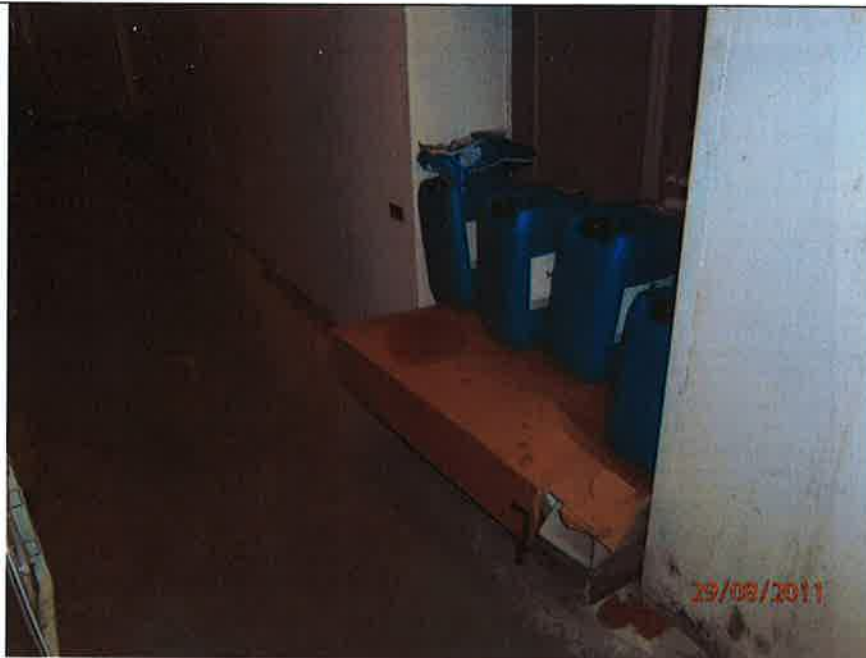
Fig. 20.3: Bund 20 – Cable breach of bund wall

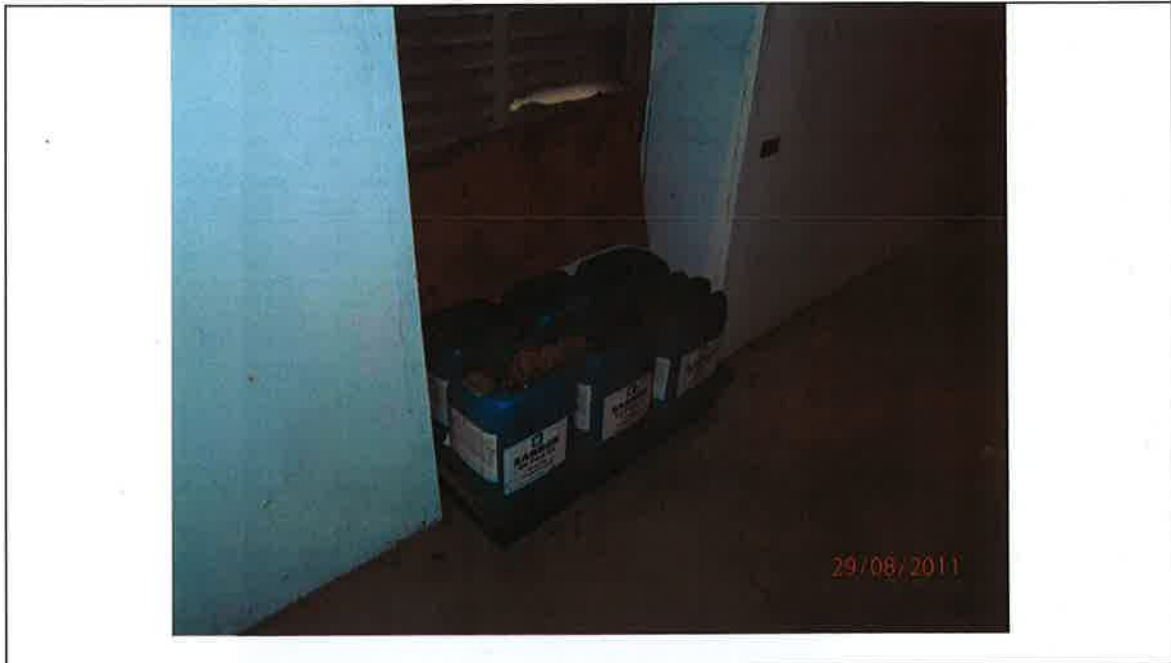
Fig. 21.1: Bund 21

Company: Diageo Baileys Global Supply		Bund Location:	
Site: DBGS, Nangor Road		In Refrigeration Building	
PM Bund Ref. No.: Bund 21 & 22 Small Bucket Bunds		Photo: Fig. 21.1 & 22.1	
Bund Dimensions: 0.92m x 0.48m x 0.12mH each		Vessel(s) – Materials of Construction: Mostly plastic + 1 metal bucket	
Bund Materials of Construction: Plastic		Vessel(s) – Total Storage Volume: Bund 21: 200l Bund 22: 120l	
Bund Lining Material: N/A		Vessel(s) – 110% of Volume of Largest Vessel: 22l	
Bund Retention Volume: 53l each		Vessel(s) – 25% of Total Storage Volume: Bund 21: 50l Bund 22: 30l	
Tank Contents: Bund 21: 10 x 20l Sabroe Synthetic Refrigeration Oil Bund 22: 6 x 20l Sabroe Synthetic Refrigeration Oil	WGK Class	Risk Phrases	Haz Category
	2	R45	A
	2	R45	
Compatibility of Chemicals in Bund: No compatibility issue – refrigerants stored together			
Results of Visual Inspection		Date of Visual Inspection: 29/08/2011

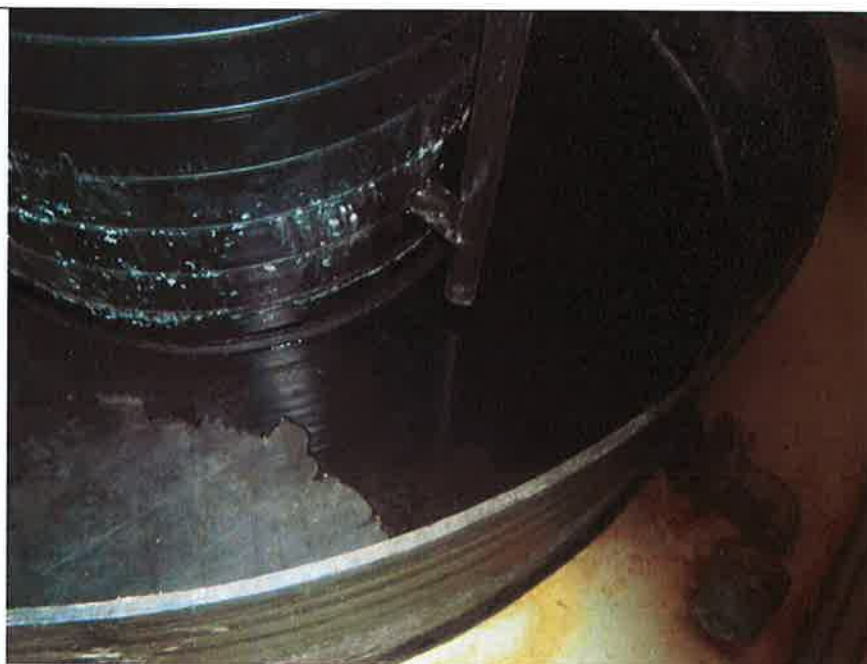
Fig. 25.2: Bund 25 – Liquid retention in bund

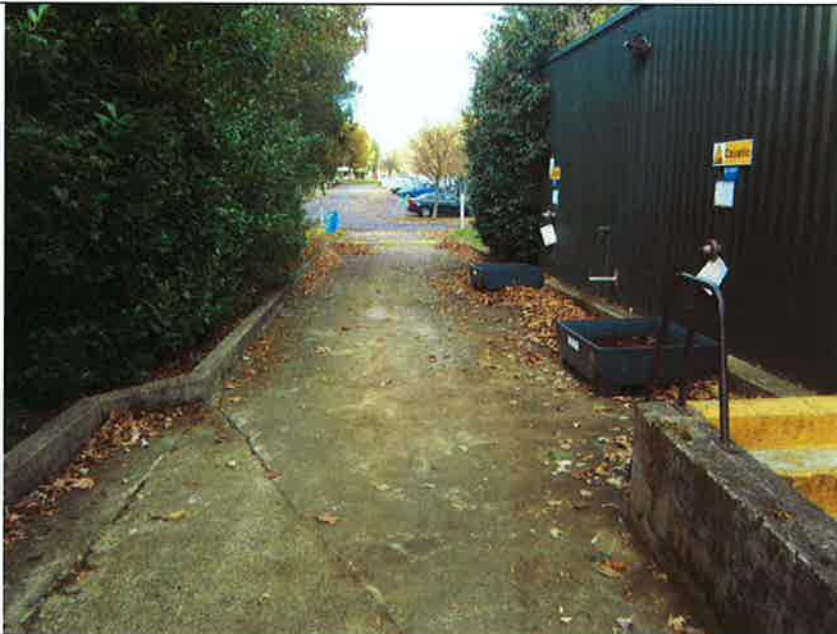
Fig. 27.2: Bund 27 – connection point for acid delivery does not extend over grey Chemstore container

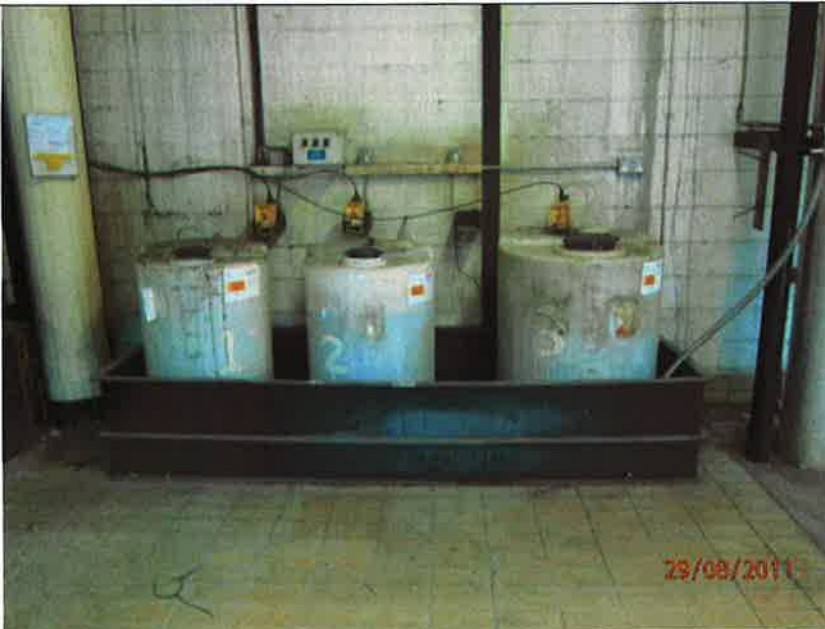
Fig 29.1: Bund 29 - Chemical Additives for Boilers

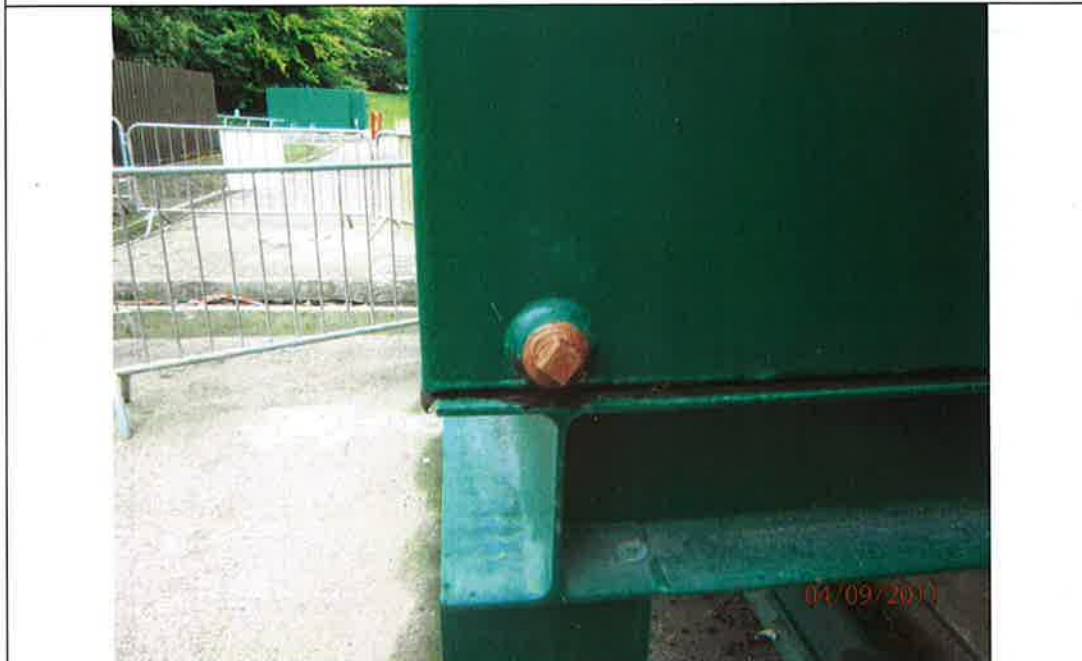
Company: Diageo Baileys Global Supply		Bund Location:	
Site: DBGS, Nangor Road		Westside of Boiler House	
PM Bund Ref. No.: Bund 39 Diesel Tank		Photo: Fig. 39.1 & 39.2	
Bund Dimensions: Approx 5.7m x 1.5m x 0.3mH		Vessel(s) – Materials of Construction: Plastic and steel	
Bund Materials of Construction: Galvanised Steel		Vessel(s) – Total Storage Volume: 4m ³	
Bund Lining Material: N/A		Vessel(s) – 110% of Volume of Largest Vessel: 4.4m ³	
Bund Retention Volume: 2.6m ³		Vessel(s) – 25% of Total Storage Volume: 1m ³	
Tank Contents: Diesel (approx 4m ³)	WGK Class	Risk Phrases	Haz Category
	2	R40	B
Compatibility of Chemicals in Bund: N/A			
Results of Visual Inspection		Date of Visual Inspection: 29/08/2011	
<u>Bund & Tank Integrity:</u> Bund in good condition. No evidence of leaks or cracks.			
<u>Bund Drainage System:</u> Local bunding– Outlet at base of tank for decanting			
<u>General Observations:</u> Double Skinned tank- tank not labelled

Fig. 39.2: Bund outlet at base for decanting
